## REPORT ON STRUCTURAL CONDITION OF BOAT SHED No. 21, LAKE WENDOUREE

Inspected Property Address:	Boat Shed No. 21 Lake Wendouree, VIC 3350
Client Details:	Mick Harris
Client Attended Inspection:	Yes
Contract Details:	Site assessment to provide advice on the structural condition of Boat Shed No. 21
Inspection Date and Time:	9.30am, 27 <sup>th</sup> May 2020
Building Consultant:	Jason Kern, BPB Reg: EC-2236
Contact:	Phone: 0439 313 142
Address:	963 Sebastopol Smythesdale Road, Ross Creek VIC 3351

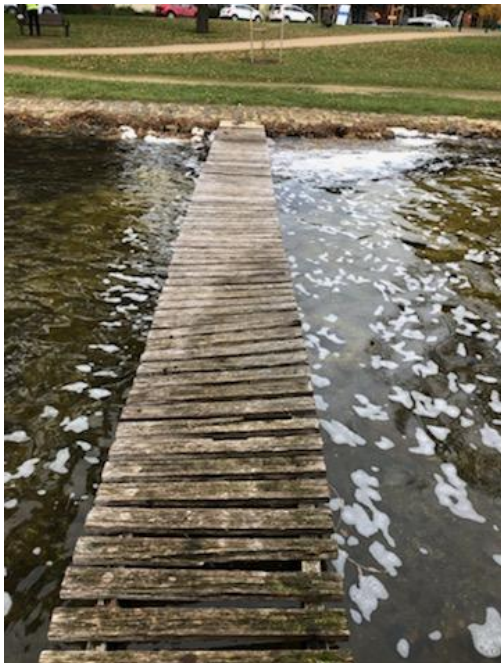
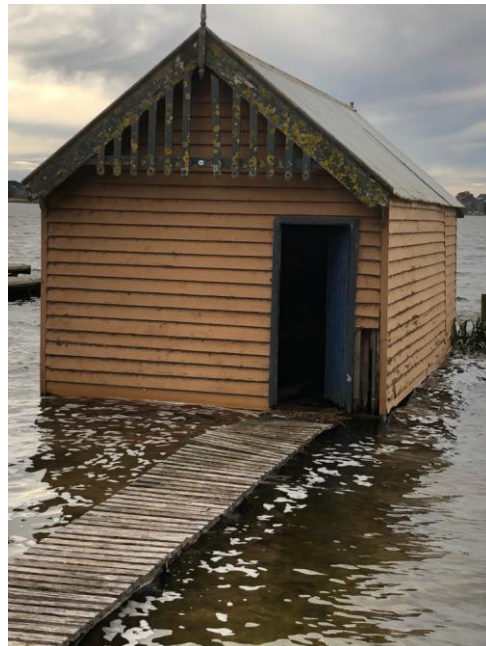
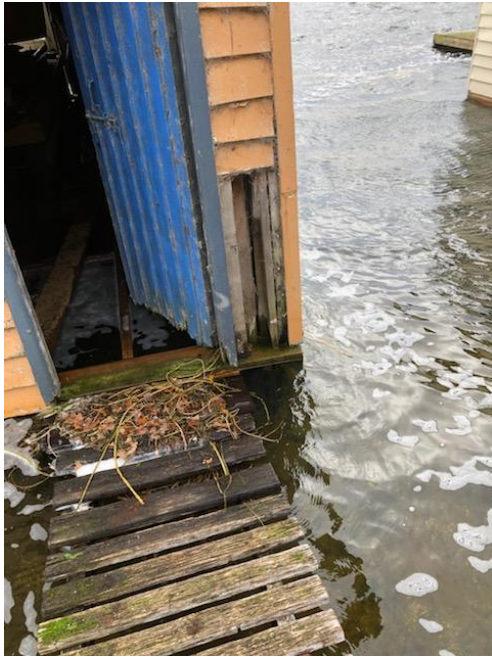
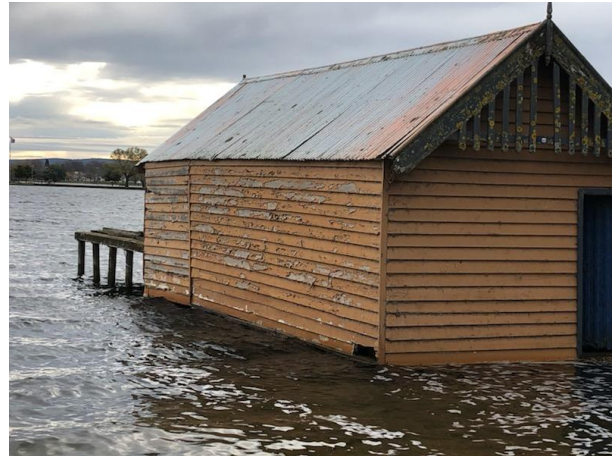
General view of access and condition of the external elements of the Boat Shed.

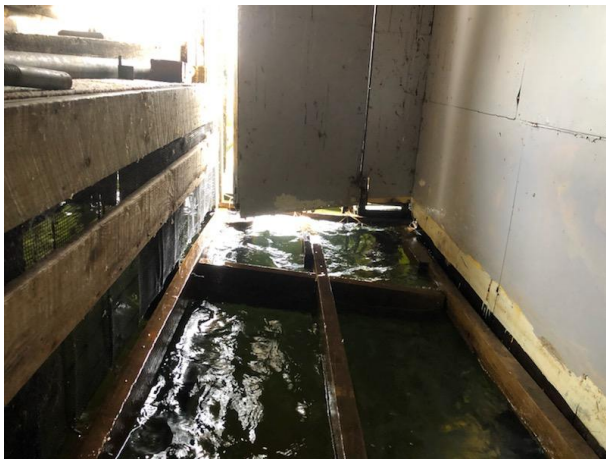
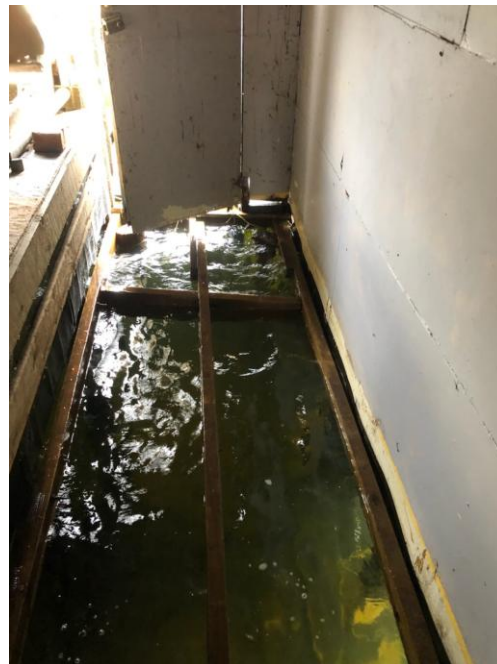
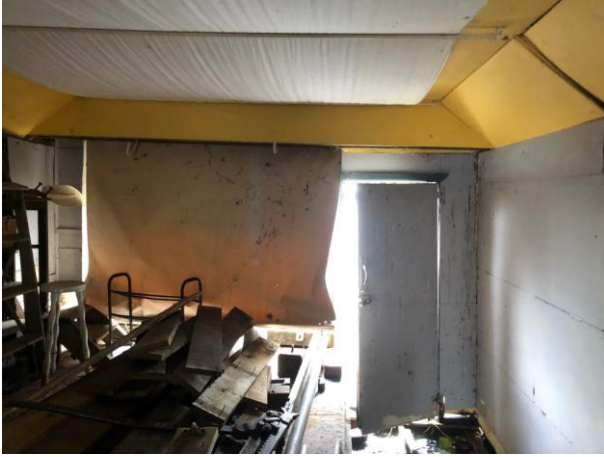
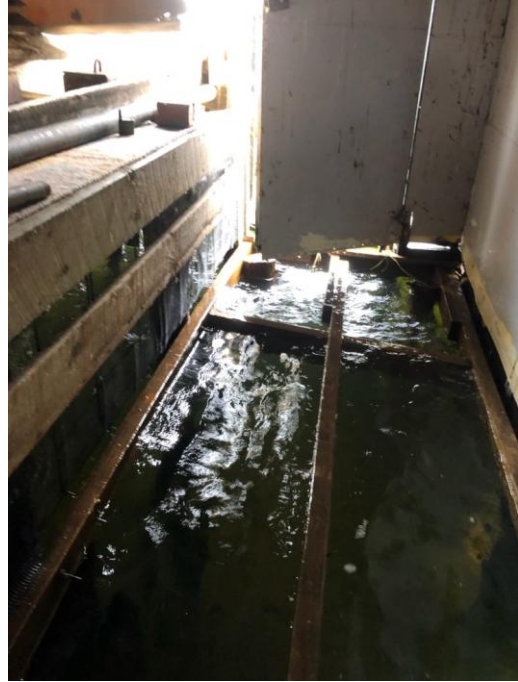
The structure has dropped at the rear (North Eastern corner).

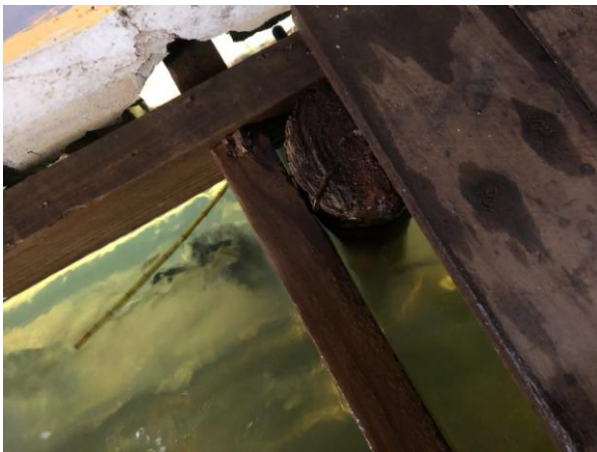
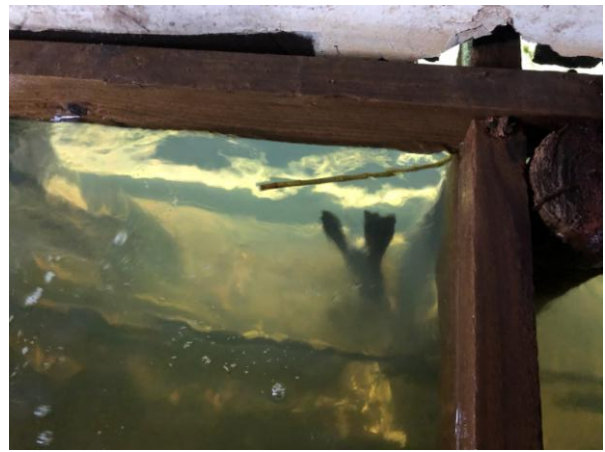
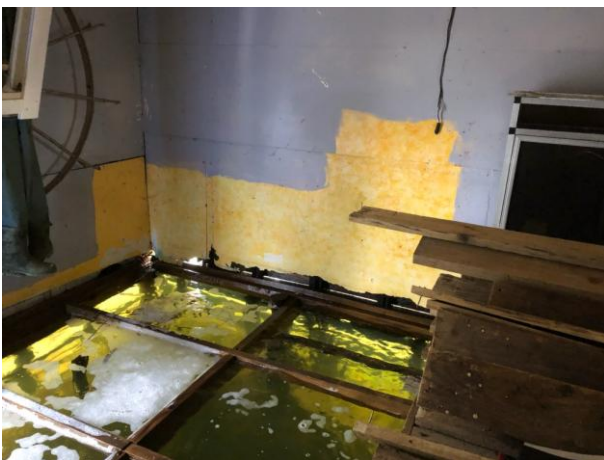
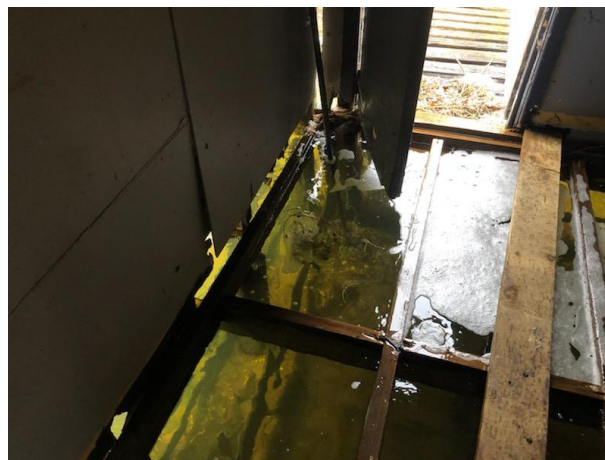
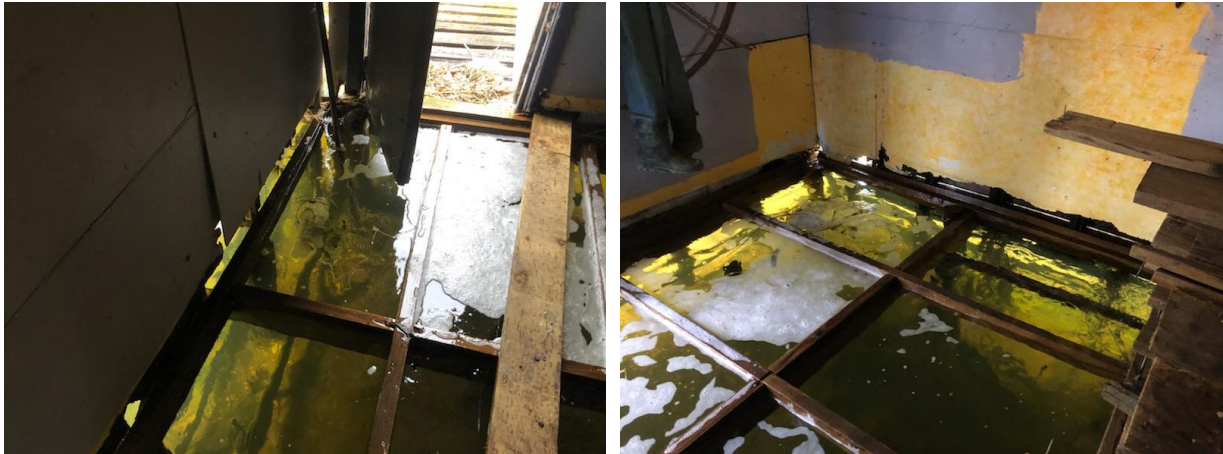
There is evidence of rectification works to the piles and subfloor. Physical separation of the subfloor and walling is also evident. Planks are also needed to safely access the Boat Shed as no decking/flooring remains. All of which indicates that the rectification works were either ineffective, poorly implemented or a combination of both.

There is no simple solution to rectifying the current failures of the wall framing and subfloor members. The building needs rebuilding from ground up. Even the access bridge to the building is in need of rebuilding and is currently unsafe.

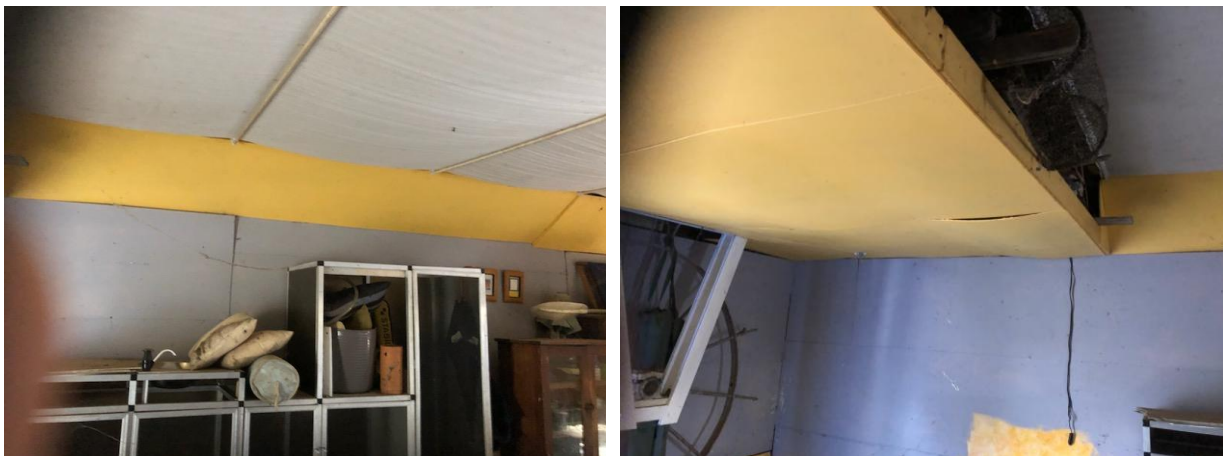
Evidence of stresses being applied to the cement sheet lining to the Boat Shed. This lining is providing stability to a frame that has essentially rotted and separated from the subfloor. If the lining fails the loss of support could result in frame failure and visible damage to the structure as a whole.

A significant issue with the building is the fact that the subfloor is immersed. The floor level is too low and as such the wall framing is constantly wetting and drying which has resulted in failure of the connection to the subfloor. The Eastern wall is physically loose and disconnected in part from the subfloor. Ongoing decay and loss of connection could result in the collapse of the wall and the building as a whole. The cement sheet lining to the building is providing structural support to the frame but is showing stress, evidenced by bulging of the sheeting and disconnection from the wall framing.
