# FORMER PENTRIDGE PRISON - LAUNDRY

EXTRACT FROM HERITAGE INFRASTRUCTURE  
AUDIT UPDATE 2023

Urquhart Street, Wardens Walk, Stockade Avenue and Via Roma -  
Coburg, Merri Bek

November 2023

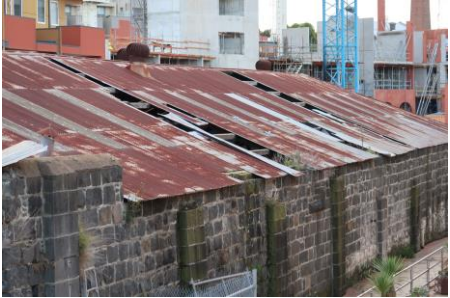
<b>L.01 - Corrugated roof</b>

<p>Image 1. 2023 – Corrugated roofing</p>	
<p><i>Condition: (P) = Poor, (F) = Fair, (G)= Good</i></p>		<i>P</i>
<p><i>Works Completed 2020-2023:</i></p> <p><b>Status:</b> No works completed to date. Roof to former laundry building in severely decayed condition, with many sections of sheeting missing.</p>		
<p><i>Recommended works:</i></p> <ul style="list-style-type: none"> <li>• Replace corrugated roof in its entirety to match existing profile, slope, and material.</li> </ul>		
<p><i>Priority: Urgent</i></p>

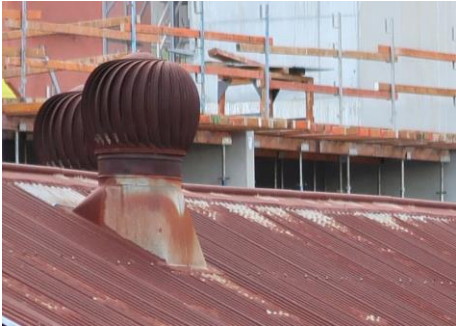
<b>L.02 - Ridge/hip capping</b>

<p>Image 1. 2023 – Ridge capping</p>	
<p><i>Condition: (P) = Poor, (F) = Fair, (G)= Good</i></p>		<i>P</i>
<p><i>Works Completed 2020-2023:</i></p> <p><b>Status:</b> No works completed to date. All cappings severely corroded.</p>		
<p><i>Recommended works:</i></p> <ul style="list-style-type: none"> <li>• Install new galvanised roll top ridge capping to ridge and hips.</li> </ul>		
<p><i>Priority: Urgent</i></p>

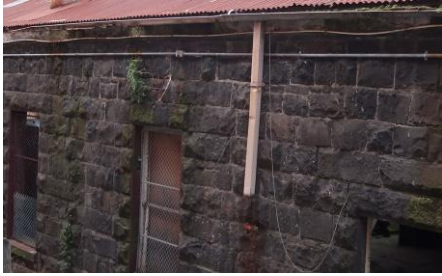
<b>L.03 - Rainwater goods</b>

<p>Image 1. 2023 – Corrugated Roofing</p>	
<p><i>Condition: (P) = Poor, (F) = Fair, (G)= Good</i></p>		<i>P</i>
<p><i>Works Completed 2020-2023:</i></p> <p><b>Status:</b> No works completed to date. Rainwater goods failing or missing completely.</p>		
<p><i>Recommended works:</i></p> <ul style="list-style-type: none"> <li>• Supply and install all new eaves/box gutters as applicable, downpipes, clips and the like to North, East, and West elevations. Connect to legal point of discharge.</li> </ul>		
<p><i>Priority: Urgent</i></p>

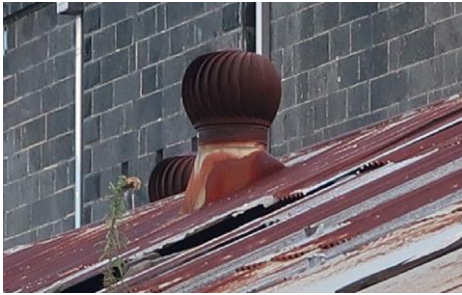
<b>L.04 - Roof vents/cowls</b>

<p>Image 1. 2023 – Roof vents/cowls</p>	
<p><i>Condition: (P) = Poor, (F) = Fair, (G)= Good</i></p>		<i>P</i>
<p><i>Works Completed 2020-2023:</i></p> <p><b>Status:</b> No works completed to date. Existing cowls to roof in decayed and corroded condition.</p>		
<p><i>Recommended works:</i></p> <ul style="list-style-type: none"> <li>• Pending future use of the building, remove or replace cowls to ensure roof is made weathertight..</li> </ul>		
<p><i>Priority: Urgent</i></p>

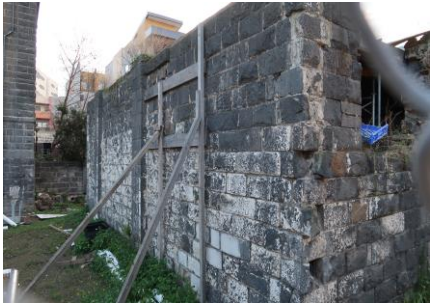
L.05 - Bluestone walls - south

<p>Image 1. 2023 – Bluestone wall, south elevation</p>	
Condition: (P) = Poor, (F) = Fair, (G)= Good		P
<p><i>Works Completed 2020-2023:</i></p> <p><b>Status:</b> No works completed to date. Visible lean to existing bluestone wall, does not appear sufficiently braced by adjacent walls.</p>		
<p><i>Recommended works:</i></p> <ul style="list-style-type: none"> <li>Engage structural engineer for advice. Allow to dismantle and rebuild full extent of wall.</li> </ul>		
<p><i>Priority:</i> Urgent</p>

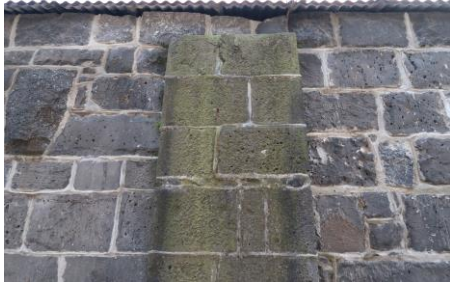
L.06 - Bluestone walls

<p>Image 1. 2023 – Bluestone wall</p>	
Condition: (P) = Poor, (F) = Fair, (G)= Good		F
<p><i>Works Completed 2020-2023:</i></p> <p><b>Status:</b> No works completed to date. Significant organic growth can be seen across and atop all bluestone walls due to lack of rainwater goods.</p>		
<p><i>Recommended works:</i></p> <ul style="list-style-type: none"> <li>Undertake full façade clean to remove organic growth, using non-toxic cleaning solution.</li> </ul>		
<p><i>Priority:</i> A</p>

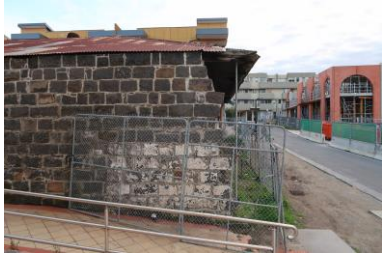
L.07 - Bluestone walls

<p>Image 1. 2023 – Bluestone wall</p>
<p><i>Condition: (P) = Poor, (F) = Fair, (G)= Good</i></p>	
<p><i>P</i></p>	
<p><i>Works Completed 2020-2023:</i></p> <p><b>Status:</b> No works completed to date. North wall entirely missing, with adjacent walls partially collapsed.</p>	
<p><i>Recommended works:</i></p> <ul style="list-style-type: none"> <li>Make safe areas of bluestone wall which are falling away.</li> <li>Dismantle and rebuild sections of rotated or missing bluestone.</li> </ul>	
<p><i>Priority: Urgent</i></p>

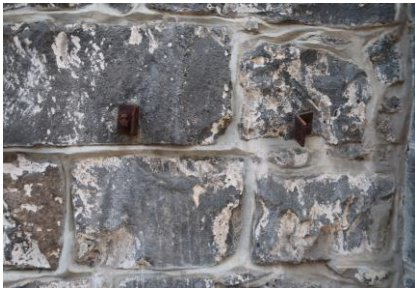
L.08 - Embedded metal

<p>Image 1. 2023 – Embedded metal</p>
<p><i>Condition: (P) = Poor, (F) = Fair, (G)= Good</i></p>	
<p><i>F</i></p>	
<p><i>Works Completed 2020-2023:</i></p> <p><b>Status:</b> No works completed to date. Several redundant items embedded in both internal and external faces of bluestone.</p>	
<p><i>Recommended works:</i></p> <ul style="list-style-type: none"> <li>Carefully remove all redundant embedded items and repair substrate</li> </ul>	
<p><i>Priority: B</i></p>

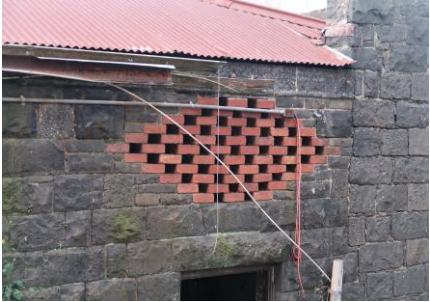
L.09 - Brickwork

Condition: (P) = Poor, (F) = Fair, (G)= Good		F
<p><i>Works Completed 2020-2023:</i></p> <p><b>Status:</b> No works completed to date. Minor deformation of decorative brick vent to west elevation</p>		
<p><i>Cyclical works:</i></p> <ul style="list-style-type: none"> <li>Inspect and review at two-year frequency (refer Management Schedule).</li> </ul>

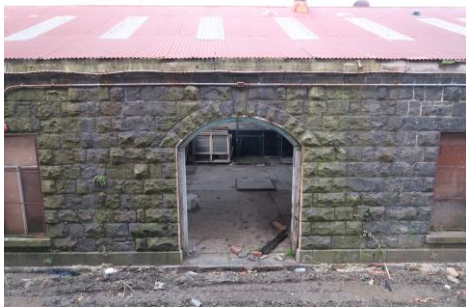
L.10 - Bluestone

Condition: (P) = Poor, (F) = Fair, (G)= Good		P
<p><i>Works Completed 2020-2023:</i></p> <p><b>Status:</b> No works completed to date. Moderate pointing loss to all bluestone walls. Where repointing has been undertaken, hard, cementitious mortar has been used.</p>		
<p><i>Recommended works:</i></p> <ul style="list-style-type: none"> <li>Repoint bluestone in its entirety to match original lime mortar mix. Cut out and replace cementitious mortar.</li> </ul>		
<p><i>Priority:</i> B</p>

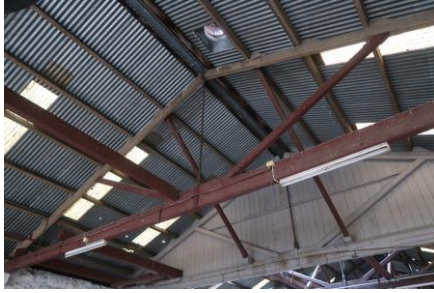
<b>L.11 - Timber roof framing</b>

<p>Image 1. 2023 – Timber trusses</p>	
<i>Condition: (P) = Poor, (F) = Fair, (G)= Good</i>		<i>F</i>
<p><i>Works Completed 2020-2023:</i></p> <p><b>Status:</b> No works completed to date. Internal timber roof trusses are in generally fair condition. Sections of trusses exposed due to dilapidated roof sheets showing minor signs of rotting and organic growth.</p>		
<p><i>Recommended works:</i></p> <ul style="list-style-type: none"> <li>Engage structural engineer to inspect condition of timber trusses.</li> <li>Cut out sections of rotten or damaged timber and splice in sections of new timber to match original size and species. Retain timber trusses in fair condition in situ.</li> </ul>		
<p><i>Priority: A</i></p>

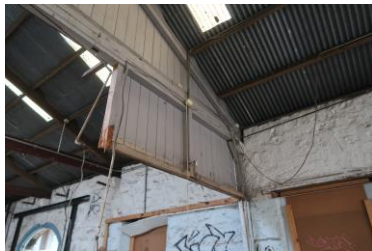
<b>L.12 - Timber partition</b>

<p>Image 1. 2023 – Remnant timber partition</p>	
<i>Condition: (P) = Poor, (F) = Fair, (G)= Good</i>		<i>F</i>
<p><i>Works Completed 2020-2023:</i></p> <p><b>Status:</b> No works completed to date. Remnant timber partition still in place and in fair condition.</p>		
<p><i>Cyclical works:</i></p> <p>Retain timber partition in situ. Inspect and review at two-year frequency (refer Management Schedule).</p>

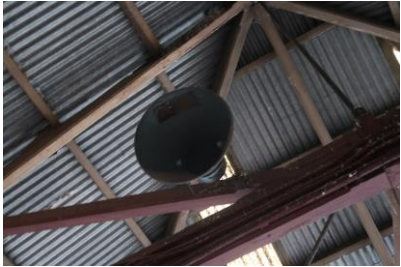
<b>L.13 - Redundant fixtures</b>

Image 1. 2023 – Redundant fixtures
<i>Condition: (P) = Poor, (F) = Fair, (G)= Good</i>		<i>F</i>
<p><i>Works Completed 2020-2023:</i></p> <p><b>Status:</b> No works completed to date. Several redundant electrical fixtures (speakers, conduit, wires) remain in situ.</p>		
<p><i>Recommended works:</i></p> <ul style="list-style-type: none"> <li>• Remove redundant electrical and services fixtures.</li> </ul>		
<p><i>Priority: B</i></p>

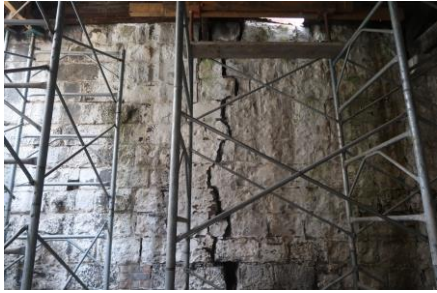
<b>L.14 - Bluestone - south wall</b>

Image 1. 2023 – South wall crack
<i>Condition: (P) = Poor, (F) = Fair, (G)= Good</i>		<i>P</i>
<p><i>Works Completed 2020-2023:</i></p> <p><b>Status:</b> No works completed to date. Major cracking to full height of south wall assumedly due to poor drainage of adjacent courtyard.</p>		
<p><i>Recommended works:</i></p> <ul style="list-style-type: none"> <li>• Engage structural engineer to review condition of wall and provide advice for dismantling and reconstruction.</li> </ul>		
<p><i>Priority: Urgent</i></p>

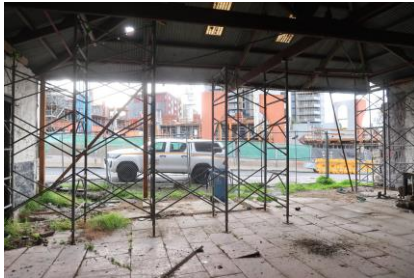
L.16 - North wall

<p>Image 1. 2023 – Missing section of wall</p>	
<p><i>Condition: (P) = Poor, (F) = Fair, (G)= Good</i></p>		<i>P</i>
<p><i>Works Completed 2020-2023:</i></p> <p><b>Status:</b> No works completed to date. Entire north wall missing; temporary props installed to support roof. Structural cracking to bluestone walls to east and west.</p>		
<p><i>Recommended works:</i></p> <ul style="list-style-type: none"> <li>Engage structural engineer to review and provide advice for replacement of missing wall and remediation of cracking masonry.</li> </ul>		
<p><i>Priority: Urgent</i></p>

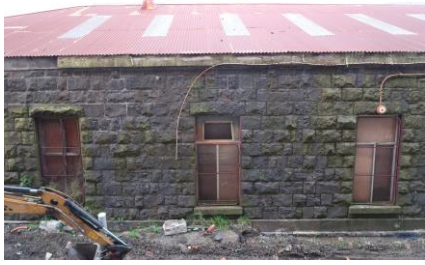
L.18 - Doors/Windows

<p>Image 1. 2023 – Doors/windows</p>	
Condition: (P) = Poor, (F) = Fair, (G)= Good		P
<p><i>Works Completed 2020-2023:</i></p> <p><b>Status:</b> No works completed to date. Existing original windows and doors are boarded up and missing components/hardware. Timber door frames are locally rotten or compromised.</p>		
<p><i>Recommended works:</i></p> <ul style="list-style-type: none"> <li>• Install new windows, doors, jambs, and architraves to match original detail.</li> <li>• Where missing replace internal timber reveals to match existing shape and profile, prepare and paint.</li> </ul>		
Priority: B

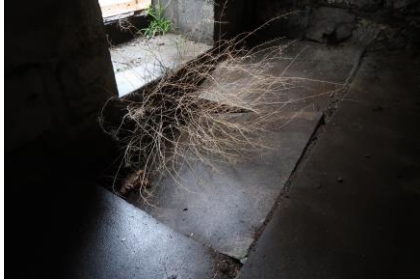
<b>L.19 - Bluestone flagstones</b>

Image 1. 2023 – Flagstone Floor
<i>Condition: (P) = Poor, (F) = Fair, (G)= Good</i>		<b>P</b>
<p><i>Works Completed 2020-2023:</i></p> <p><b>Status:</b> No works completed to date. Total subsidence to bluestone flagstones in south-east corner due to undermining of ground surface.</p>		
<p><i>Recommended works:</i></p> <ul style="list-style-type: none"> <li>Engage structural and Civil engineers to review existing sub-floor condition. Complete new stormwater system connected to legal points of discharge. Remediate footings and repave bluestone floor.</li> </ul>		
<i>Priority: A</i>

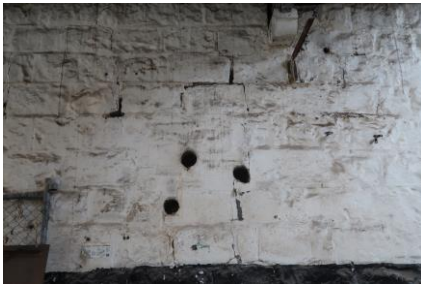
<b>L.20 - Bluestone walls</b>

Image 1. 2023 – Core Holes
<i>Condition: (P) = Poor, (F) = Fair, (G)= Good</i>		<b>F</b>
<p><i>Works Completed 2020-2023:</i></p> <p><b>Status:</b> No works completed to date. Several small core holes to interior side of eastern wall.</p>		
<p><i>Recommended works:</i></p> <ul style="list-style-type: none"> <li>Locally repair core holes with pigmented mortar to match colour of adjacent masonry.</li> </ul>		
<i>Priority: B</i>

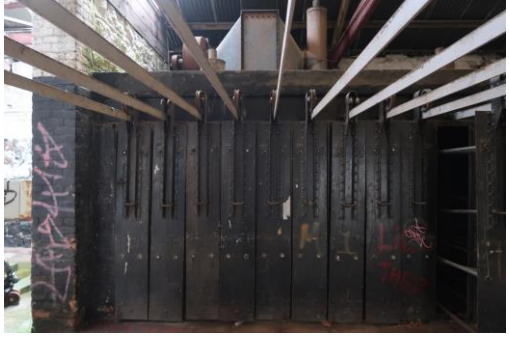
L.21 - Cast iron drying racks

<p>Image 1. 2023 – Cast iron drying racks</p>	
Condition: (P) = Poor, (F) = Fair, (G)= Good		F
<p><i>Works Completed 2020-2023:</i></p> <p>2023: No works completed to date. Original cast iron drying racks remain in situ in fair condition.</p>		
<p><i>Cyclical works:</i></p> <ul style="list-style-type: none"> <li>Inspect and review at regular frequencies. Drying racks should be retained in situ or repurposed within the building pending future use.</li> </ul>

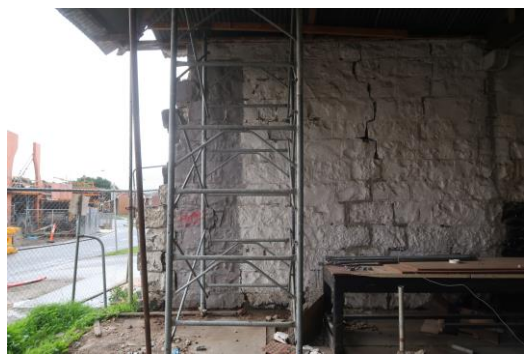
L.22 - Paintwork

<p>Image 1. 2023 – Internal paint finishes</p>	
Condition: (P) = Poor, (F) = Fair, (G)= Good		P
<p><i>Works Completed 2020-2023:</i></p> <p><b>Status:</b> No works completed to date. Various paint finishes to interior wall. Paint is generally in poor condition and peeling due to ongoing water ingress.</p>		
<p><i>Recommended works:</i></p> <ul style="list-style-type: none"> <li>Repaint interior as part of future works (there is no urgency to undertake this work).</li> </ul>

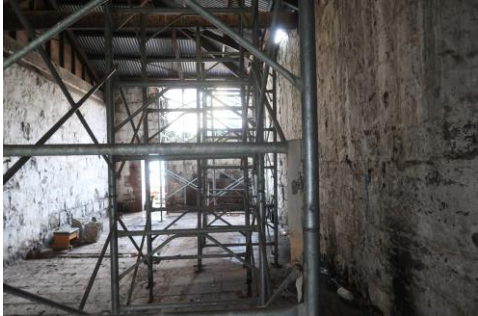
L.23 - Temporary scaffolding

Image 1. 2023 – Internal scaffolding
Condition: (P) = Poor, (F) = Fair, (G)= Good		P
Works Completed 2020-2023:		
<b>Status:</b> No works completed to date. Internal scaffolding in place to support corrugated roof at north and south ends.		
<i>Recommended works:</i> <ul style="list-style-type: none"> <li>Engage structural engineer to inspect current installation and provide advice for ongoing temporary propping.</li> </ul>		
<i>Priority: Urgent</i>

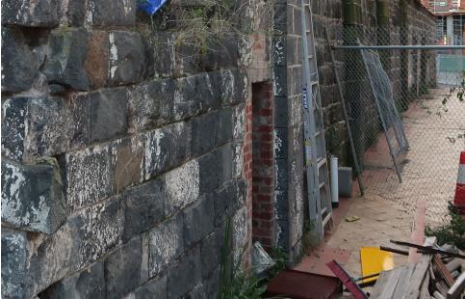
L.24 - Brick infill

Image 1. 2023 – Non-original brick infill
Condition: (P) = Poor, (F) = Fair, (G)= Good		F
Works Completed 2020-2023:		
<b>Status:</b> No works completed to date. Non original brick infill used to rebuild original doorway.		
<i>Recommended works:</i> <ul style="list-style-type: none"> <li>Remove non original brick infill and replace with bluestone to match original detail as part of future works (there is no urgency to undertake this work).</li> </ul>

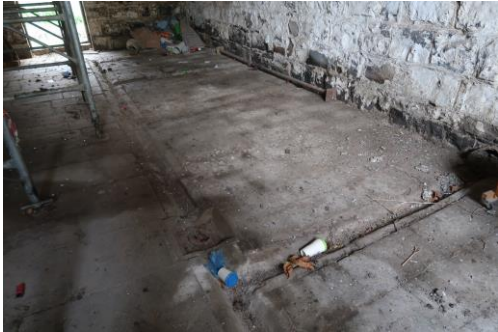
<b>L.25 - Floor drainage</b>

Condition: (P) = Poor, (F) = Fair, (G)= Good		<b>F</b>
<p><i>Works Completed 2020-2023:</i></p> <p><b>Status:</b> No works completed to date. Original/early floor drainage in situ in bluestone floor.</p>		
<p><i>Cyclical works:</i></p> <ul style="list-style-type: none"> <li>Inspect and review at regular frequencies. Any future works should protect original floor in current condition.</li> </ul>

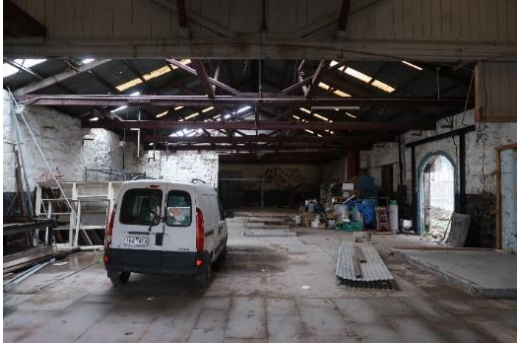
<b>L.26 - Debris</b>

Condition: (P) = Poor, (F) = Fair, (G)= Good		<b>F</b>
<p><i>Works Completed 2020-2023:</i></p> <p>2023: No works completed to date. Various materials stored inside building, including salvaged windows, containers, and other deleterious debris.</p>		
<p><i>Cyclical works:</i></p> <ul style="list-style-type: none"> <li>Undertake cyclical cleaning of interior space on a regular basis.</li> </ul>
