Arboricultural Assessment and Report

NCCEC Point Nepean Research & Education Field Station Development.

9 December 2024
Tree Logic Ref. 011175

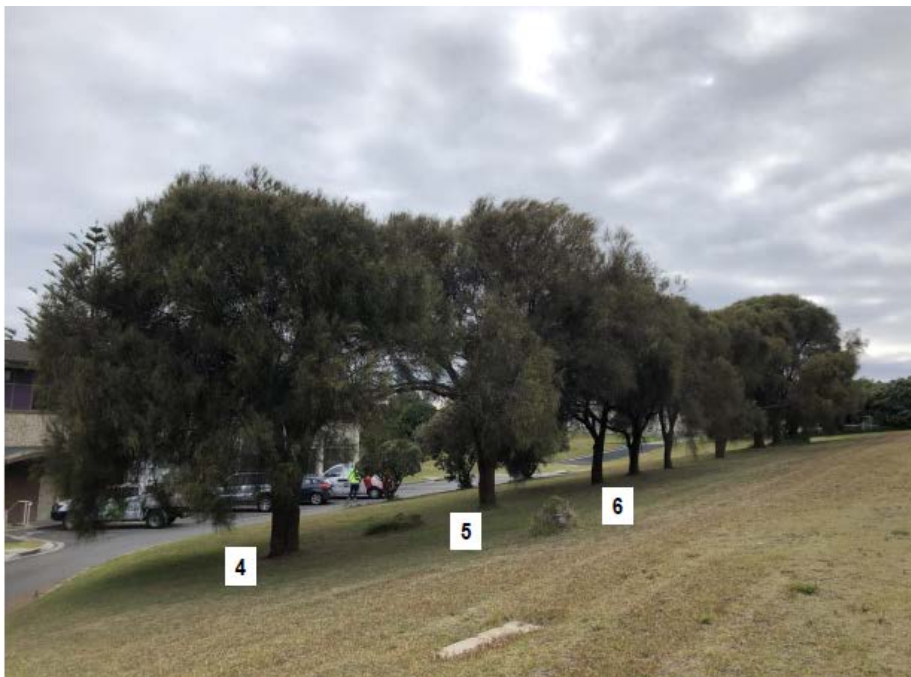
- 3.3 Trees 2 and 4 – 14 are Drooping She-oaks (*Allocasuarina verticillata*) of varying size and condition. The Treelogic report (2021) provides comment on these trees stating that *'the row of Drooping She-oaks south of Badcoe Hall varying in their condition with numerous trees exhibiting structural defects and/or crown dieback. Only three individual trees (Tree 6, 9 and 11) were rated Moderate B and expected to potentially have a longer life expectancy owing to their health and structural condition.'*

- 3.4 The arboricultural report has classified Trees 2 and 4 – 14 to be planted indigenous (native) trees owing to their linear planting pattern and relative even-size. According to the Victorian Heritage Database Report, She-oaks and Banksia formed part of the natural vegetation where large quantities were cut to supply lime kilns resulting in these species to become scarce in Portsea. The construction of new buildings in 1963 – 1965 saw the army carry out extensive landscape plantings of exotic and native species including She-oaks in 1965 - 1966. Based on historical images, the trees proposed for removal do not form part of these plantings.

Figure 1: Exert from the Treelogic arboricultural report showing the relative size, condition and location of Trees 4 – 14 located south of Badcoe Hall.

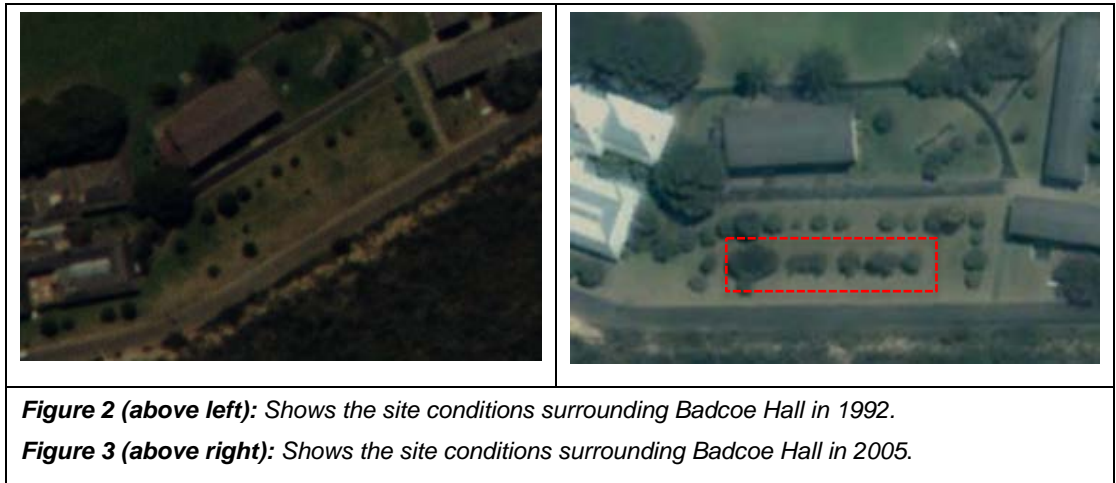
- 3.6 A review of historic aerial images spanning the period 1939 – 2012 was undertaken to establish the approximate age of the Drooping She-oaks (<https://imagery.aerialphotography.fsdf.org.au/>, downloaded 12/07/2023). The aerial images show that Badcoe Hall is visible in the 1975 image which was constructed between 1963 – 1965 as the Assembly Hall and later renamed Badcoe Hall. In 1975, several trees appear to the south of Badcoe Hall that are associated with the army's plantings in 1965 – 1966. The location of these trees do not correspond with the trees that are proposed for removal. This earlier planting was likely removed as part of the driveway construction in 2012. Trees 4 – 14 appear in the aerial images in 2005, but not in 1992. Tree 2 is of similar age and dimensions as Trees 4 – 14 therefore it is likely that they were all planted at the same time. The trees

proposed for removal were planted between 1992 and 2005 making them approximately 20 – 30 years of age. This suggested age is generally consistent with their size in relation to the species expected growth rate and development.

- 3.7 The age of the Drooping She-oaks shows they did not form part of the landscape plantings at the time Badcoe Hall was constructed in 1963 – 1965. While today the trees contribute somewhat to the landscape character there is no direct association between the establishment of the trees and Badcoe Hall, or any other buildings from an earlier time that give the site its heritage value.

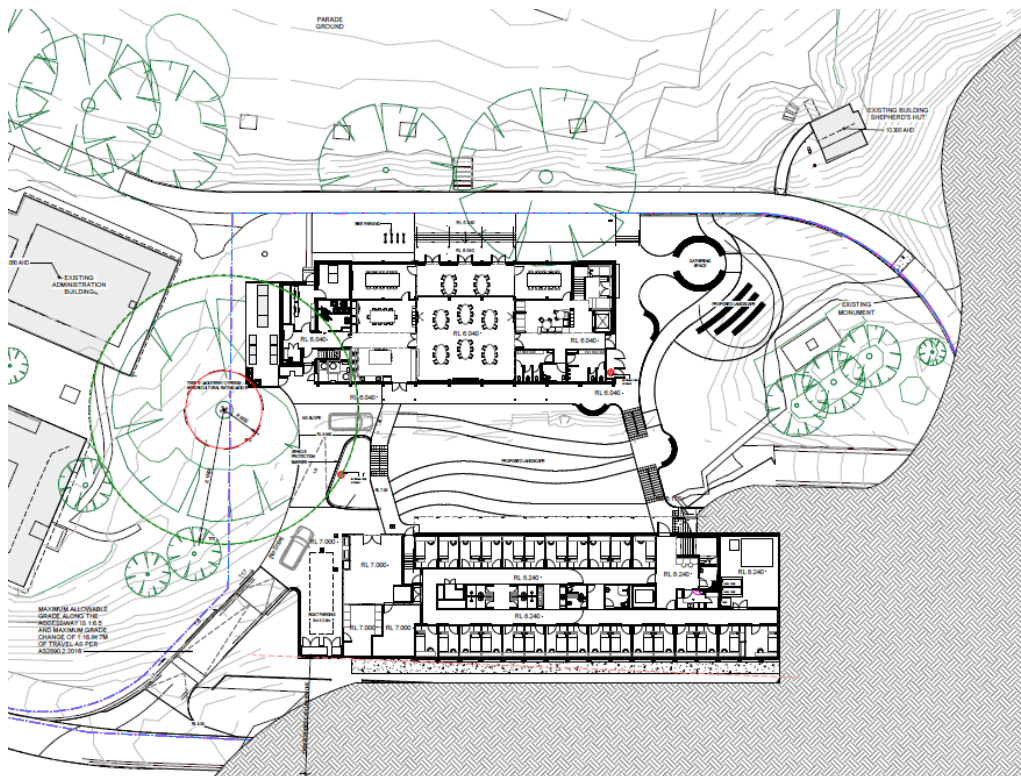
Figure 4: Exert from L00 Key Plan, Dwg No, A_0103.

- 4.1 A review of the town planning drawing set was undertaken to determine whether retained trees would be impacted by the development.
- 4.2 Apart from Trees 2, 4 – 14, all other trees including Trees 1, 3, 15 – 23 and Tree groups 1 and 2 are nominated for retention as part of the proposed development. The proposed development includes the construction of a multi-storey building to the south of Badcoe Hall, as well as the refurbishment of Badcoe Hall. The existing driveway will be re-aligned adjacent to Tree 3 and car parking is to be established at the rear of the accommodation building.
- 4.3 The arboricultural addendum issued by Treelogic supports the design in relation to the impacts to Tree 3 of which it is expected to tolerate.

- 4.4 All other trees including Trees 1, 15 – 23 and Tree groups 1 and 2 are not expected to be impacted by the proposed development.
