Arboricultural Assessment and Report

23 Bambra Road, Caulfield North.

1 February 2024
Tree Logic Ref. 013359

Prepared for Ron Harris / 23 Bambra Road, Caulfield North.
Prepared by David Phillips / Senior Consulting Arborist / Tree Logic Pty. Ltd.

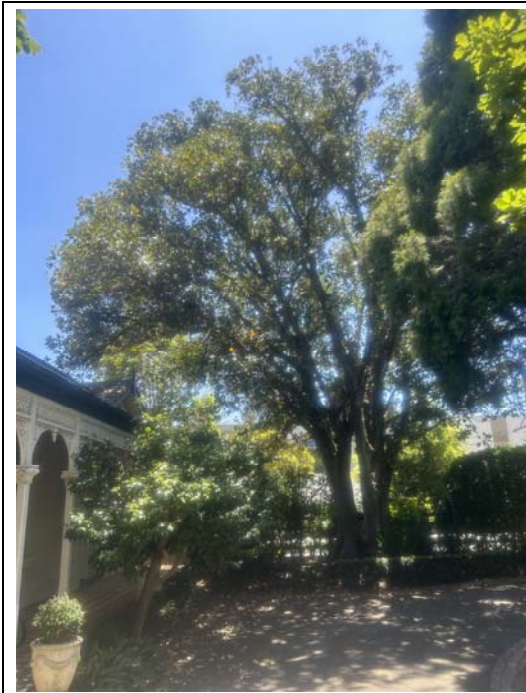
- 4.6 The site inspection observed disruption to the asphalt driveway and cracking to the external façade of the residence adjacent to Tree 1. The damage to the house and driveway is consistent with the influence of tree roots, although the age of the residence may also be a contributing factor. It is likely that its roots are contributing to the damage due to its size, proximity to the residence and the extensive root systems and relatively high-water demand that Fig trees have. The client also claims the tree's roots have evaded the water pipes causing pits to overflow. Should the tree be removed to mitigate further damage, consideration should be given to consulting a structural engineer. The reason being is that soil moisture levels surrounding the house removal will change following the tree's removal that may affect the integrity of the footing/s.

Figure 2 (upper left): Shows the relative size, condition and location of Tree 1, a mature Moreton Bay Fig. The tree has been planted close to the residence where its roots are likely contributing to damage of the driveway and dwelling.

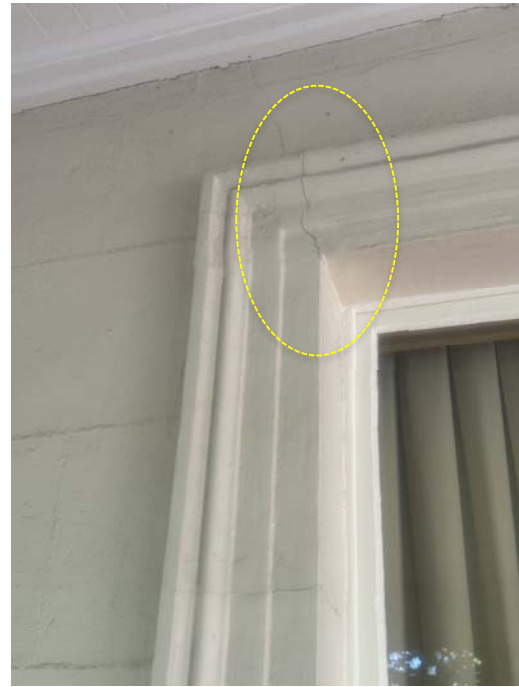
Figure 3 (upper right): Shows cracking of the external façade of the residence adjacent to Tree 1.

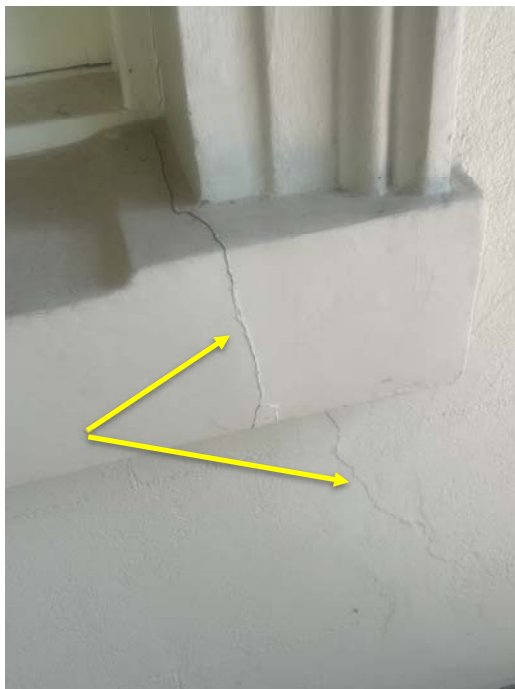
Figure 4 (above left): Shows cracking of the windowsill adjacent to Tree 1.

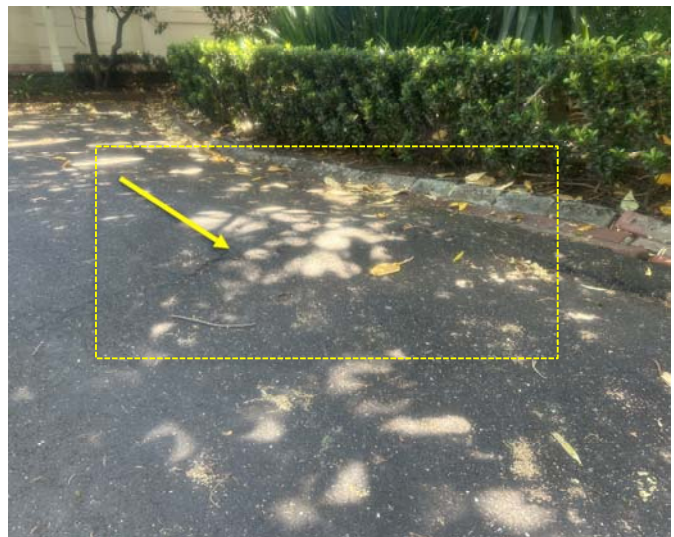
Figure 5 (above right): Shows the area of cracking and disruption to the asphalt driveway from the roots of Tree 1.

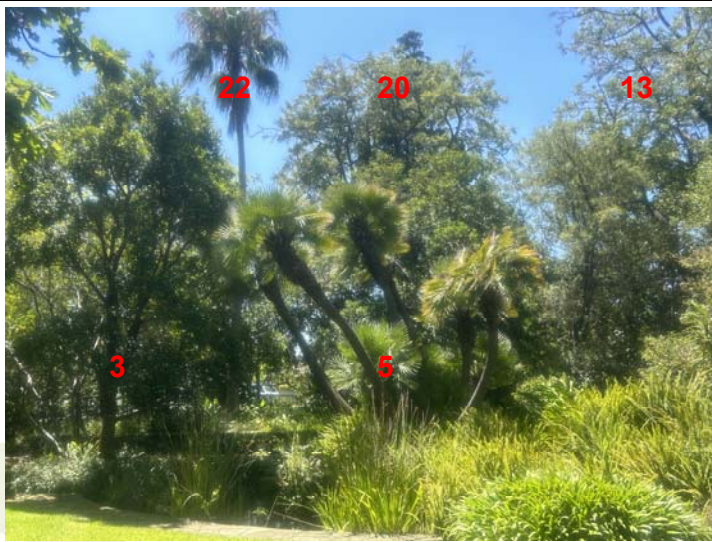
Figure 8 (left): View facing north-east showing lower storey Trees 3 and 5 and overstorey Trees 13, 20 and 22.

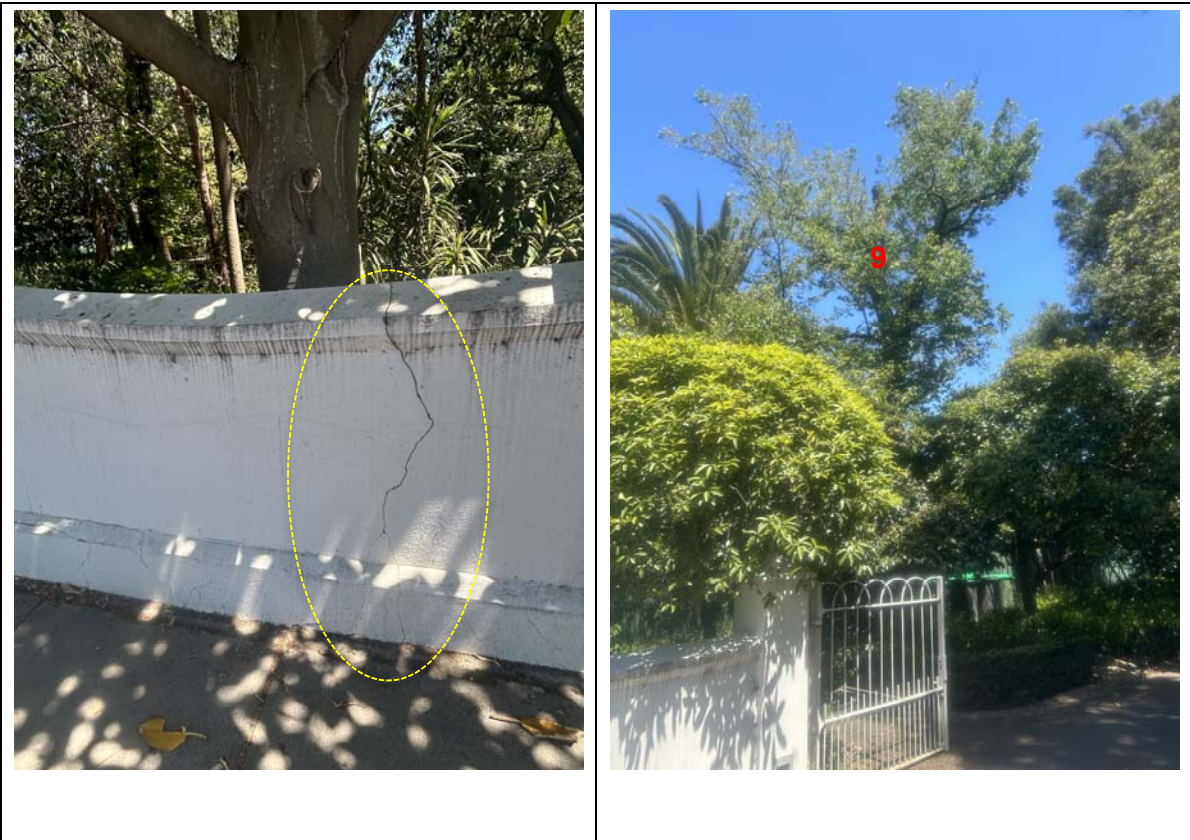
- 3.9 Two (2) trees, being Trees 9 and 19 exhibited poor structure. Tree 9, an English Elm (*Ulmus procera*) had its main leaders lopped and the resulting crown was comprised of adventitious (epicormic) growth that is poorly attached. Poorly structured trees exhibited major structural defects that generally require practical intervention where high valued targets are present.

- 4.7 Tree 17 was a self-seeded specimen approximately 12 m tall with a crown spread of 10 m and located within 0.5 m of the front boundary fence. The tree is in the active growth phase of its development (semi-mature) where it is expected to grow larger at maturity. The tree's roots were cracking the masonry wall with a vertical crack observed immediately adjacent to the tree and in other sections. No disruption to the public footpath was observed. With increased growth into the future, the tree's roots are expected to cause greater damage to the fence and potentially the public footpath. Similarly, a self-sown Fig tree was growing at the base of Tree 10 and its roots are also expected to damage to the boundary wall into the short to medium term future.

Figure 9 (above left): Shows cracking to the front boundary fence from the roots of Tree 17.

Figure 10 (above right): View facing south-west showing the relative size, condition and location of Tree 9, an English Elm. The Elm exhibited poor structure due to past lopping of its main leaders.
