Structure ID	SN6028
Bridge Name	Eltham-Yarra Glen Rd Bridge
Crossing (road or stream)	Maroondah Aqueduct
Structure Type	Bridge
Asset Class	Road over River
Construction Material	Masonry
Date of Construction	4/14/1905
Date of Inspection	29/08/2023

Client:	ELTHAM-YARRA GLEN ROAD BRIDGE DEFECT REPAIR WORKS
---------	---

Title:	DEFECT REPAIRS SHEET 01 OF 04
--------	-------------------------------

Discipline:	STRUCTURES
Drawing No.:	H372089 - STR - DRG - 001
Rev.:	A

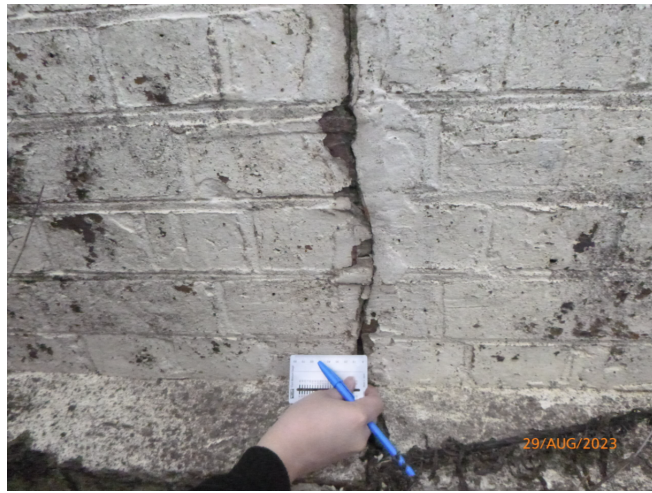
DEFECT 2: FULL HEIGHT CRACK CLOSE TO EAST END OF NORTHERN PARAPET

COMPONENT	DEFECT	LOCATION	AFFECTED AREA (APPROX.)	REPAIR METHOD
BRIDGE PARAPET	CRACKING	<ul style="list-style-type: none"> - NORTHERN PARAPET, APPROX. 2.7M FROM EAST END - NORTHERN PARAPET, APPROX. 1.3M FROM WEST END - NORTHERN PARAPET, MIDSPAN - NORTHERN PARAPET, APPROX. 1.8M FROM WEST END - NORTHERN PARAPET, AT EAST END IMPOST - SOUTHERN PARAPET, APPROX. 3M FROM EAST END - SOUTHERN PARAPET, MIDSPAN - SOUTHERN PARAPET, APPROX. 0.7M FROM WEST END 	<ul style="list-style-type: none"> - FULL HEIGHT CRACK RANGING FROM 1.5MM TO 8MM (DEFECT 2) - CRACK WIDTH UP TO 1.4MM, PROPAGATING OVER 3-4NO. BRICKS (DEFECT 3) - FULL HEIGHT CRACK WITH UP TO 0.7MM NOTED WITH VEGETATION/MOSS GROWING WITHIN CRACKS (DEFECT 4) - CRACK WIDTH UP TO 1.4MM NOTED AT TOP FACE (DEFECT 5) - HORIZONTAL CRACK AT TOP LAYER OF BRICKS UP TO 2MM NOTED WITH LENGTH OF 1.6M LONG (DEFECT 7) - FULL HEIGHT CRACK UP TO 2MM (DEFECT 8) - FULL HEIGHT CRACK UP TO 1MM, PROPAGATES FROM TOP FACE TO BOTTOM (DEFECT 9) - CRACKS WIDTH UP TO 3MM ON TOP FACE OF PARAPET (DEFECT 10) 	REPOINT CRACKED MORTAR IN ACCORDANCE WITH RPM32 IN BRIDGE MAINTENANCE AND REPAIR MANUAL 2018

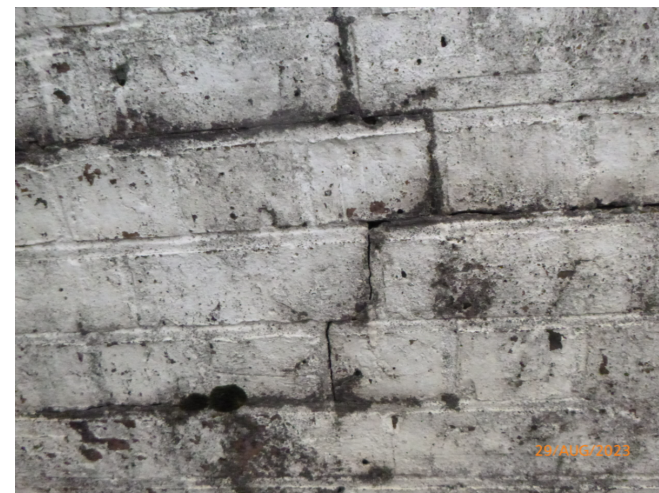
DEFECT 3: CRACKS PROPAGATING OVER 4NO. BRICKS AT WEST END OF NORTHERN PARAPET

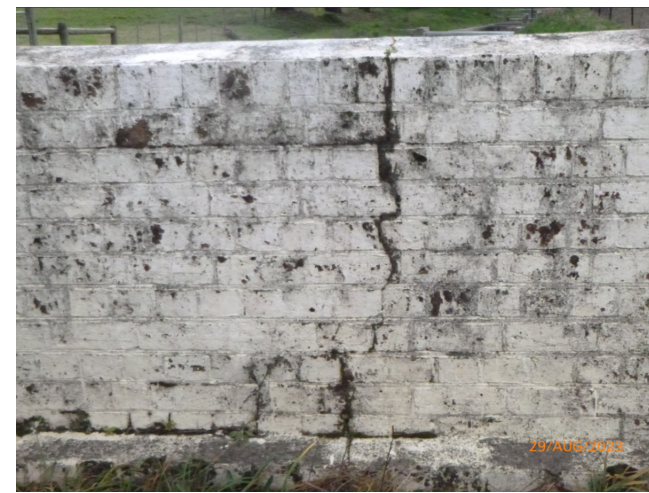
DEFECT 4: FULL HEIGHT CRACK AT MIDSPAN OF NORTHERN PARAPET

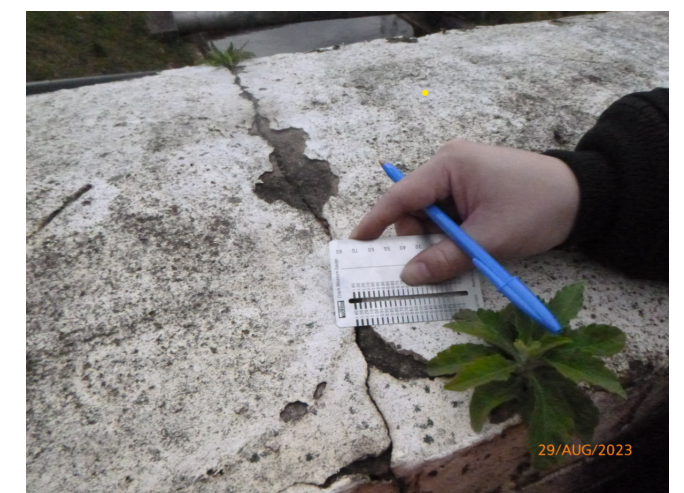
DEFECT 5: CRACKS ON TOP SURFACE OF WEST END NORTHERN PARAPET

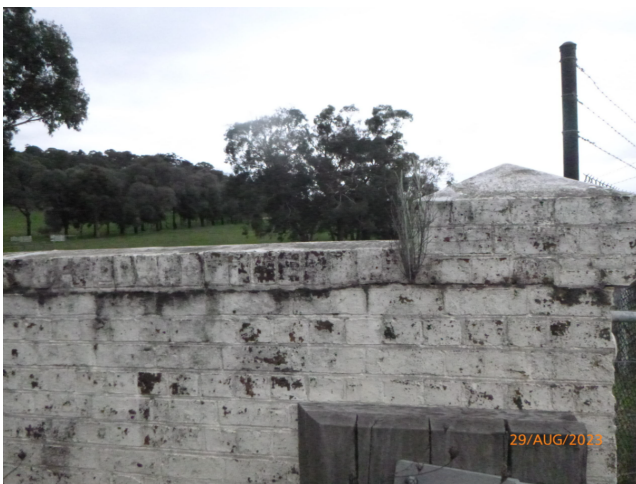
DEFECT 7: HORIZONTAL CRACK ALONG TOP LAYER OF BRICK AT NORTHERN PARAPET

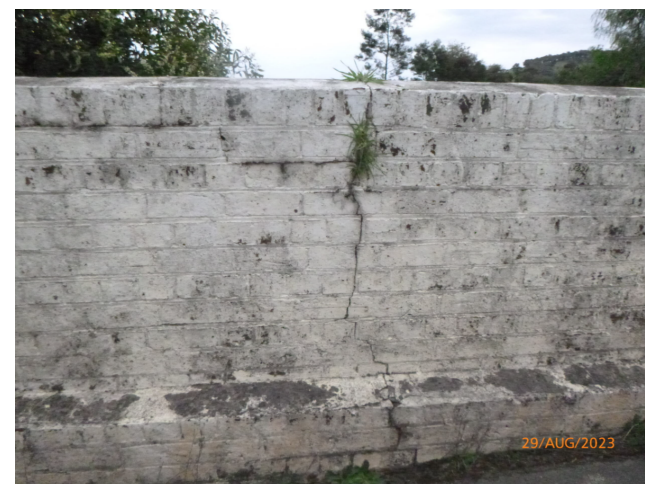
DEFECT 8: FULL HEIGHT CRACK CLOSE TO EAST END OF SOUTHERN PARAPET

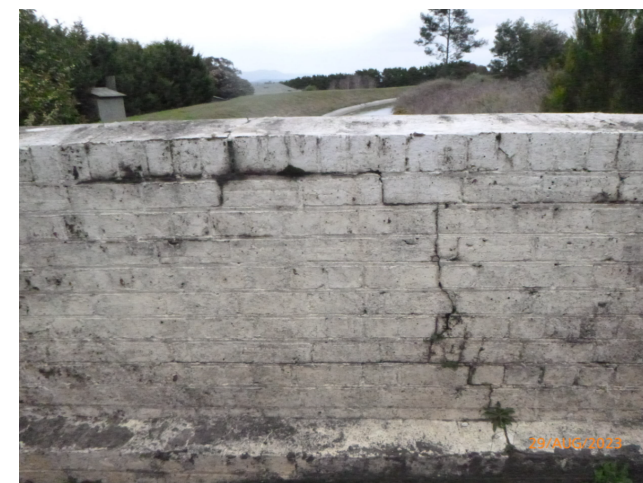
DEFECT 9: FULL HEIGHT CRACK AT MIDSPAN OF SOUTHERN PARAPET

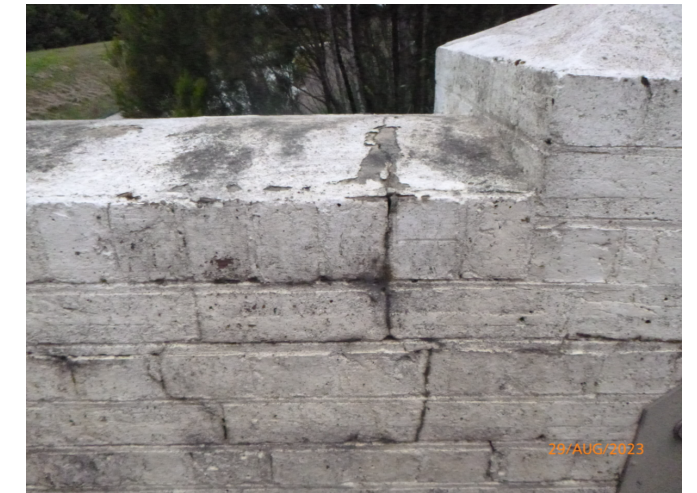
DEFECT 10: CRACKS ON TOP FACE OF WEST END SOUTHERN PARAPET

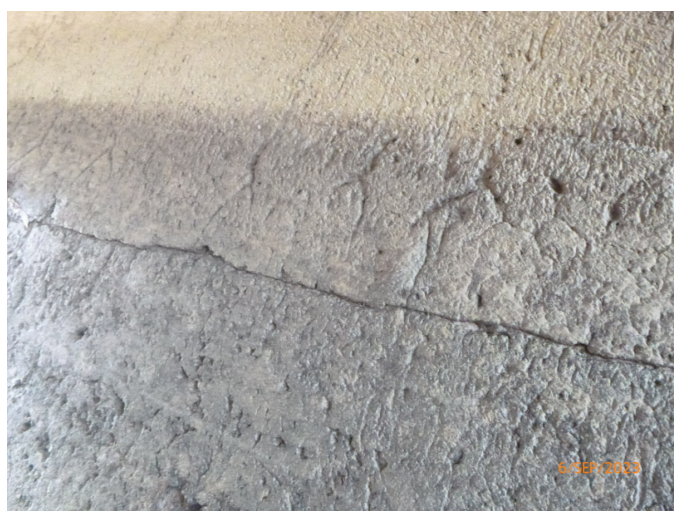
DEFECT 13: FULL LENGTH LONGITUDINAL CRACK ACROSS EAST WATERWAY INVERT PROTECTION FACE

WATERWAY INVENT PROTECTION	CRACKING	<ul style="list-style-type: none"> - EAST WATERWAY - WEST FACE OF WATERWAY INVENT PROTECTION 	<ul style="list-style-type: none"> - FULL LENGTH LONGITUDINAL CRACK UP TO 0.3MM (DEFECT 13) - VERTICAL CRACKS UP TO 1MM (DEFECT 27) 	REPAIR THE CRACK WITH GROUT/EPOXY IN ACCORDANCE WITH RPM02 IN BRIDGE MAINTENANCE AND REPAIR MANUAL 2018
	SPALLING	<ul style="list-style-type: none"> - WEST FACE OF WATERWAY INVENT PROTECTION 	<ul style="list-style-type: none"> - SPALLING OF CONCRETE APPROX. 1300MM X 500MM IN SIZE (DEFECT 26) 	PATCH REPAIR OF CONCRETE IN ACCORDANCE WITH RPM09 IN BRIDGE MAINTENANCE AND REPAIR MANUAL 2018
BRIDGE ARCH	MORTAR LOSS	<ul style="list-style-type: none"> - NORTHERN FACE, WEST ABUTMENT - BOTH FACES, ABOVE WATERWAY INVENT PROTECTION - SOUTH FACE, BELOW WEST PARAPET 	<ul style="list-style-type: none"> - MORTAR LOSS ON ARCH RING (DEFECT 16) - MORTAR LOSS NOTED UP TO THREE LAYERS OF BRICKS (DEFECT 20) - MORTAR LOSS OF ARCH BRIDGE (DEFECT 23) 	REPOINT MORTAR IN ACCORDANCE WITH RPM32 IN BRIDGE MAINTENANCE AND REPAIR MANUAL 2018

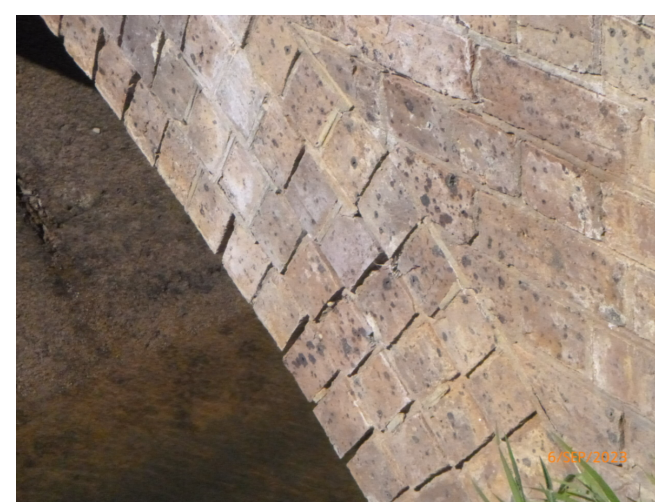
DEFECT 16: MORTAR LOSS ON NORTHERN FACE OF ARCH RING

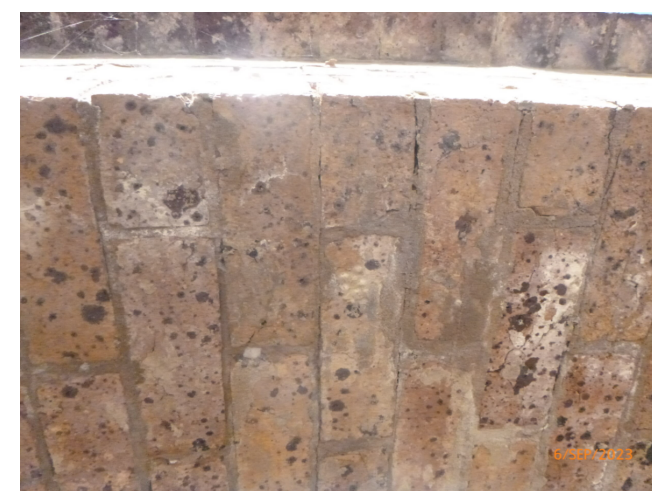
DEFECT 19: FULL LENGTH TRANSVERSE CRACK ACROSS ENTIRE LENGTH OF ARCH CROWN

CRACKING	<ul style="list-style-type: none"> - CROWN OF ARCH - MIDSPAN, CLOSE TO SWALLOW NEST - WEST FACE, SOUTHERN ELEVATION -NORTHERN SPANDREL WALL, EAST ABUTMENT - SOUTHERN SPANDREL WALL, EAST ABUTMENT 	<ul style="list-style-type: none"> - FULL LENGTH TRANSVERSE CRACK RANGES FROM HAIRLINE TO 0.4MM FOR ENTIRE LEGTH, MAINLY RUNS ALONG MORTAR (DEFECT 19) - LONGITUDINAL CRACK RANGING FROM HAIRLINE TO 0.8MM ACROSS ENTIRE LENGTH (DEFECT 21) - LONGITUDINAL CRACK RANGING FROM HAIRLINE TO 1.2MM FOR APPROX. 2.5M LONG ON ARCH (DEFECT 22) - FULL HEIGHT VERTICAL CRACK RANGING FROM 0.5MM TO 8MM ON SPANDREL WALL (DEFECT 24) - FULL HEIGHT VERTICAL CRACK RANGING FROM 0.5MM TO 2MM ON SPANDREL WALL (DEFECT 25) 	REPOINT CRACKED MORTAR IN ACCORDANCE WITH RPM32 IN BRIDGE MAINTENANCE AND REPAIR MANUAL 2018

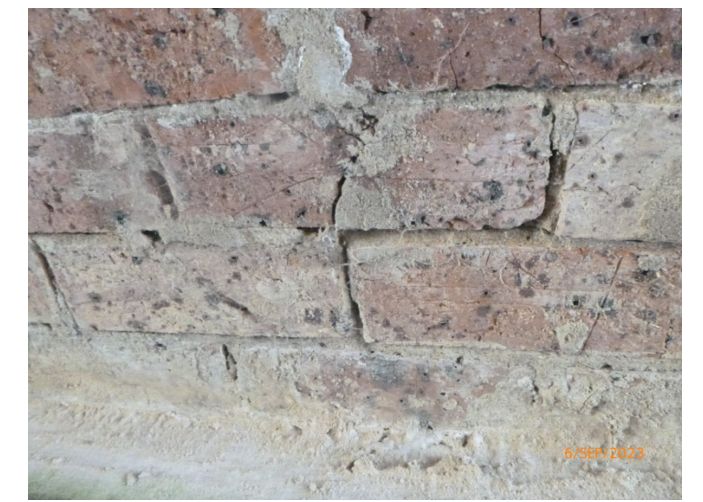
DEFECT 20: MORTAR LOSS ON TWO LAYERS OF BRICKS ABOVE EAST WATERWAY INVERT PROTECTION
