Leaded Lights at St. Hilda's - 1 Clarendon Street, East Melbourne.

St.Hilda's - 1 Clarendon Street, East Melbourne was built in 1907 in an Art & Crafts/Edwardian style. The leaded lights which are to be found on both the ground floor and first floor are excellent examples of the period.

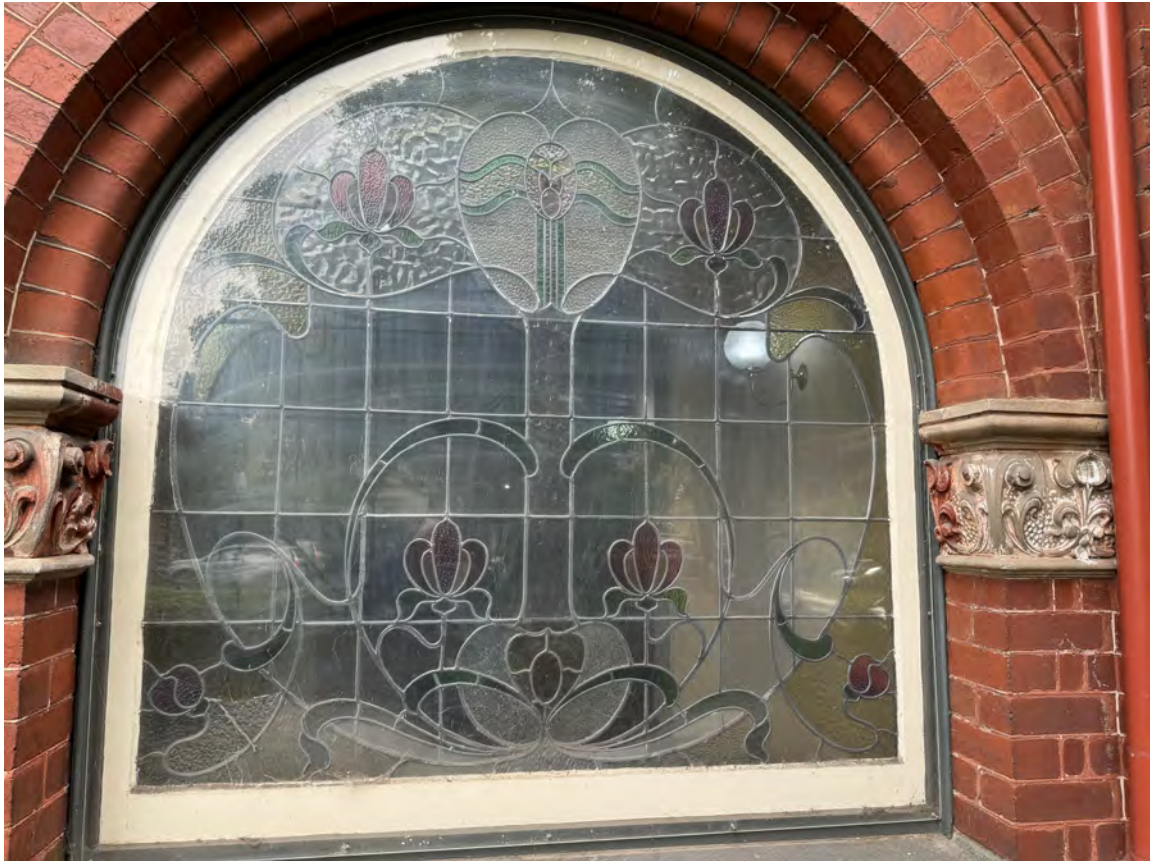
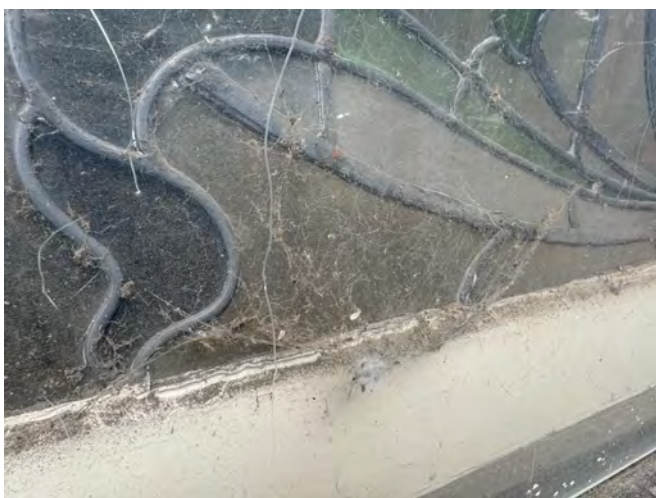
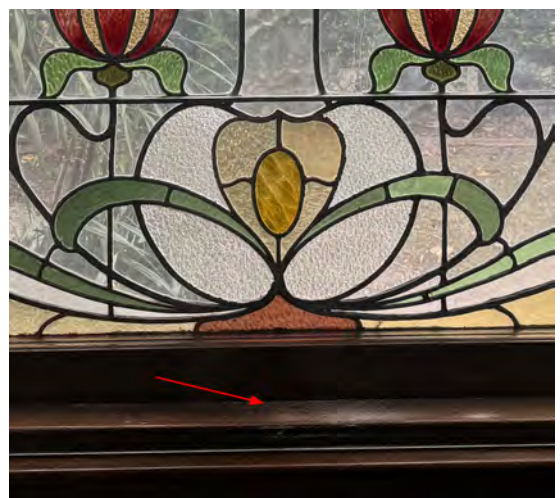
WG.01 - Is a fixed sash approximately 1670mm x 1670mm with an arch top. The leadlight is currently sandwiched in between two pieces of clear acrylic sheet. These sheets are not sealed and dirt, cobwebs along with dust from loosening of old putty from the leadlight have accumulated in the interspaces.

The panel exhibits severe bowing in the lower section. Several pieces of glass are broken, the lead in the bottom section is in poor condition and there is evidence of previous repairs.

The ferramenta (reinforcing bars) have been soldered to the panel. Overall condition is difficult to assess due to the placement of the acrylic sheets.

The panel in its current condition is in danger of further collapse and hence at risk of more original material (glass) being broken.

It is recommended that the panel be removed and lower section be rebuilt, replacing the lead matrix and any broken pieces of glass be replaced with either salvaged glass of the period or the closest possible match using modern glasses. Also recommended is that the current ferramenta to be removed and replaced with 10mm diameter steel bars attached in the more conventional method using copper wire ties. This would assist if further restoration was necessary.

It cannot be guaranteed, however, once removed from its frame that other defects in the lead matrix may cause the panel to break apart. All due care would be taken with the panel with a minimalist interventional approach - 'do as much as necessary but as little as possible'.

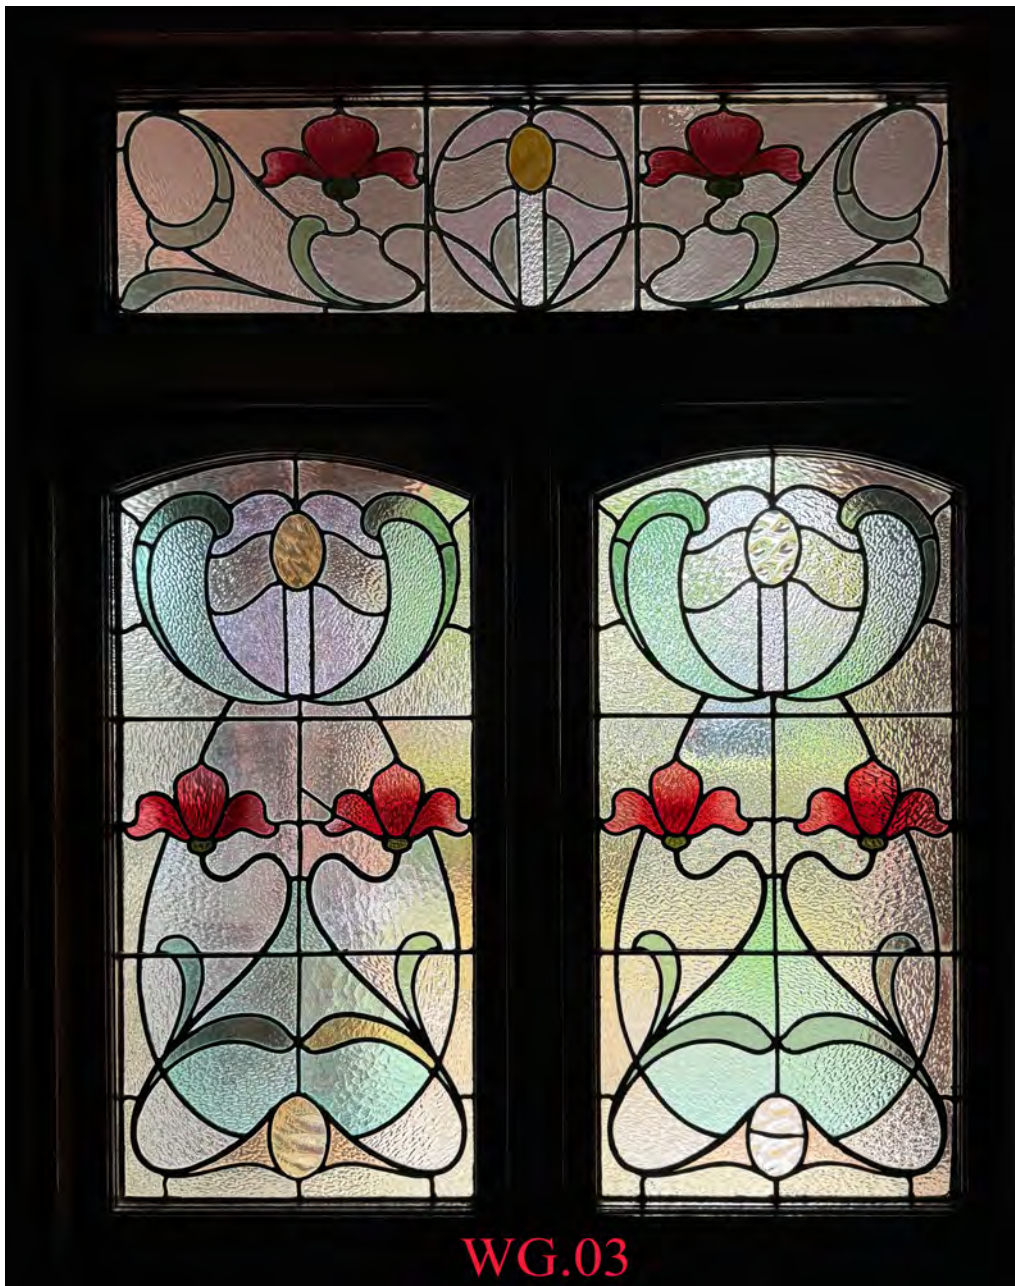
WG.03 - Two sashes and toplight. Sashes - previous repairs evident. Glass replacement and false leading over cracked pieces of glass. Bars soldered onto the panel. Toplight is in good condition.

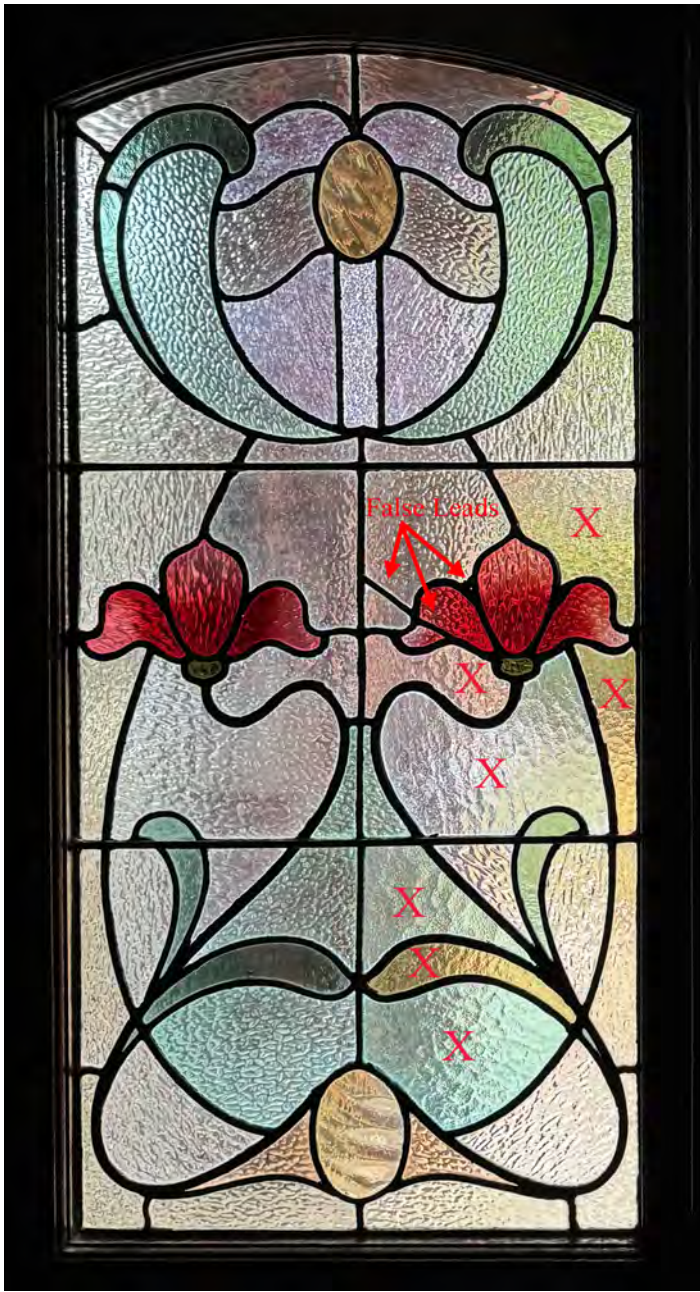
WG.03 - LHS Multiple glass replacements and addition of false leads over cracked pieces of glass.

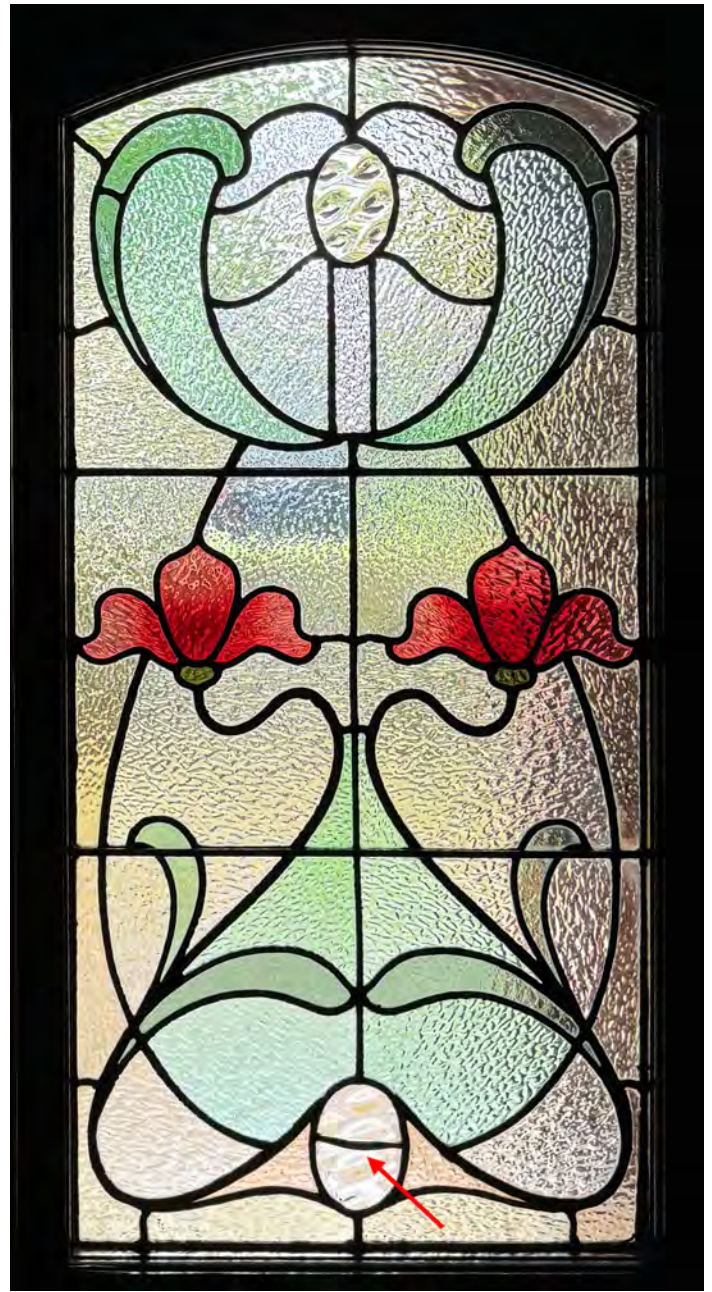
WG.03 - False lead over a crack in a piece of Venetian glass.

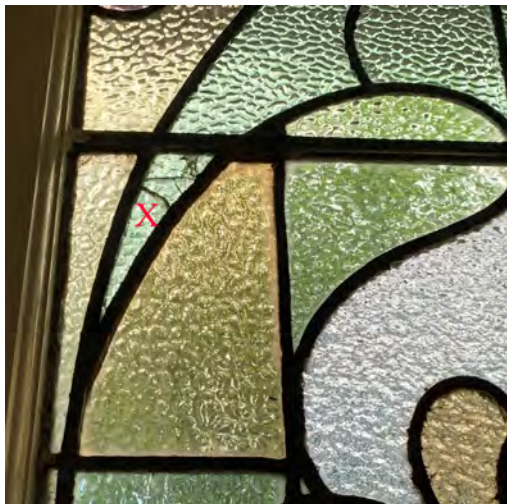
Cracked Glass

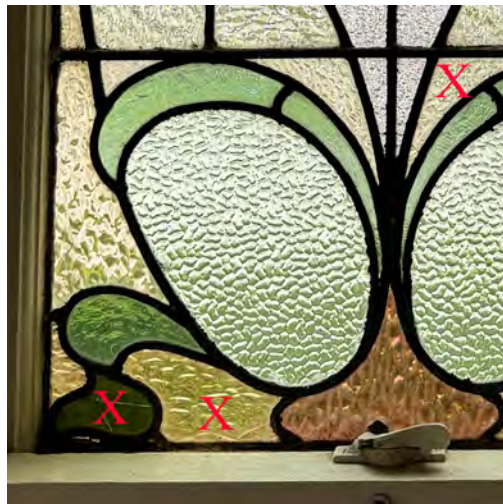
Cracked Glass

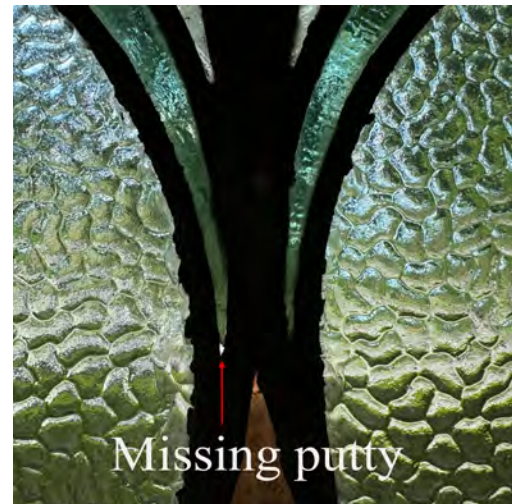
Missing Putty

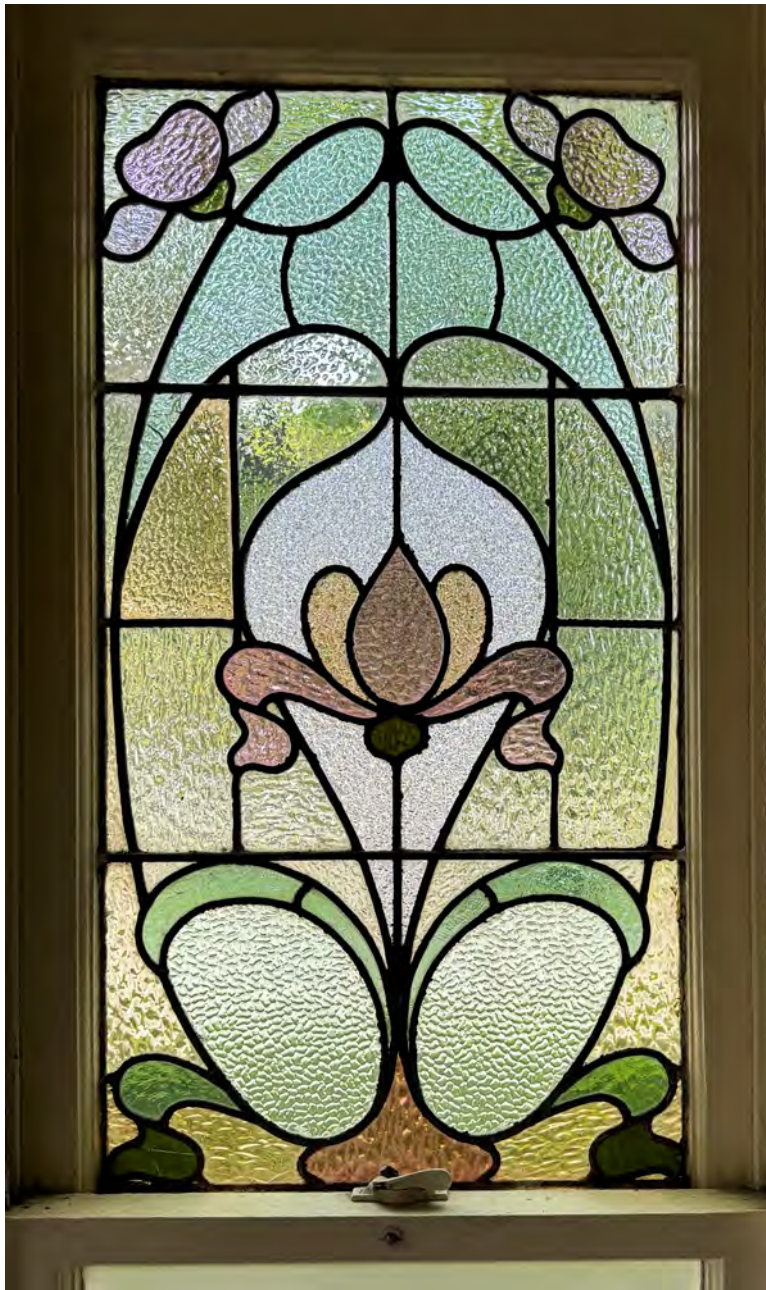
WG.04 - WG.08 Typical Panel

Five panels of identical design and glass types. In overall good condition. Some cracked glass and missing putty. Bars soldered onto the panels.

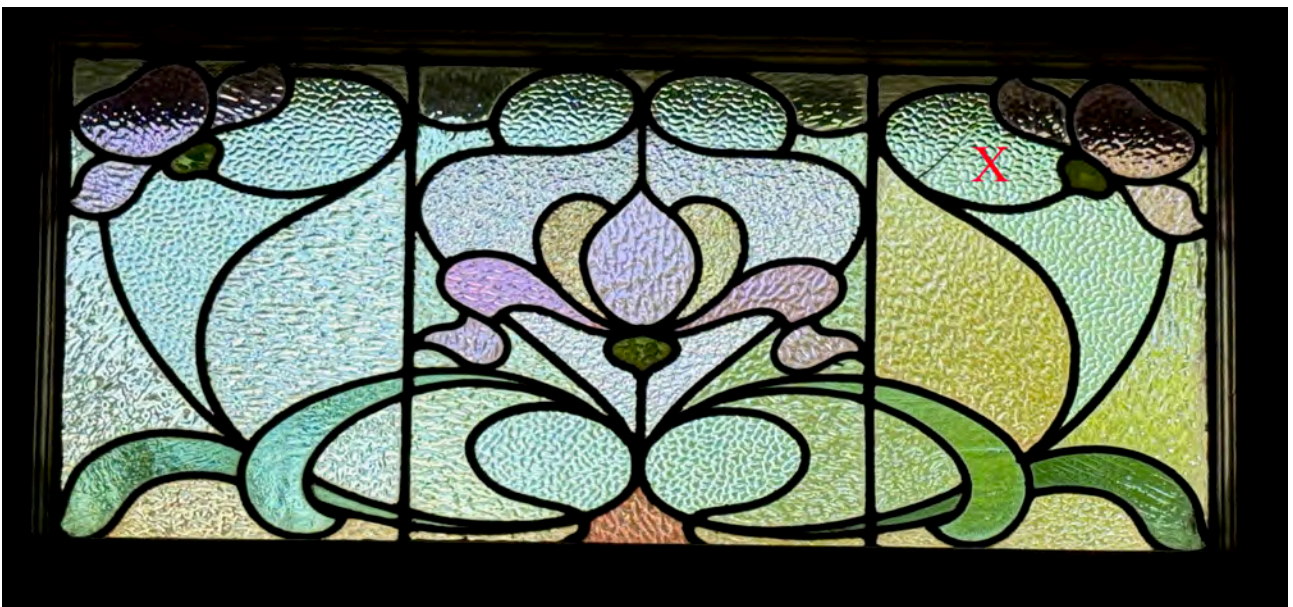
WG.09 - In good condition. One cracked piece of pale green Venetian Ripple. Bars soldered onto the panel.

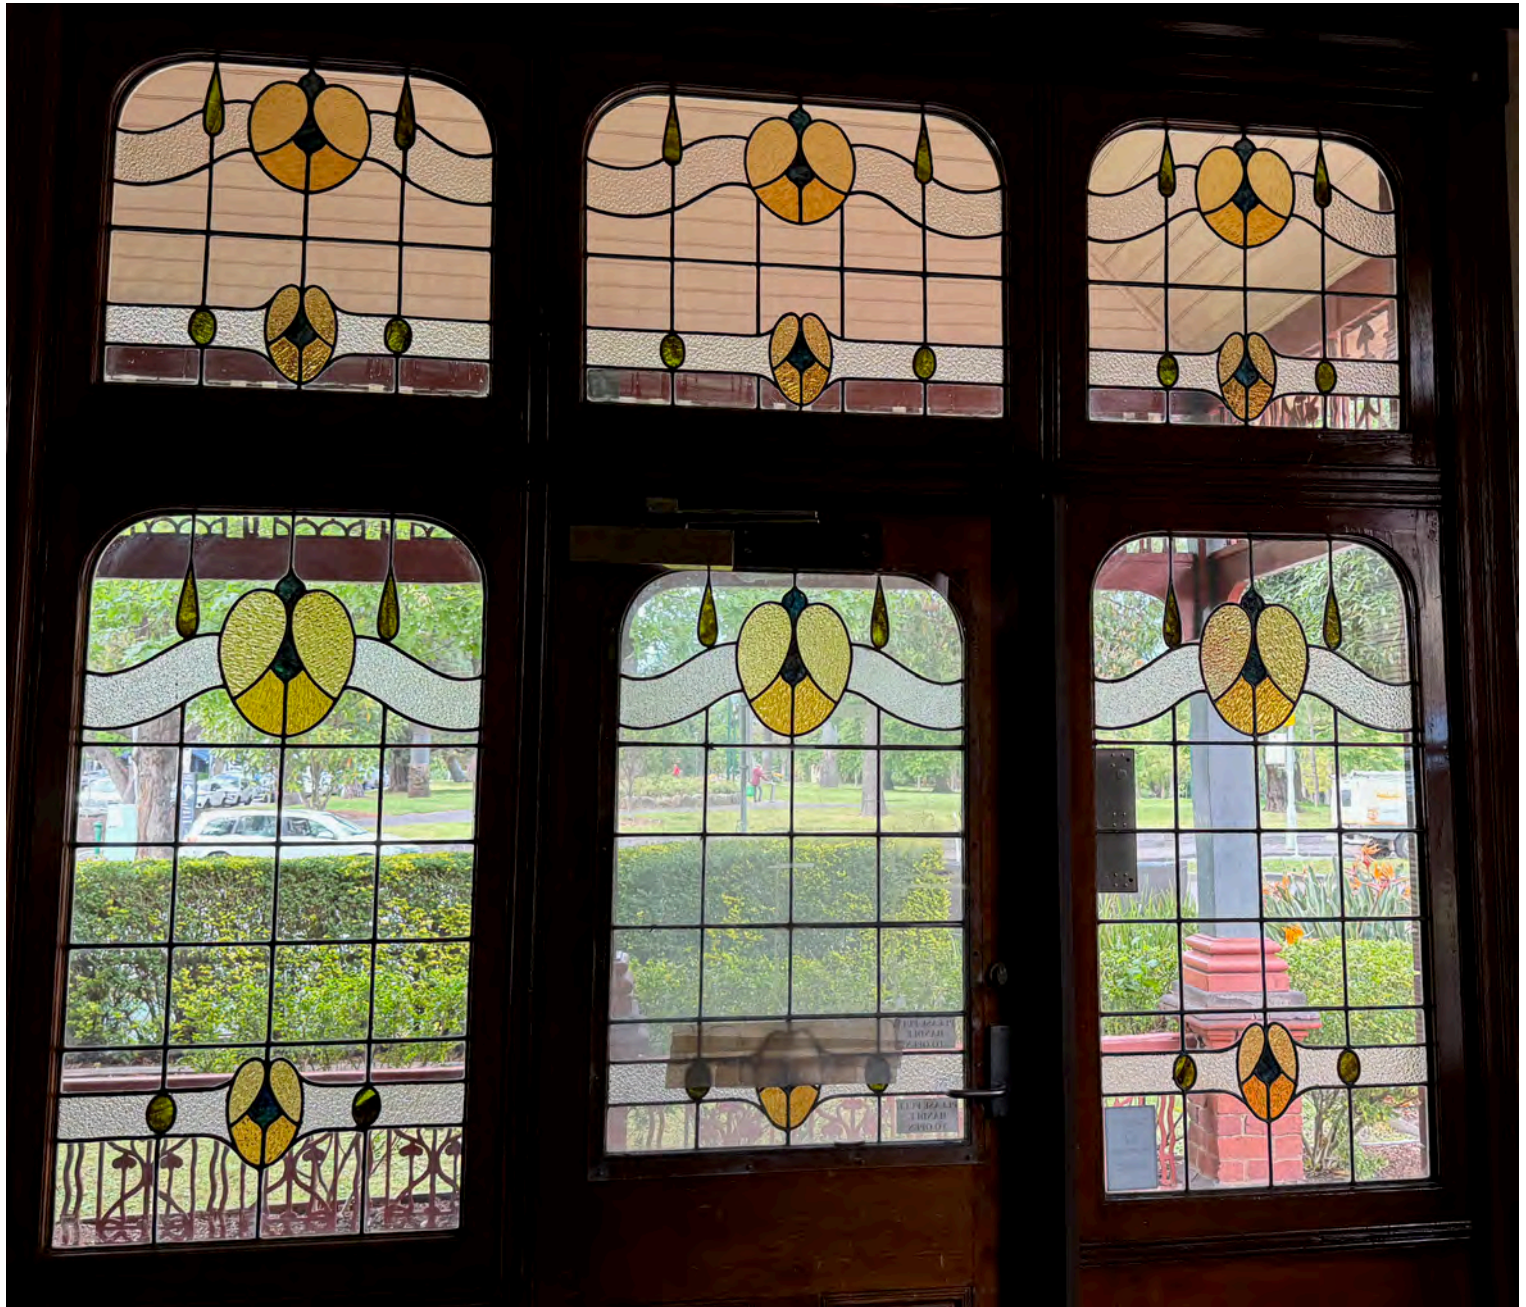
WG.11

Door panel - Covered with acrylic sheet. Damaged by impact. Glass has come away from the lead matrix. Currently taped over. There are some broken pieces of glass. Panel has reinforcing bars held with copper ties. These in places have come away from the lead.

The highlight windows appear to be in good condition. Bars soldered to panels.

It is recommended that the panel be removed and rebuilt replacing the entire lead matrix and any broken pieces of glass be replaced with either salvaged glass of the period or the closest possible match using modern glasses.

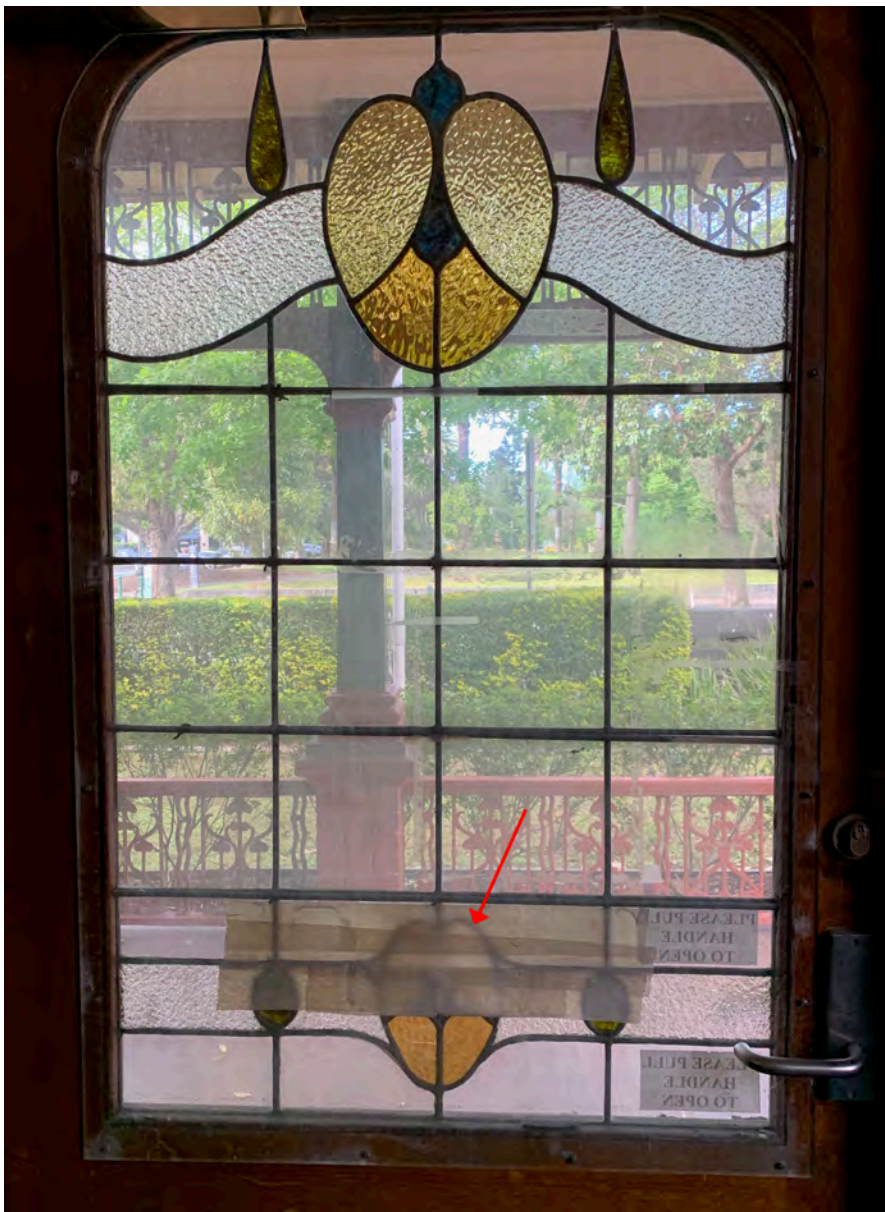
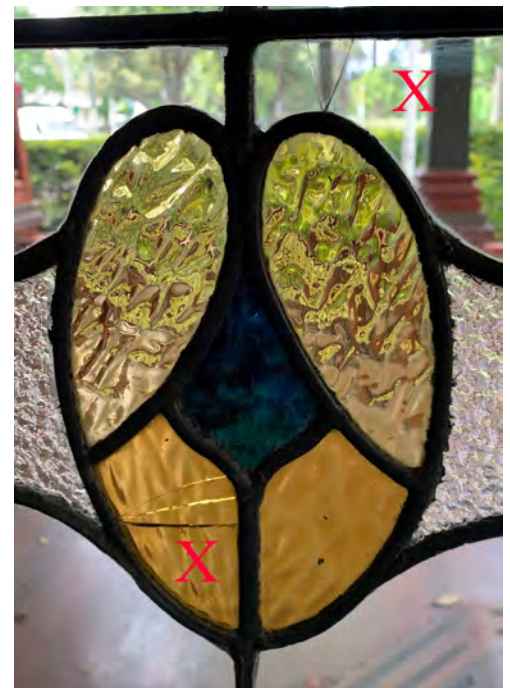
LHS Sidelight- Detail

The sidelights each have a few cracked pieces of glass. These could be repaired using the appropriate glass in situ. Bars soldered to panels.

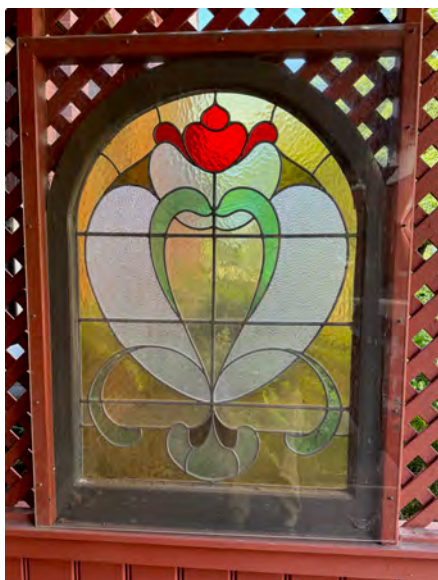
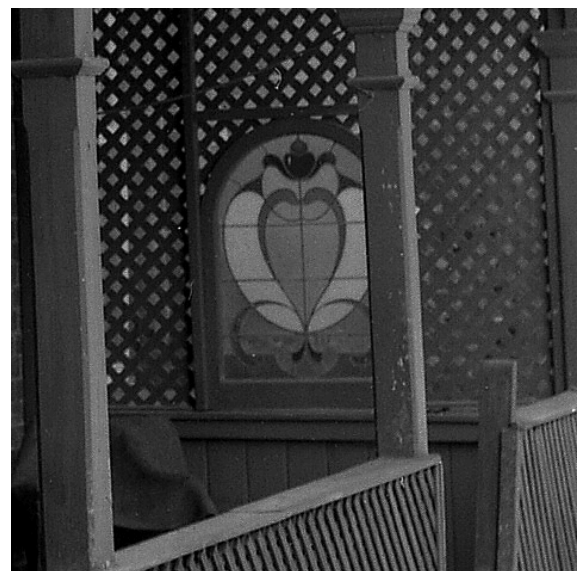
WG.16 - Leadlight window at the end of veranda. This window has been placed in between two acrylic sheets. The leadlight is not an original part of the fabric of the building. It is made largely from European Cathedral glass with some mouth blown antique glass. Probably circa late 1970's.

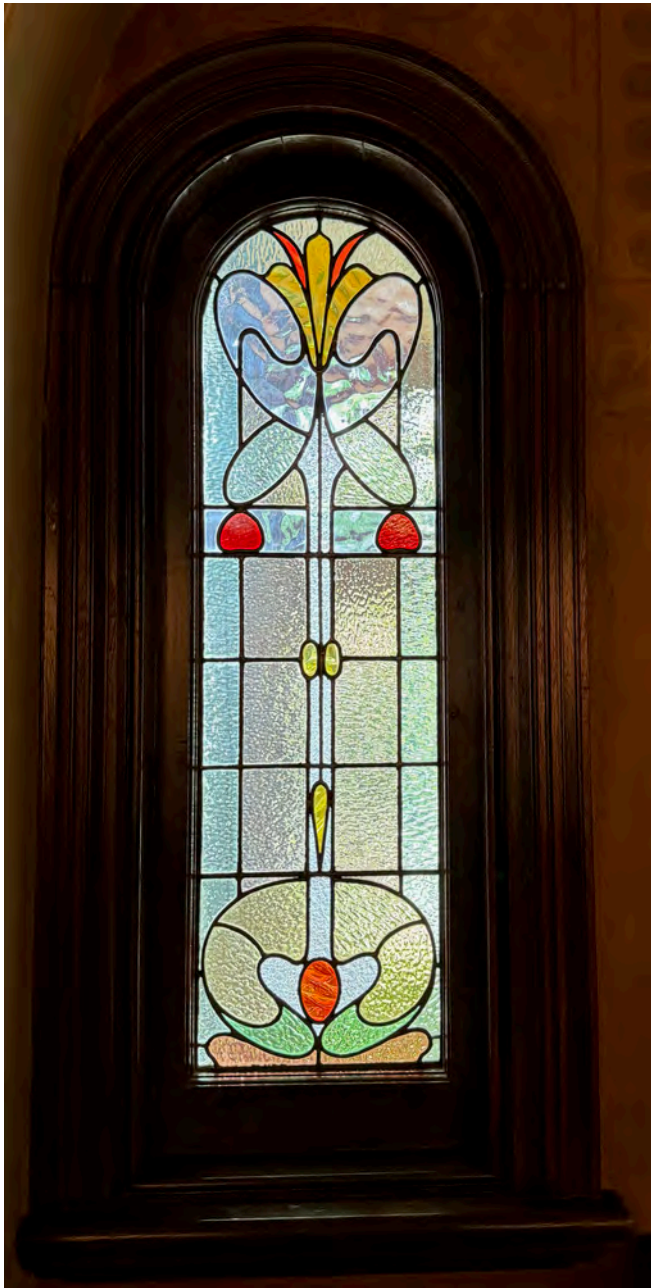
WG.40 & WG.41 - Two sashes with arched tops. Leadlights in good condition.

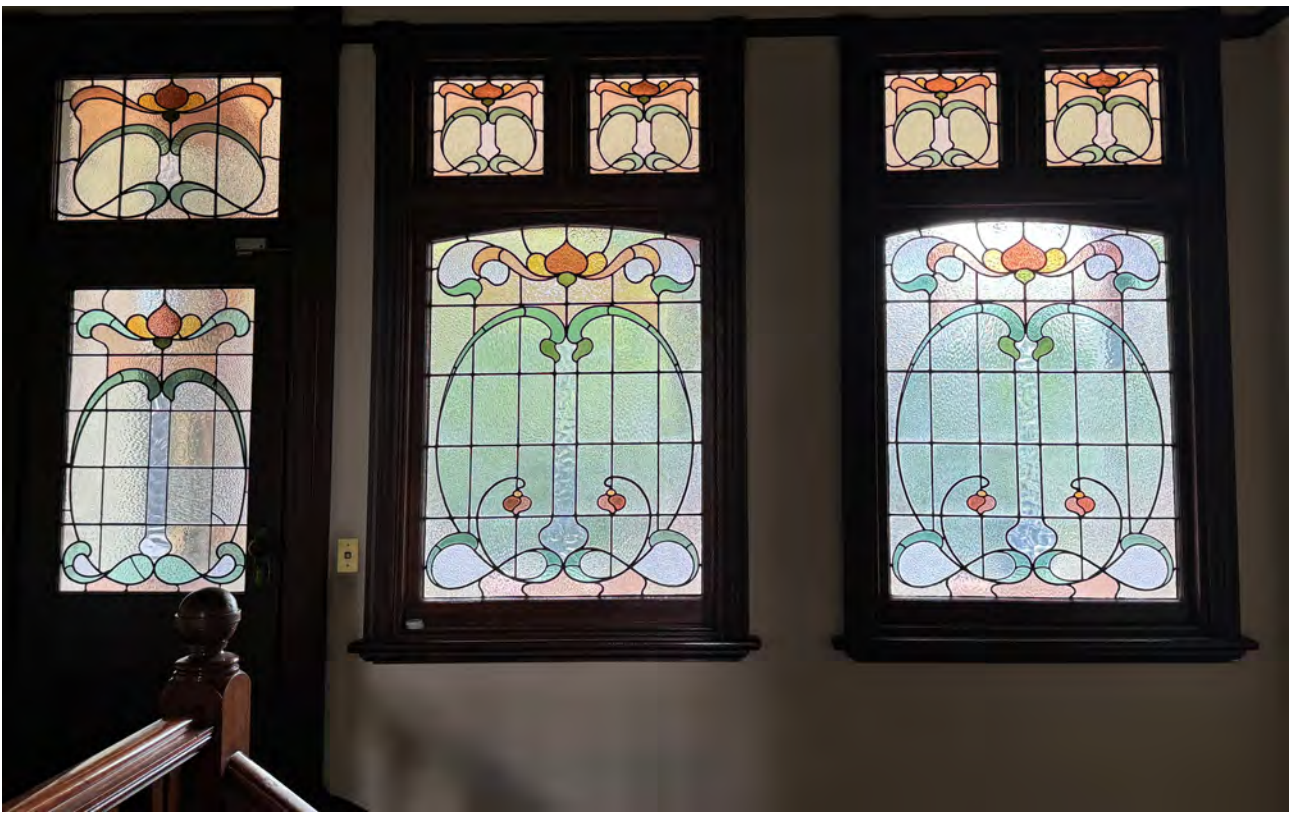
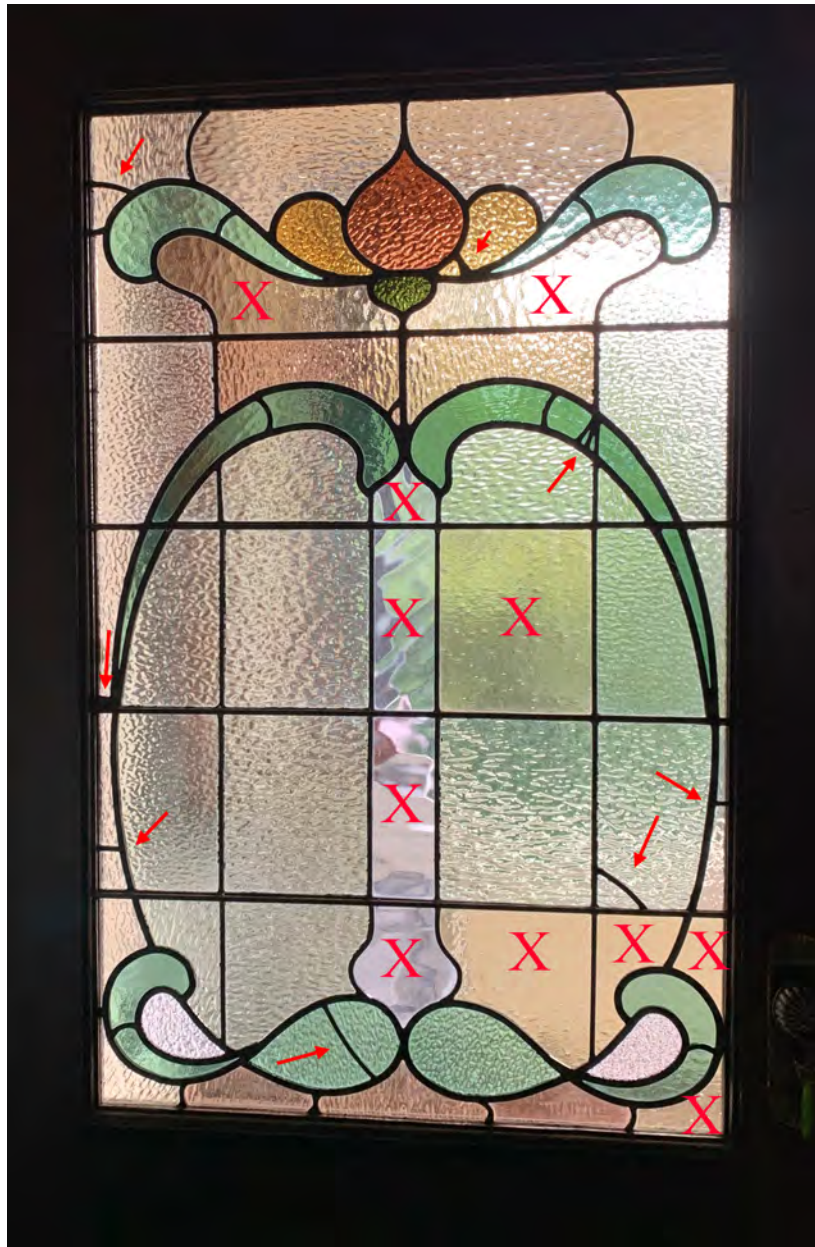
W1.01 - Door Panel

Door panel - The panel has been rebuilt. Glass has been replaced and false lead applied over cracked pieces of glass.

X denotes replacement glass, arrows show application of false lead.

It is recommended that the panel be removed and rebuilt by replacing the entire lead matrix and any broken pieces of glass or previous replacement pieces of glasses be replaced with either salvaged glass of the period or the closest possible match using modern glasses. Bars are secured by copper ties.

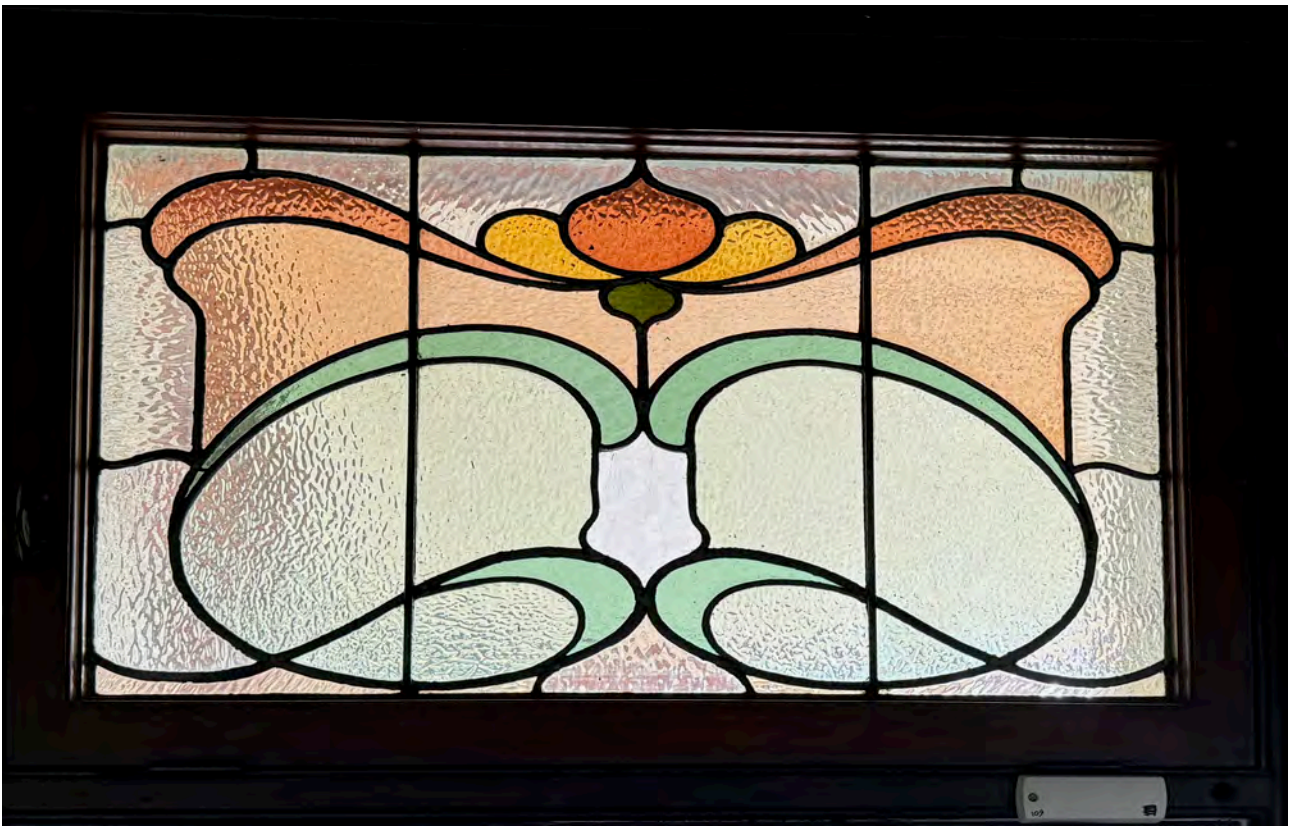
W1.01 - Transom Panel

Transom panel is in good condition. Bars soldered to the panel.

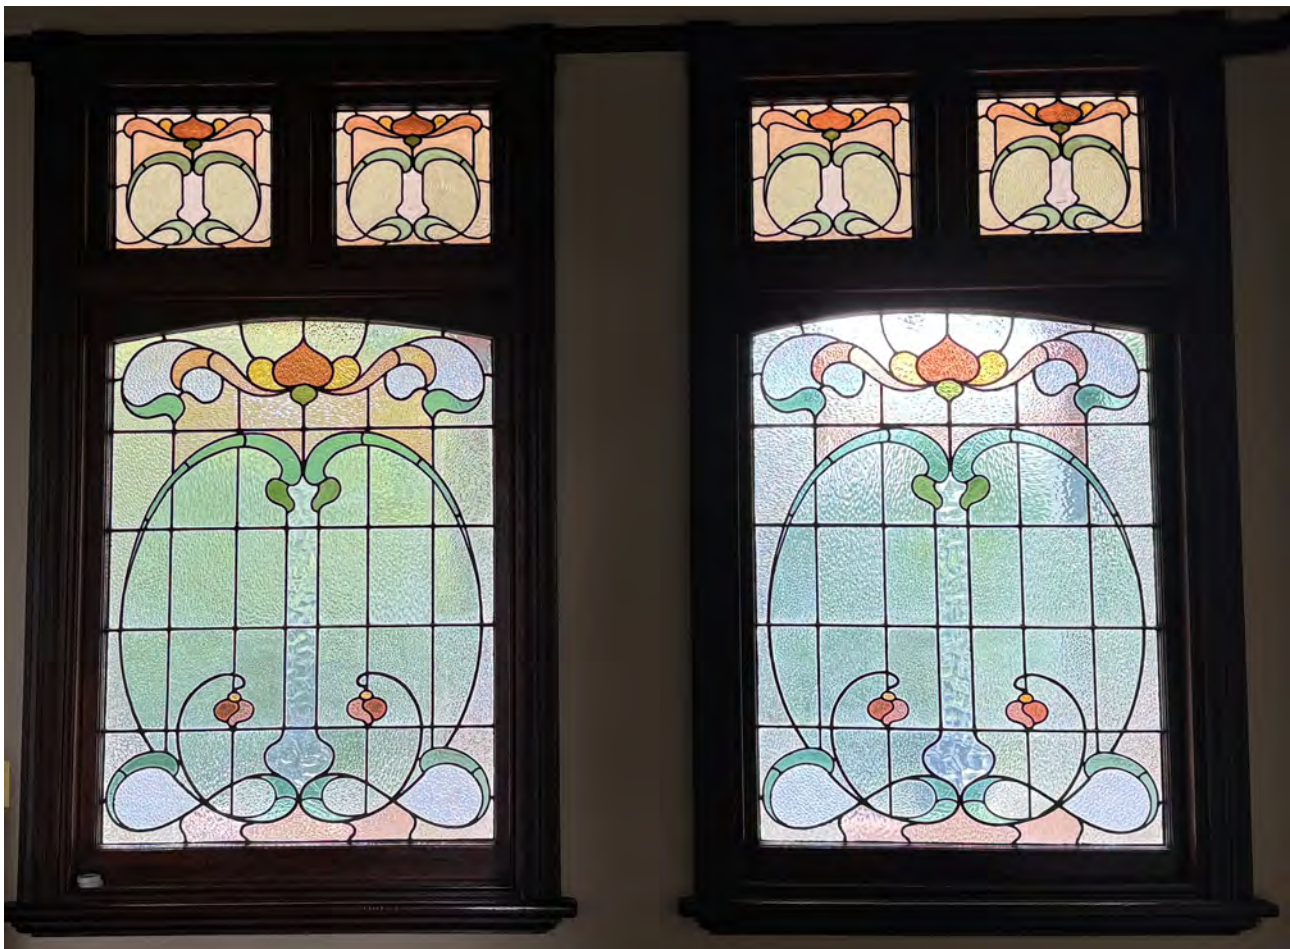
W1.02 & W1.03 - Stairwell Windows

The two larger arched top panels are in good condition. Bars soldered to the panel.

The four highlight windows all exhibit a degree of bowing but are stable e.g. no movement in the lead matrix. Condition check should be carried out every 3 - 5 years.

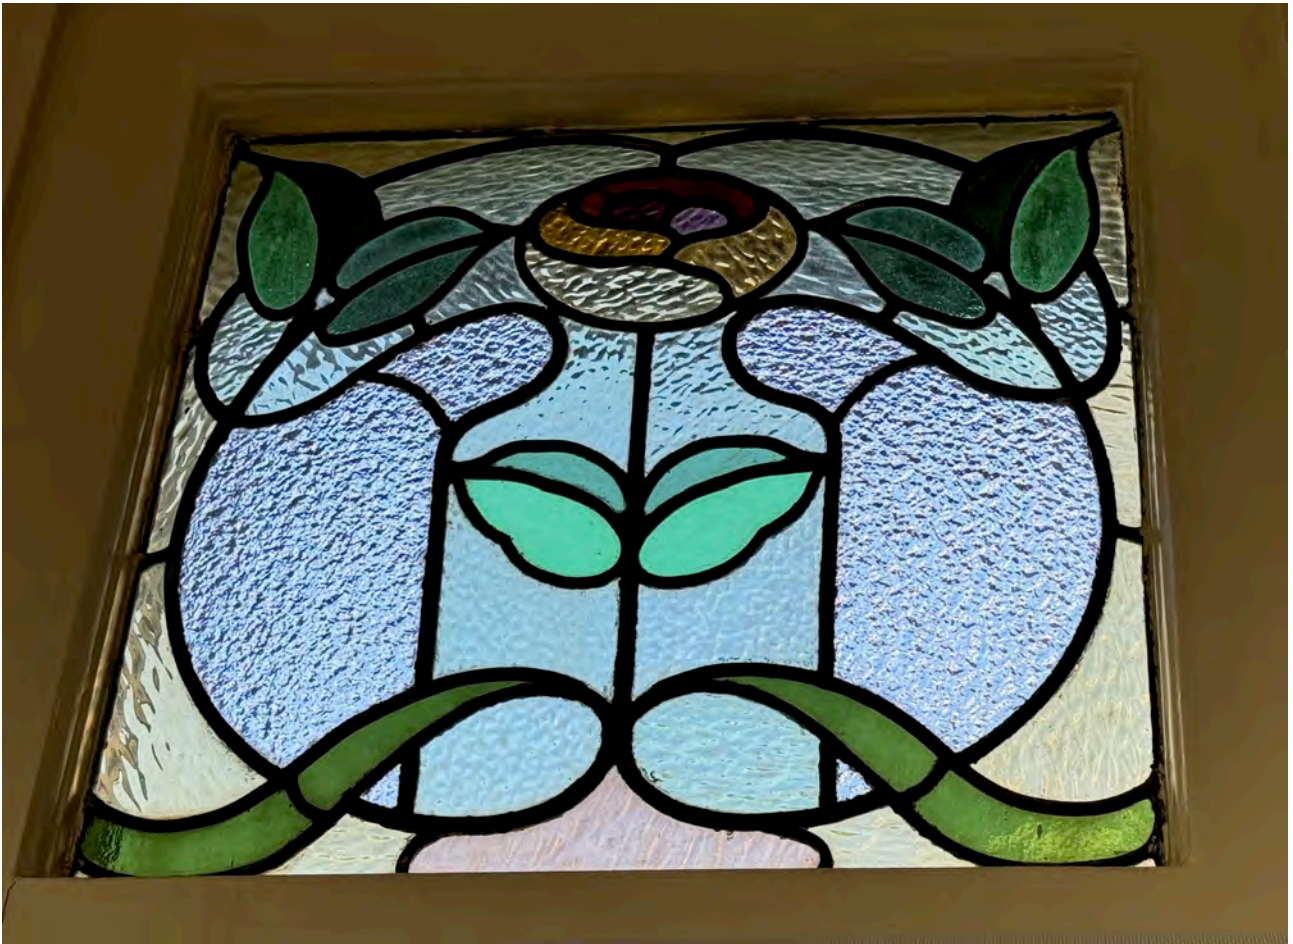
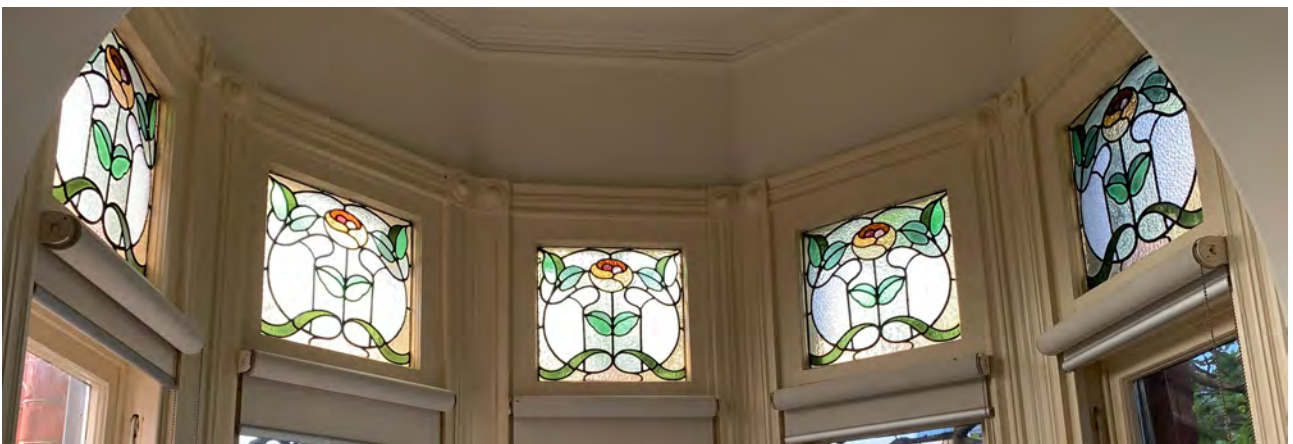
Highlight windows in a curved bay. Five panels of identical design and glass types. Panels are quite bowed but are stable. Condition check should be carried out every 3 - 5 years.
