Assessment of 23 trees within the Avenue  
of Honour, Bacchus Marsh

## **Health and condition review**

**Prepared For:** Moorabool Shire  
Council  
Att: Ross Holton  
PO Box 18, Ballan,  
VIC 3342

**4 February 2020**

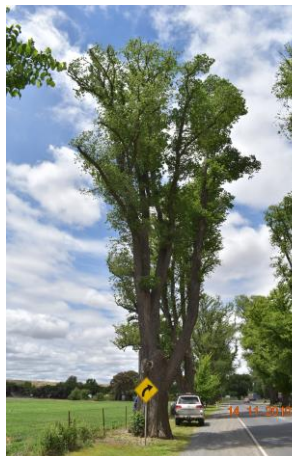
Figure 3: Tree N33

4 trees (ID N33, N35, S108 & S116. Figure 3, Figure 4, Figure 5 & Figure 6 respectively) are recommended for removal. They each have extensive decay in the trunk or root buttress or extensive decay in main stems. There are no mitigation options to maintain the tree at an acceptable level of risk in accordance with accepted industry standards (AS4373-2007).

The trees recommended for removal could be heavily reduced (or lopped) to significantly reduce likelihood of failures but has the additional outcome of exacerbating tree decline and is not a long-term management strategy; it should only be considered as a stopgap measure to stagger removals if desired.

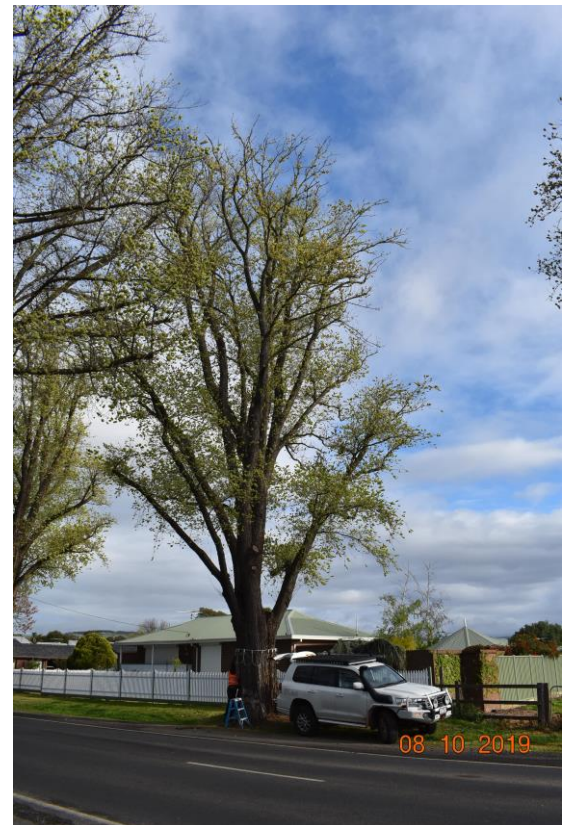
**Tree ID:** N03

Mechanical damage at base, no decay obvious, ARBOTOM revealed minor decay between ribs, trunk still sound. Decay at 3m in old failure stub. Decay visible at previous branch unions.

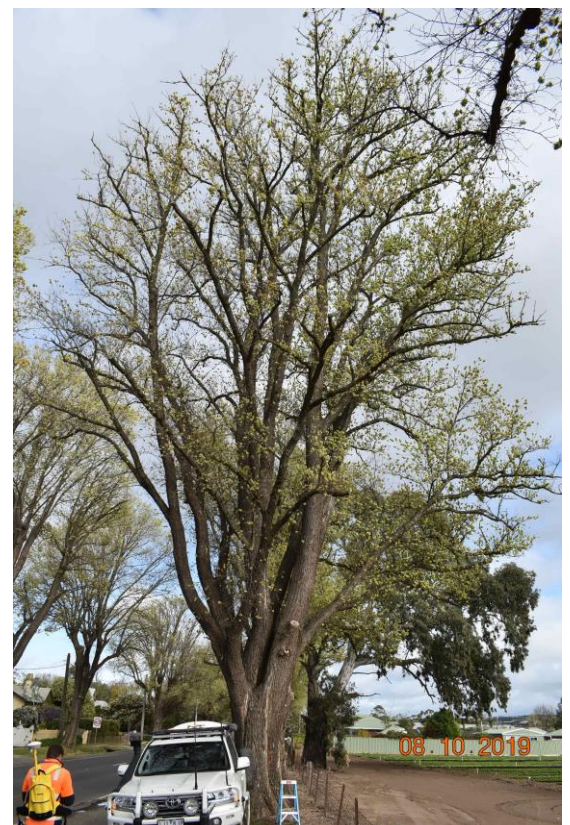
**Tree ID:** N11

Suspected lightning damage. Mechanical damage on roadside stem. Moderate decay in upper branch union (~22m) on central stem.

Inspect problematic union, reduce if heavily decayed. Weight reduction above decayed union on central stem and roadside branches.

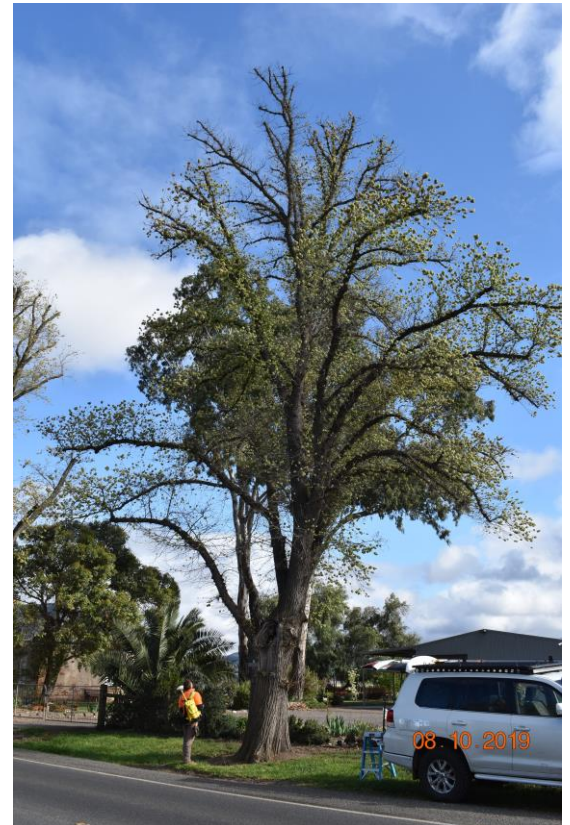
**Tree ID:** N27

Significant decay in main stem at failed union. Considerable decay through trunk. Minor deadwood in upper canopy. Failure unlikely towards roadway.

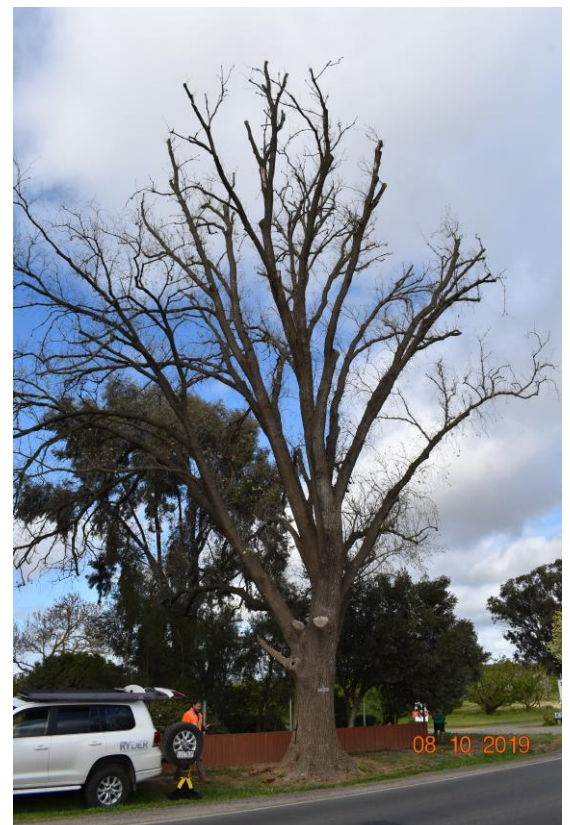
**Tree ID:** S32

Moderate dieback and considerable reduction in health. Deadwood in upper canopy. Decay cavity in trunk at base. Significant decline.

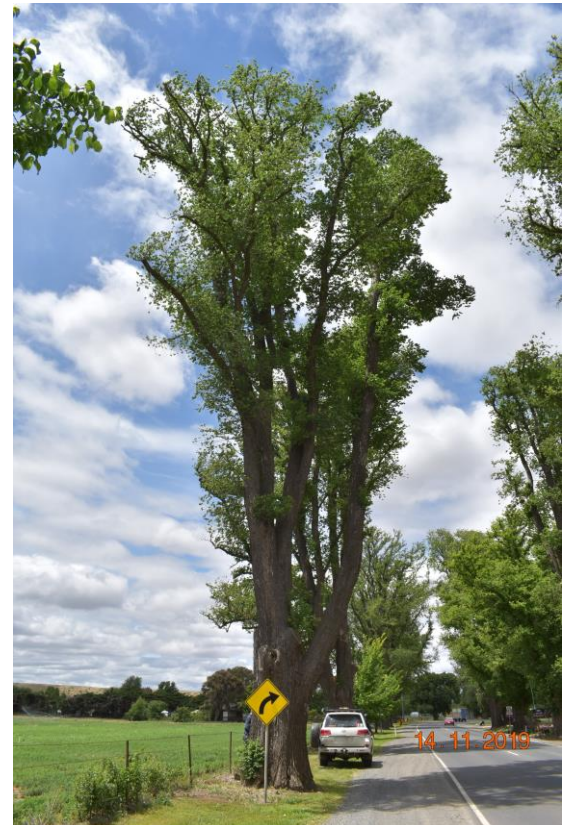
**Tree ID:** N33

ARBOTOM indicates major internal trunk decay near base. Codominant stems above 5m, mild inclusion.

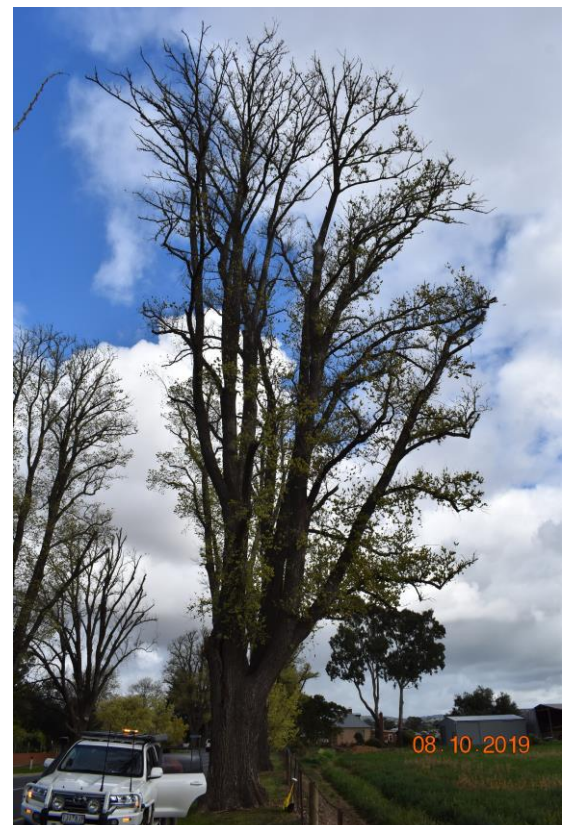
**Tree ID:** N35

Decay at major split, 4m, aerial ARBOTOM indicates considerable decay in central stem.

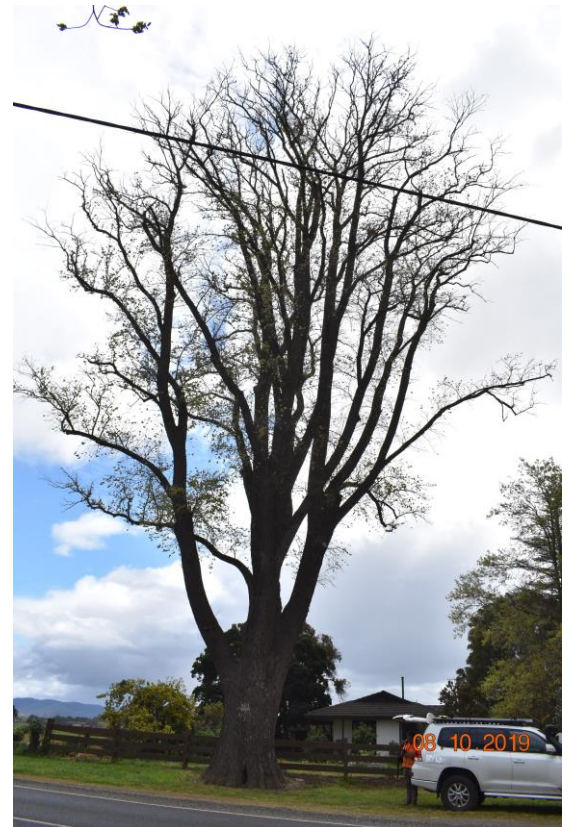
**Tree ID:** N47

Upper canopy decline, moderate deadwood. Basal decay pocket. Codominant stems on roadside, mild inclusion, considerable reaction wood.

Remove deadwood in upper canopy. Inspect cable tensions and conditions.

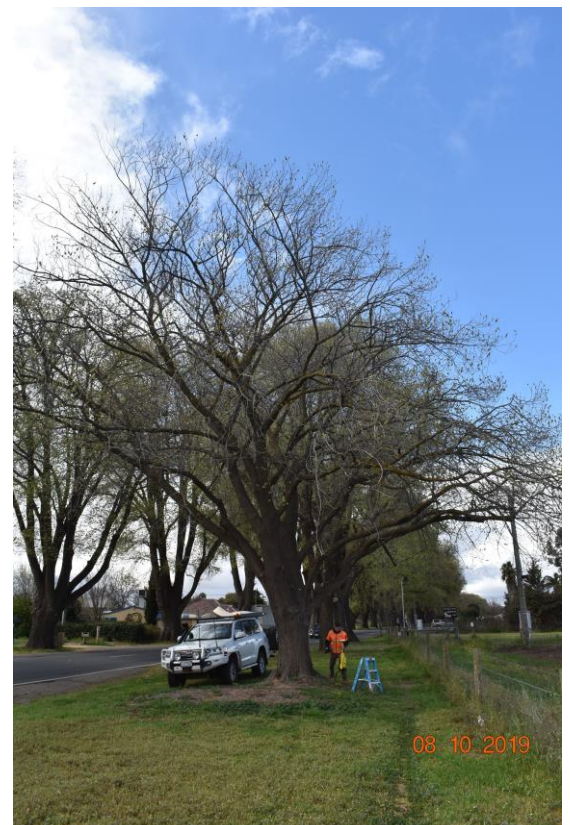
**Tree ID:** S58

Codominant union at 2m with vascular necrosis but minimal decay.

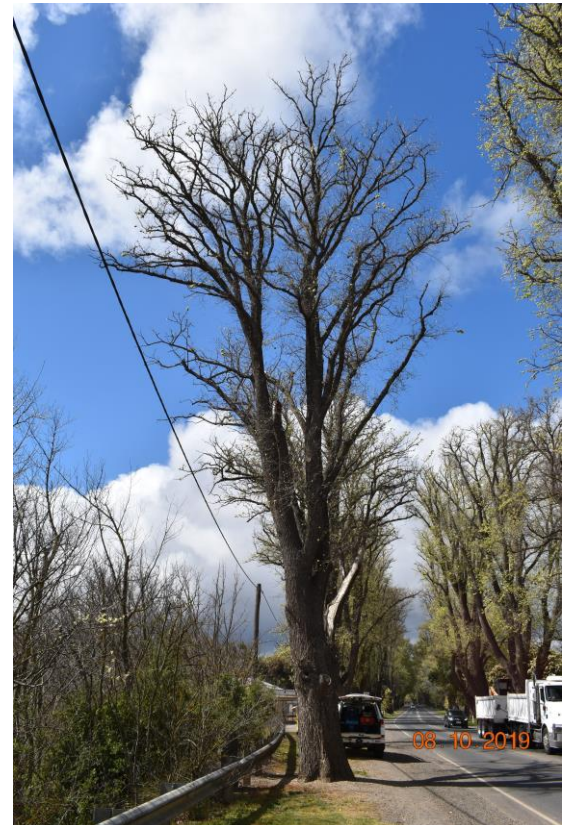
**Tree ID:** N101

Deadwood in upper canopy. Moderate wound on trunk. Minor decay hollows throughout. Loss of soil from erosion of bank.

Remove deadwood. Continue existing veteran tree management, slowly reducing canopy weight and height to limit branch and stem failure potential.

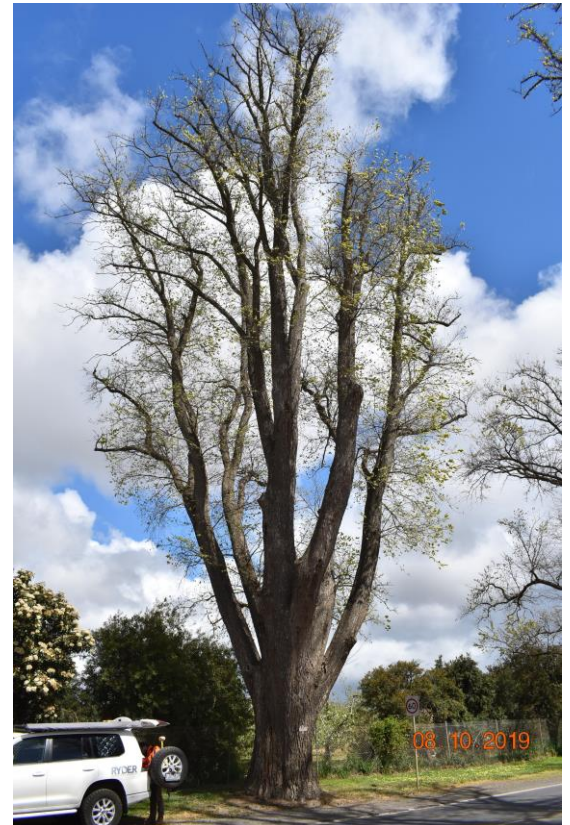
**Tree ID:** S106

Moderate deadwood. Moderate decline. Minor decay cavities. Moderate decay on top of lowest lateral branch to the west.

Remove deadwood. Remove lower lateral branch to the west. Reducing canopy on south to manage as veteran. Inspect cable tension and condition.

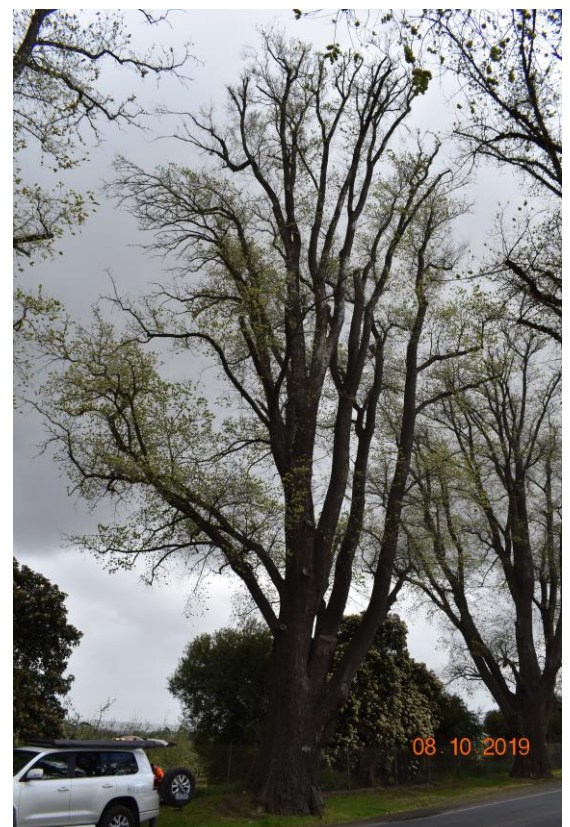
**Tree ID:** S108

Moderate deadwood in upper canopy. Moderate decline. Minor decay cavities at previous branch unions. ARBOTOM indicates extensive decay of root buttress.

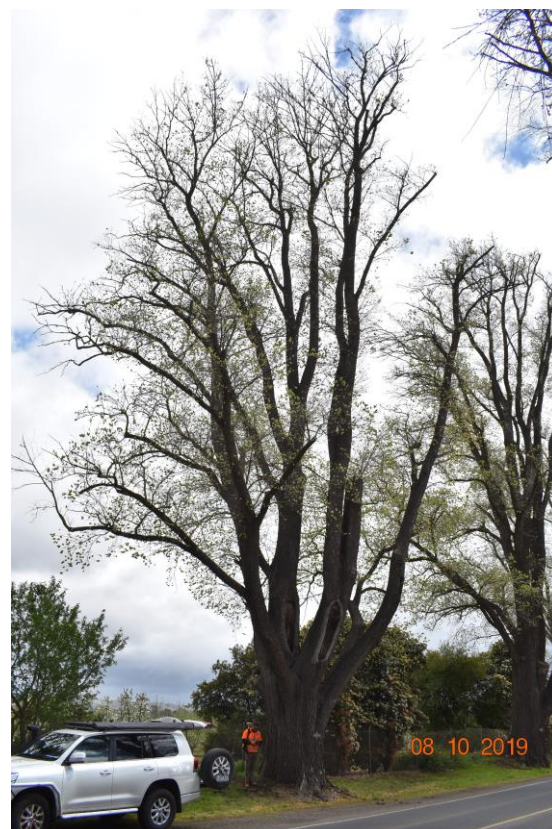
**Tree ID:** S110

Moderate deadwood in upper canopy. Minor decay cavities at previous branch unions. Fungal fruiting body noted on previous large pruning wound. Vascular dieback of lateral branch to south.

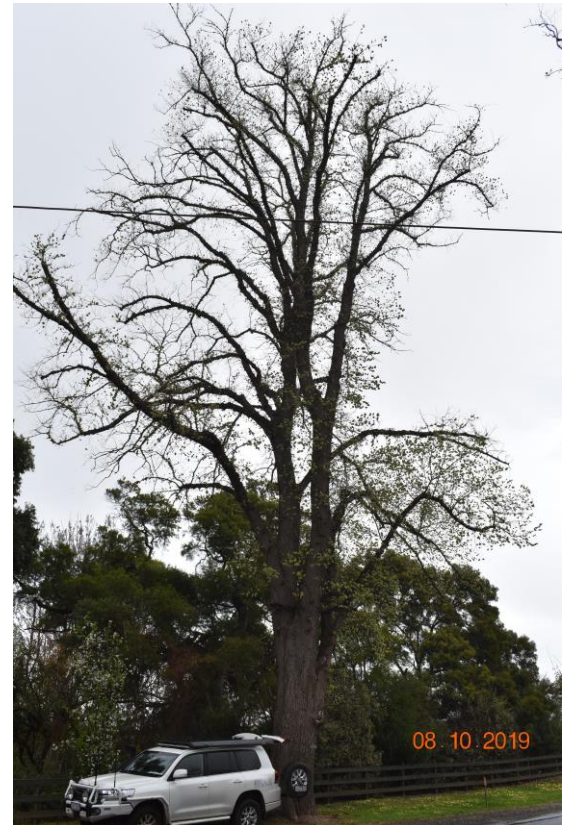
**Tree ID: S116**

Moderate decline, minor deadwood in upper canopy, considerable epicormic growth. Cavity in trunk, ARBOTOM indicates extensive internal decay. Hanging branch lodged in canopy.

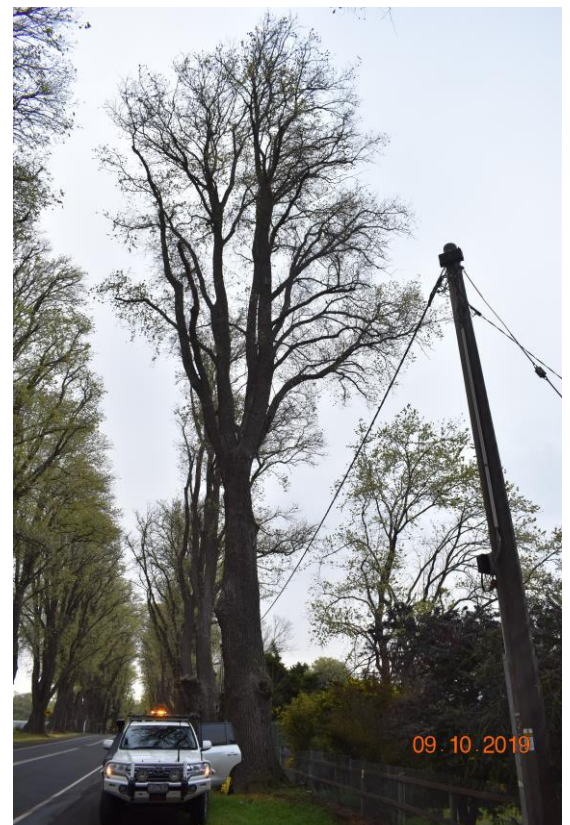
**Tree ID: S144**

Minimal deadwood in canopy. Minor decay in old branch unions and stubs although main trunk appears sound. Several upper canopy unions codominant with minor inclusion but unlikely to fail.

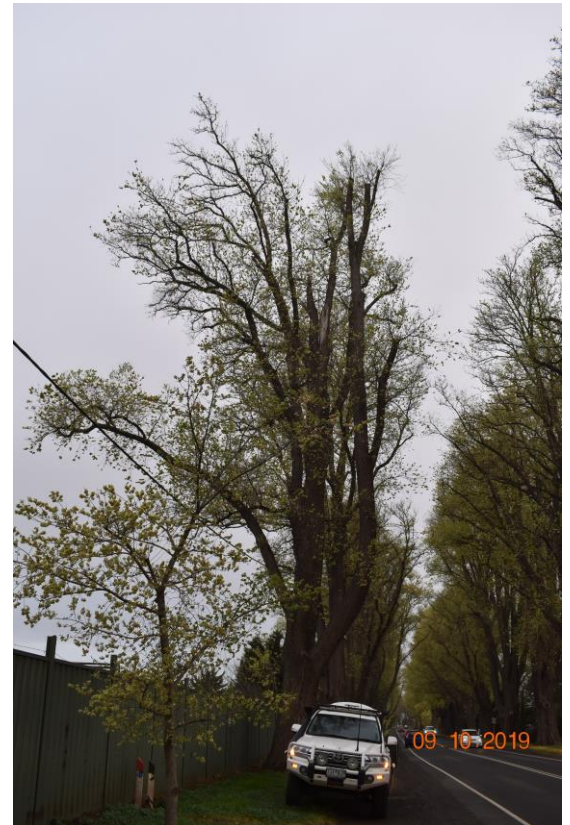
**Tree ID:** S152

Minor root damage from mowing. Moderate cavity at 3m not affecting structural integrity. Several previous failures, one large.

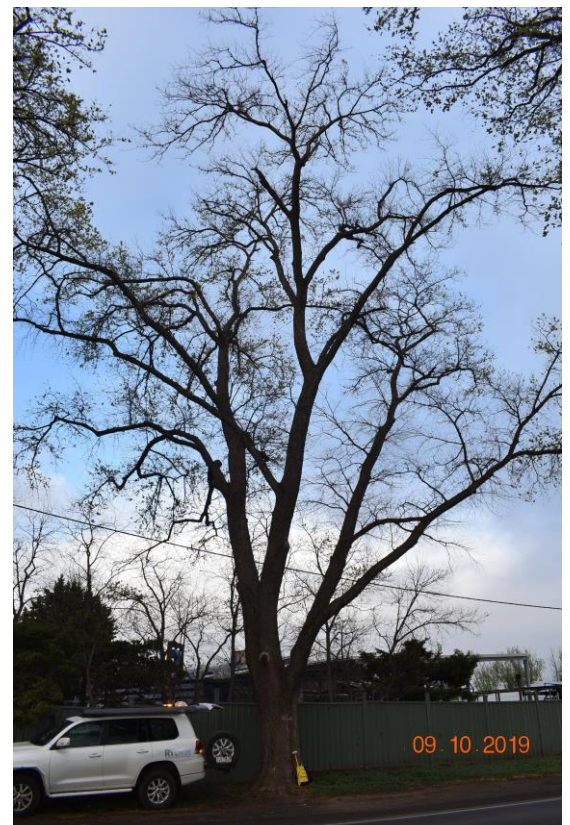
**Tree ID:** S156

No major decay evident, minor decay in upper branches.

Remove decayed branches over abbatoir. Reduce low branch over road by ~10%. Inspect cable tension and condition.

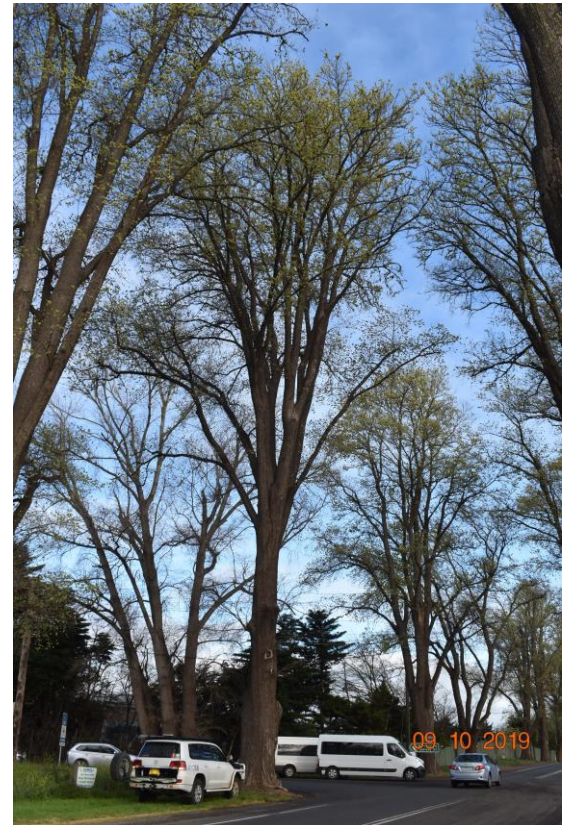
**Tree ID:** S160

Cavity and decay in main trunk; ARBORTOM indicates good residual wall thickness. Trunk has been consistently damaged by vehicles. Codominant from 4m, although union appears sound.

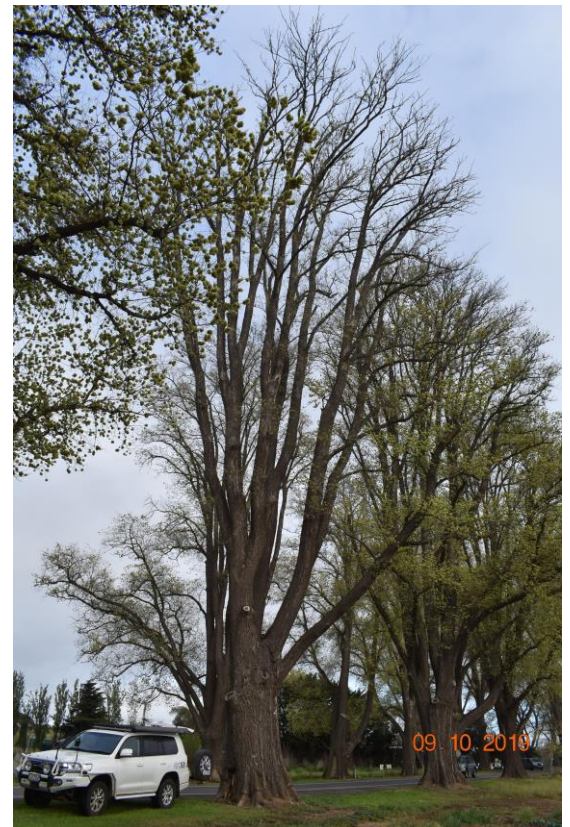
**Tree ID:** N169

Decline, deadwood in upper canopy and seasonal growth is poor. ARBOTOM confirms significant decay in large cavity at the base. Several small cavities at previous branch stubs.

Remove defective branch over roadway in upper canopy.  
Remove deadwood. Reduce height of canopy to manage as veteran. Reinspect in 2 years.
