Tree Condition Assessment

Site Address: Chinese Temple. 2/76 Raglan Street, South Melbourne. 3205
Date of Inspection: 09/11/24
Client: Open Air Events Pty Ltd
Client Contact: Jeremy Crowe
Attending Arborist: Joel Sharp

A tree health and structure assessment of two trees; a *Liquidambar styraciflua* (Sweetgum) tree (herein referred to as Tree 1) and a *Platanus x acerifolia* (London Plane) tree (herein referred to as Tree 2). A non-invasive, ground-based health and structure assessment was undertaken on 09/11/2024.

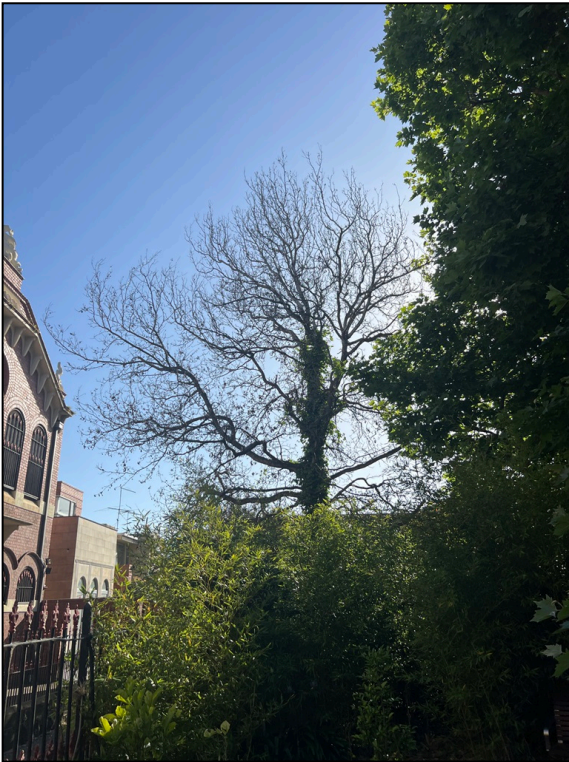
The tree is dead. No evidence of live foliage was observed. Significant necrosis and associated bark delamination was observed at the base of the tree. English Ivy was observed growing on the main trunk of the tree.

Tree structure is poor. Desiccation associated with tree death has impacted wood integrity resulting in multiple observed branch failures.

Top left: View from west illustrating overall tree condition.
Top right: View from south illustrating necrosis and bark delamination at the base of the tree.

1. Within 12 months, remove the tree.

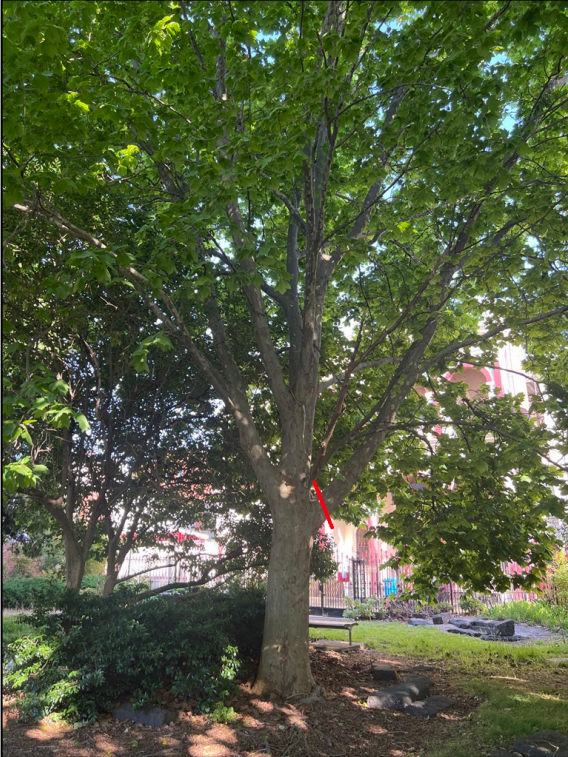
Removal of the large ascending branch which grows from the lower east trunk face with diameter of approx.. 200mm (pictured below) has been requested for removal by the client to allow for the installation of a temporary space of worship.

The requested live branch removal is not expected to have a significant impact on the tree's health or structure due to the species' high tolerance to pruning and current good health. To help lessen impact, additional irrigation is recommended during the summer months (Dec. | Jan. | Feb.). The branch removal will remove approx.. 10% of the tree's live foliage which lies within the acceptable limits of the Heritage exemptions. Tree cutting must be performed by a minimum AQF Level 3 Certified Arborist to ensure that the pruning cuts adhere to the Australian Standard for Pruning of Amenity Trees 4373-2007.

Top left: View from south illustrating requested branch removal and tree condition.

1. Within 12 months, remove all deadwood greater than 30mm basal diameter.
2. Undertake requested branch removal following obtainment of City of Port Phillip Significant Tree Permit.
3. Supply additional irrigation during the summer months (Dec.| Jan. |Feb.).
