Excellent Roofing Pty Ltd

Customer: B.E Architecture

Job Address: 1/19 Clarendon St, East Melbourne

JOB INSPECTION REPORT:

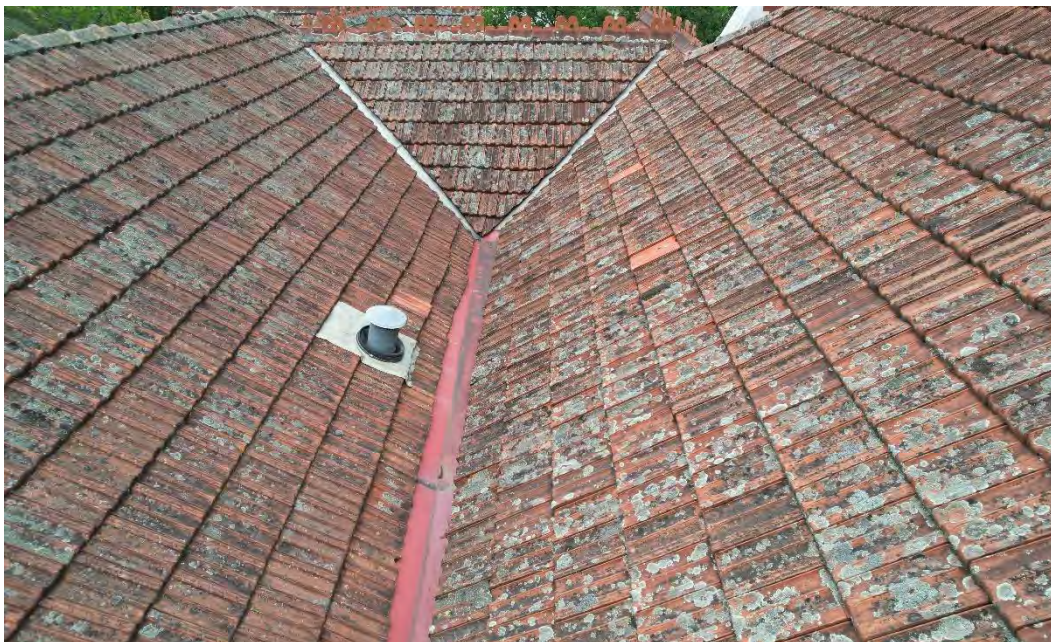
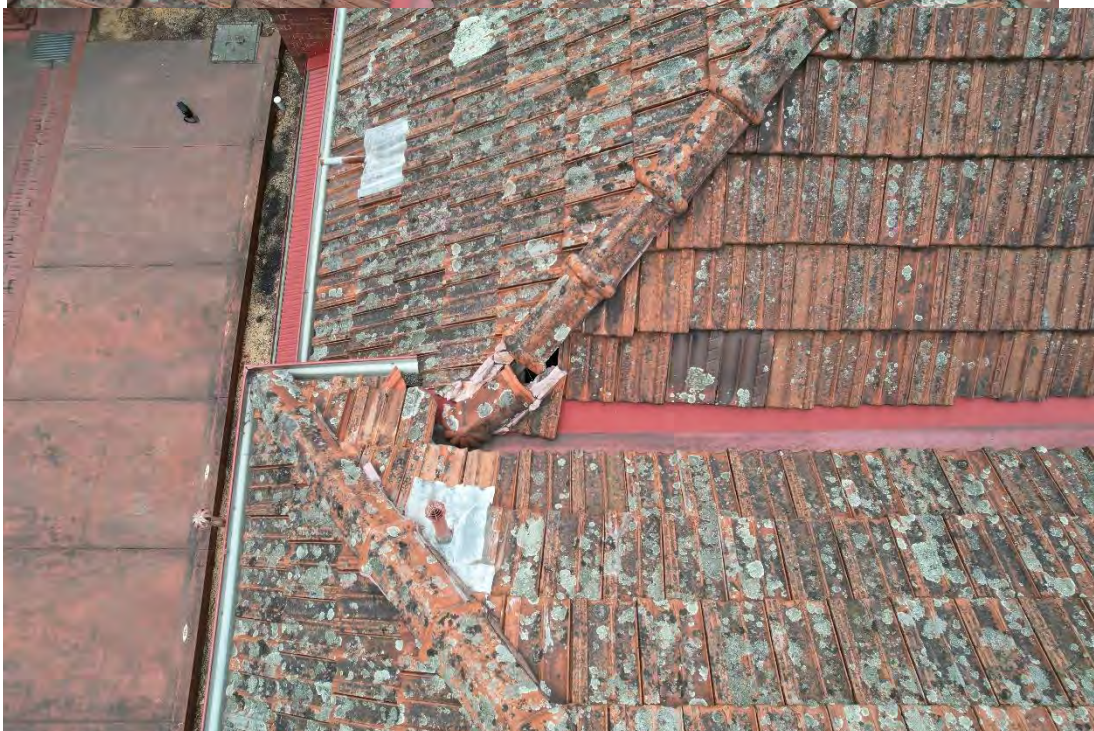
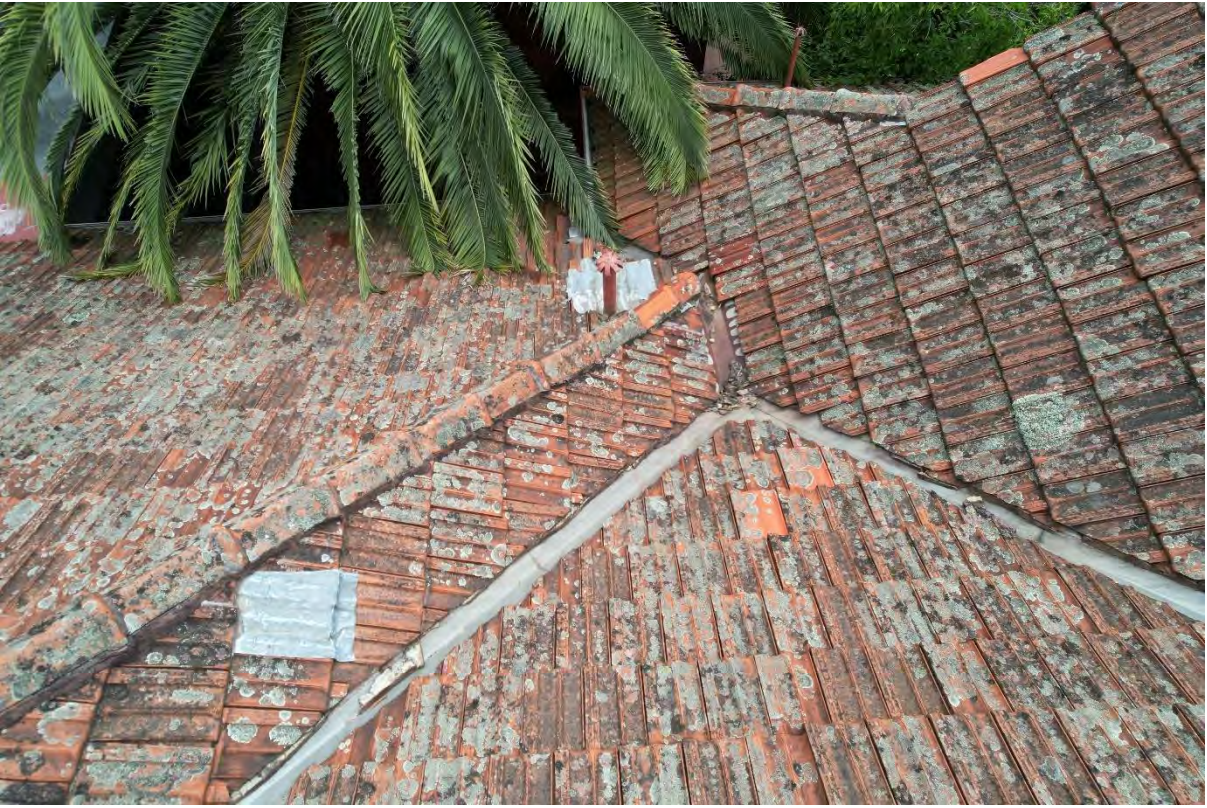
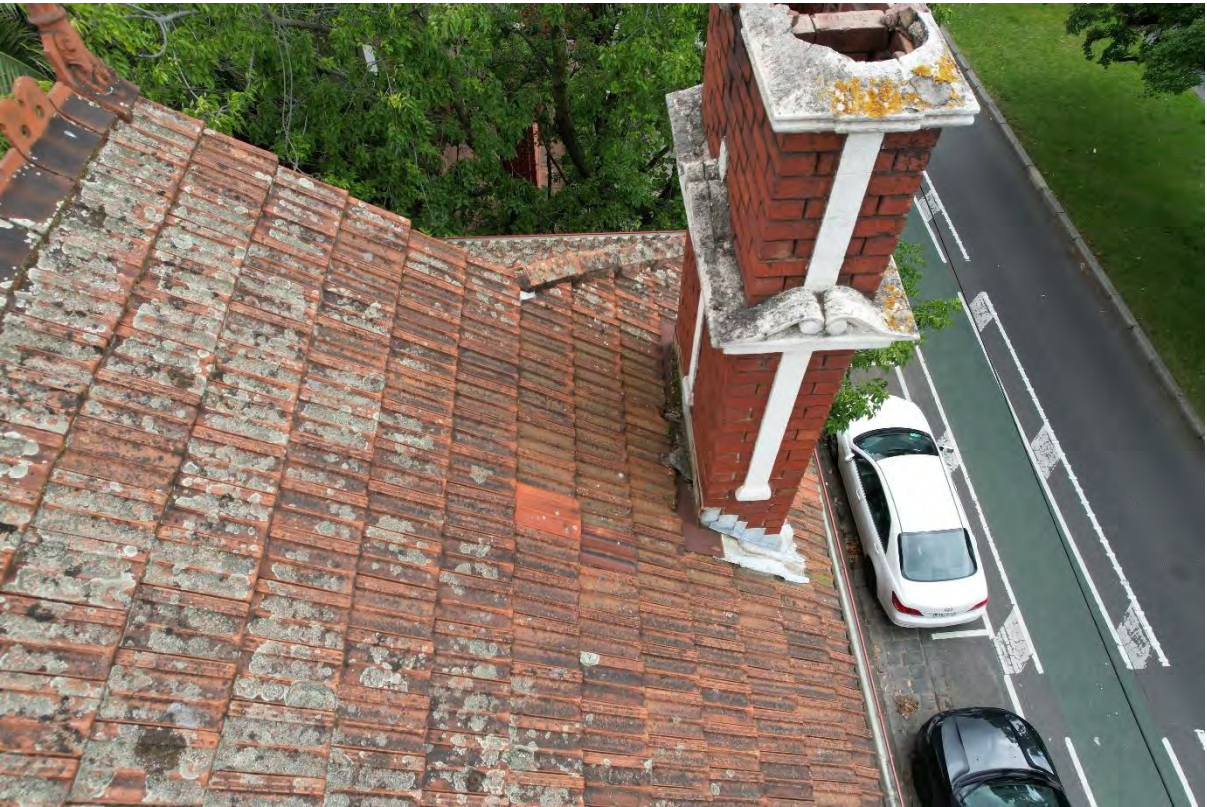
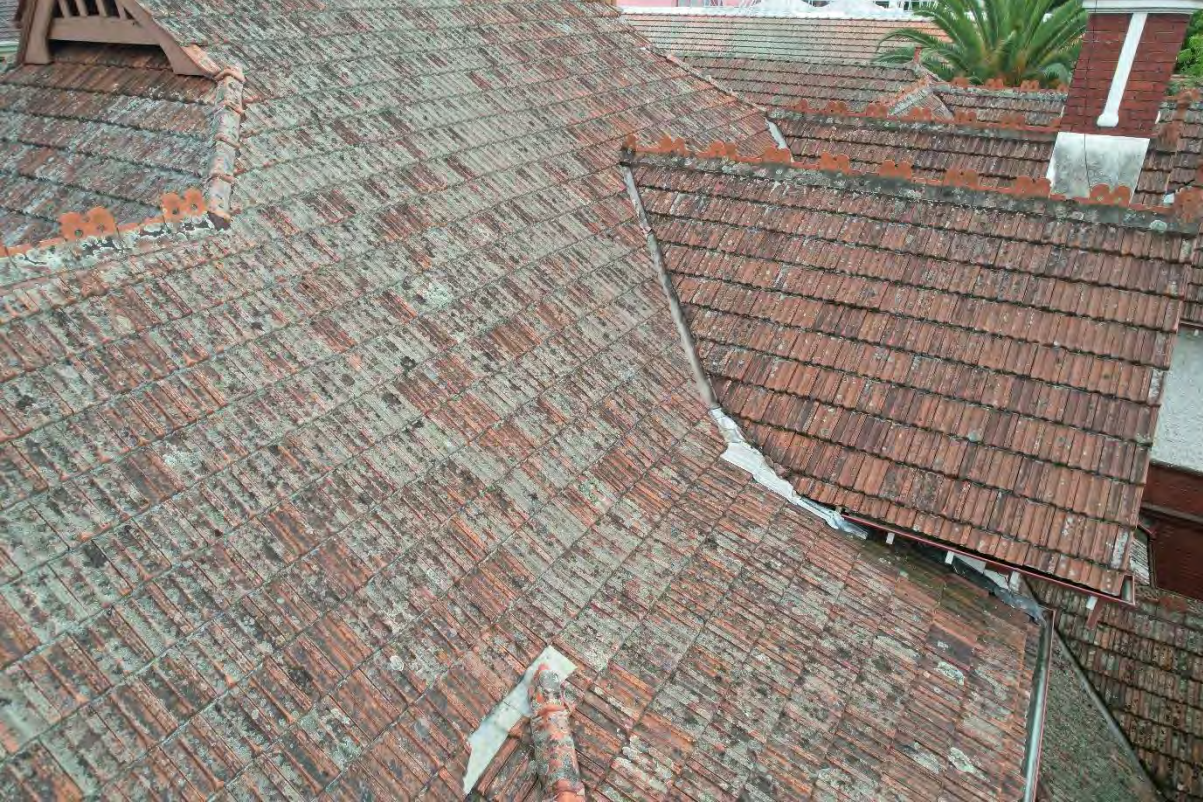
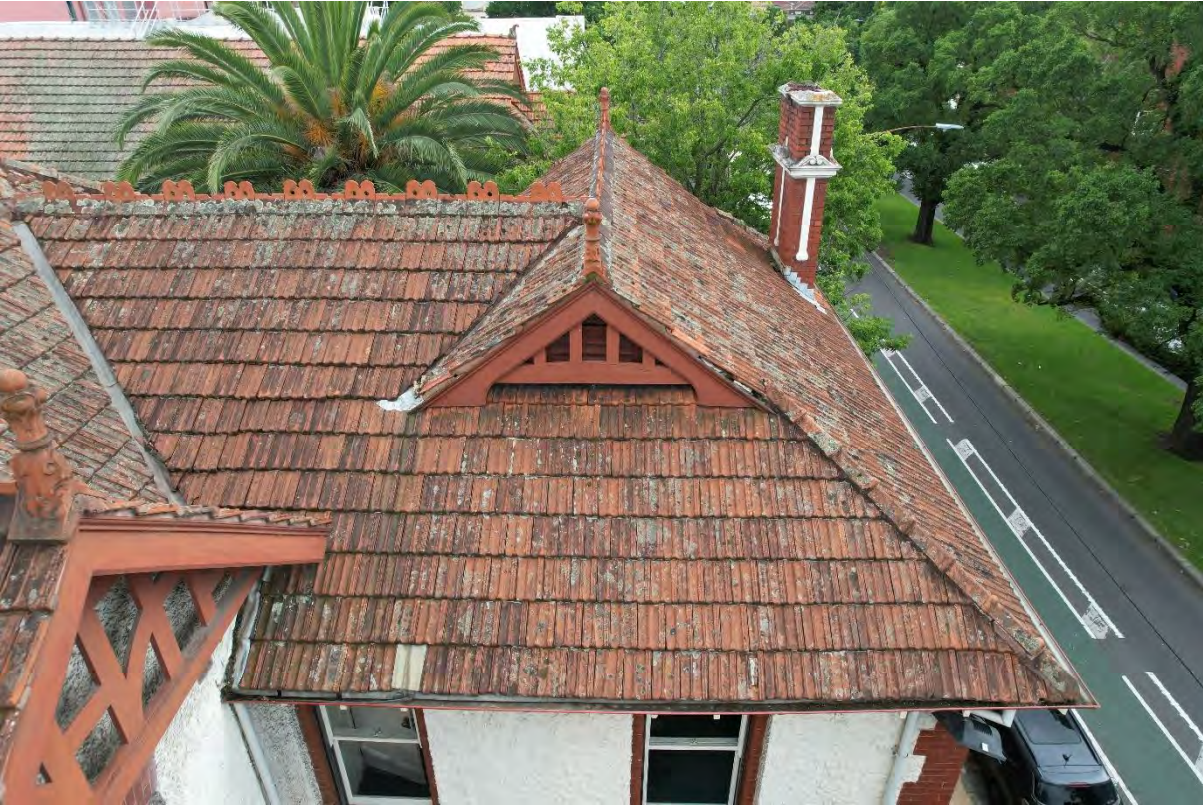
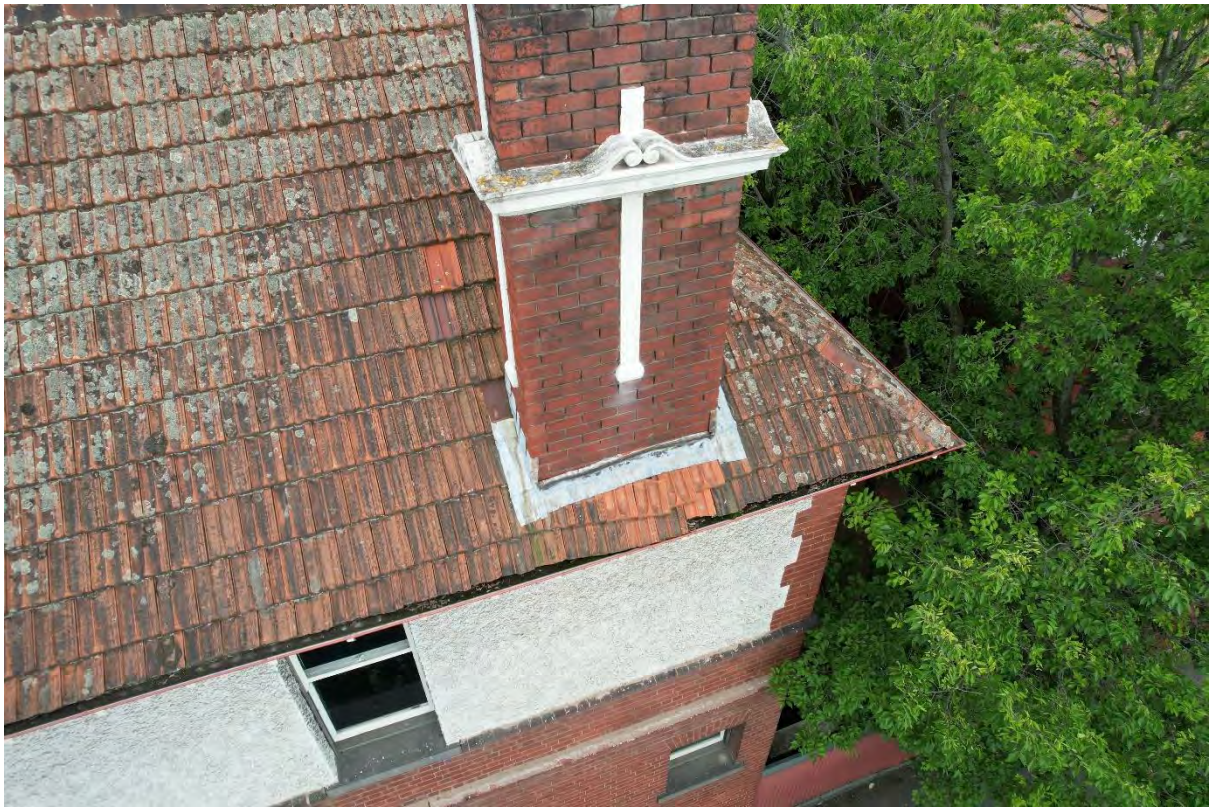
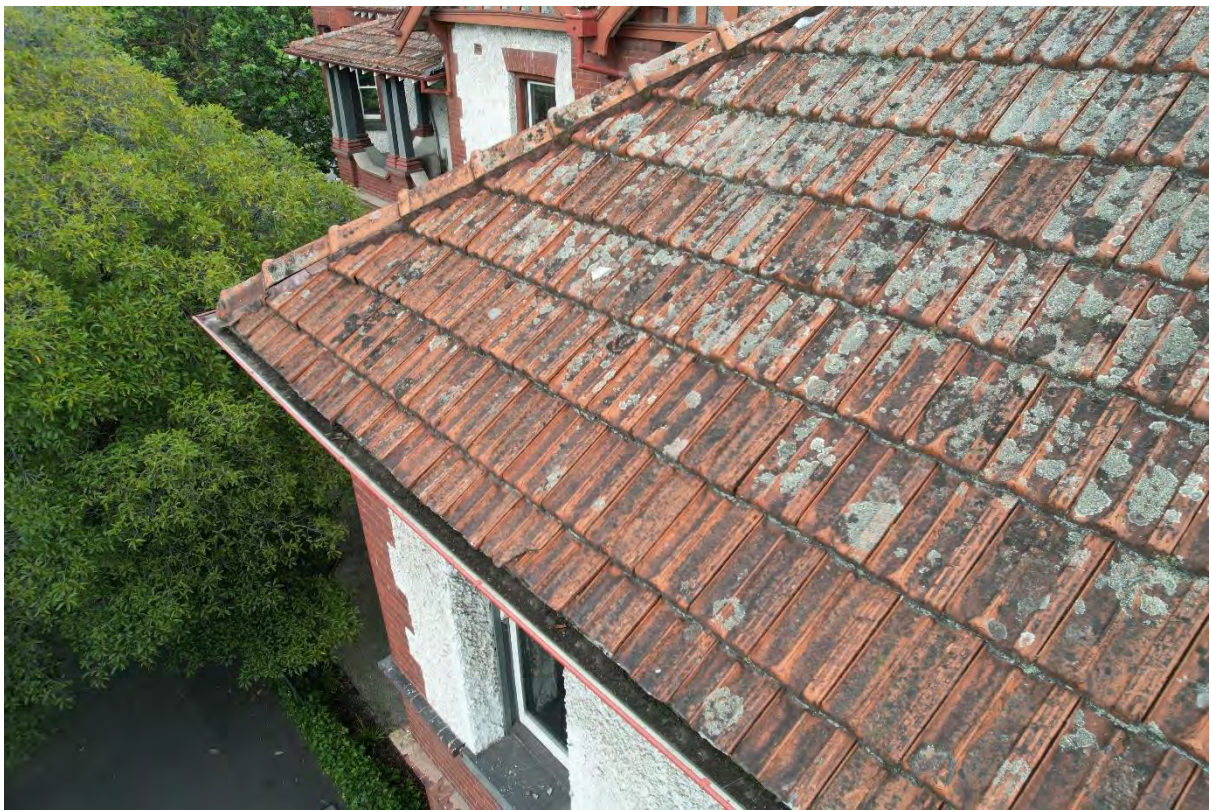
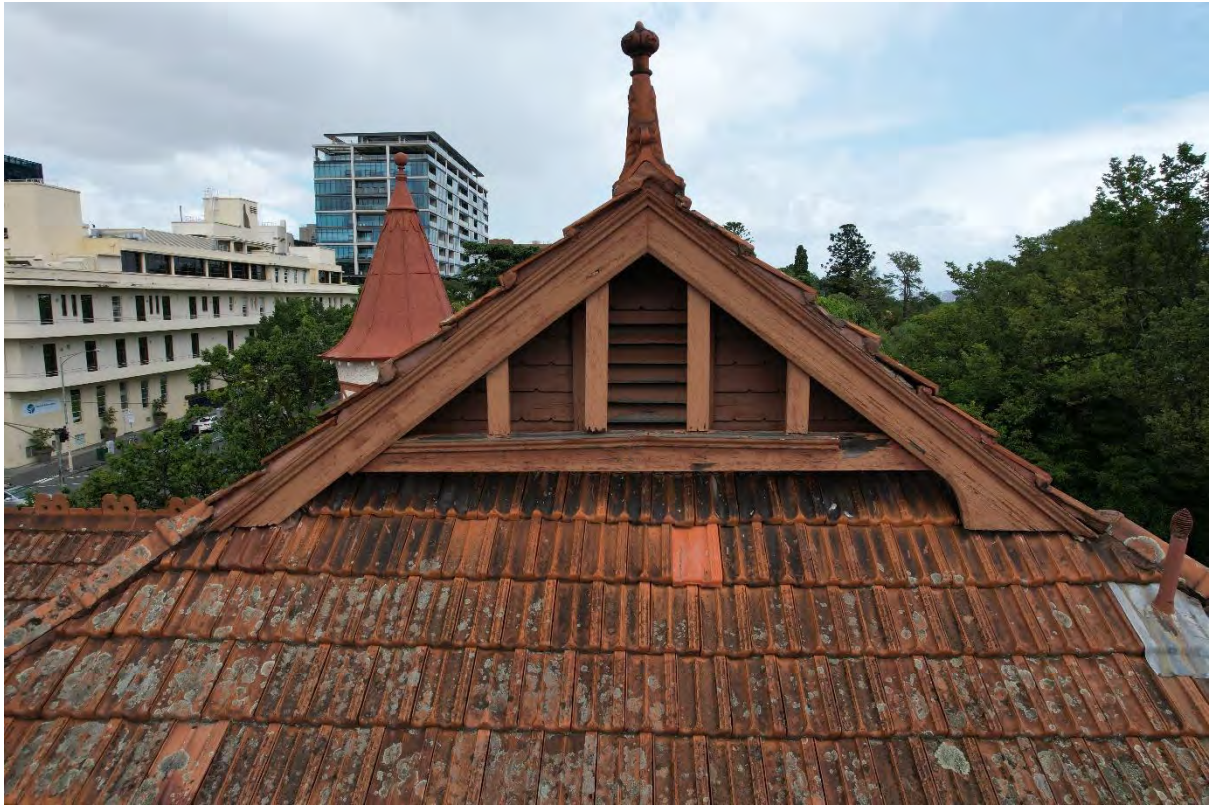
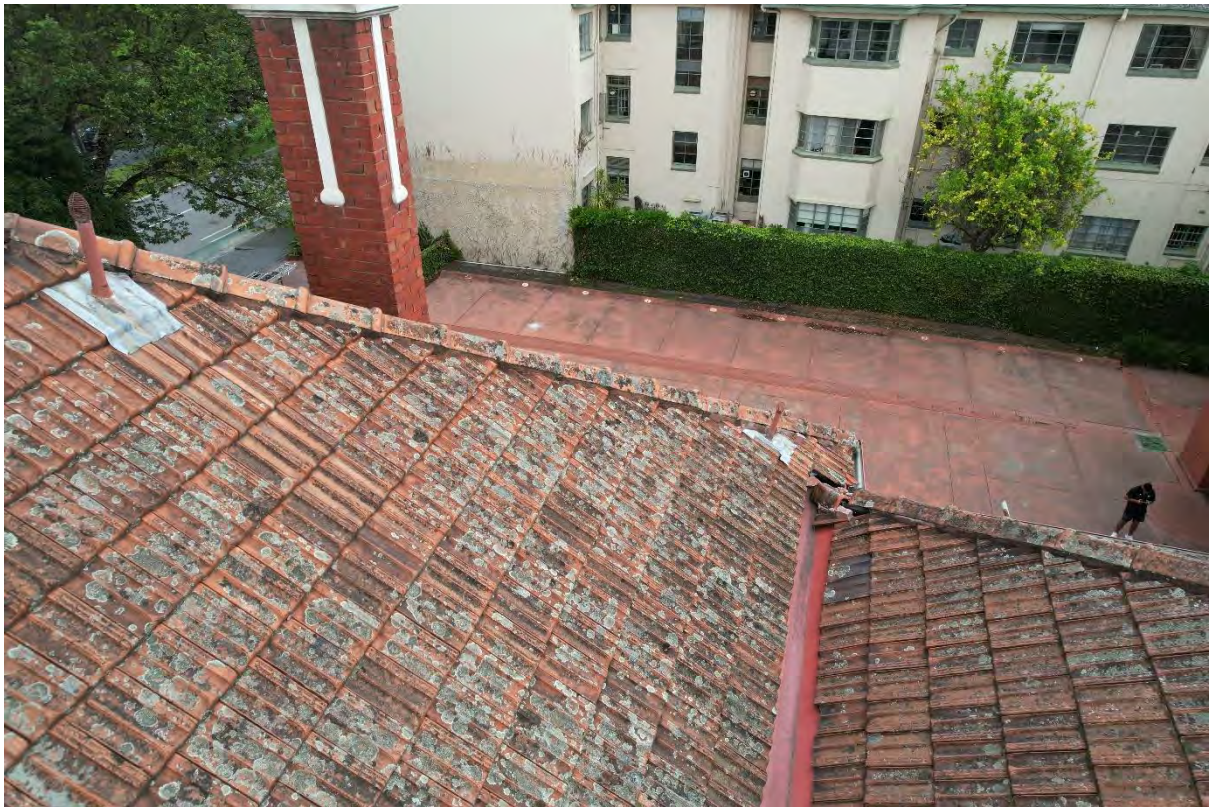
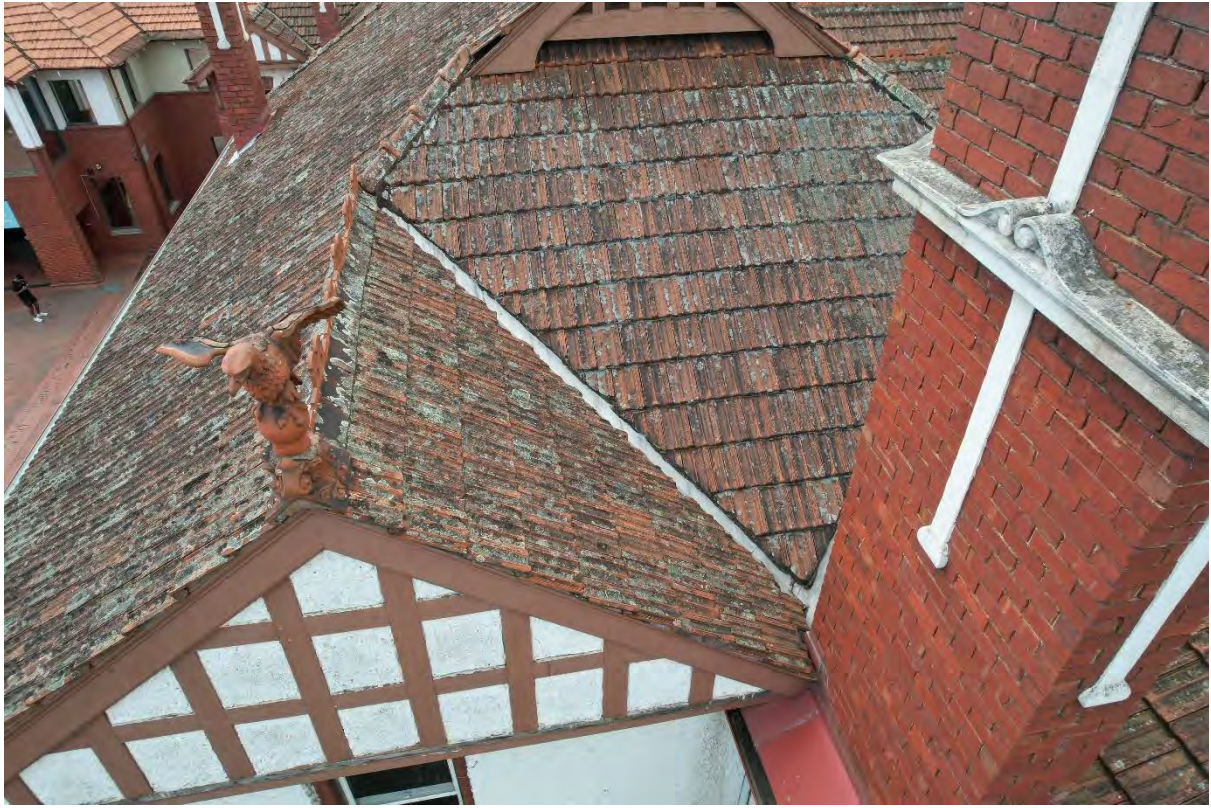
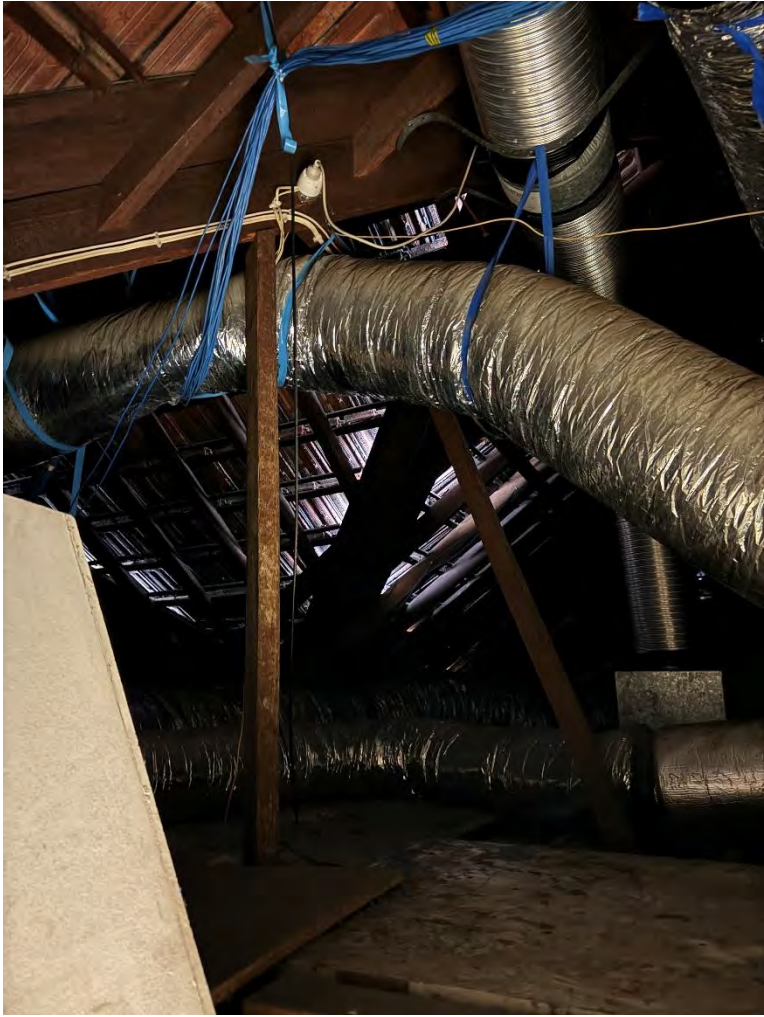
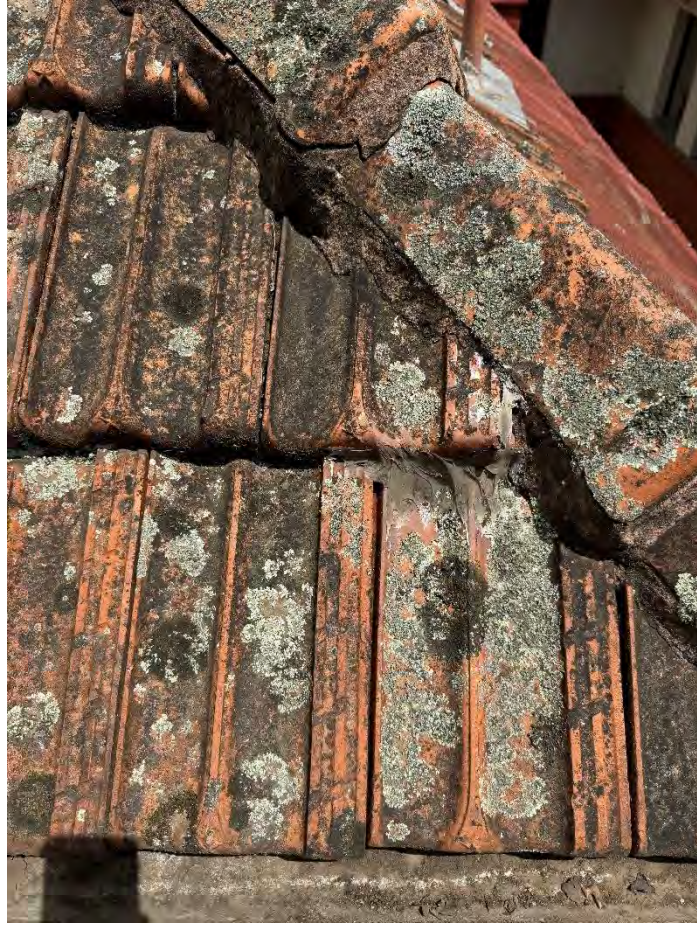
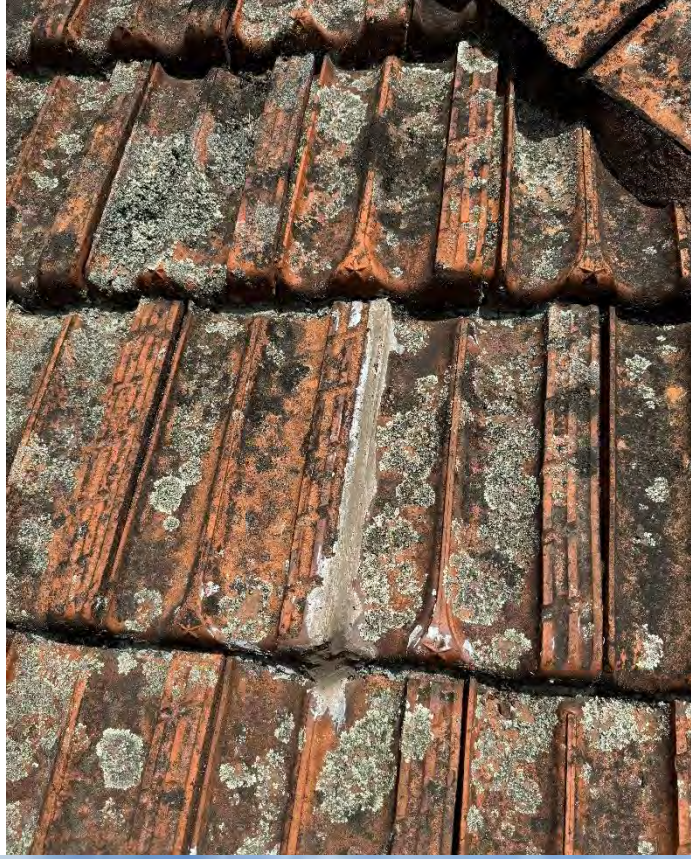
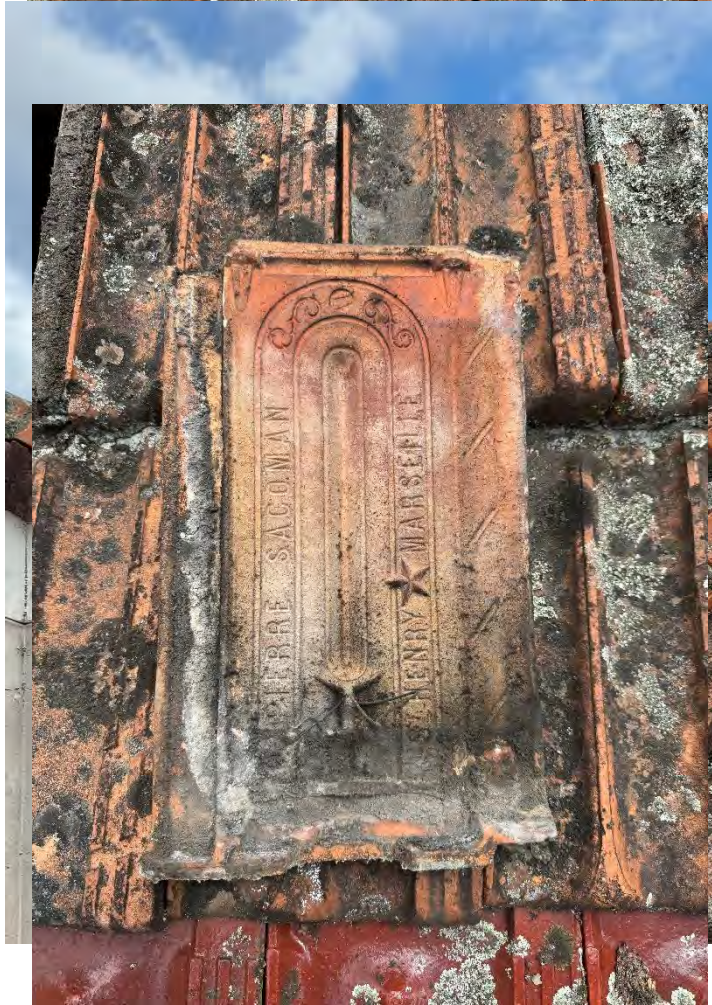
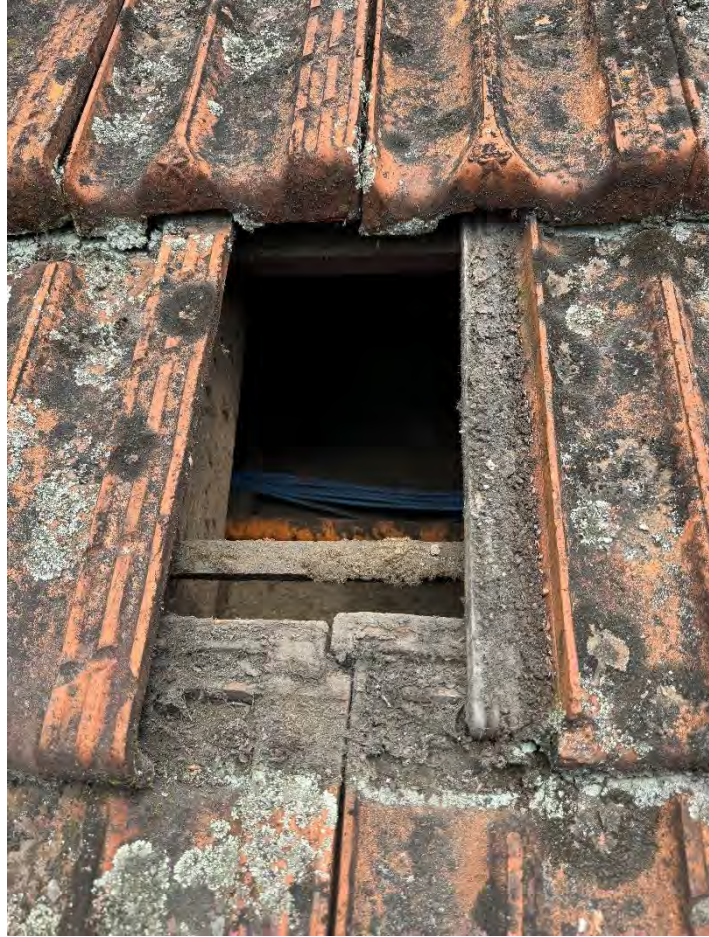
Upon inspection of this roof, I found the roof to be in very poor condition. These tiles are original and would be approximately 100 years old. The tiles that are on this roof have become very porous and water is penetrating through the tiles and entering the ceiling cavity due to their age. I also found there are multiple broken tiles and ridge capping as well as tiles that have been joined together with silicone throughout the roof that have not been removed or have had temporary repairs completed to them. The condition of the original mortar is beyond repair, there is multiple sections on the ridge capping and gable ends where the mortar has fallen out. There are many gaps throughout the roof area due to the tiles slipping off the battens, not secured with the correct fixings and dislodged due to the mortar falling out. Once entering the ceiling cavity, I found that there were many areas daylight was entering. This causes multiple ways that water, debris and rodents can enter the ceiling. I found there to be no sisalation paper (sarking) installed under the battens and tiles. The benefits to having sisalation paper are:

All flashings, valley irons, penetrations and chimney flashings were found to be in poor condition, they are badly rusted and unsealed. The gutters and downpipes seemed to be in good condition due to being previously replaced.

The fascia's and scotias require maintenance. They need to be replaced in some areas. The roof structure seems to be in good condition from what I was able to access from the manhole. A carpenter is required to inspect and carry out any works if required.

In summary this roof requires a full roof replacement with heavy duty sarking, new battens and new terracotta tiles and ridge capping to match colour and profile as close as possible with stock available. This roof will then have a full workmanship warranty and a 50 year performance guarantee on the tiles.
