PROJECT 1-19 CLARENDON ST

DRAWING EXTERNAL REPAIR WORK  
- SOUTH ELEVATION

EXTERNAL REPAIR WORK - EAST ELEVATION

| A | HW RFI 01 | NOV 2024 |
|---|---|---|
| DRAWING | EXTERNAL REPAIR WORK - WEST ELEVATION | |

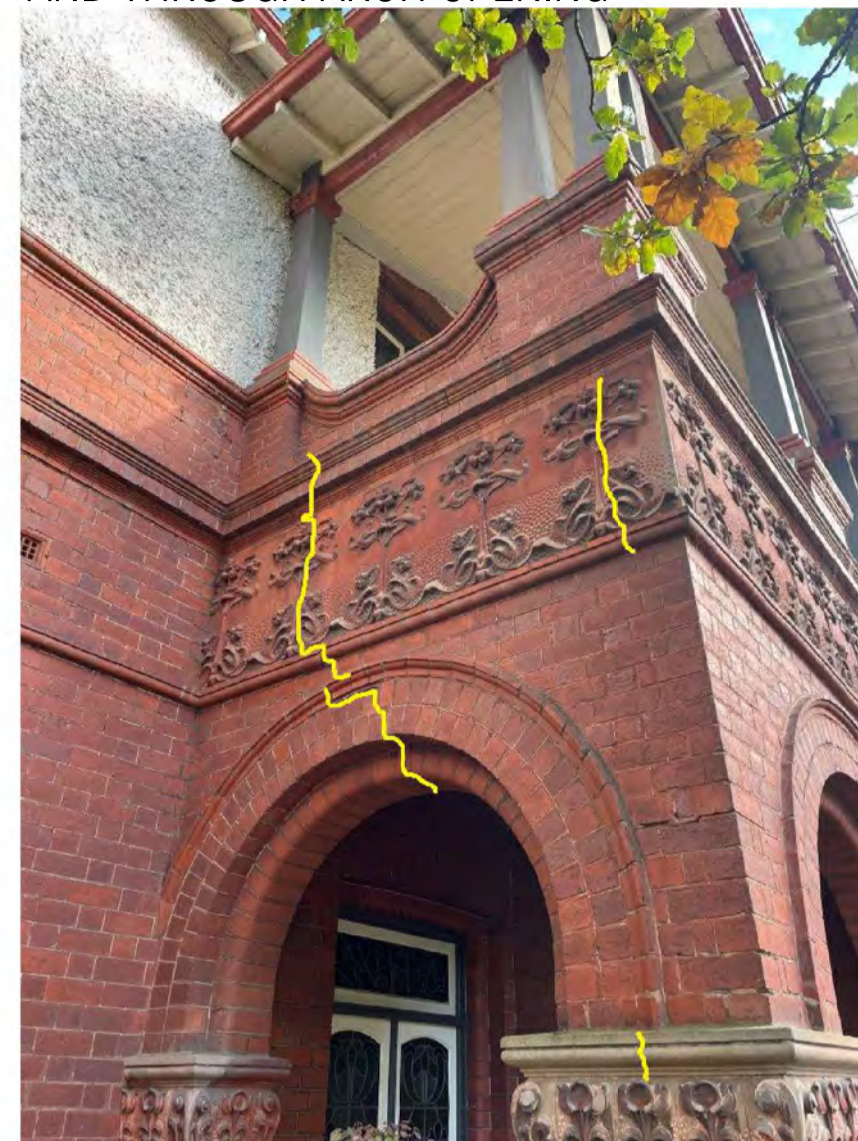
STRUCTURAL CRACK TO WALL.  
AND THROUGH ARCH OPENING

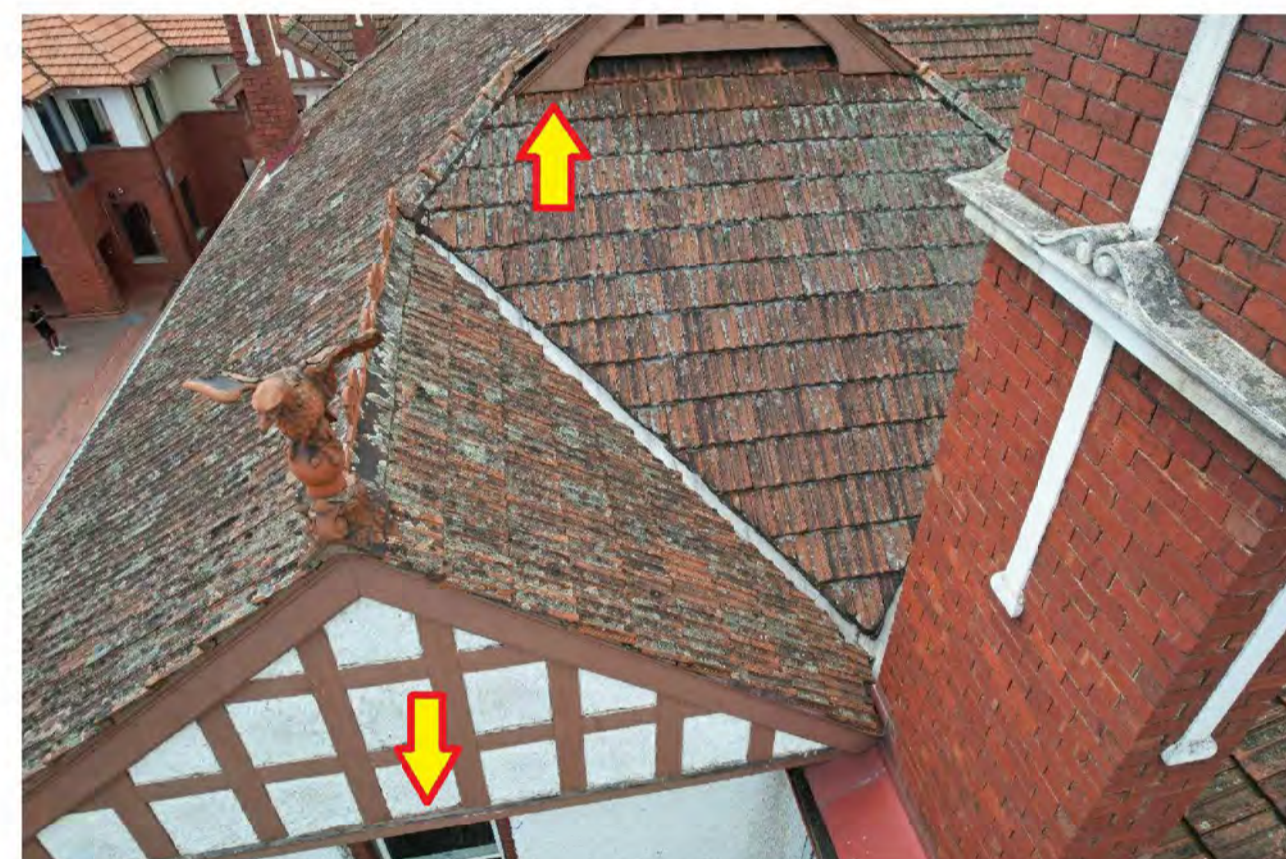
GAP BETWEEN ROOF TILES AND FASCIA.  
FILL REQUIRED FOR WATER PROOFING

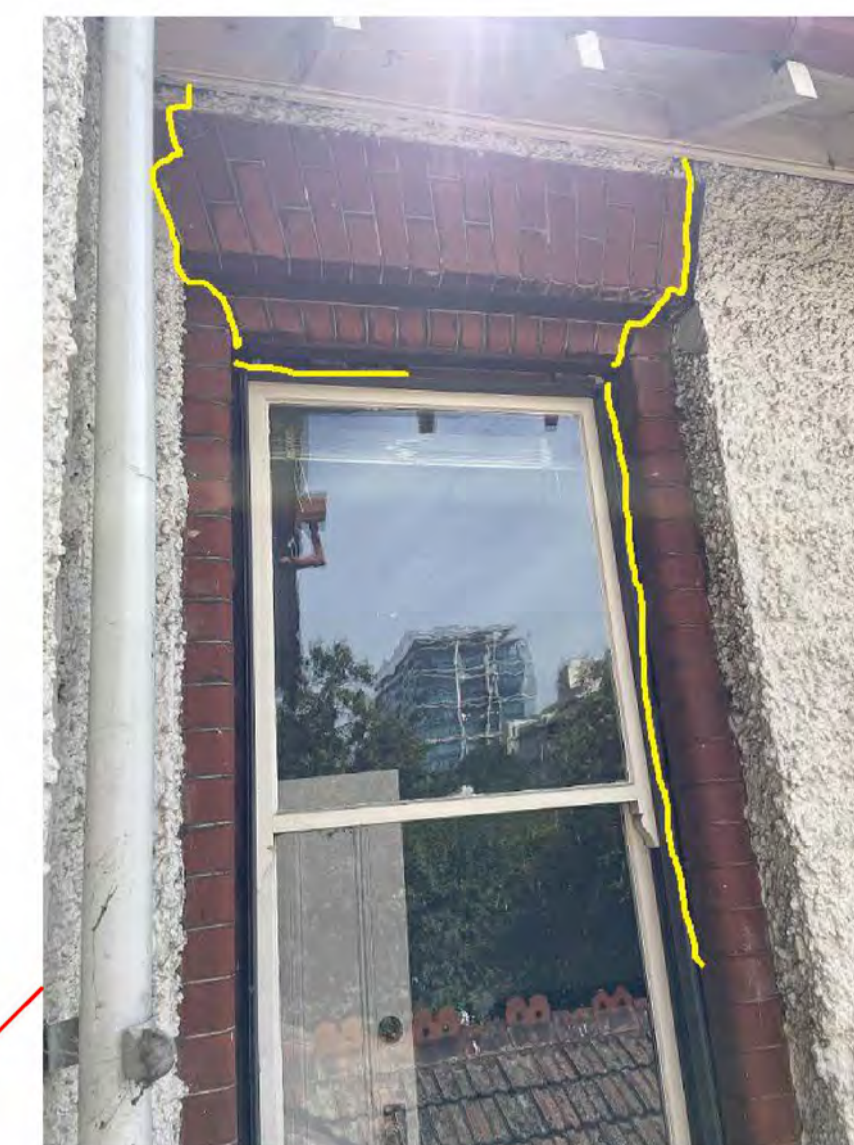
TIMBER STRAPPING SHOWING SIGNS OF ROT. REPAIR REQUIRED

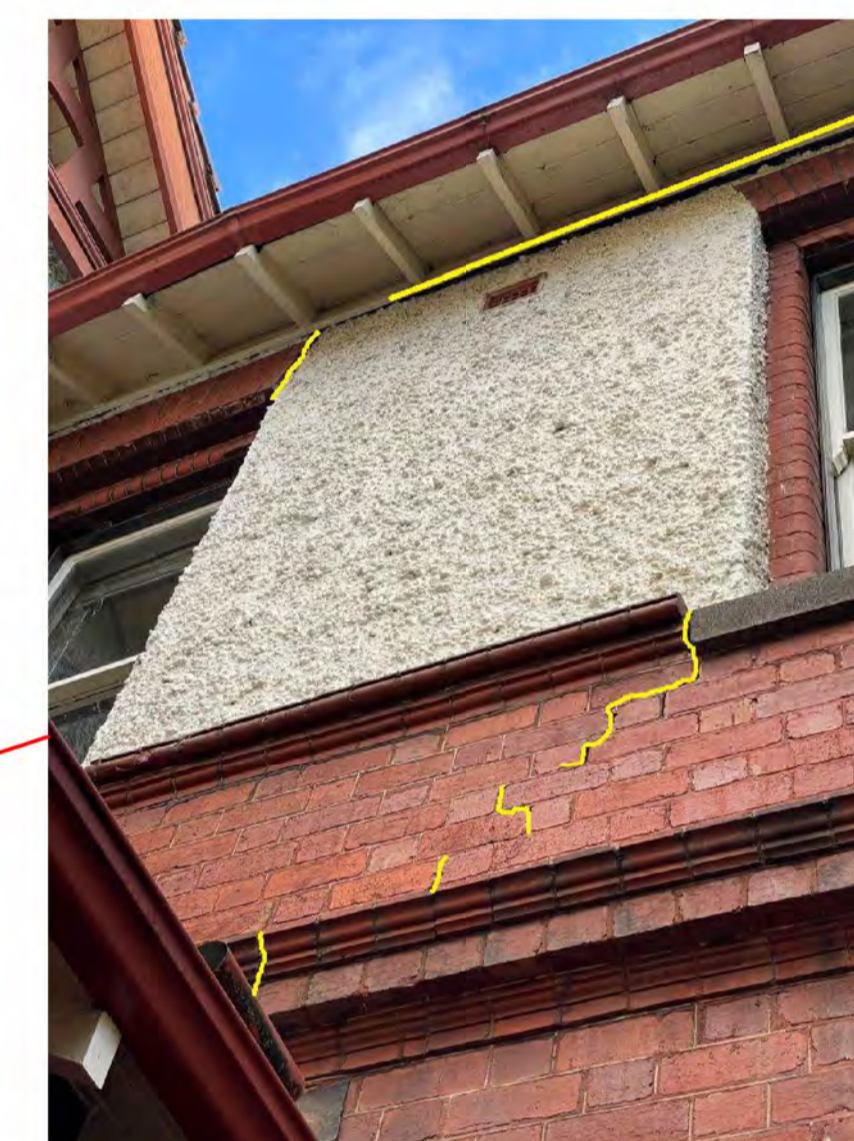
BRICK LINTEL SEPARATING

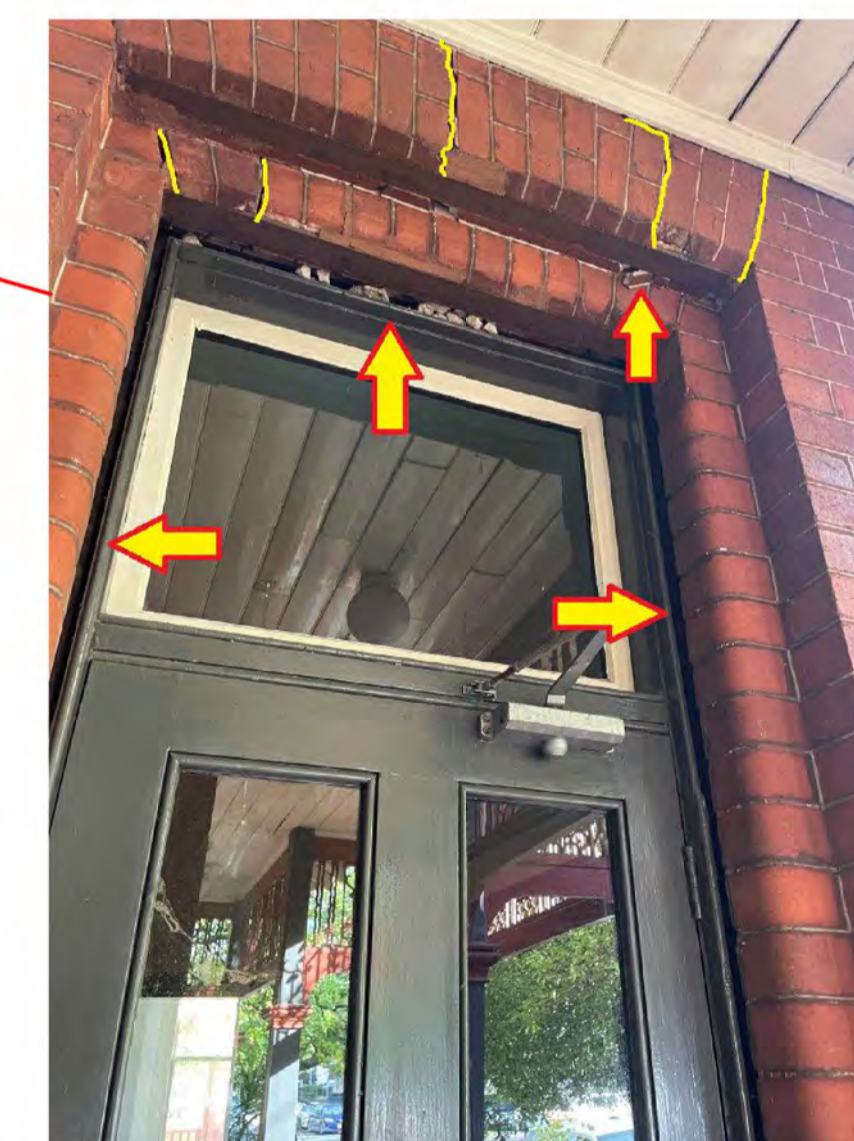
STRUCTURAL CRACK  
IN BRICK WALL

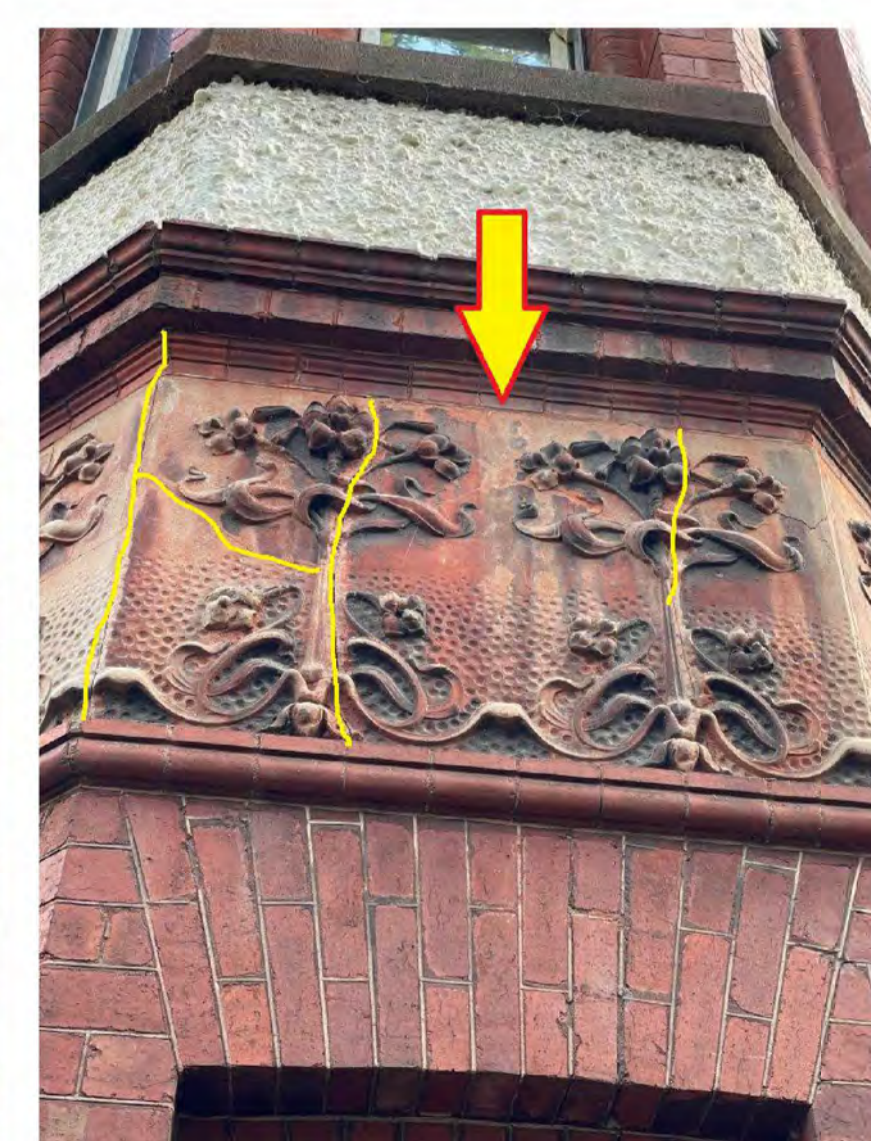
WATER DAMAGE BEHIND TERRACOTTA TILES.  
ROTTEN TIMBER SILLS

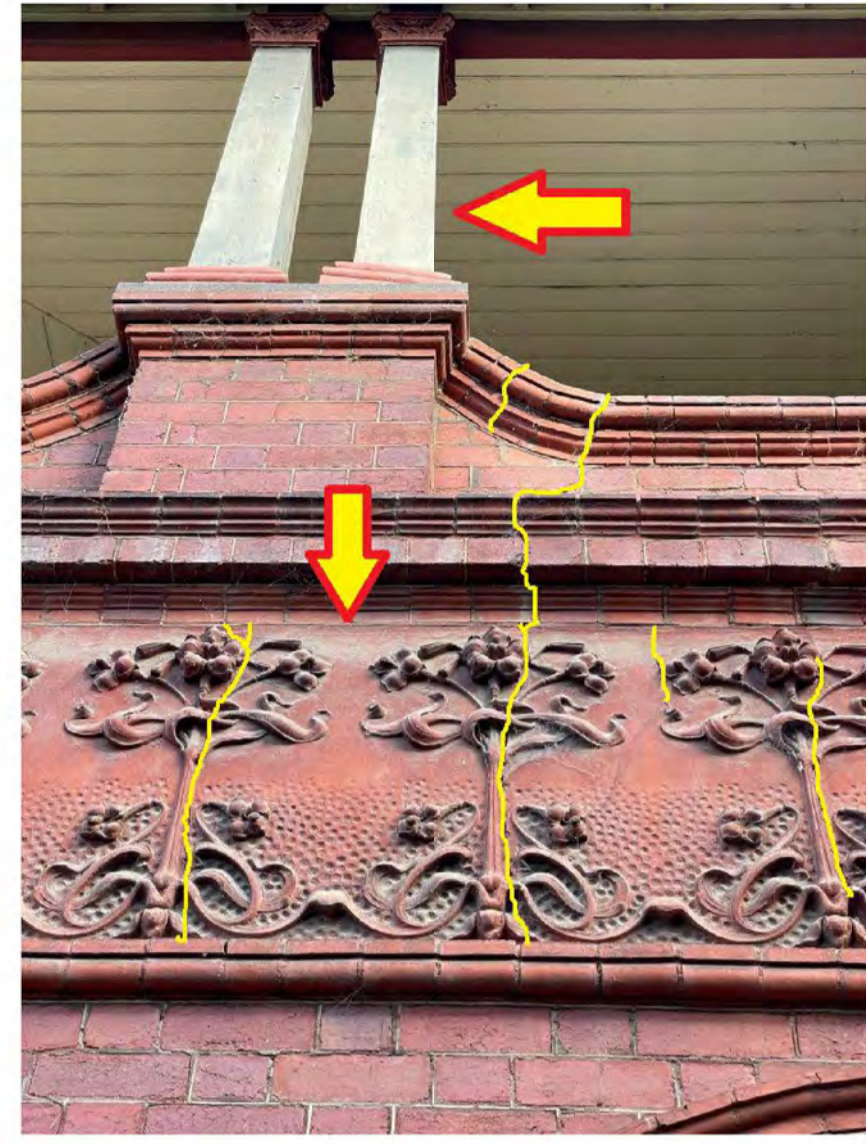
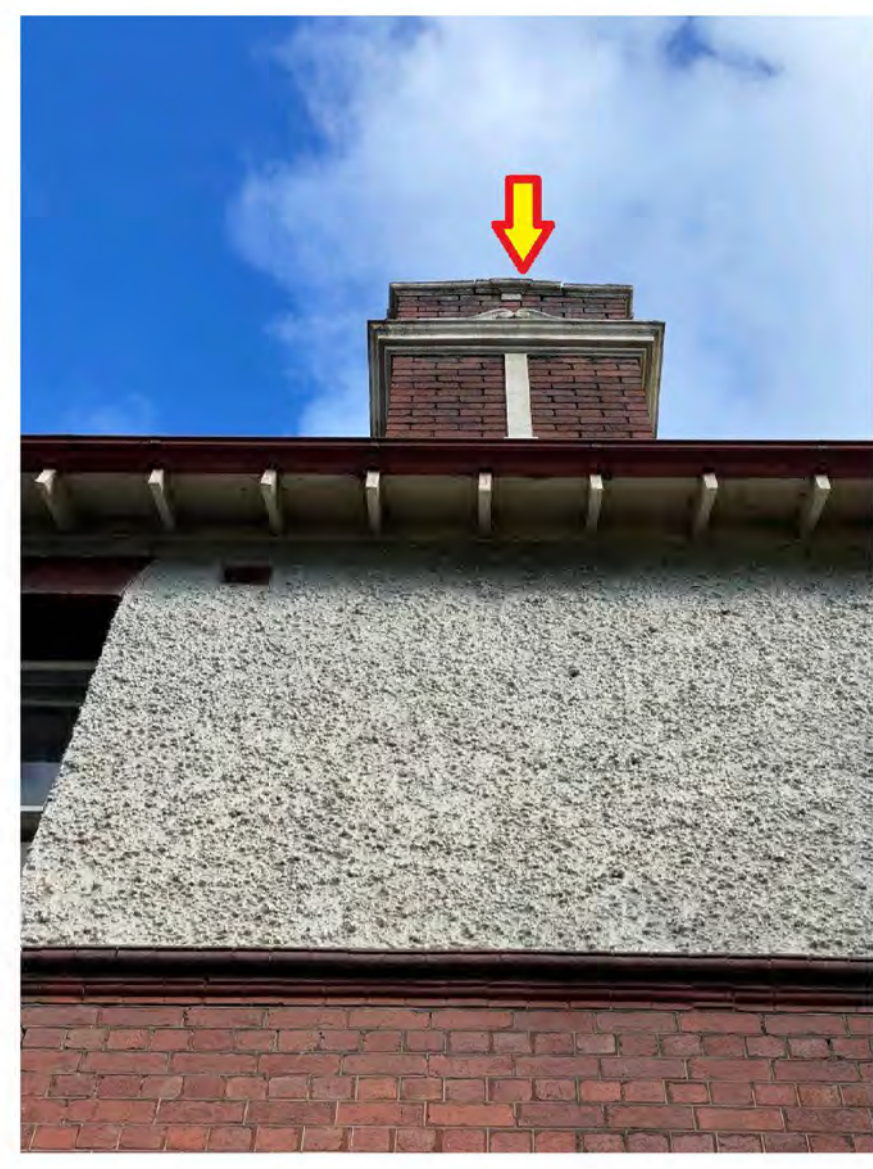
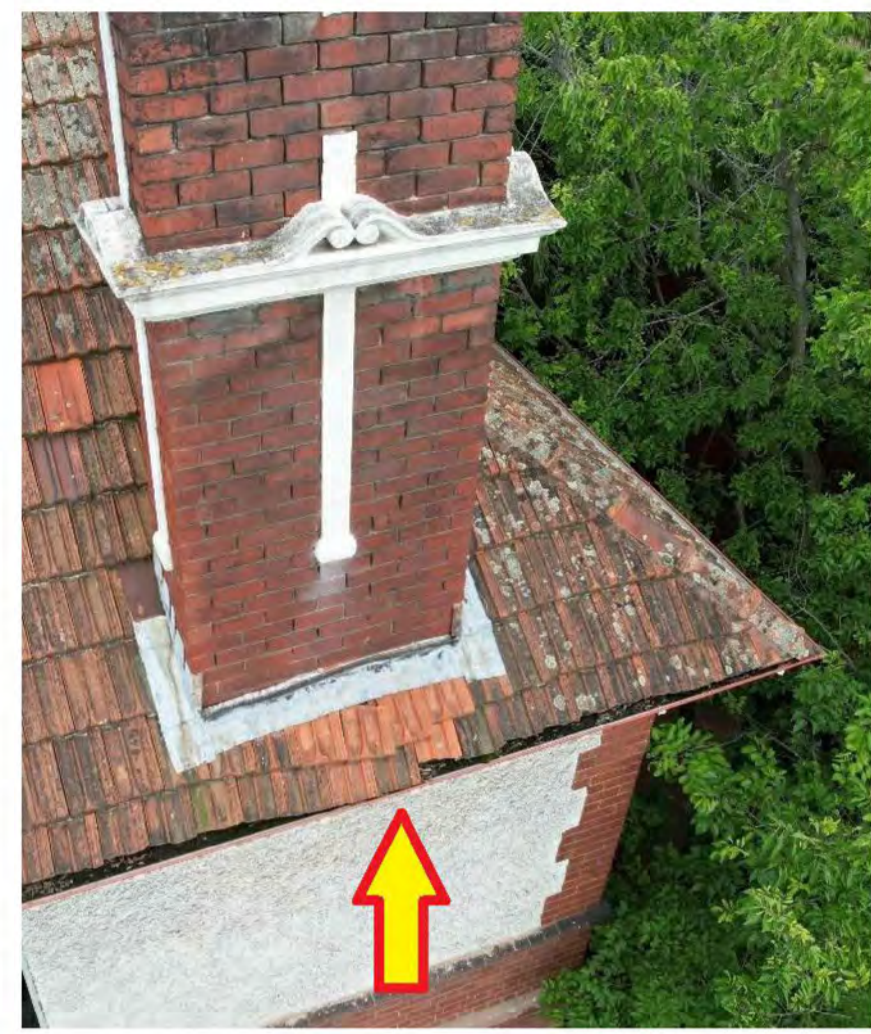
STRUCTURAL WALL CRACK TO FF BALUSTRADE  
SUPPORT COLUMN TWISTED AND LEANING  
CRACKED TERRACOTTA TILE WITH WATER  
DAMAGE

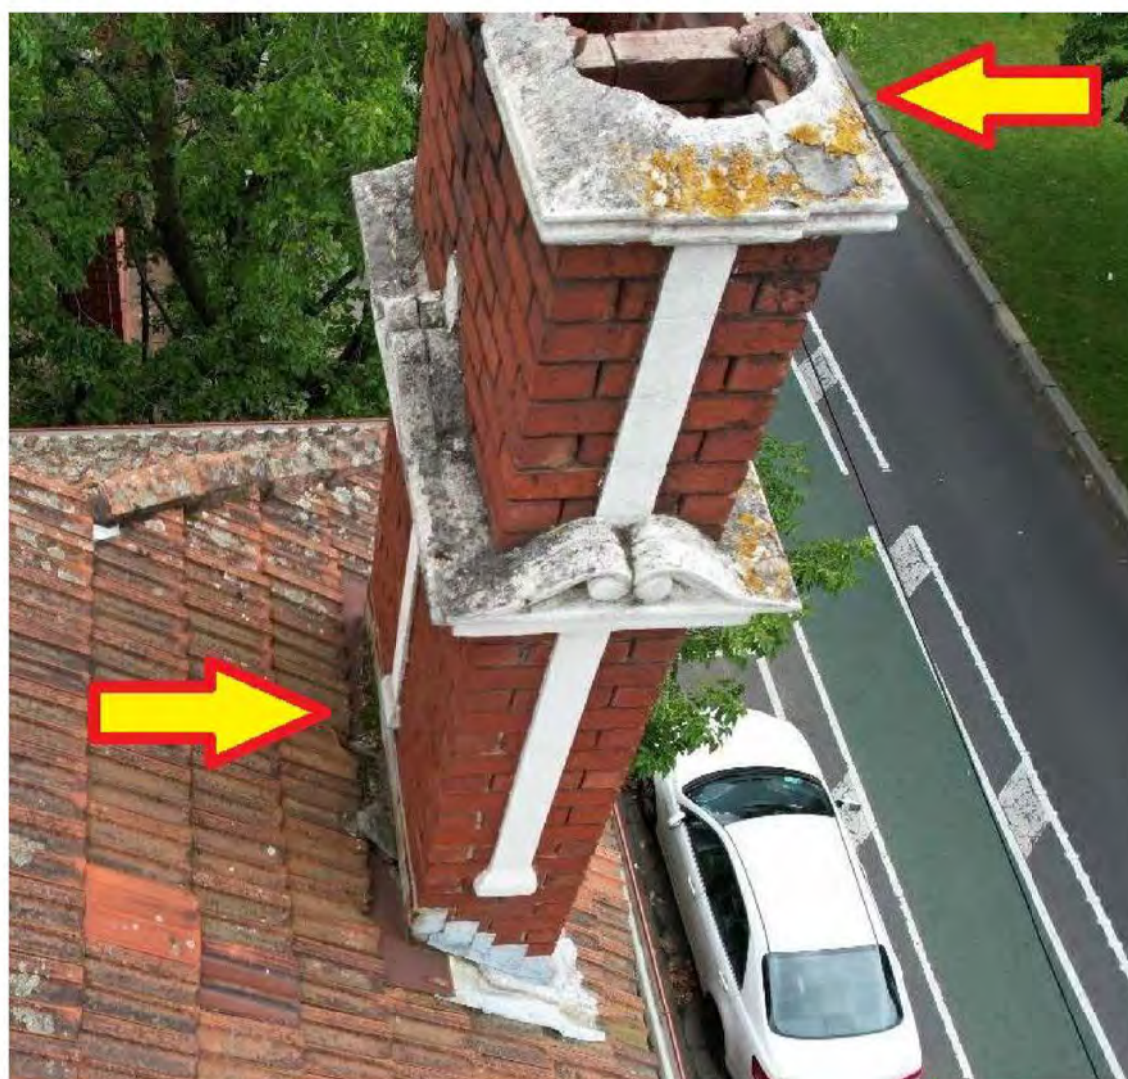
GAPS BETWEEN FLASHING TO ROOF TILES.  
WATER ISSUE.  
GUTTER REQUIRE A THOROUGH CLEAN OUT

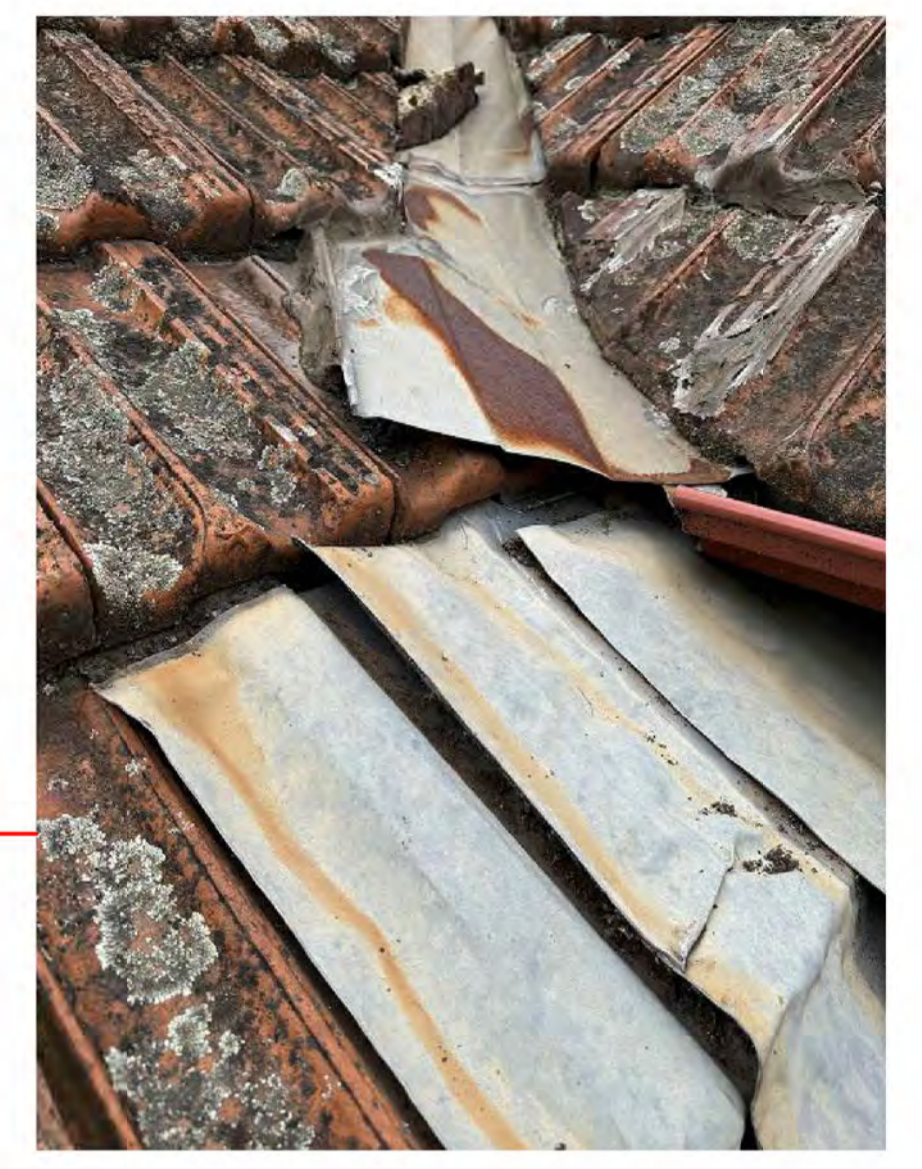
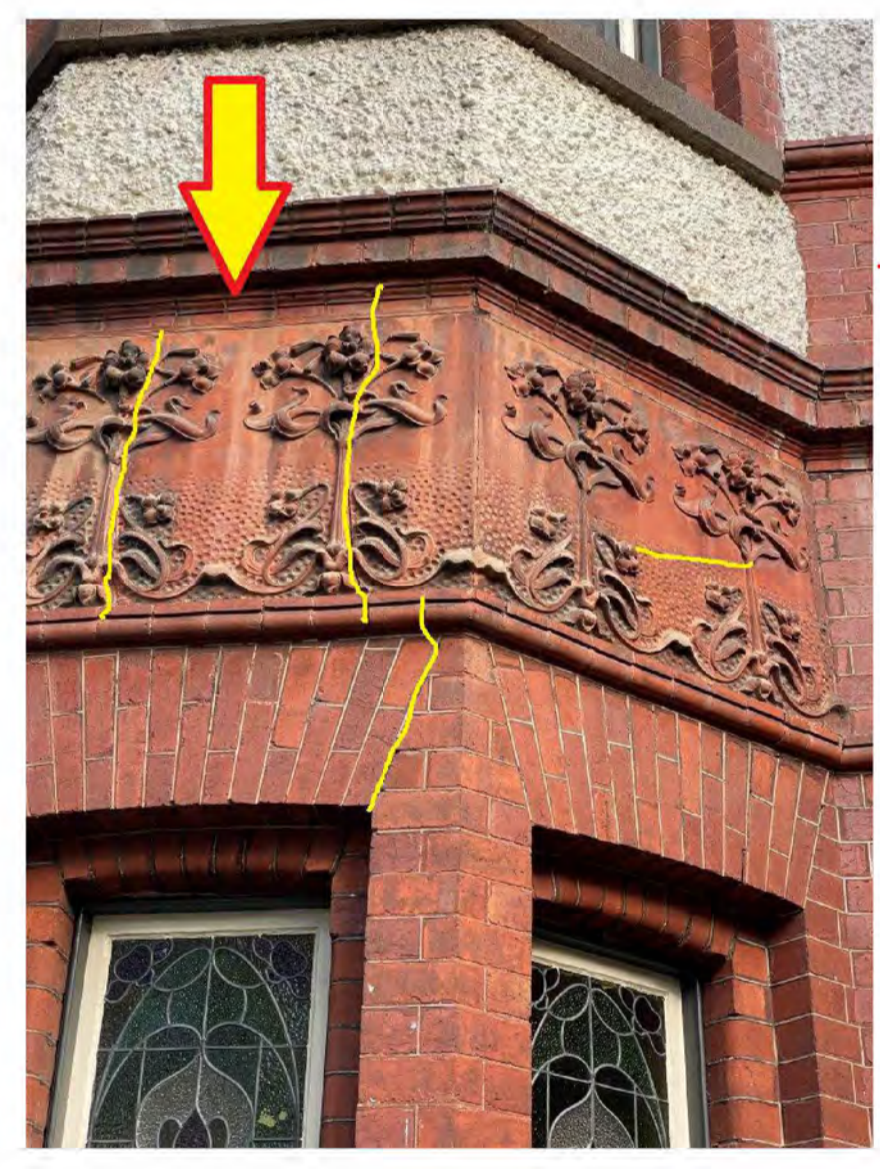
CHIMNEY CAPPING CRACKING AND  
FALLING OFF. TERRACOTTA POTS  
MISSING, WATER LEAKING IN

RUSTED ROOF FLASHING  
FLASHING NOT OVERLAPPING  
PROPERLY WITH LARGE GAPS CAUSING  
WATER DAMAGE TO INTERIOR DURING  
HEAVY RAINFALL

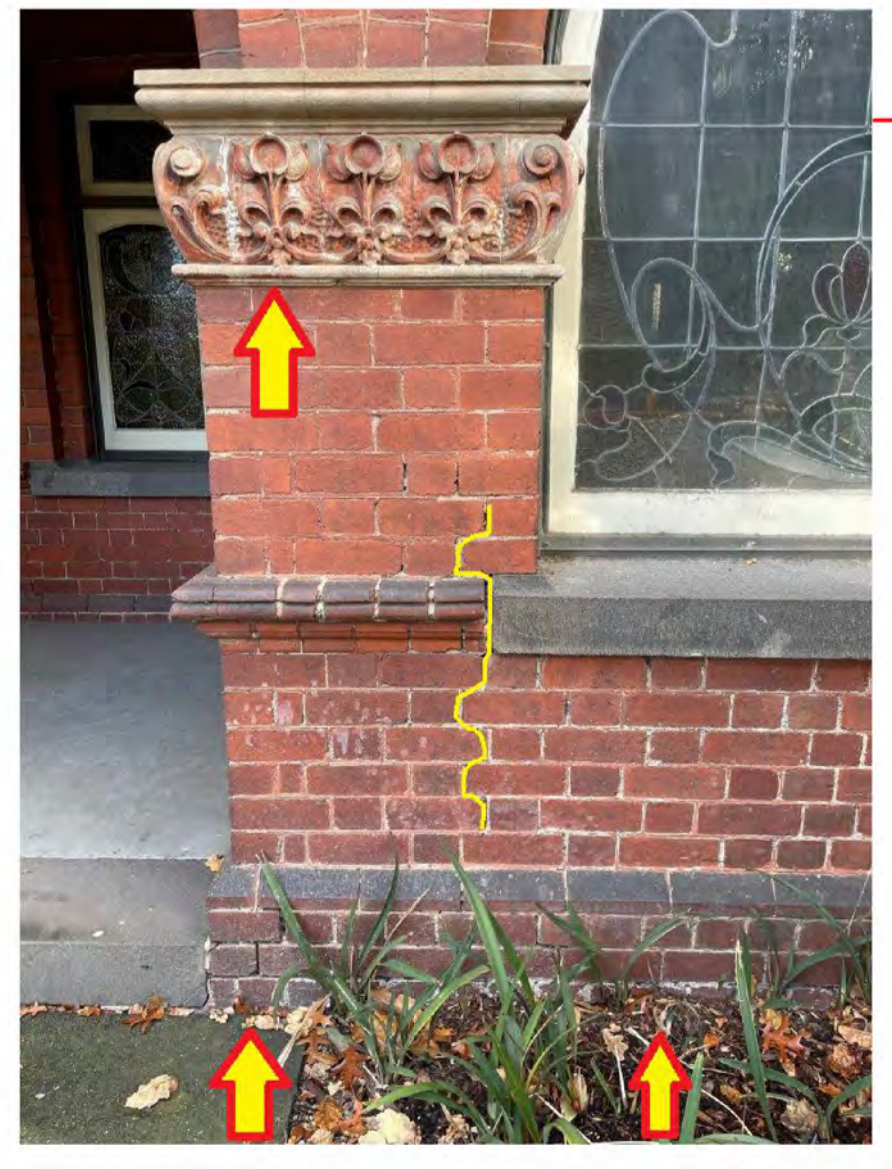
WATER DAMAGE BEHIND TERRACOTTA  
COLLAR  
LEANING BRICK PILLAR SEPARATING FROM  
WINDOW SILL.  
RISING DAMP AT BASE OF BRICK WALL

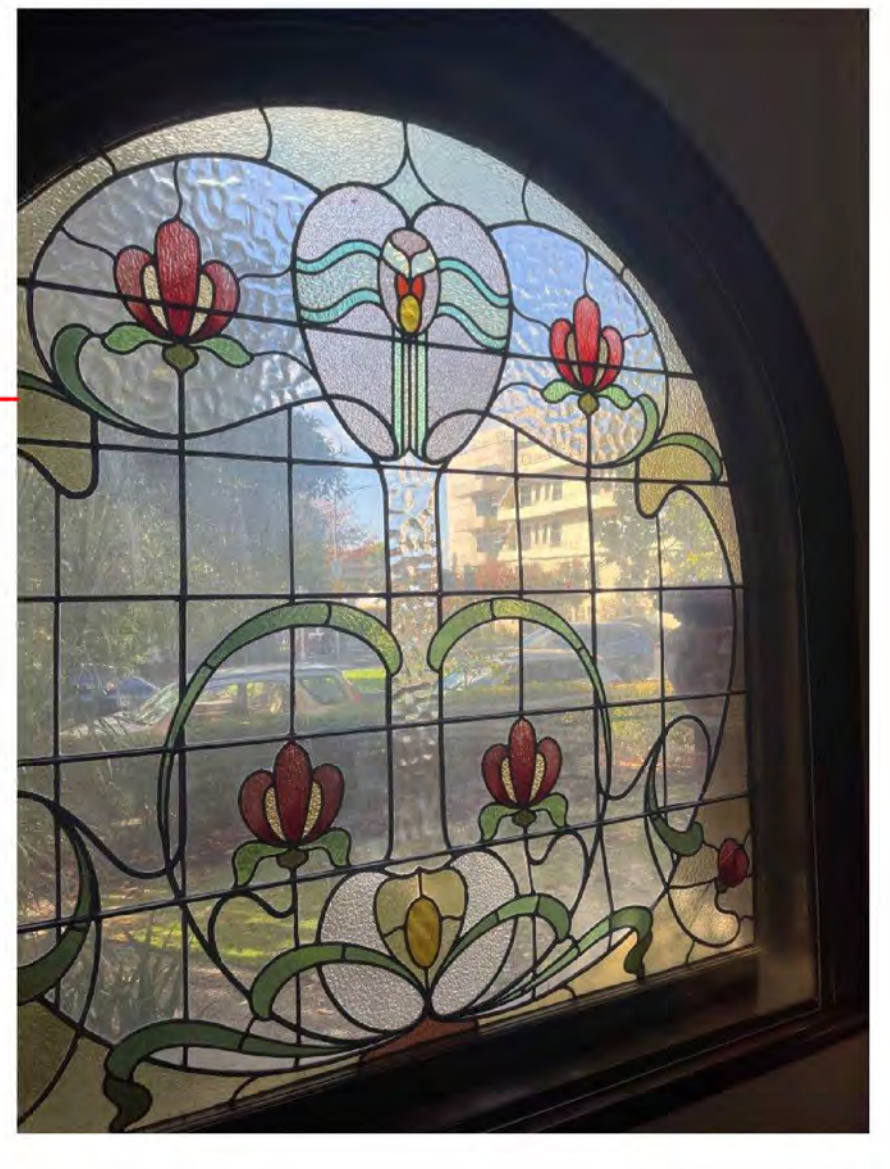
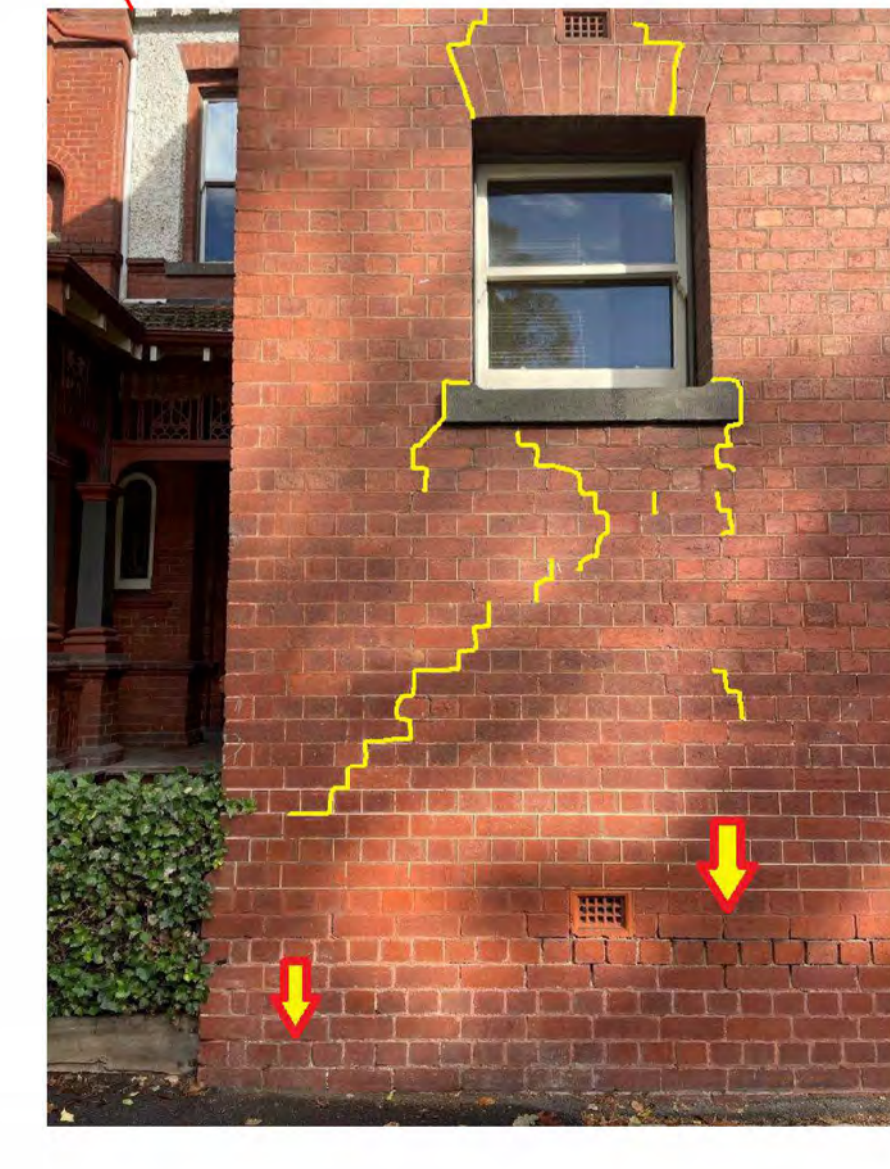
EXISTING STAINED GLASS WINDOW  
DISTORTED AND BOWING INWARDS  
PERSPEX PANEL FIXED TO INTERIOR  
AND EXTERIOR

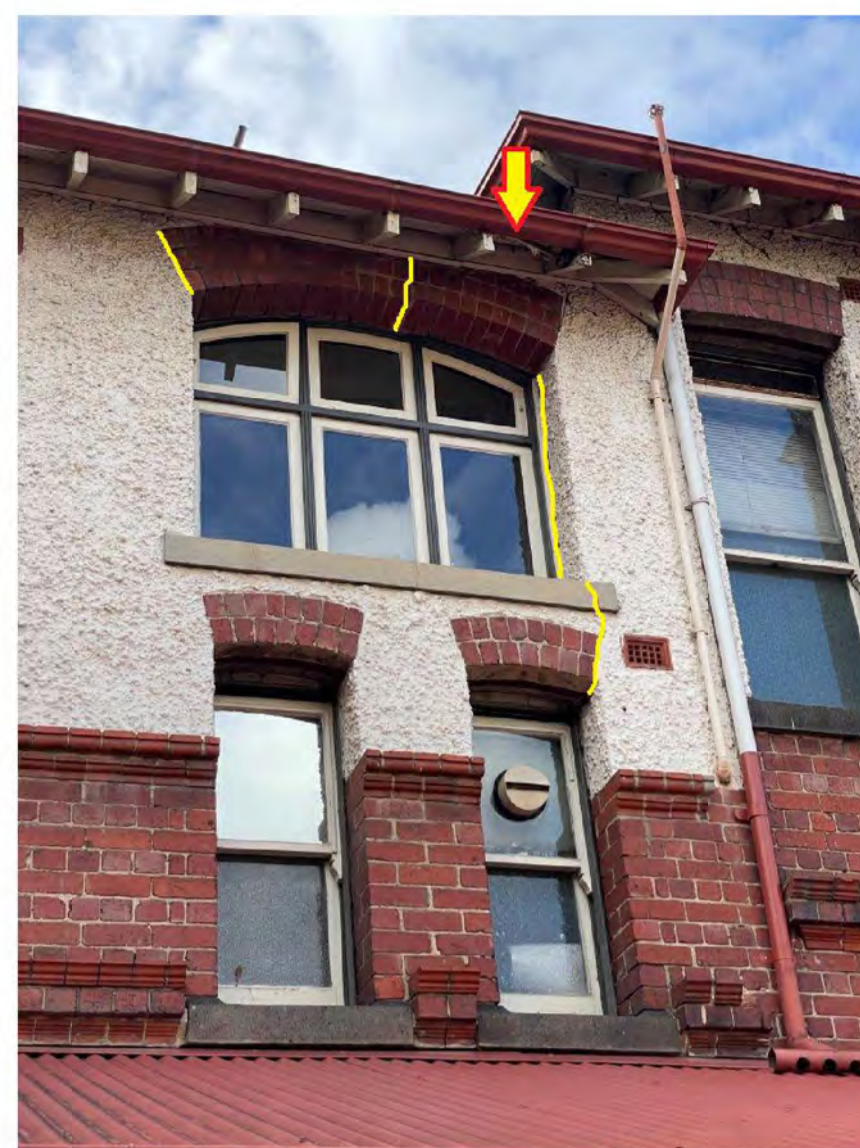
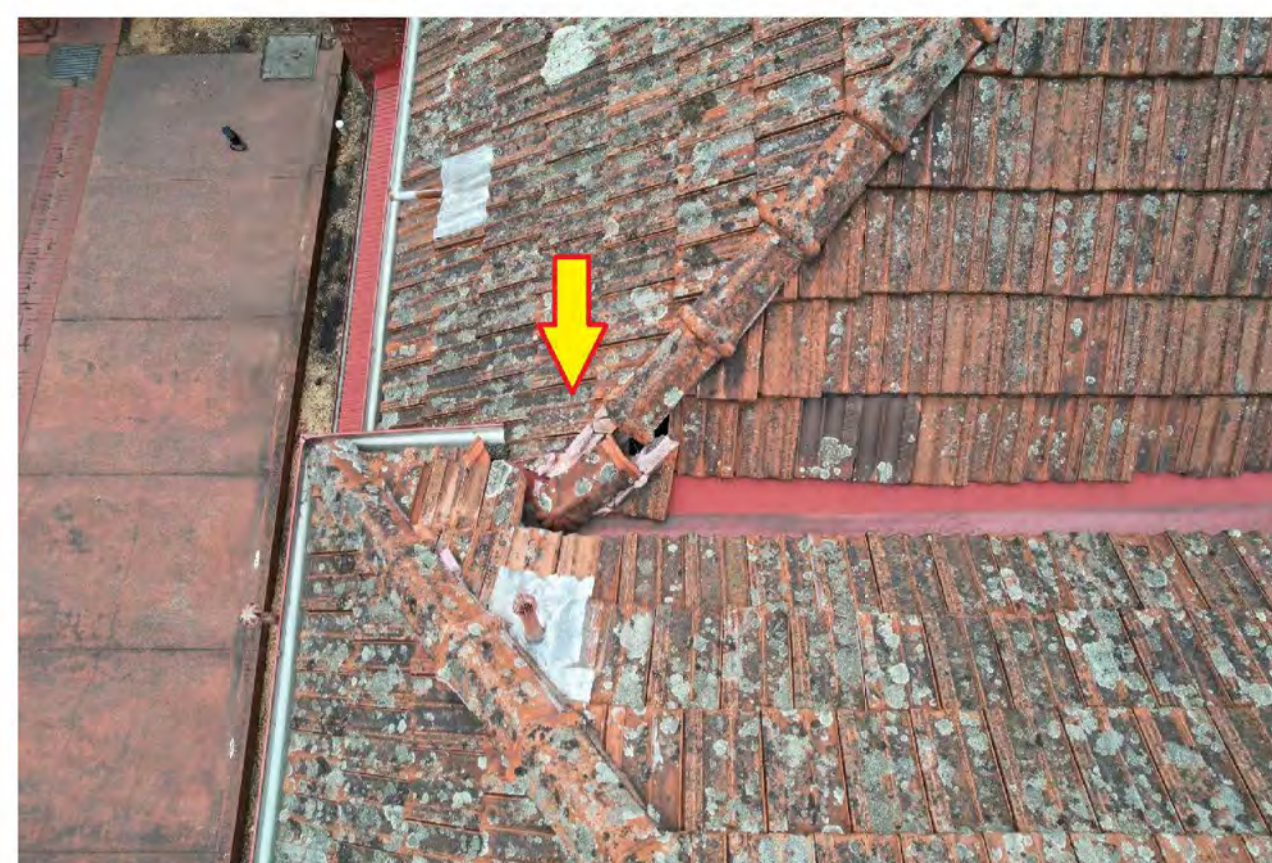
CRACKS IN LINTEL & SILL /  
GAPS TO WINDOW FRAME  
ROOF SOFFIT DEGRADED

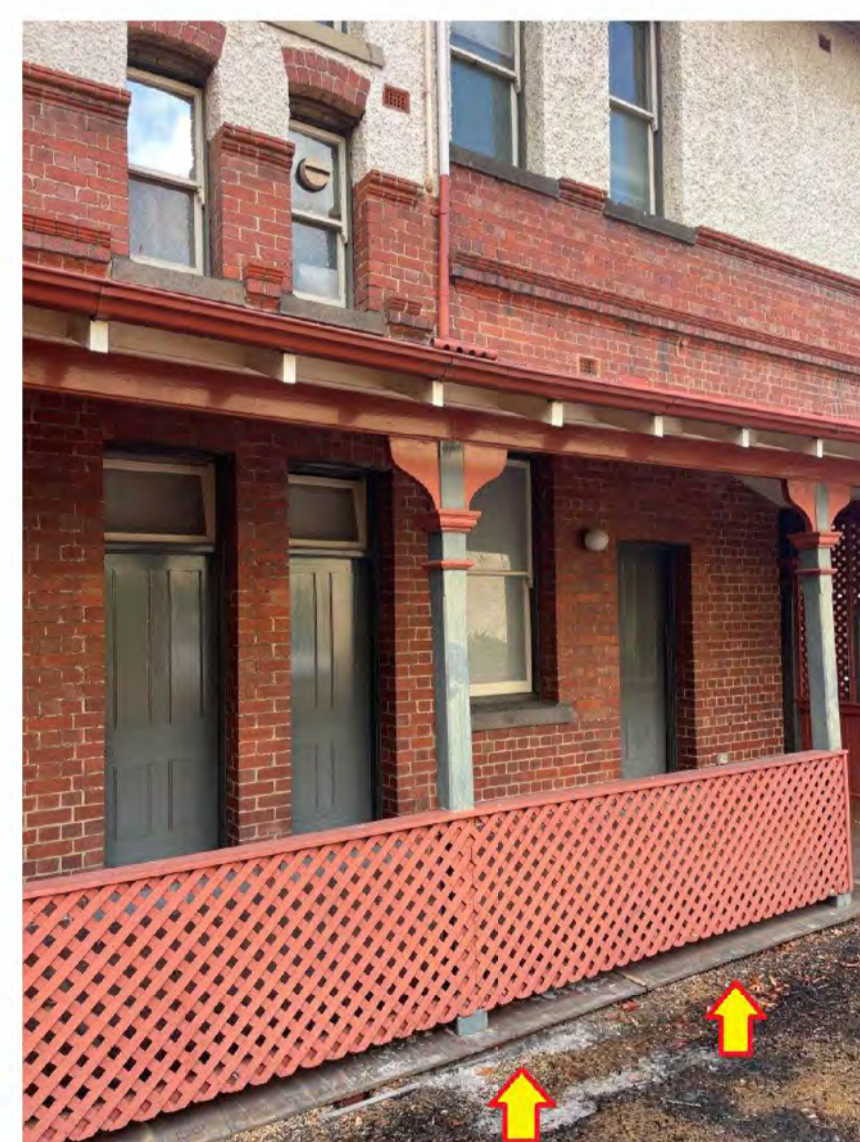
NO SUB-FLOOR VENTILATION  
RISING DAMP UP THE WALL WITH SALT DAMAGE

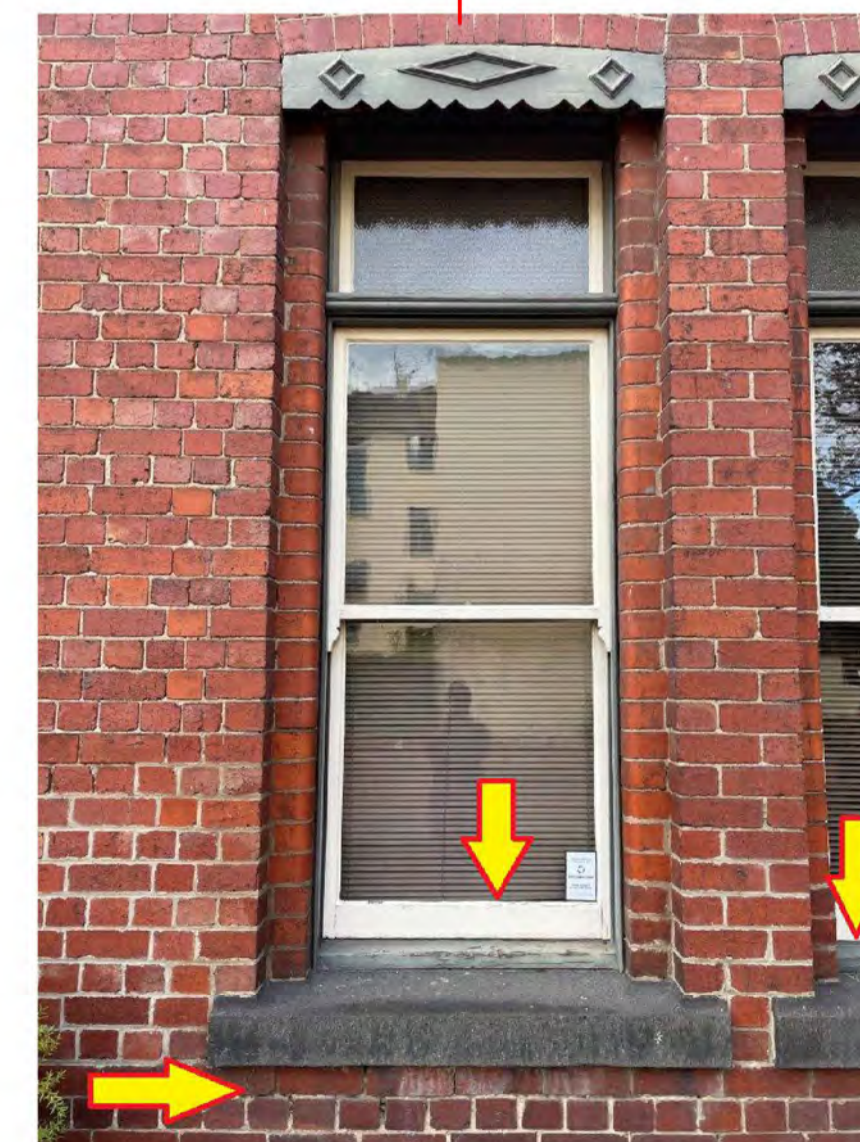
CRACKING LINTEL

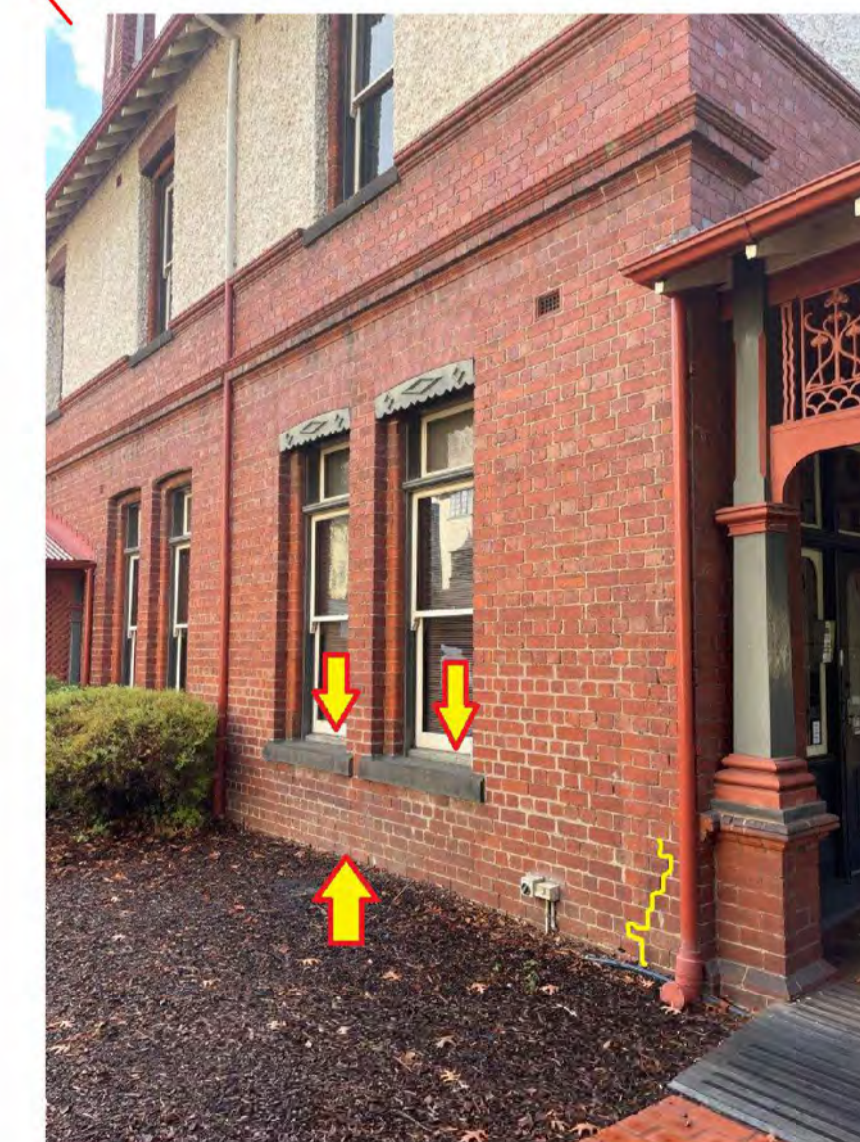
RISING DAMP UP THE WALL  
ROTTEN WINDOW FRAMES

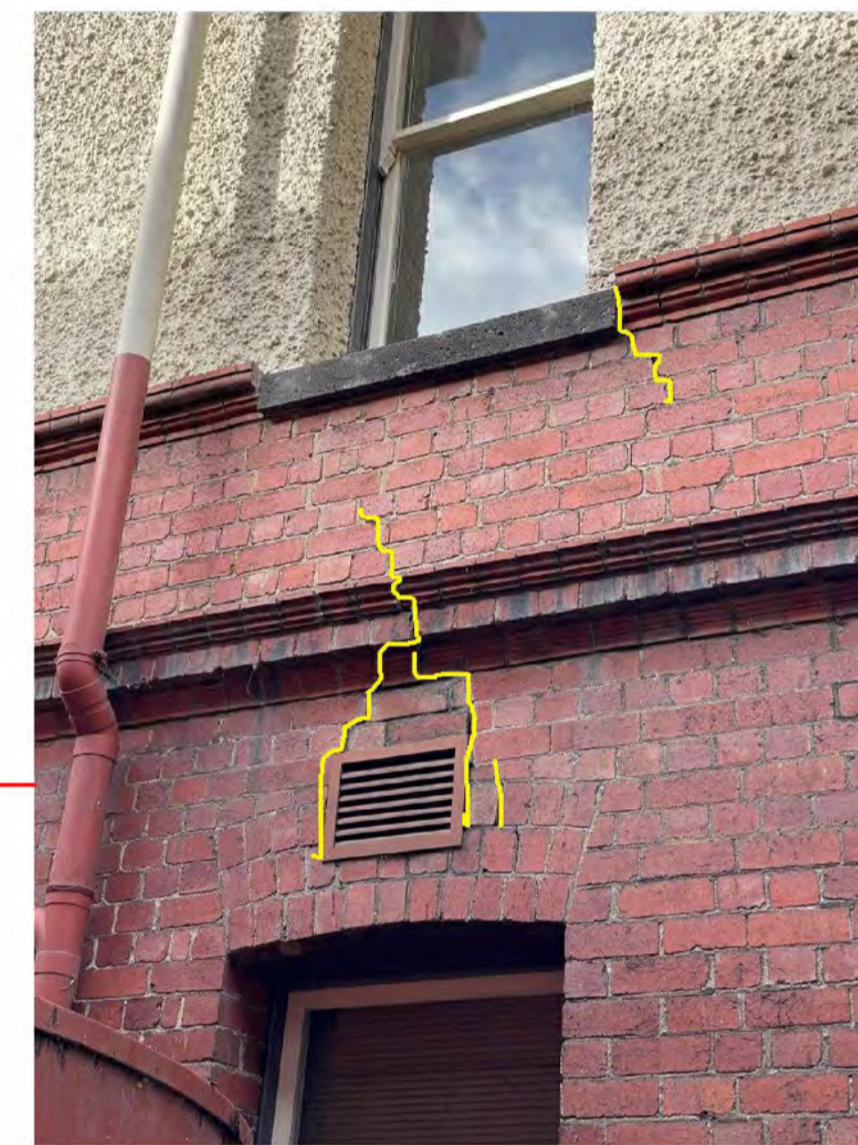
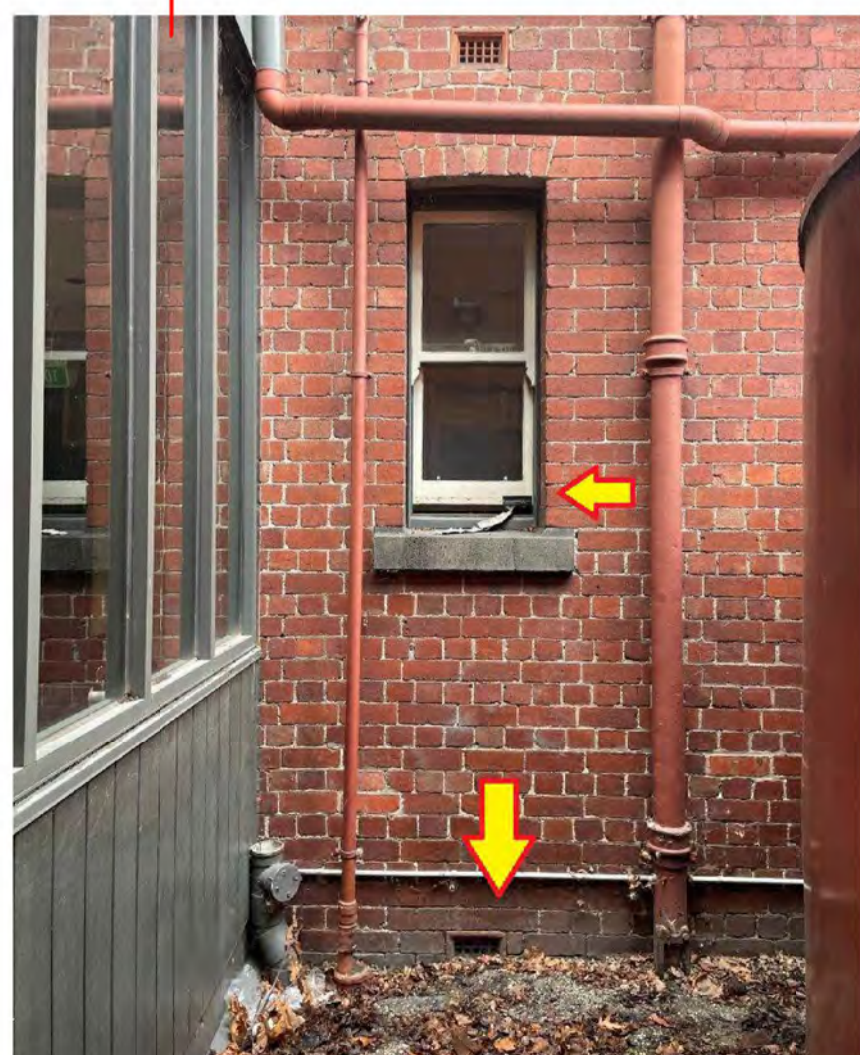
CRACKING IN MASONRY WALL

ROTTEN / DILAPIDATED TIMBER FRAME

STRUCTURAL REVIEW REQUIRED TO ALL WINDOW LINTELS
