PROJECT 1-19 CLARENDON ST

DRAWING EXTERNAL REPAIR WORK  
- SOUTH ELEVATION

EXTERNAL REPAIR WORK - EAST ELEVATION

| A | HW RFI 01 | NOV 2024 |
|---|---|---|
| DRAWING | EXTERNAL REPAIR WORK - WEST ELEVATION | |

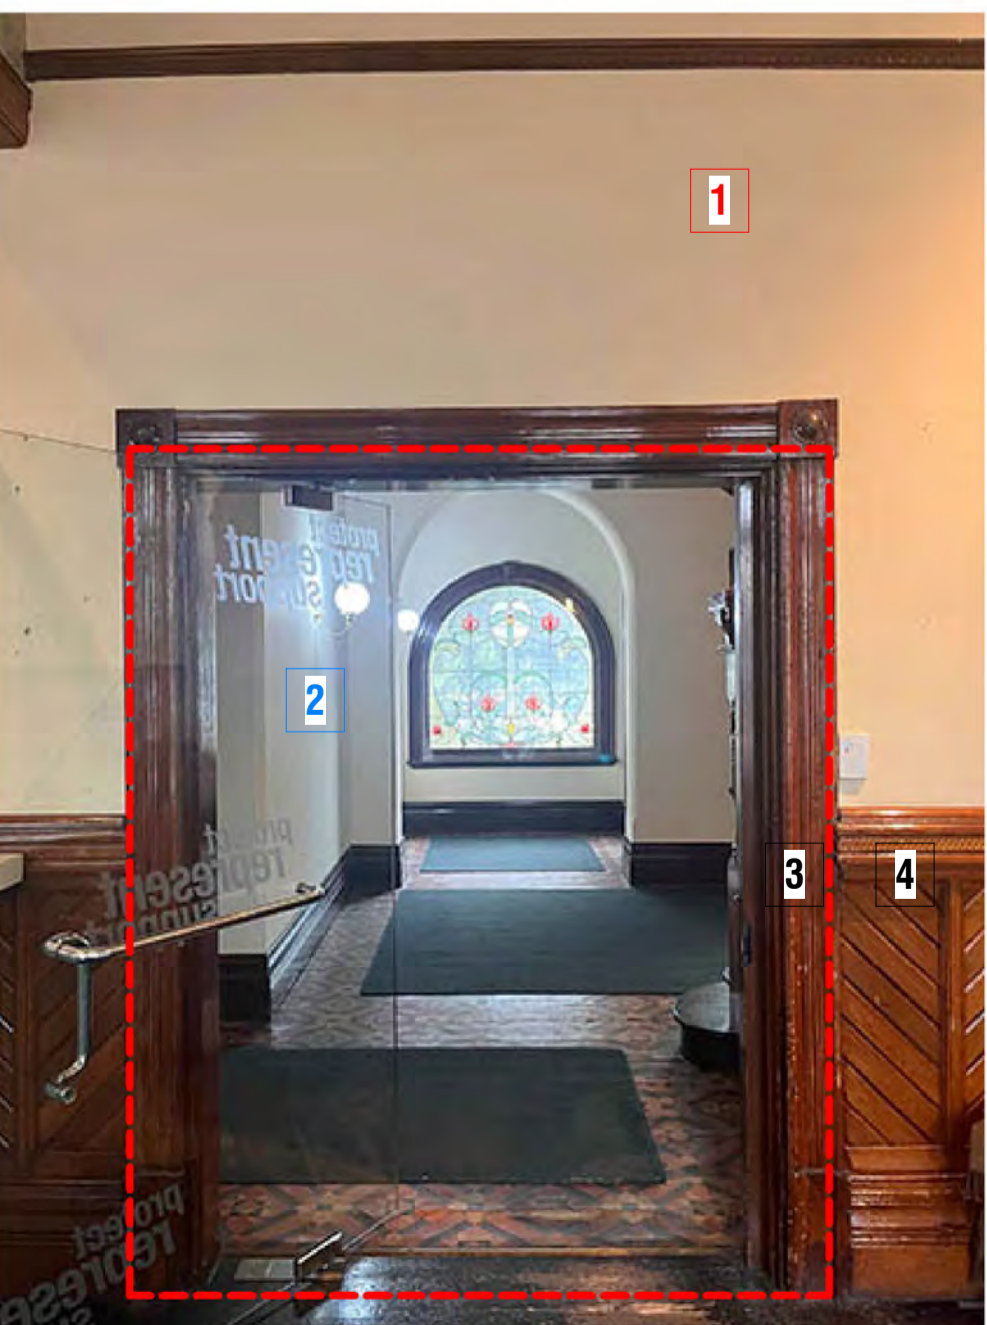
PHOTO - CURRENT GLASS PIVOT DOOR

1. CURRENT PAINT COLOUR: LIGHT WHITE TONE PAINT. TYPE UNKNOWN. PROPOSED PAINT COLOUR: LIGHT TONE DISTEMPER PAINT
2. GLAZED PIVOT COMMERCIAL DOOR TO BE REPLACED
3. ORIGINAL ARCHITRAVE - RED CEDAR TIMBER. CURRENT FINISH: CLEAR VARNISH. TBC IF ORIGINAL
4. TIMBER WAINSCOTTING AND DADO RAIL / SKIRTING. TIMBER TYPE: HUON PINE. TBC IF ORIGINAL. CURRENT FINISH: CLEAR VARNISH. TBC IF ORIGINAL

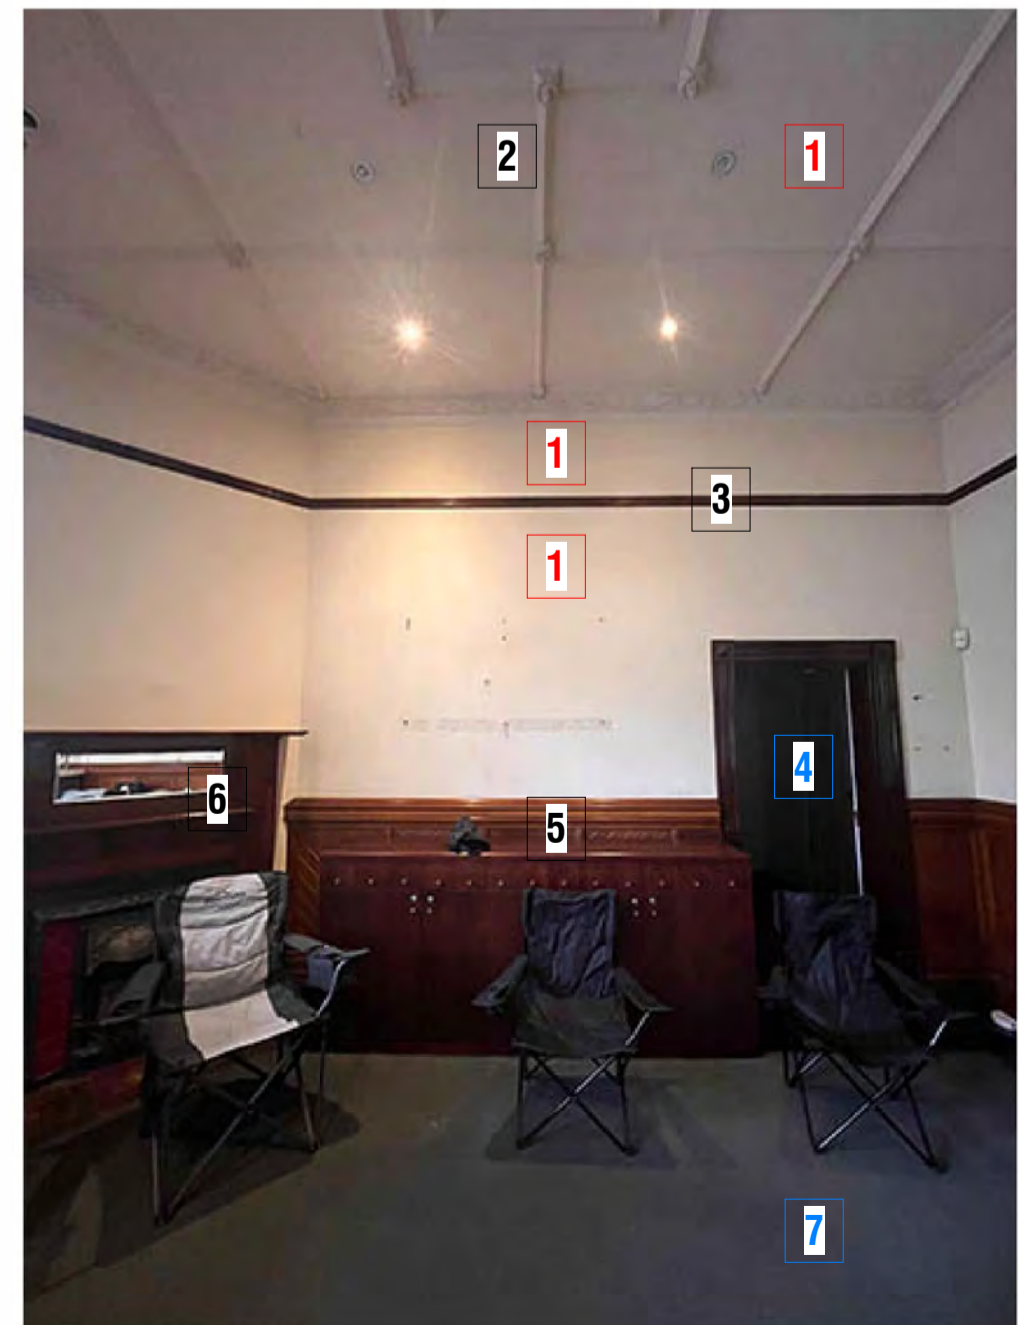
PHOTO - CURRENT ROOM BEHIND RECEPTION DESK

1. CURRENT PAINT COLOUR: LIGHT WHITE TONE PAINT. TYPE UNKNOWN. PROPOSED PAINT COLOUR: LIGHT TONE DISTEMPER PAINT
2. DECORATIVE CEILING BATTENS / CORNICES TO REMAIN
3. TIMBER DADO TO REMAIN. TIMBER TYPE: RED CEDAR. FINISH: CLEAR VARNISH. TBC IF ORIGINAL
4. NON-ORIGINAL DOOR AND ARCHITRAVE TO REMAIN. CURRENT FINISH: PAINTED. NOT ORIGINAL
5. TIMBER WAINSCOTTING AND DADO RAIL / SKIRTING. TIMBER TYPE: HUON PINE. TBC IF ORIGINAL. CURRENT FINISH: CLEAR VARNISH. TBC IF ORIGINAL
6. TIMBER SURROUND TO REMAIN
7. NON-ORIGINAL CARPET OVER ORIGINAL BALTIC FLOORING. REMOVE RUG

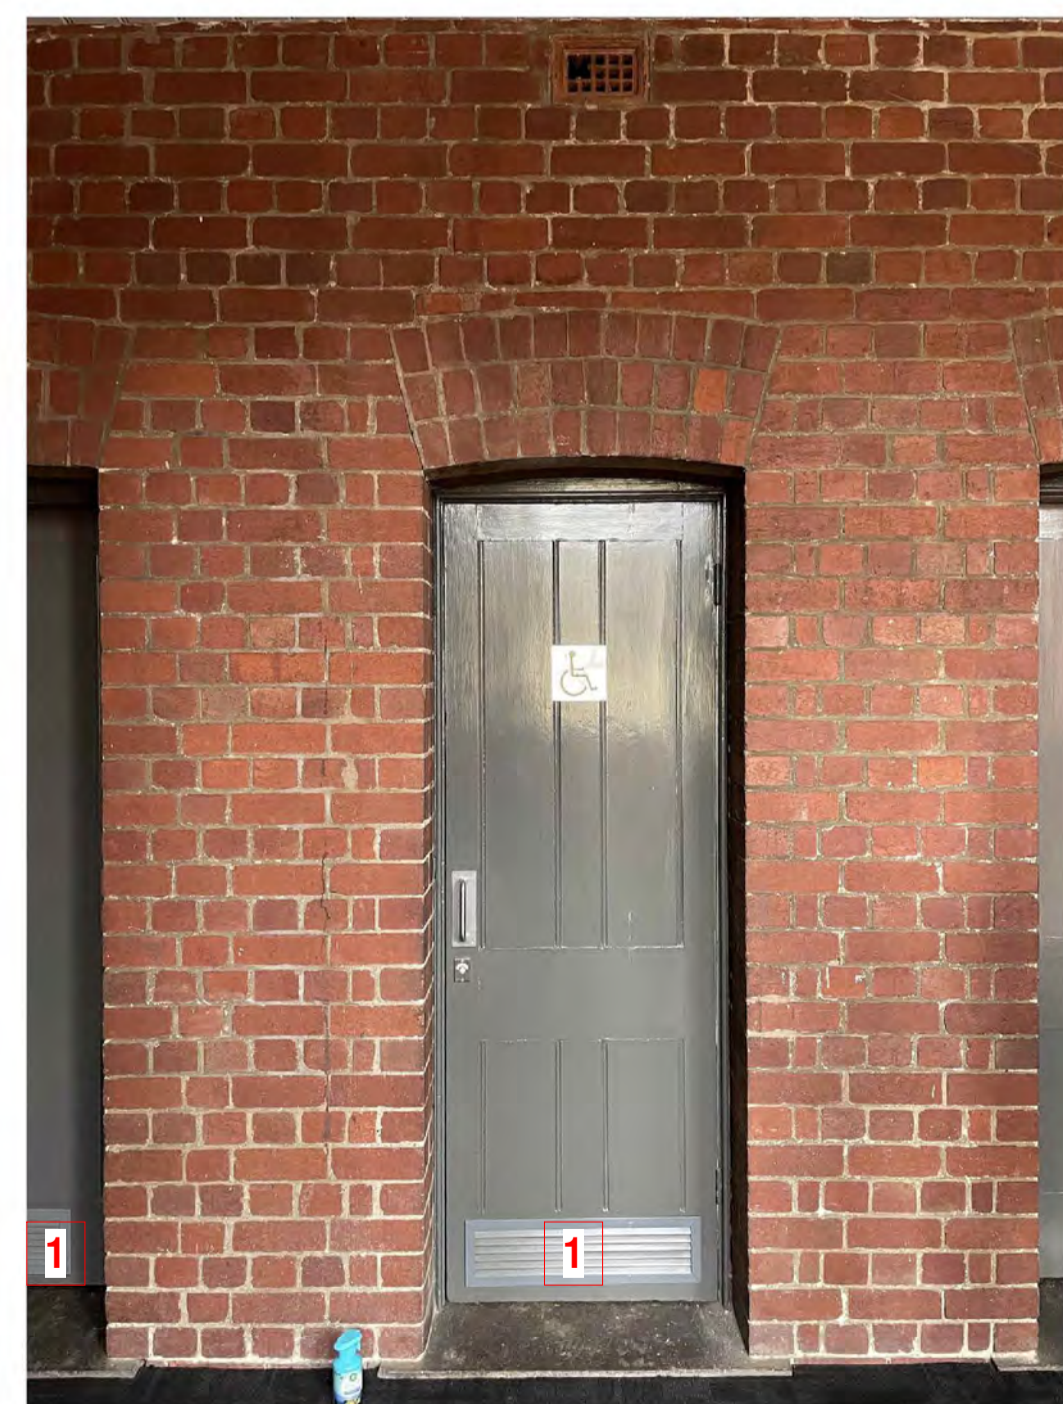
PHOTO - CURRENT WC DOORS

- 1. NON-ORIGINAL GRILLE TO DOORS. DOORS TO BE REPLACED WITH STEEL FRAME GLAZED DOORS / WINDOW

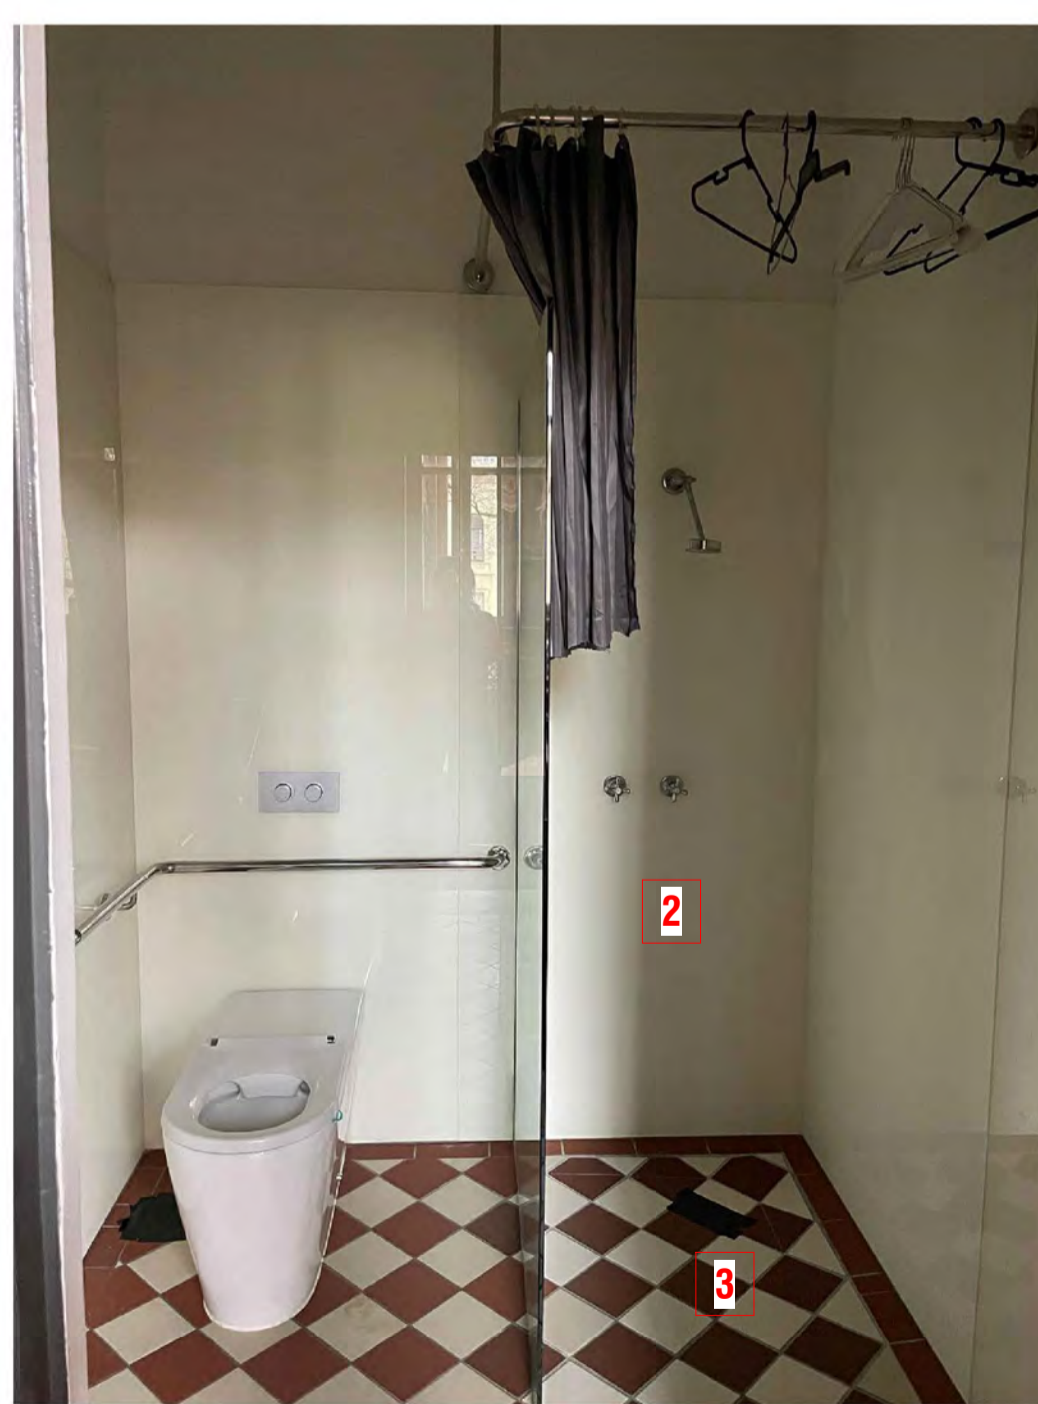
PHOTO - CURRENT ACCESSIBLE TOILET

- 1. NON-ORIGINAL CEILING. REMOVE
- 2. NON-ORIGINAL WALL PARTITIONS. REMOVE
- 3. NON-ORIGINAL TILES. REMOVE
- 4. NON-ORIGINAL DOORS. REMOVE
- 5. NON-ORIGINAL PAINT FINISHES. REPAINT

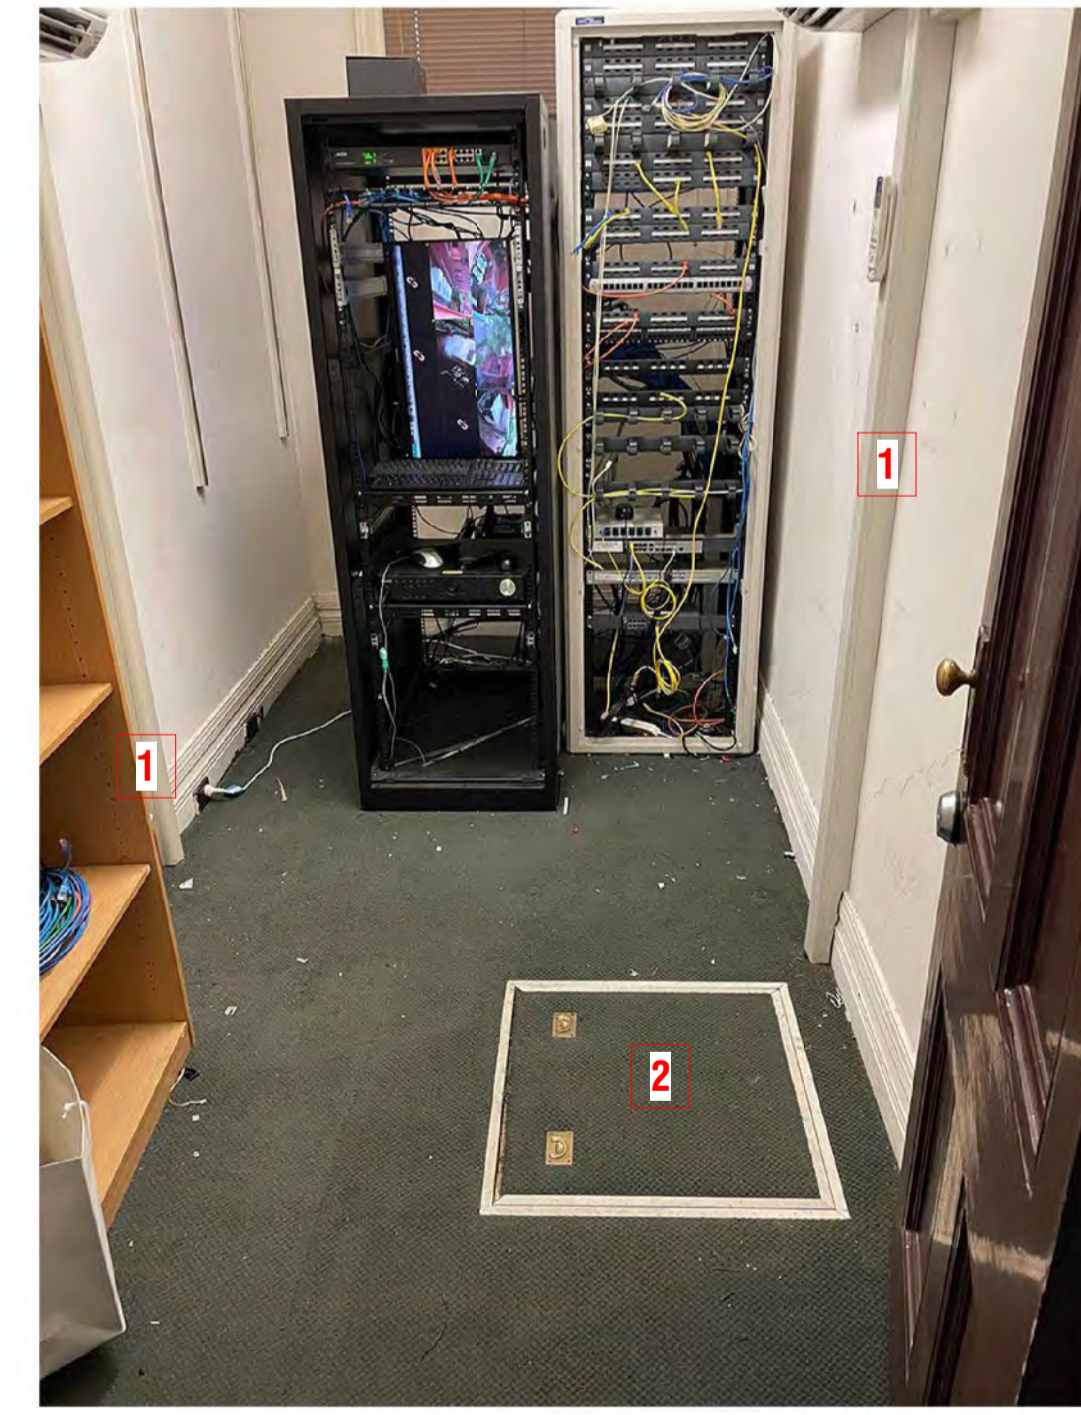
PHOTO - VIEW INTO CURRENT COMPUTER SERVER ROOM

- 1. NON-ORIGINAL DUCTING / AC UNIT. REMOVE
- 2. NON-ORIGINAL CARPET TO PLY FLOORING. REMOVE AND REPLACE WITH NEW TIMBER FLOORING

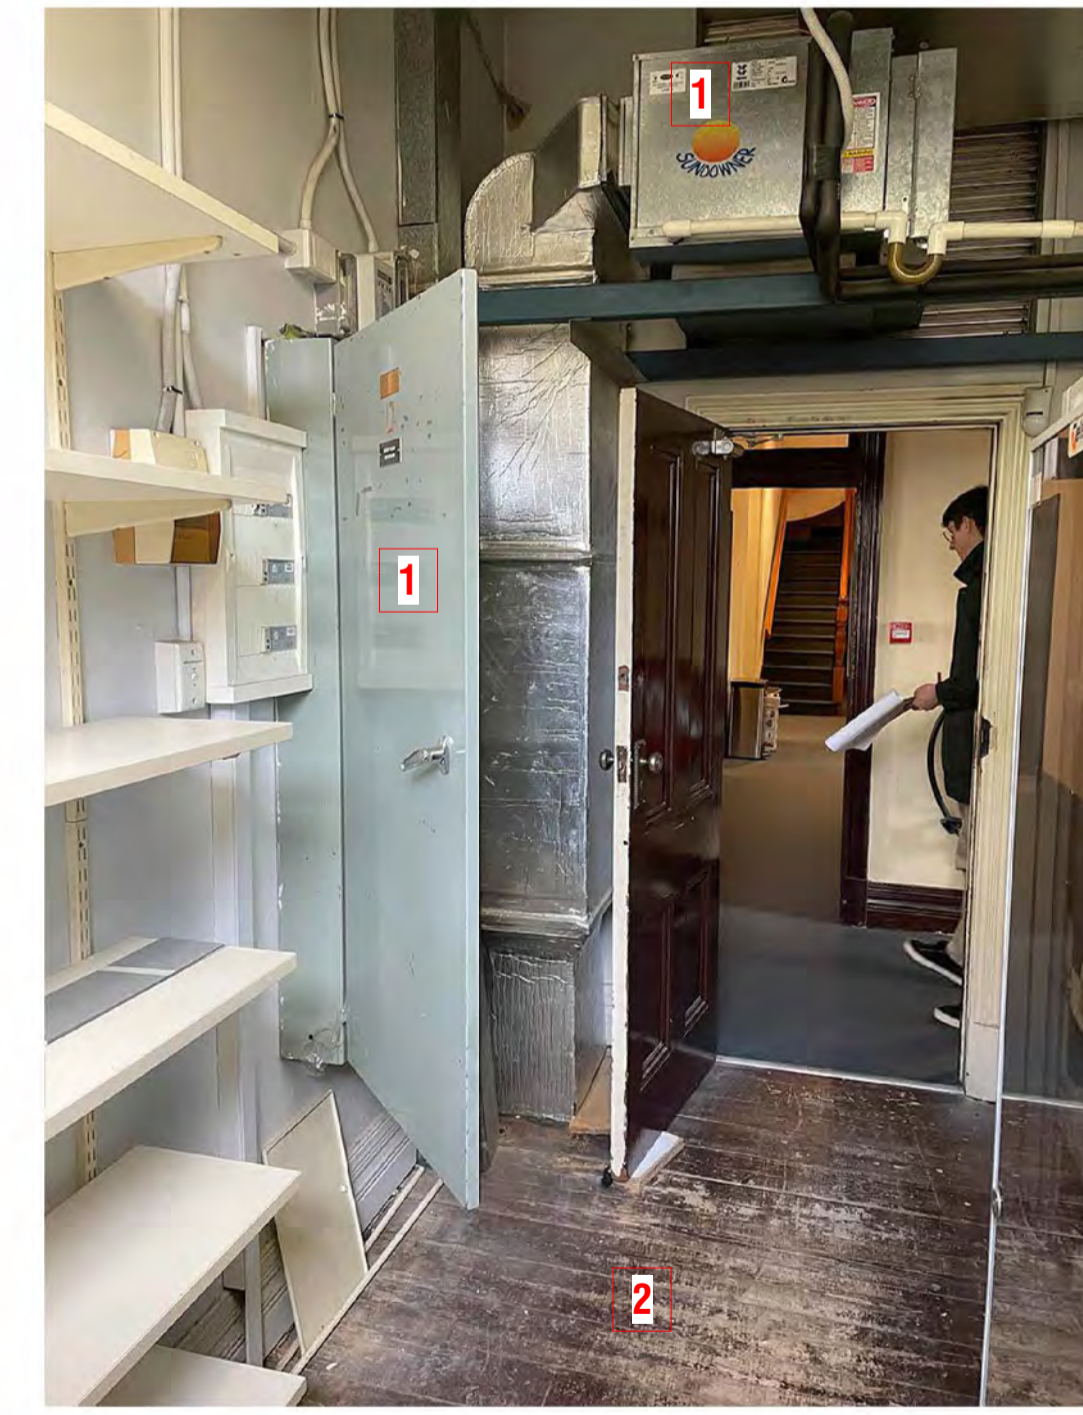
PHOTO - VIEW INTO AC DUCT ROOM

- 1. ROOM IS FILLED WITH SERVICES / DUCTWORK / SHELVES ETC. REMOVE ALL.
- 2. TIMBER FLOORING TO REMAIN. NEW TIMBER FLOOR OVER

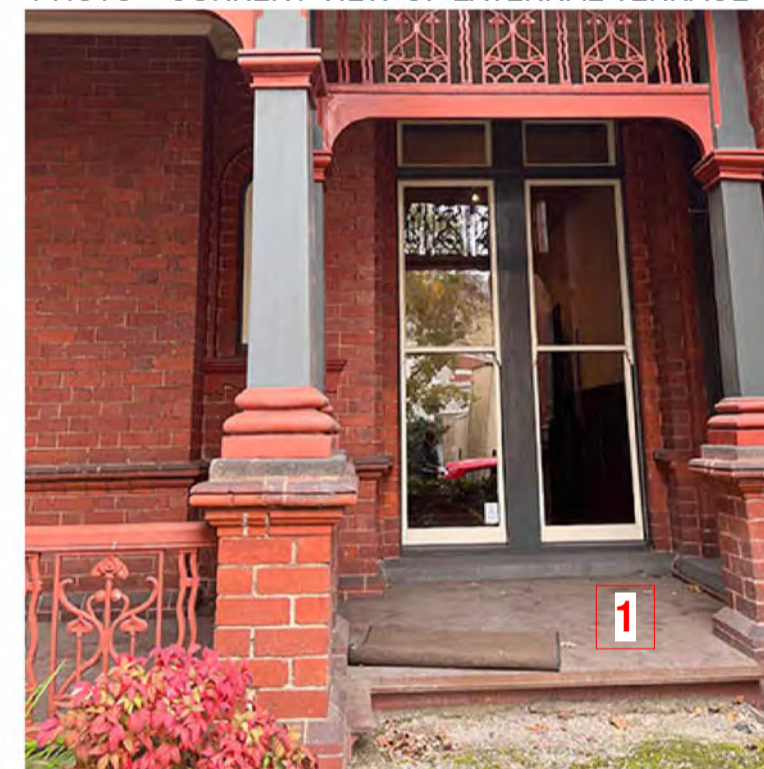
PHOTO - CURRENT VIEW OF EXTERNAL TERRACE

1. NON-ORIGINAL JARRAH FLOORING NOTED IN 2001 RENOVATION DRAWINGS

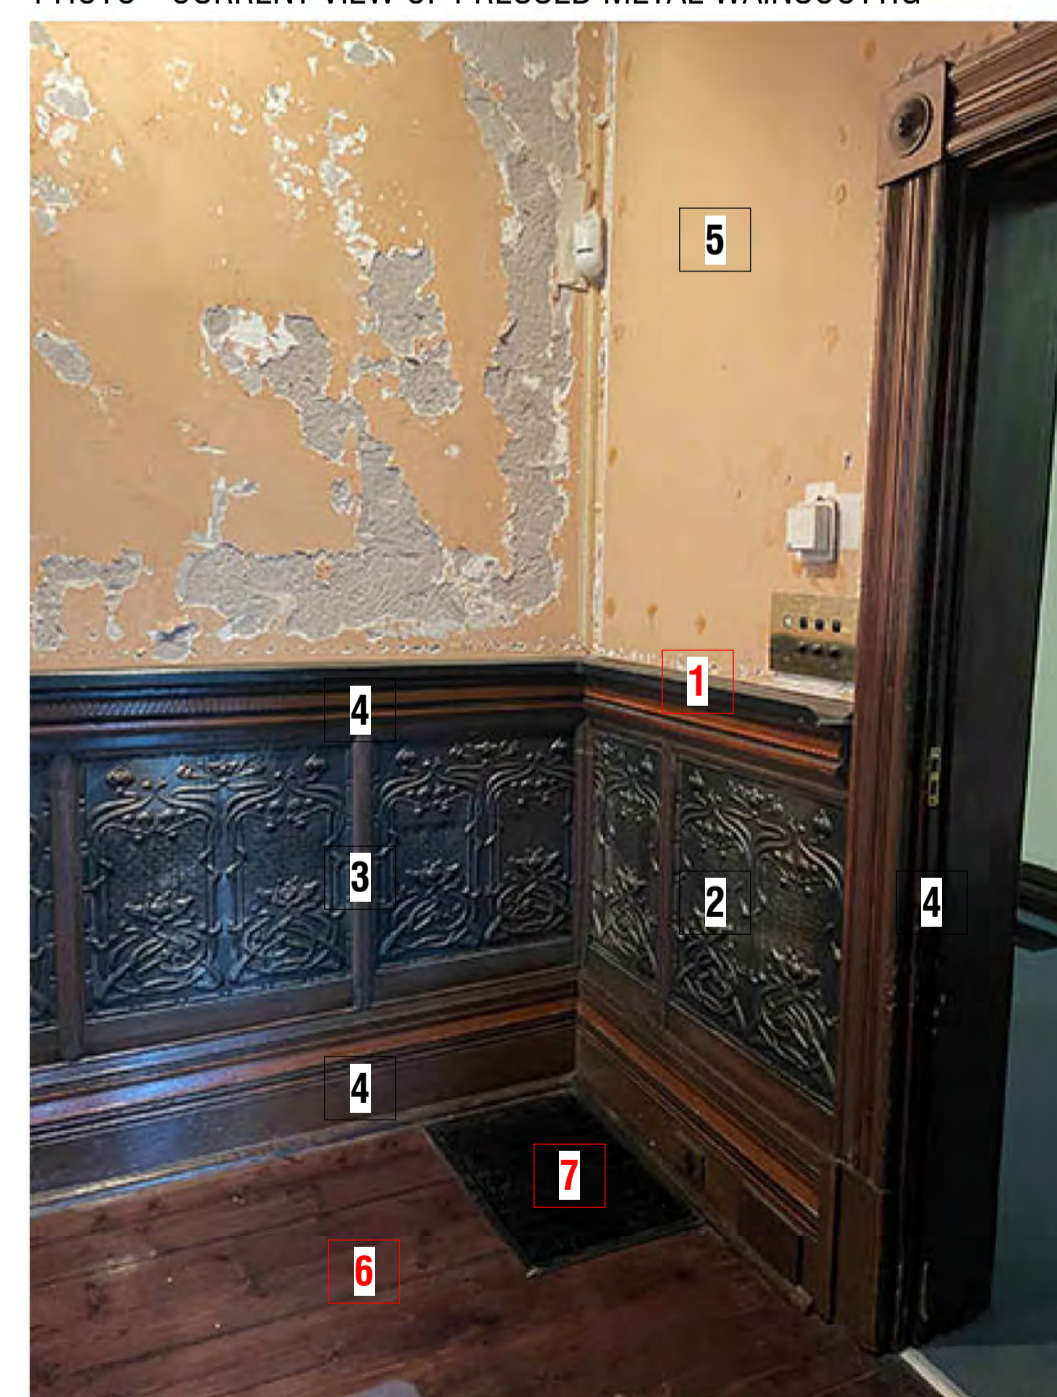
PHOTO - CURRENT VIEW OF PRESSED METAL WAINSCOTTING

1. NON-ORIGINAL TIMBER LEDGE. REMOVE  
2. PRESSED METAL WAINSCOTTING. TBC IF LEFT UNPAINTED ORIGINALLY  
3. PRESSED METAL BOARDER AROUND WAINSCOTTING. PAINTED. TBC IF ORIGINAL  
4. DADO / TIMBER SKIRT / ARCHITRAVES TO REMAIN. TIMBER TYPE: RED CEDAR. FINISH: CLEAR VARNISH. TBC IF ORIGINAL  
5. CURRENT PAINT FINISH: BEIGE. TBC IF ORIGINAL PAINT TYPE: UNKNOW. PROPOSED PAINT FINISH: LIGHT TONE  
6. ORIGINAL BALTIC PINE TIMBER FLOORING TO REMAIN. NEW TIMBER FLOOR FINISH OVER  
7. NON-ORIGINAL VENT GRILLE CUT-OUTS IN ORIGINAL FLOORING. COVER OVER WITH NEW TIMBER FLOORING.
