SCHEDULE OF PROPOSED CONSERVATION WORKS

YORK HOUSE - 131 St. Georges Road, North Fitzroy

Updated 22.4.2024

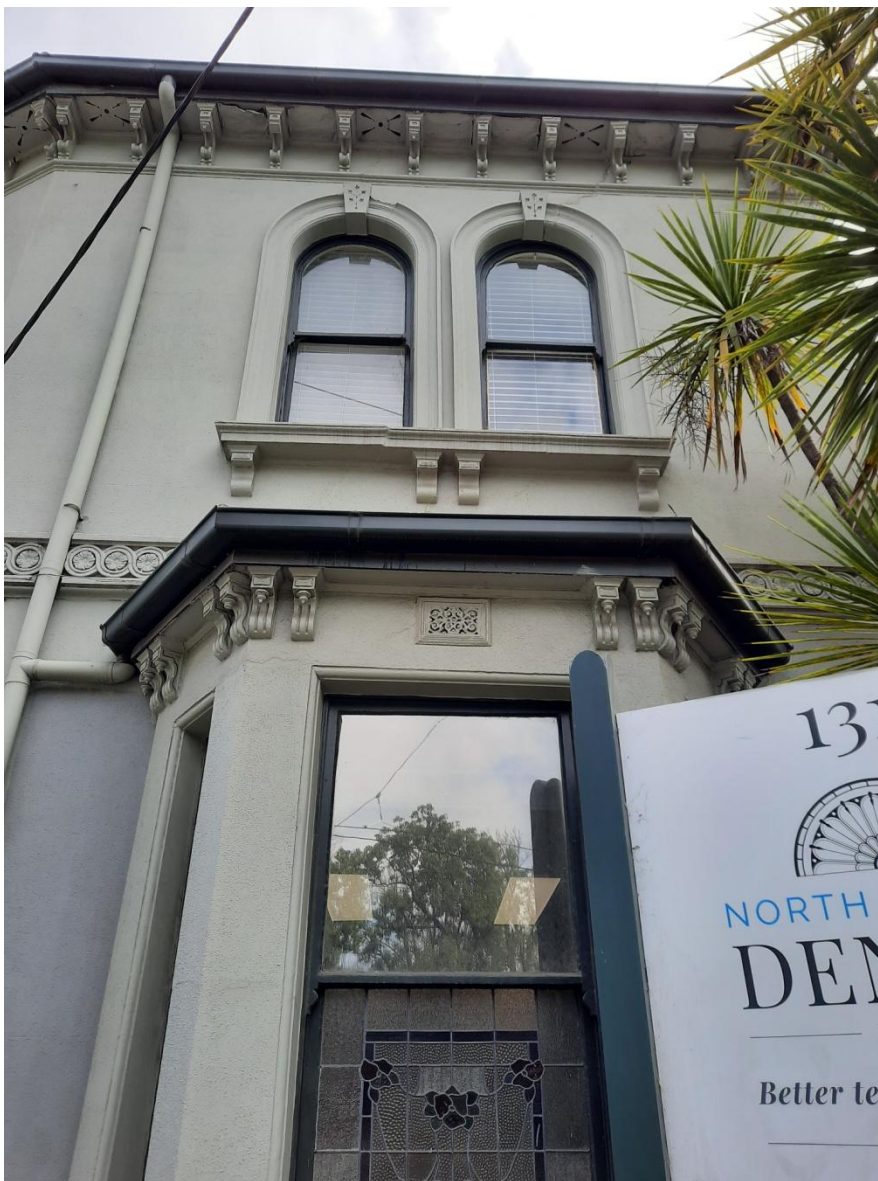
Figure A

There is minor cracking through the base of the bay window and through the wall above. This cracking extends upwards through the first floor external wall and is most noticeable by the movement that has occurred on the projecting sill of the first floor pair of windows. The cracking extends from above the head of the pair of windows to the eaves soffit.

Bay window showing cracking in the first floor window sill and cracking in the first floor window moulding and in the render above the window.

The external rendered surfaces in the vicinity of the cracking will be removed to expose the brickwork. Loose mortar in the brickwork will be cleaned out and refilled with sand lime mortar. The patched areas will be re-rendered with sand lime cement based render to match the surrounding surface. The window sill at the first floor will be rebuilt as necessary to achieve a straight and horizontal sill. The decorative moulding profile will be reproduced and render applied. The wall surface above the window heads will be exposed and repaired as noted above. The cracked projecting profile rendered architraves next to the keystone will be repaired.

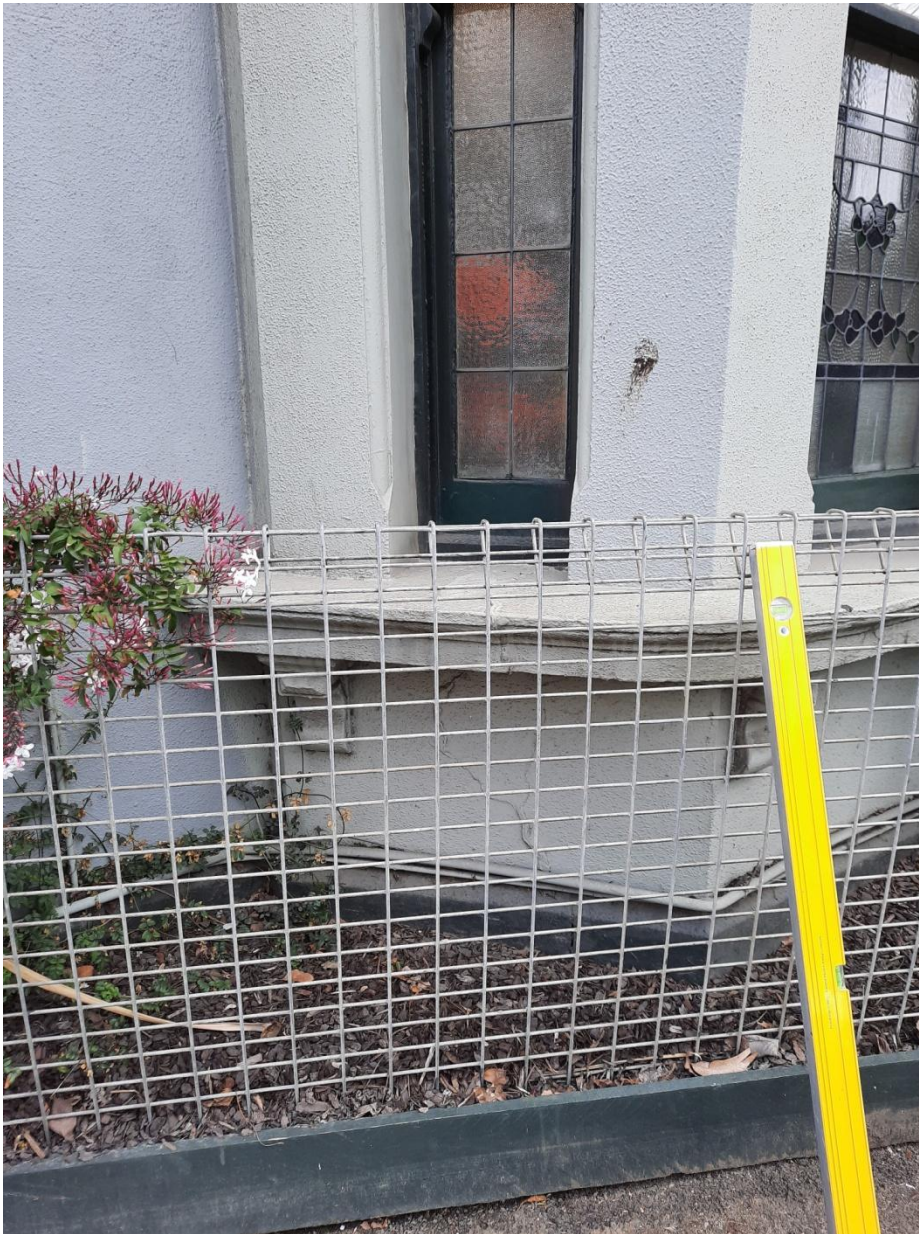
Figure B

Bay window showing cracking in the window sill and in render of the wall beneath the sill .

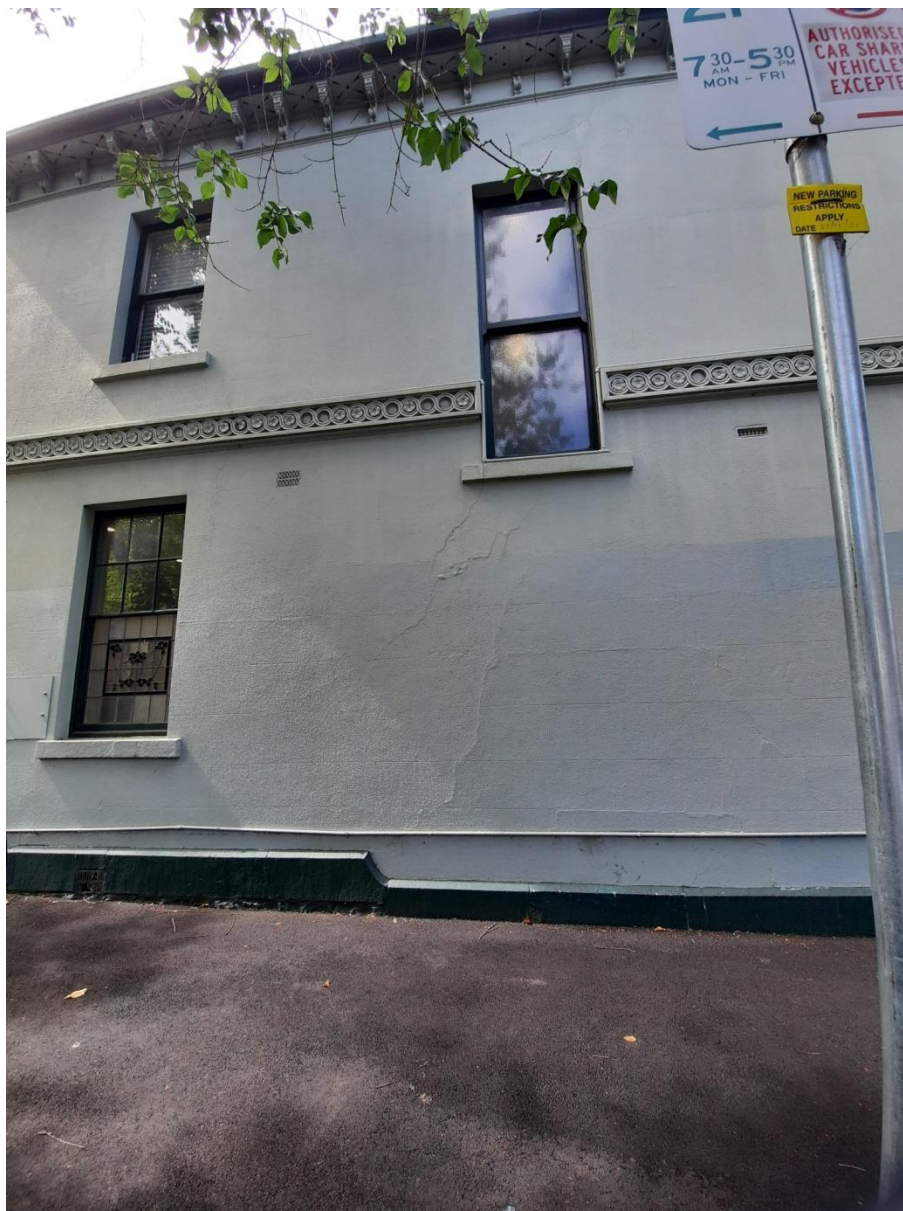
Figure C

Several corbel eaves brackets are missing and some others are damaged or loose. The eaves soffits have decorated flat panels between the corbel brackets. Several are missing and some others are damaged

West elevation showing attached pipes and conduits, missing corbel eaves brackets and missing paterae in the string course.

The rendered decorative string course at first floor level is in need of some repairs. A number of the paterae/rosettes, set inside the interlacing pattern of the string course, are missing.

Existing damaged and loose corbel brackets will be removed and repaired where possible, then reinstated. If not possible to repair, they will be replaced with like for like. Missing corbel brackets will be reinstated with new to match the existing. Existing damaged or loose soffit panels will be removed and repaired where possible, then reinstated. If not possible to repair, they will be replaced with like for like. Missing soffit panels will be reinstated to match the existing.

Check all the remaining patera/rosettes to ensure they are not loose. Make a mould of a typical paterae/rosette and cast new ones from external quality cement based material. Reinstall all missing or loose patera/rosettes.

The exposed conduits and pipes will be removed from the wall facing Brunswick Street North. Where removed, the wall surface will be patched and repaired. On the north walls, where possible, conduits and pipes will be removed. The locations and extent of removal will depend on the ability to conceal them within the building fabric. Where conduits and pipes are removed, the wall surface will be patched and repaired.

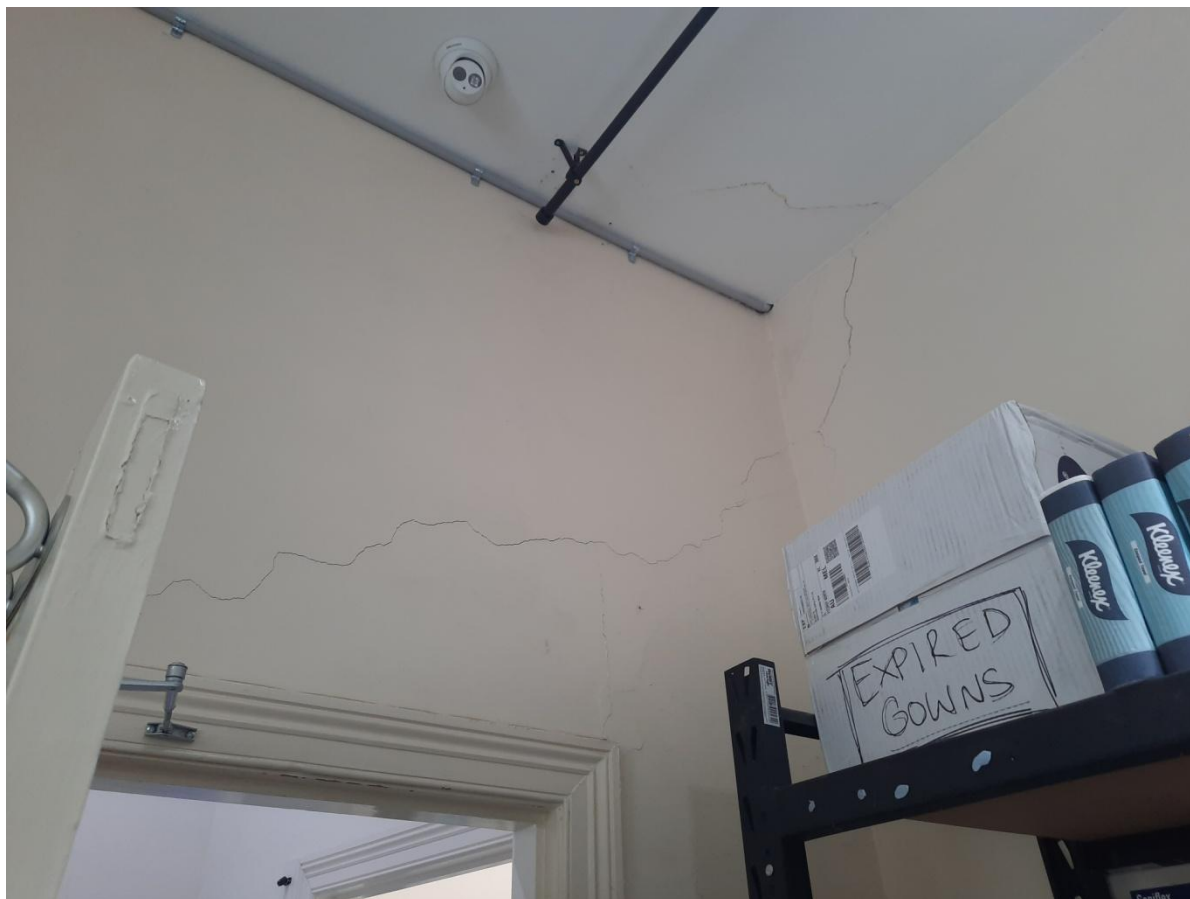
Figure D

The plaster of the first floor room walls, although not drummy, has hairline cracking in several places.

First floor room showing hair line cracking in plaster walls and ceiling.

The cracked plaster will be cut out and plaster patched to match the surrounding wall surface finish. Walls that have been patched or repaired will be repainted to match the existing wall paint colour.
