Tree Protection Management Plan 'Ascension of Polka Dots on the Trees' Art Installation – St. Kilda Road, Melbourne.

2 October 2024

Tree Logic Ref. 013763

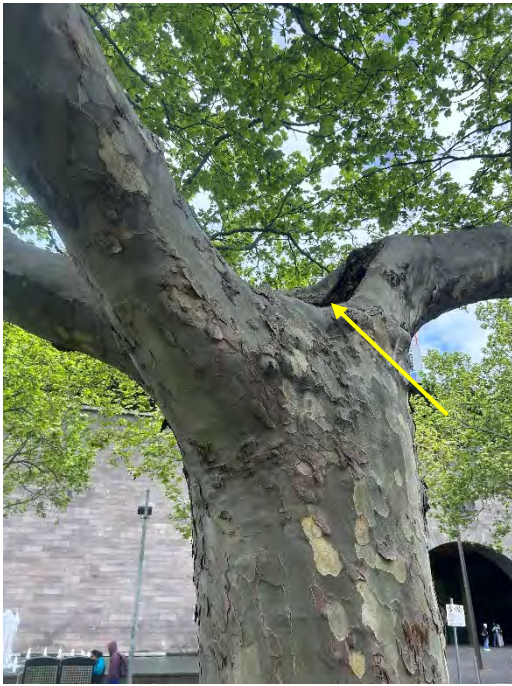
Asset ID 1029373 and 1029390 exhibited cavities that may harbor native wildlife. If native animals are present, wrapping over the cavities may accidentally trap them inside which is to be avoided. Trapped animals may also damage the fabric as they exit the cavity. Therefore, prior to wrapping, each tree is to be inspected for any cavities or hollows. If a cavity or hollow is present, inspection of the hollow must be undertaken by the installer to ensure there are no animals present. A flashlight be necessary to fully inspect the cavity. Should an animal be present, a wildlife officer is to be engaged to relocate the animal before the tree is wrapped. The cavity may also need to be covered to prevent re-entry.

Figure 7 (upper left): Shows a cavity within the primary union (junction area) of Tree 31 (Asset ID 1029373). The cavity is to be inspected for wildlife prior to wrapping the tree.

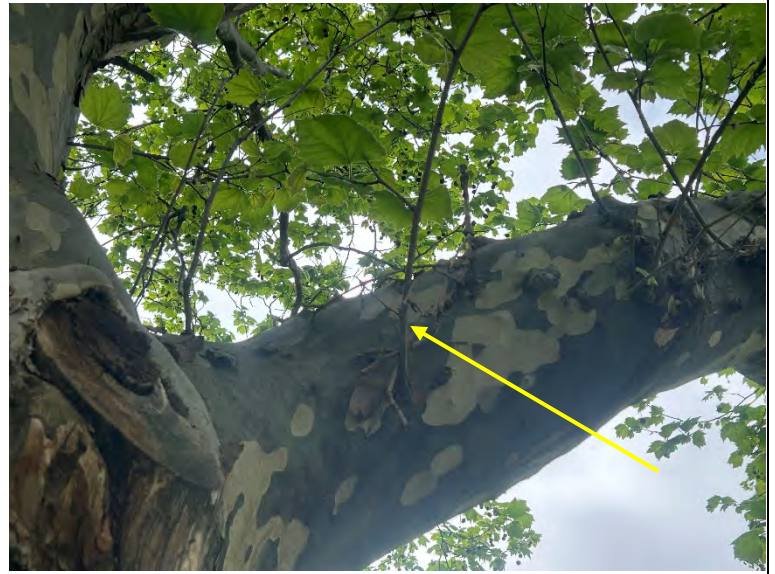
Adventitious (epicormic) shoots (10 mm diameter) were noted at the base of main branches on several trees. These shoots may be damaged during the wrapping process. Prior to wrapping these shoots are to be removed with a pair of sharp, sterilized secateurs or handsaw by the project arborist or under the guidance of the project arborist. Shoots are to be removed at the base where they attach to the main stem. Between each tree the secateurs are to be sterilized with a solution of water and bleach or tea tree oil (one part disinfectant to 10 parts water and apply for 30 seconds) carried in a spray bottle. This is to avoid the spread of any fungal or bacterial diseases that may be present. Appropriate personal protection must be utilized when using bleach or any other disinfectant.

Figure 8 (upper right): Shows an example of an adventitious (epicormic) shoot on a main branch. Prior to wrapping the shoots are to be pruned with a sharp, sterilized pair of secateurs or handsaw by the project arborist.

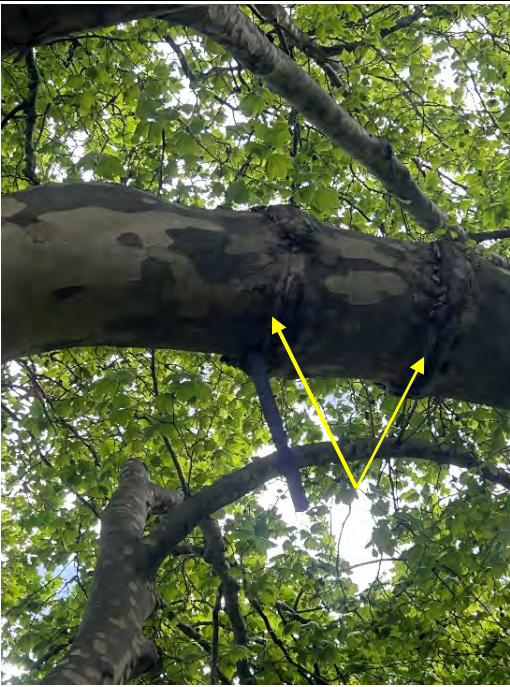
Figure 9 (above left): Shows an example of limb girdling from a wire that is embedded into the branch. Such damage reduces the functionality of the tree's transport system so all cable ties must be removed when dismantling the installations.

Removing the staples should be carried out in a manner that avoids tearing the bark. When removing the fabric, the use of a flat tool (no knives or stapler remover) that can lift the staple out at the same time the fabric is being unwrapped is recommended. The tool can also be used to lift the cable tie so it can be cut without damage to the bark.

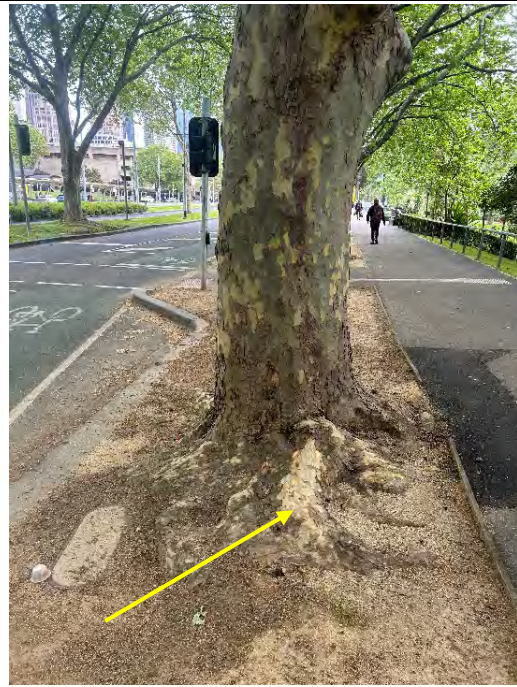
Figure 10 (above right): Shows an example exposed buttress roots. Placement of the ladders and scaffolding must avoid damaging these roots. A non-slip mat must be placed over the root/s to provide protection from the equipment.

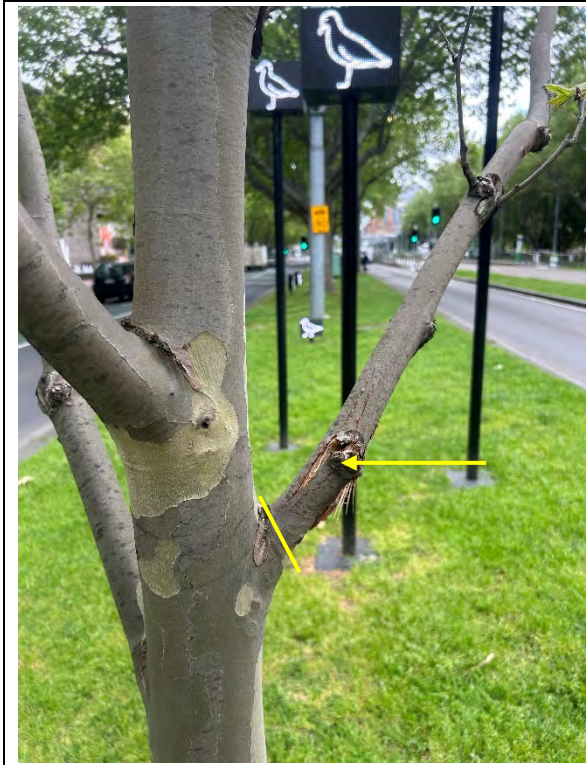
The pruning of main branches is not required as part of the project. Asset ID 1640139 (Tree 30) exhibited a damaged branch that is recommended for removal (See Figure 11). Removal of the branch for Tree 30 is to be undertaken by the project arborist in accordance with *AS4373 - 2007 Pruning of amenity trees*.

Figure 11: Shows the damaged north-east heading branch of Asset ID 1640139 (Tree 30). The branch is to be pruned at its point of attachment by the project arborist and in accordance with AS4373-2007 Pruning of amenity trees.
