VICTORIA TRADES HALL - STAGE 3 WORKS

HERITAGE IMPACT STATEMENT

54 Victoria Street, Carlton

June 2024

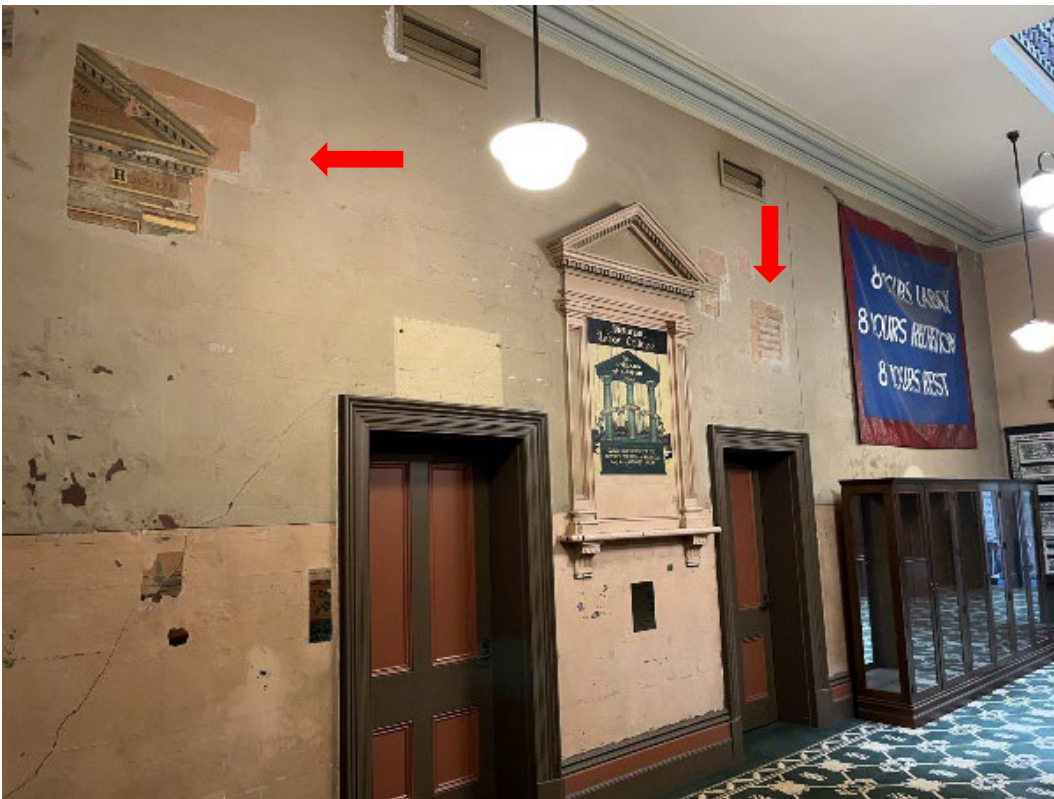
Figure 8 Revealed sections (indicated) of overpainted honour rolls on west wall of entry hall (G46)

The proposed works include the removal of overpainting, and conservation works to the painted commemorative panels and honour boards on the south and west walls in the ground floor entry hall in Stage 1 (G46, Figure 8 and Figure 9; refer Drawing No. A-600). These works have been developed based on investigations undertaken by Artcare, August 2022 (Appendix A). The investigations assessed the extent of decoration on the walls in this space, the condition, and the feasibility of recovering original decorative schemes and commemorative panels through the removal of later overpaint. As noted in the 2022 report, the honour boards on the east wall of the hall were revealed in the early 1990s (Figure 10). These will be lightly cleaned as part of the project. Dado, skirtings and cornices will be repainted to all walls in this space based on evidence arising from the initial cleaning and revealing works to the east and south walls.

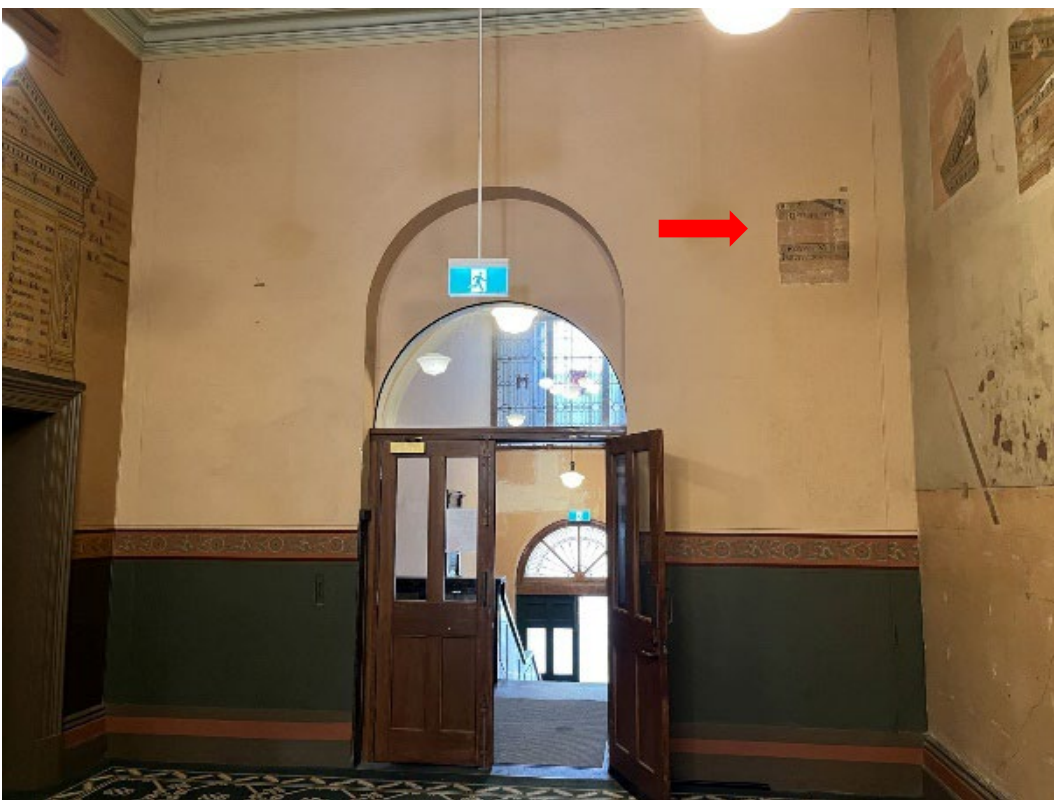
Figure 9 Revealed section (indicated) of overpainted honour roll on south wall of entry hall (G46)

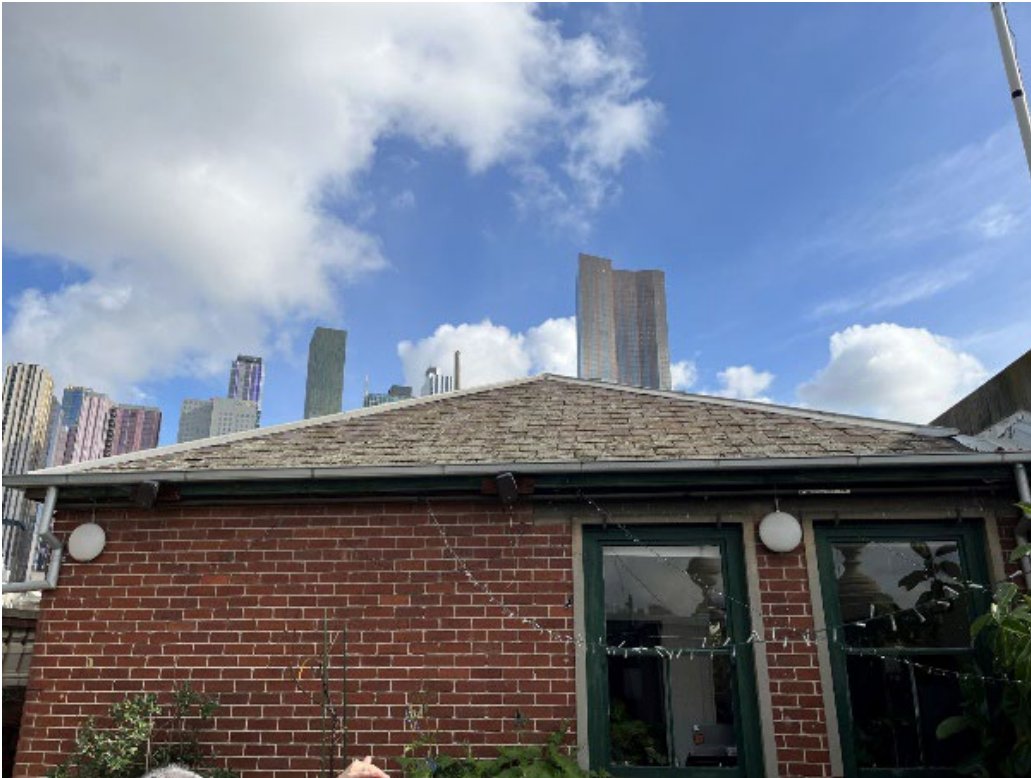
Figure 11 Slate clad roof of the Caretaker's Cottage showing existing ridge capping, gutters and downpipes to be demolished

Of the former, the proposal to remove the extant slate cladding and replace this with galvanised corrugated sheet, new insulation, sarking and rainwater goods arises from the failure of the existing roof cladding. The slate has largely reached end of life with the roof leaking, and due to the height and location of the roof, continual repair introduces complications around safe access and maintenance.

Repair is further complicated by the limited ability for accessing matching Welsh slate for any works. While not an outcome that follows the 'like for like' approach, the proposed replacement with new materials is based on the management of future maintenance burdens on Trades Hall, provision of improved thermal capacity for occupants of the cottage and weathertightness. Skylights to be replaced are non-original insertions and the proposed roof material is consistent with that applied elsewhere on Trades Hall. It is noted that the roof is not visible in principal ground level views to the building, being concealed behind a tall parapet and Stage 1, and only visible from high level vantage points overlooking the south end of Trades Hall. The Caretaker's Cottage is identified as an element of contributory significance in the CMP, and the policy framework provides some scope for an alternative approach to management of fabric, where this has limited adverse impacts on heritage values. Overall, while the proposed works will introduce a change, and loss of fabric, the overall effect is one which goes to the provision of a secure weather envelope to this structure and improve the functioning of the roof drainage and stormwater system. The proposed change will not adversely affect the architectural significance of the place and goes to the longevity of the building.

- Remove slate tiles, battens, ridge capping and rainwater goods to Caretaker's Cottage (Stage 9, Figure 11, refer to Drawing No. A-103)
- Remove metal roof sheeting, ridge capping, gutters and existing rainwater heads of Stage 1 (refer to Drawing No. A-103)
- Remove existing roof sheeting and rainwater goods on the roof of the north tower (refer to Drawing No. A-103).
- Temporary removal of ridge capping on roof of Stage 8 to provide access to skylights proposed for repairs (refer to Drawing No. A-103).

- New stainless steel rainwater heads, box gutters, new rainwater goods (dps and overflows), new sarking, ridge capping and roof insulation with timber battens and a moisture permeable membrane on the roof of the Caretaker's Cottage (refer to Drawing No. A-203)
- New box gutters, and two new sumps with overflow on roof of Stage 1 and north tower (refer to Drawing No. A-203)
- New additional mechanical plant units to be located on existing plant platform, new proposed safe-access walkways and new access hatch to Stage 6 (refer to Drawing No. A-004).

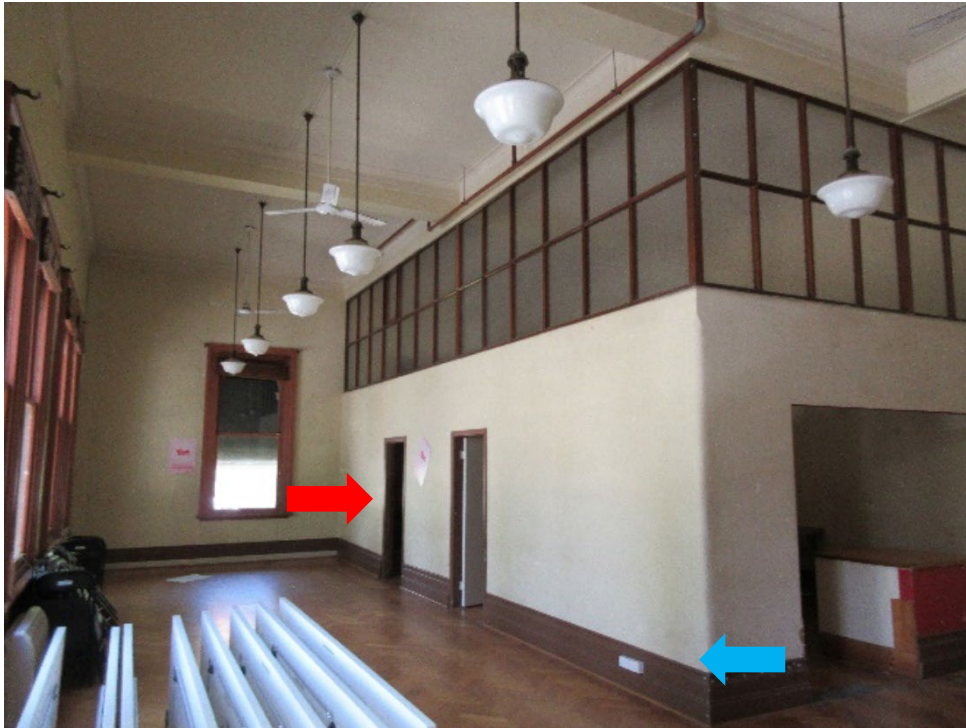
Figure 13 Layout of G39 proposed for reconfiguration to create offices; red arrow indicates door opening to be infilled and skirting; blue arrow showing location of proposed lightweight wall to extend to perimeter wall

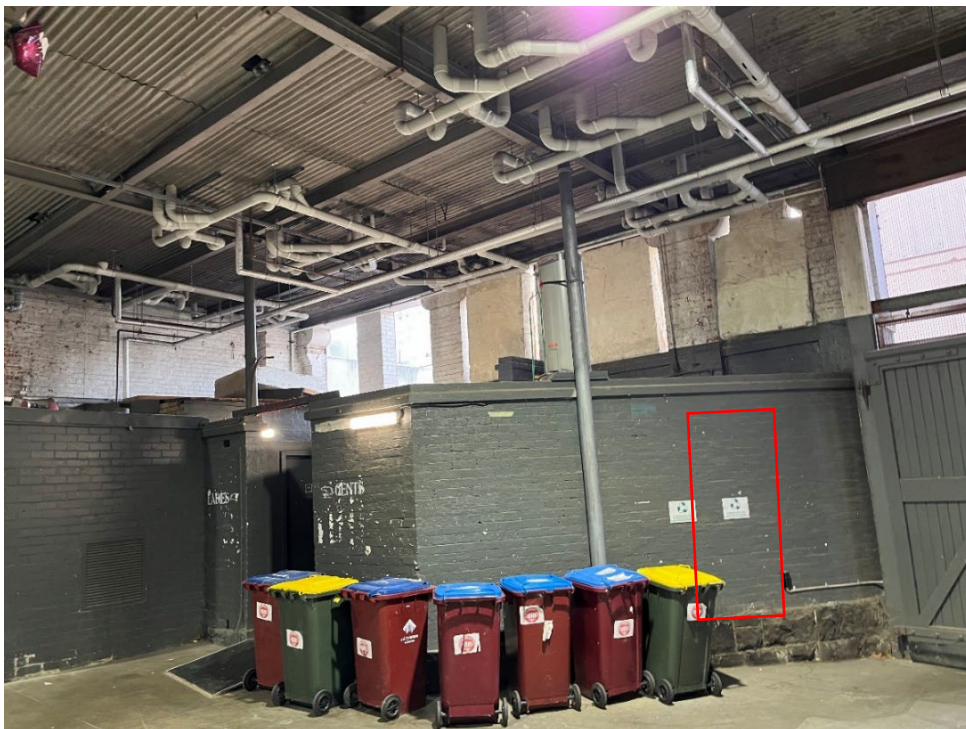
Figure 14 Toilet and store in undercroft area showing approximate portion of south angled wall proposed for demolition

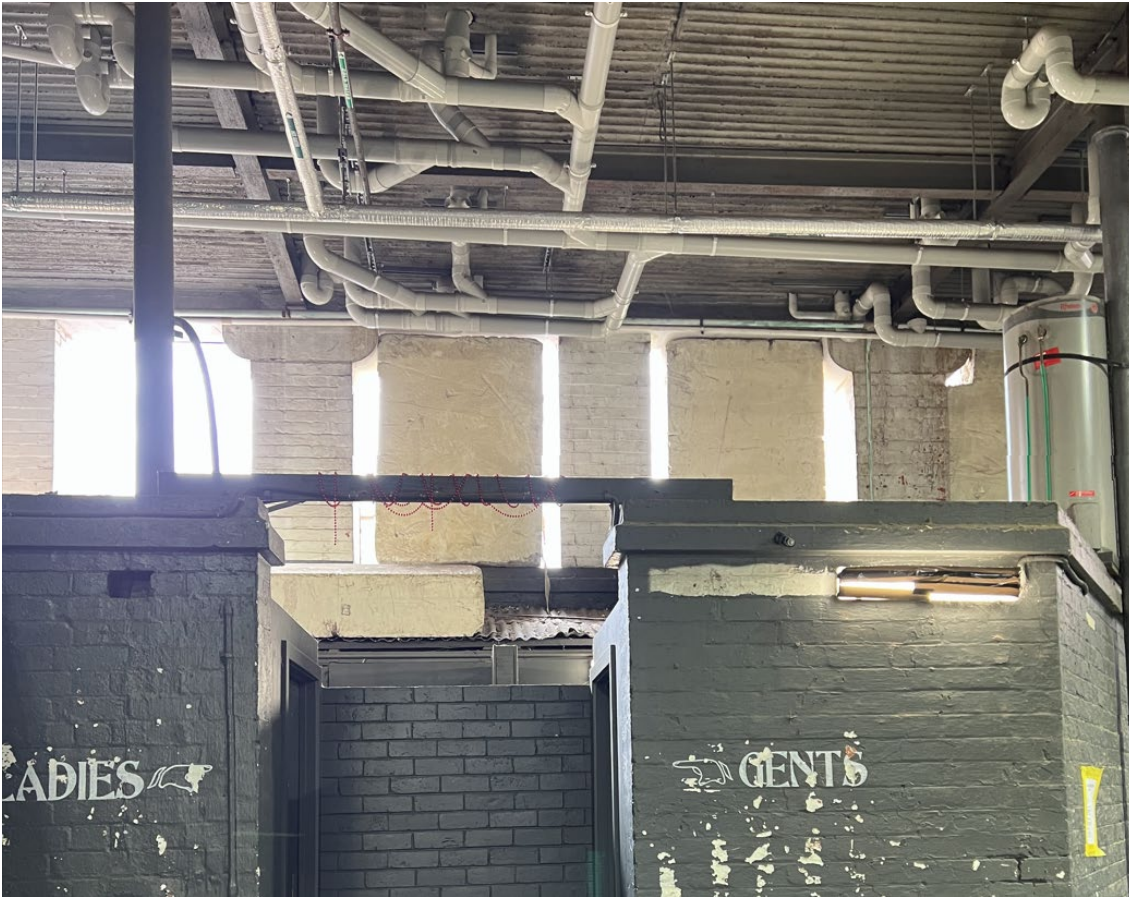
Figure 15 Openings on east wall above undercroft toilets with unfixed polystyrene infills proposed for removal

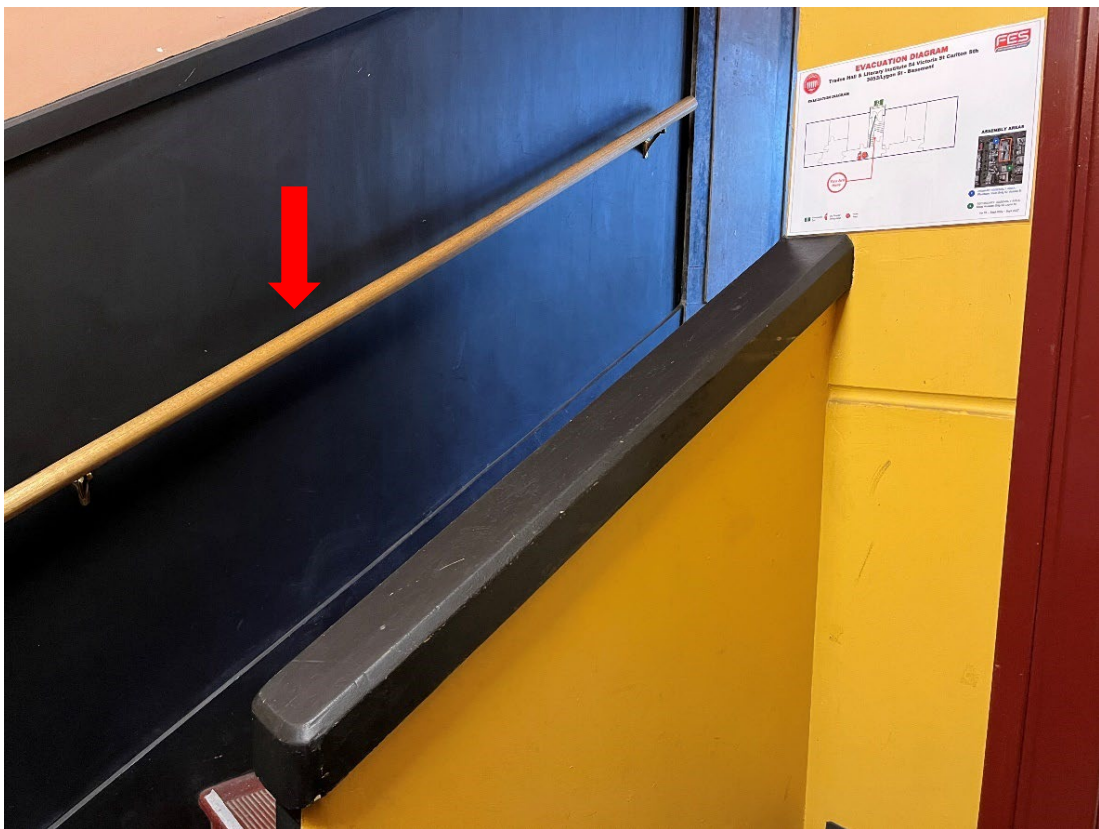
Figure 16 Stairs to basement from Victoria Street entry showing non-original timber handrail proposed for removal

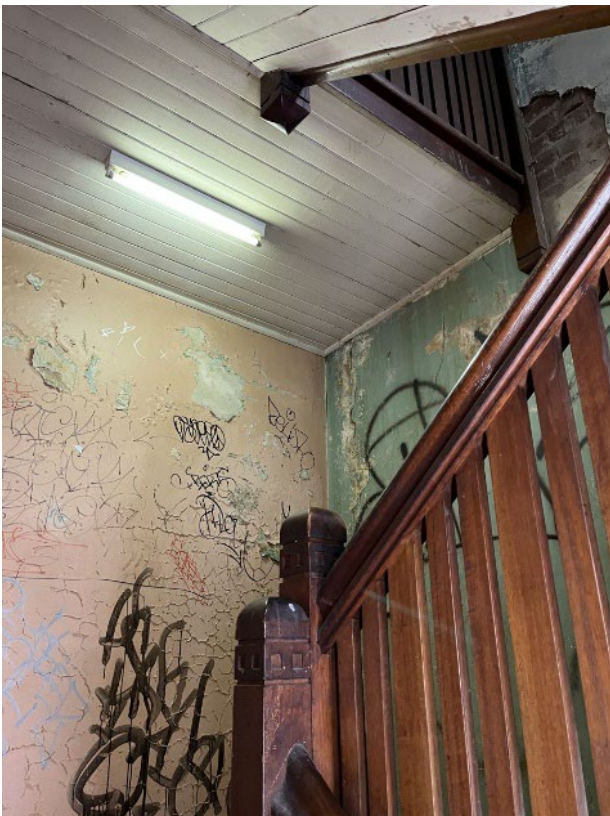
Figure 18 Typical condition found in Stair 2, north-east corner of Stage 9

- Install new timber framed glazed doors and framed with fixed glazed panels to existing opening to G46 (refer to Drawing No. A-201 and A-300).
- Stair 2 to be upgraded with new nosing and handrails to align with current DDA compliant standards (Figure 18). The deteriorated concrete ceiling and walls to be repaired (refer to Drawing No. A-302)

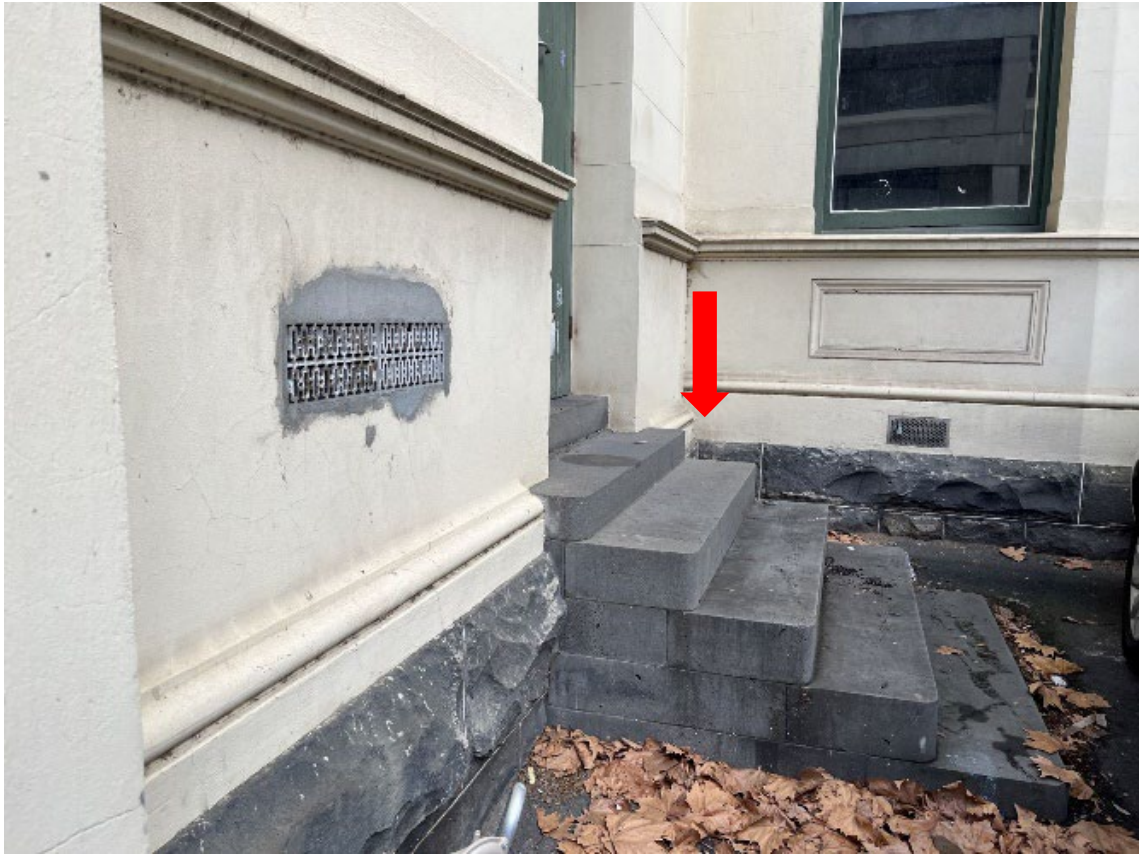
Figure 19 Non-original bluestone stairs in carpark north of Stage 9, to be dismantled and reconstructed in a new arrangement with new landing and integrated handrails

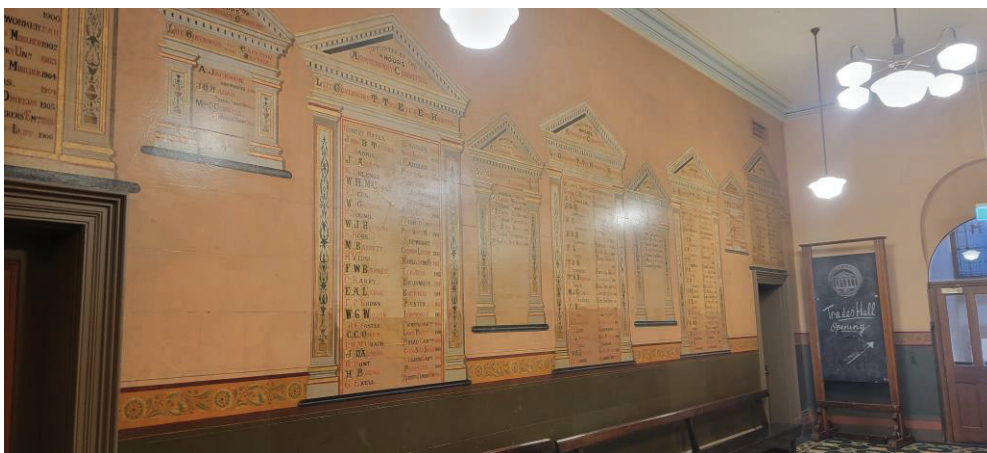
Figure 1 General view of the East wall.

It is clear the east wall was heavily retouched in the 1990s campaign, with extensive repainting of several areas. Based on the results of paint removal on the west wall, by the same team, where very little of the gilt highlighting was retained, the best interpretation is that the east wall was either covered by papers or other readily removable coverings. This is based on the observation that gold on the east wall is perfectly preserved whereas that on the west wall is largely removed in all exposed areas.

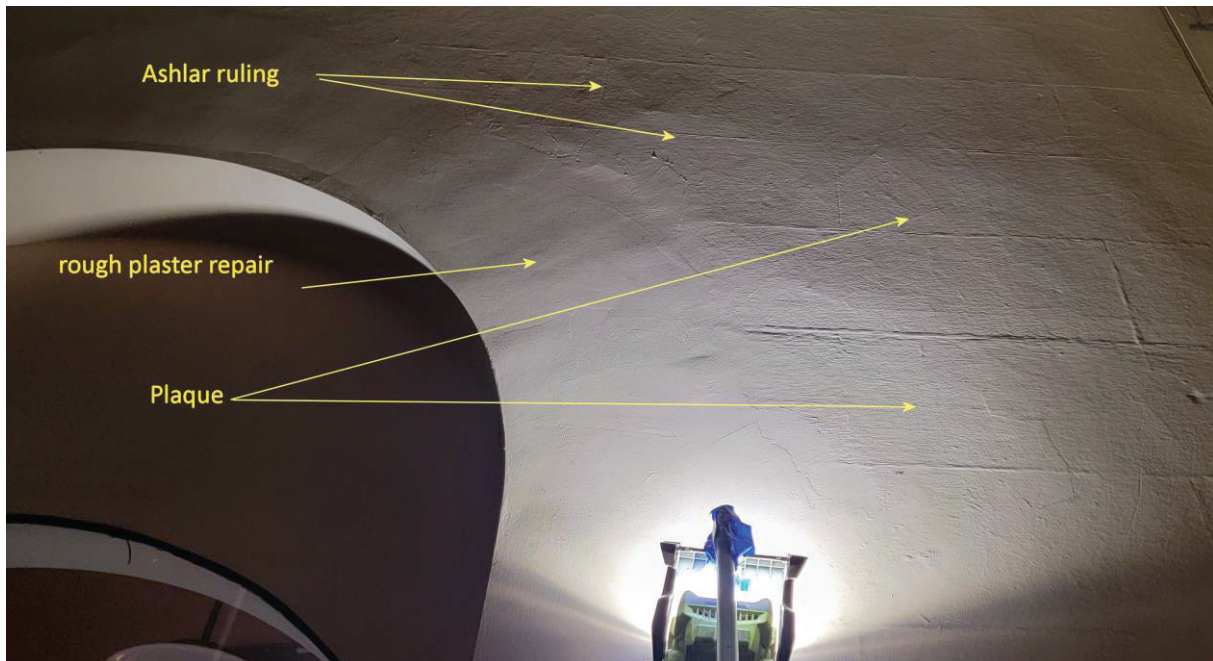
The south wall has been investigated using raking light to reveal two inscription panels placed symmetrically either side of the doorway. The raking light made it clear that the doorway was cut through an existing plaster as it has been very roughly filled around the opening.

Figure 5 Raking light on the south wall has revealed a plaque either side of the opening. A rough repair to the previously ruled ashlar in the plaster can be seen as can the faint linear outline of the pediment to the western plaque.

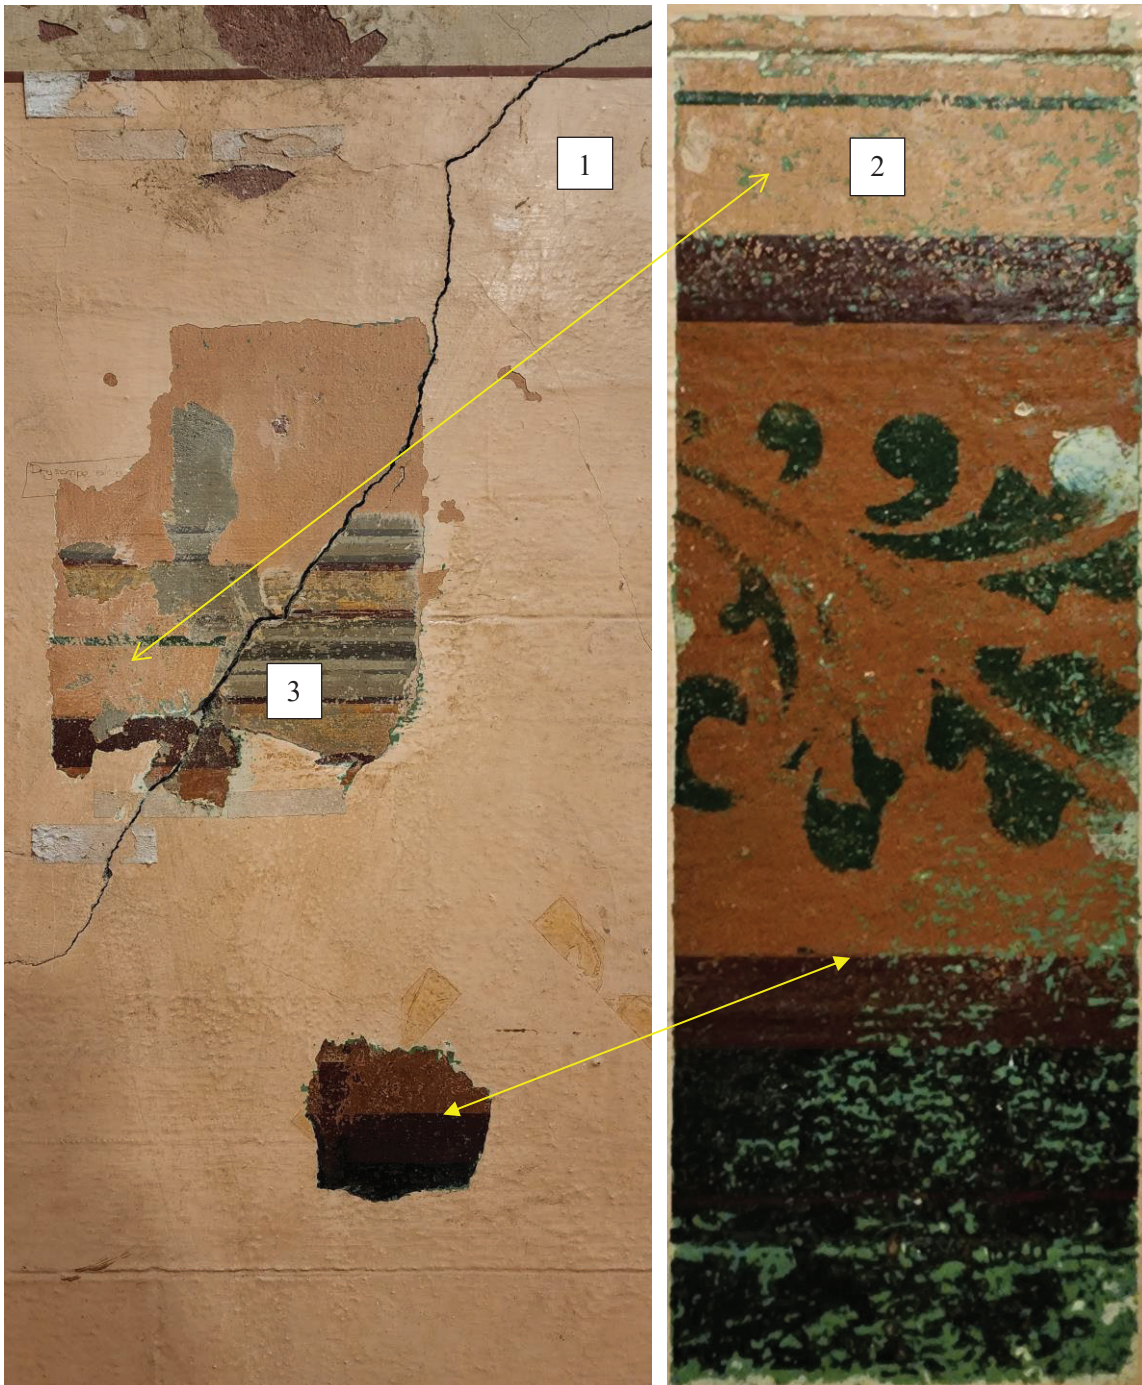
Figure 9 Two windows through the underlying paints at the level of the dado frieze (right) and just above (left). The schemes are numbered from the extant 1, to an intermediate scheme 2 and the final scheme 3 that corresponds with the inscription panels.

Figure 9 describes the scheme sequence at the dado frieze of the west wall. Immediately beneath the extant pink cream is a scheme consisting of a deep green dado surmounted by a foliate frieze, matching that currently visible on the east wall. A comparison of the corresponding parts of the stencil shows that the two match in general terms but with one or two alterations in the details. Most notably there is an absence in the west wall original of the extensive highlighting on the leaves seen on the east wall. It is noted that this east wall dado frieze has been run through many corridors at ground level in the 1990s. The variation may be either that the decorators who revealed the east wall foliage removed the highlights or that the east wall work is theirs and they have taken the pattern from another part of the building where this pattern has been applied. Beneath this scheme is that belonging to the

commemorative inscription panels. It is this scheme that is the most significant in this space as it is the only one containing the inscriptions.

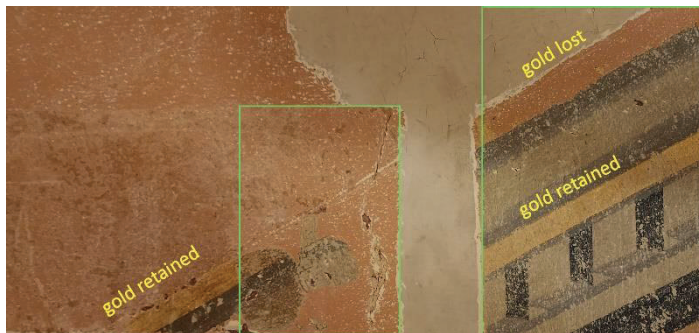
Removing paint to achieve the 1990s results would produce a severely compromised scheme requiring substantial reconstruction, as is evidenced on the east wall. Consequently, a great deal of effort has been applied to gold retention and after several unsuccessful methods a satisfactory result has finally been achieved.

Figure 12 Composite view of the 1990s paint removal efforts. It can be seen that where gold is retained well in some cases, it has been completely removed in others.

Figure 12 shows various views of the 1990s works showing variable results. In one case a gilt line has been completely removed while other areas have been scoured to an unacceptable degree. Early trials by the Artcare team struggled to improve on these results but after several solubility trials and applications of viable systems, a reasonable retention of the gold was achieved. This has been combined with development of an efficient application system with the method described in full.

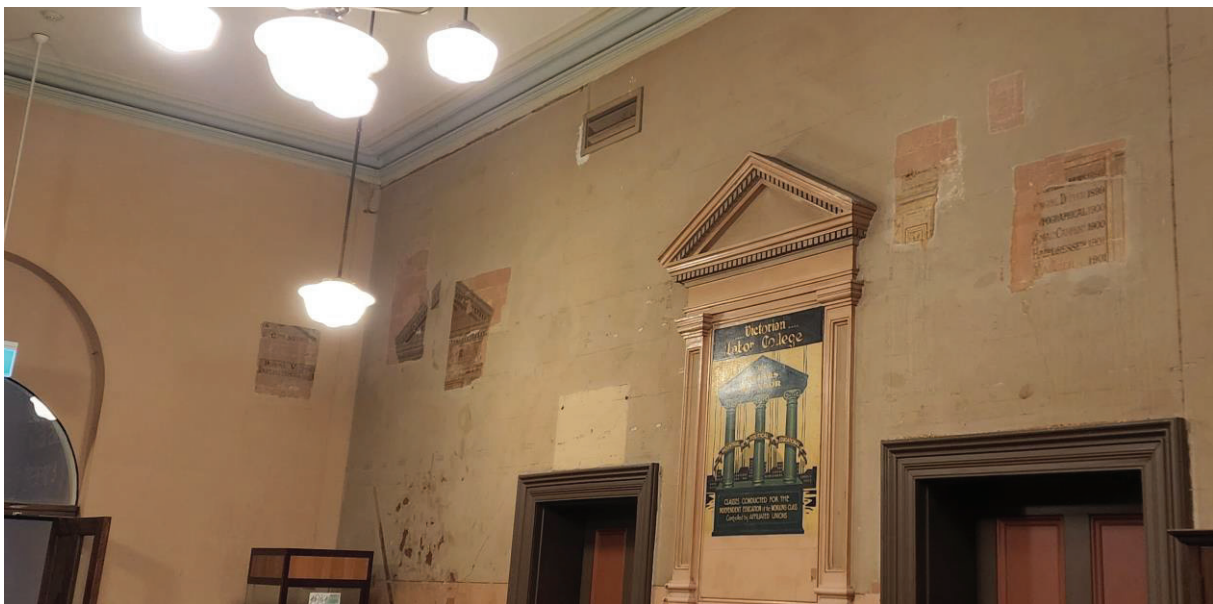
The results, particularly on the gold, have been impressive in terms of full retention without damage. This is not immediately obvious for the test areas, as much of these areas have been the subject of various prior less successful trials. The following areas have been exposed on the west wall, with the less successful results on the south wall pictured in figure 6. The less satisfactory results in the south wall are the result of insufficient time to adapt the west wall technique to the changed overpaint sequences. It is believed that further refinement will produce a satisfactory result on the south wall to match that of the west wall.

Figure 13 Overview of the paint removal trial areas on the south and west walls.

Step 1. Remove extant paint scheme consisting of two layers, one pale grey green and that below a stronger green. This is achieved by applying a poultice gel of 2 parts acetone and 1 part ethanol for 20-25 minutes or until the two paint layers are uniformly softened. An addition of 10% dichloromethane will be beneficial for softening more resistant areas, although the timing will need to be adjusted accordingly. Poultice dwell time aims to ensure that the two layers are softened uniformly such that the underlying second scheme pink layer is exposed intact with no gouging through to the original scheme and no undue residue of overpaint from the softened third scheme. Once softened with the solvent poultice the two outer layers are sliced with a dull #22 scalpel blade.
