**Arboricultural Impact Assessment**

**Tarilta Low-Level Crossing**

## Draft – Arboricultural Impact Assessment Tarilta Low-Level Crossing

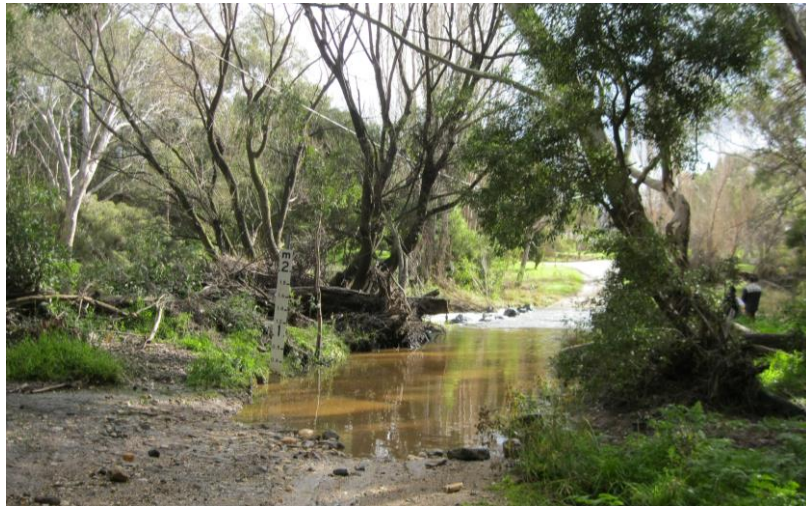
Figure 2. Trees located adjacent to the domestic zone.

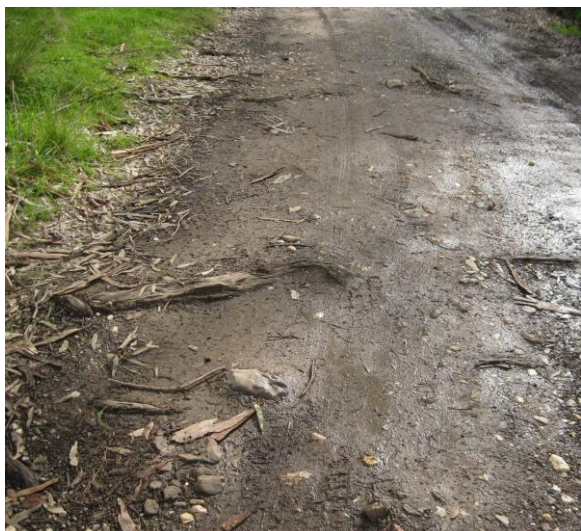
Multiple roots were observed to be located under the existing gravel leading to and from the existing Low–Level Crossing. Roots are expected to be located throughout this road corridor due to the size and proximity of surrounding vegetation. All works within the Tree Protection Zones (TPZs) of trees to be retained are to be completed sensitively and with roots remaining intact.

**Figure 3.** Large roots located under roadway

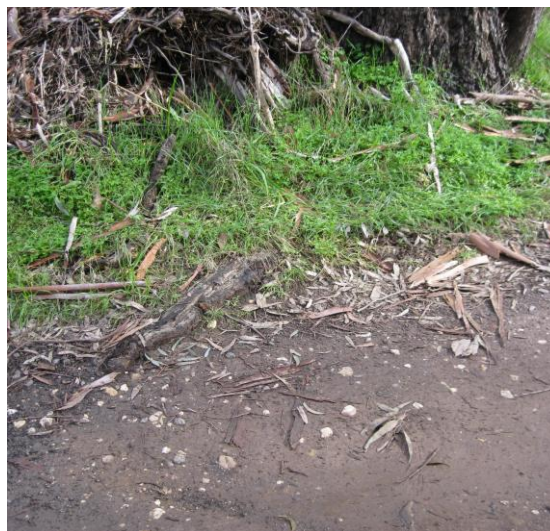
**Figure 4.** Large structural roots located under the existing roadway

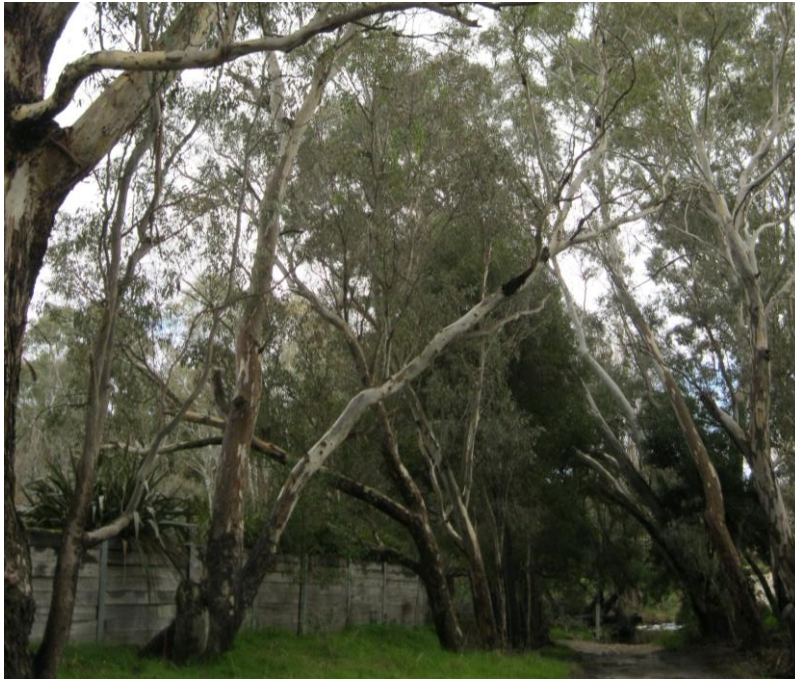
Six trees were assessed as having ‘Very High’ or ‘High’ retention value. These trees are all large, mature naturally occurring River Red Gums located along the southeastern entrance of the Low–Level Crossing. These trees have a high landscape contribution and are located within close proximity of the proposed road renewal.

**Figure 5.** Large River Red Gums with ‘Very High’ to ‘High’ retention values.

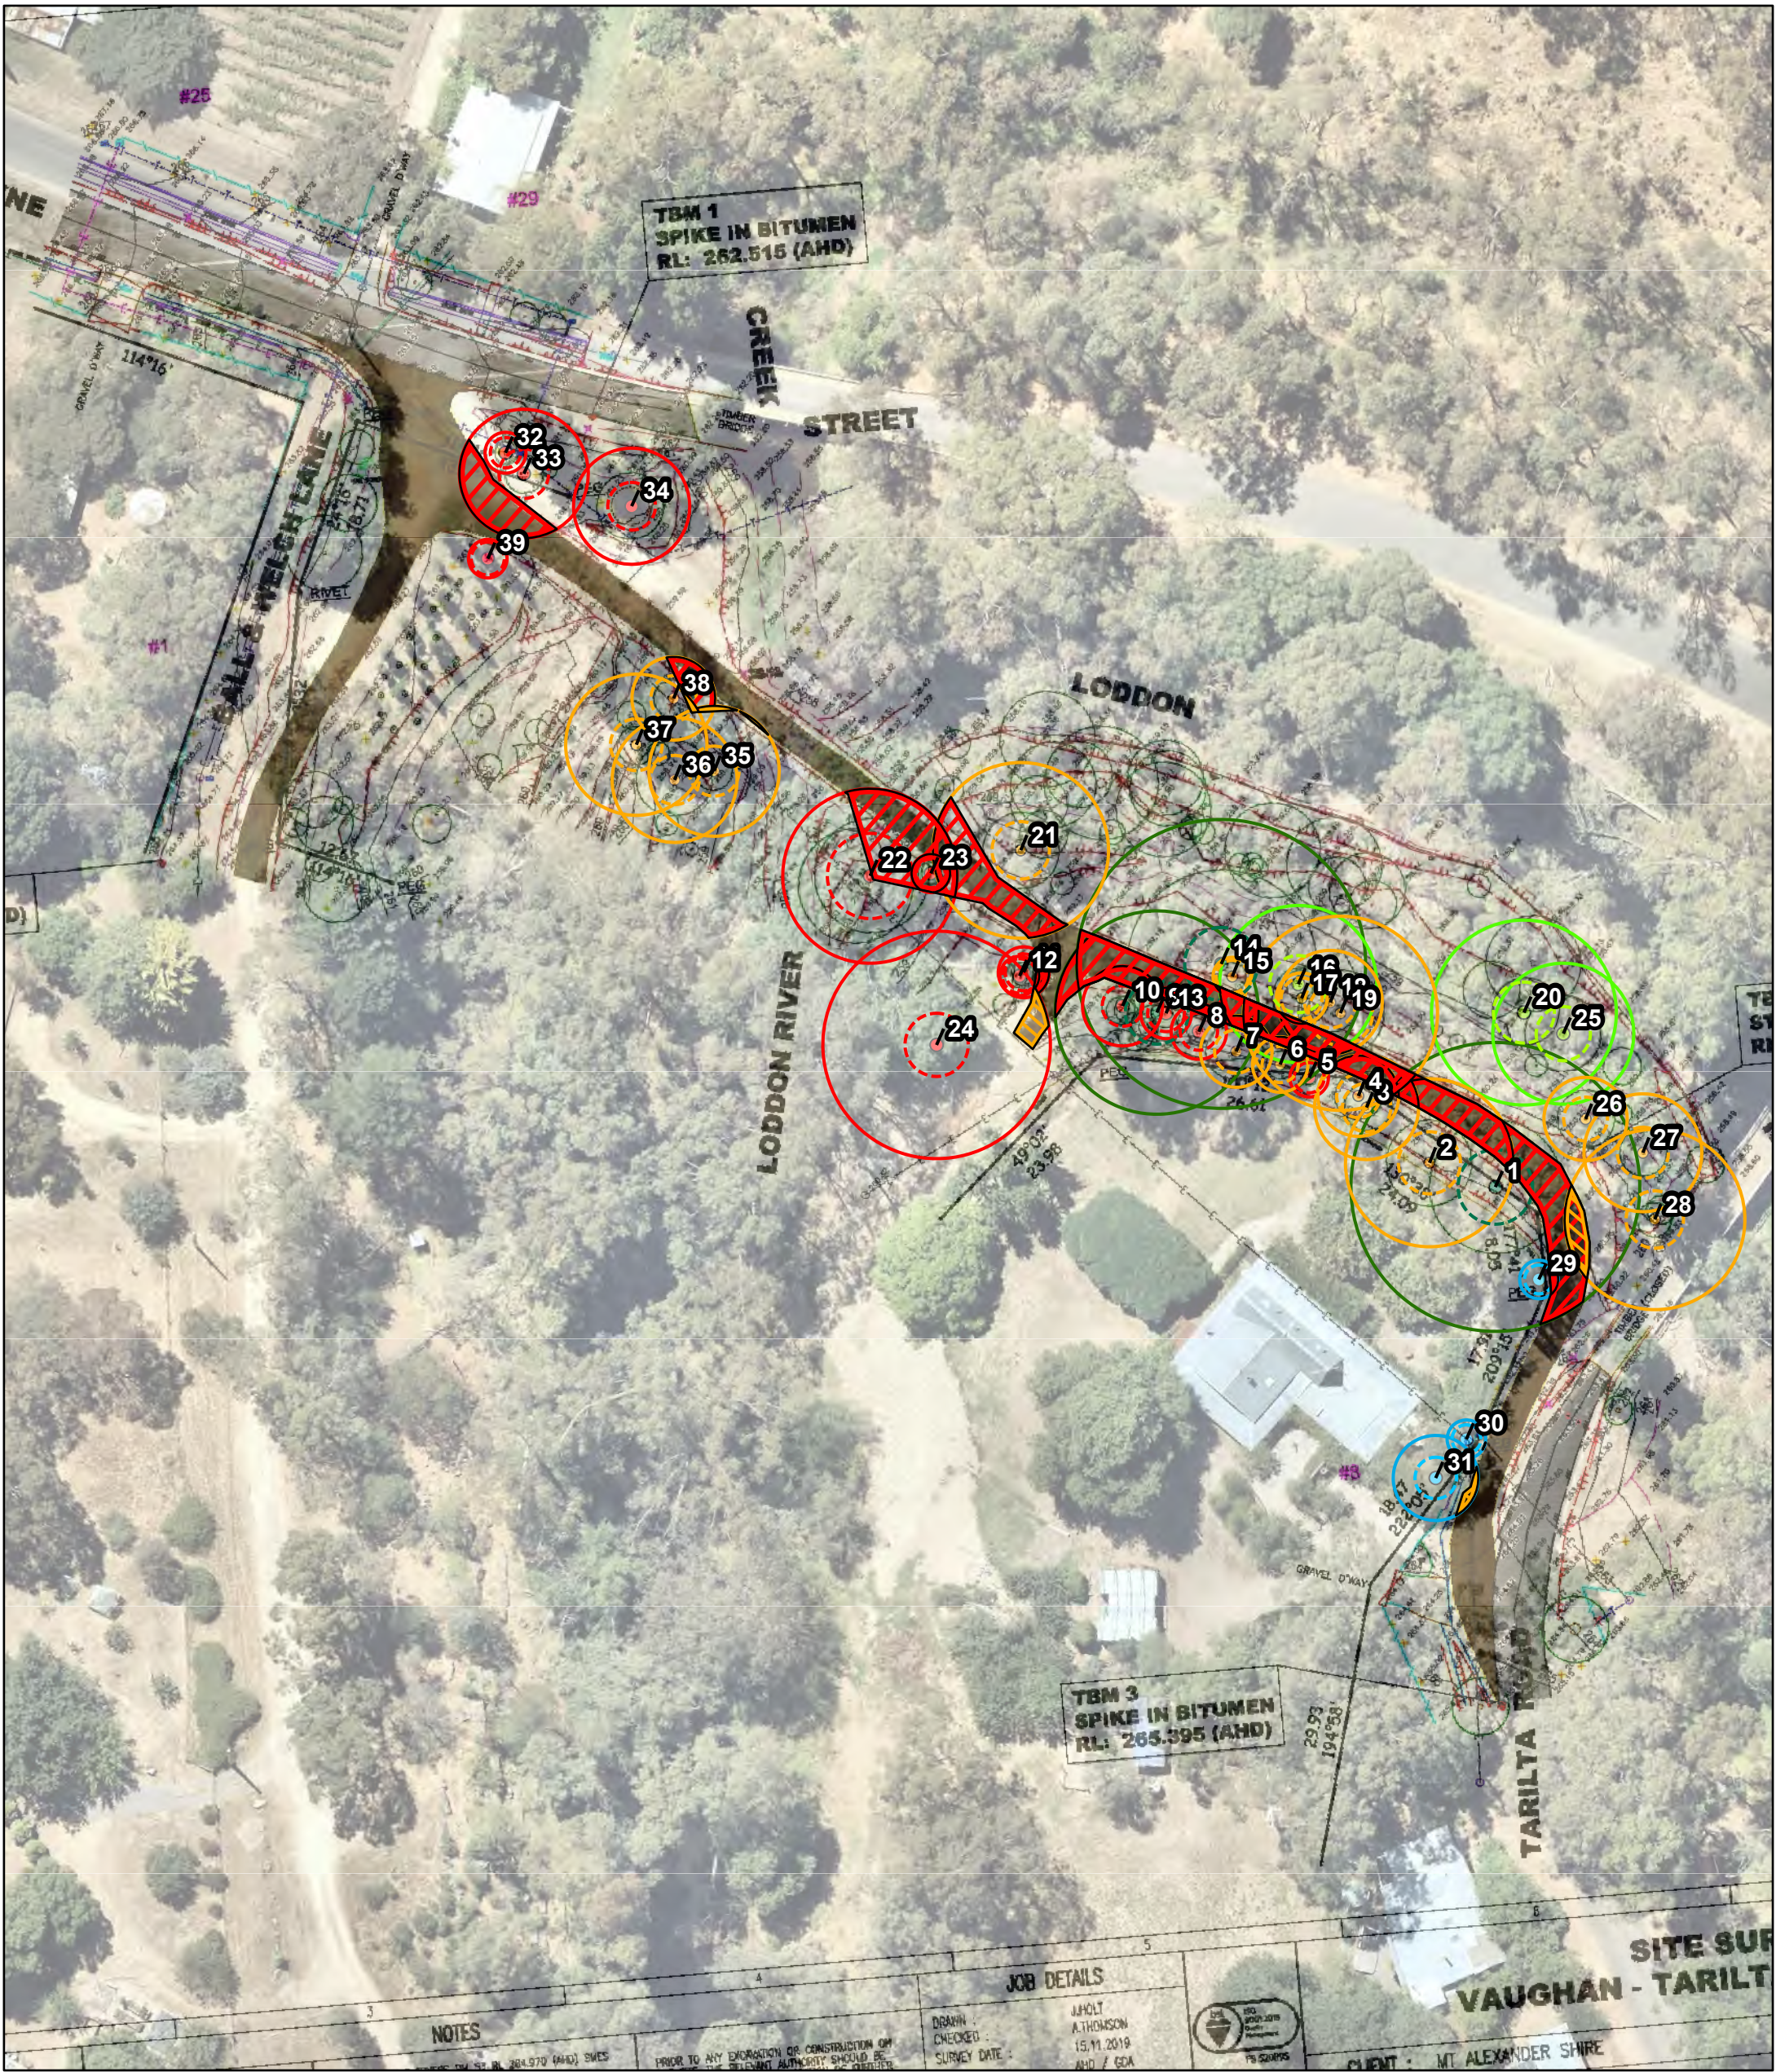
- 23 Trees incur a Major Encroachment (>10% TPZ and/or SRZ encroachment) from the proposed design;
  - Trees 22 and 23 are **not expected to tolerate** the proposed Low–Level Crossing redevelopment.

- Tree 22 is located within the existing waterway and is not expected to tolerate the proposed works due to extent of the bridge construction zone and required battering. Battering for bridge redevelopment is proposed within 1 metre of the trunk.

- Tree 23 is a small Acacia and is located within the footprint of proposed bridge redevelopment works. Tree 23 is of 'Low' retention value and is not worthy of a redesign to facilitate its retention.

- The remaining 21 trees with a Major Impact **are expected to tolerate** the proposed works. These trees are impacted by the proposed bridge upgrade and the associated road upgrades.

1. Any future road development works must be redesigned to show works within the footprint of the existing road and/or outside the TPZs of trees to be retained. Final road upgrade designs will need to be reviewed by the Project Arborist prior to the development commencing.

2. Tree 23 is to be removed prior to commencement of development works.
3. Although Tree 22 is not expected to remain viable through development works, it is recommended to be retained in the landscape as much as is feasible and without being immediately removed. Tree 22 is a large extending Weeping Willow that is expected to be adversely impacted by proposed Low–level Crossing redevelopment works. Even in a deteriorating state, this large specimen plays an important role in erosion control of the surrounding river bank and its complete removal would have an adverse impact on sediment downstream as well as displacement of other native vegetation within the riverbank. Allowing this specimen to naturally degrade is not expected to have an adverse impact and may provide habitat value for native fauna within the immediate area.

4. Standard tree protection measures are to be installed as outlined in the attached Tree Protection Plan (see Appendix 4).
  - a. Tree Protection Fencing (TPZ) is to be installed to protect all trees proposed for retention throughout development works.
