ARBORICULTURAL IMPACT ASSESSMENT

Lot 2, 30 Margaret Drive, Bacchus Marsh, Vic. 3340

28 October 2024

marg0424to_AIA.V3

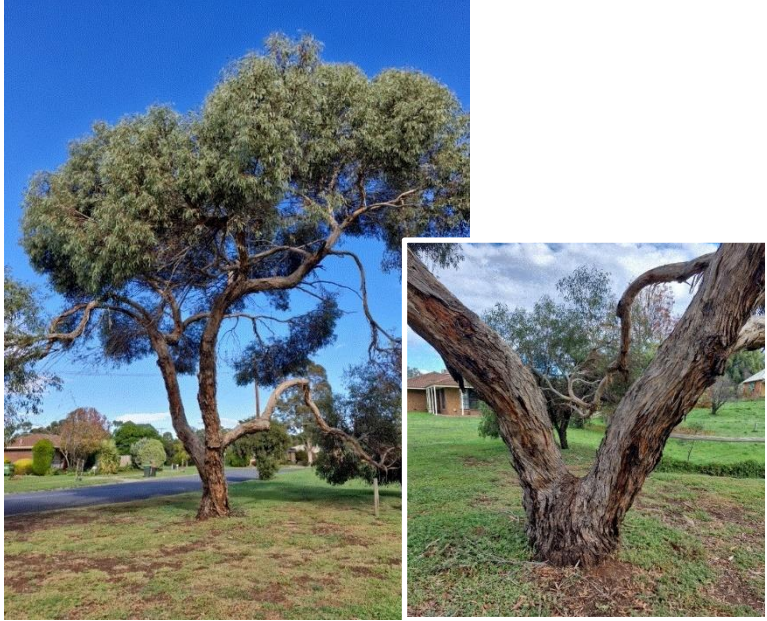
Tree #	1

Species	<i>Eucalyptus leucoxylon</i>	
Common name	Yellow Gum	
Type	Victorian native	
DBH (cm)	68	
Height (m)	14	
Spread (m)	12	
Structure	Good	
Health	Good	
Age	Mature	
Amenity value	High	
ULE (yrs)	15 > 40	
TPZ (m)	8.2	
SRZ (m)	3.1	
Notes	Street tree growing within the nature strip of Margaet Drive. Codominant stems from base, union appears sound. Minor deadwood.	
Impact assessment	Low. Proposed works are outside of the TPZ; however, may be impacted by construction related activities (see discussion).	
Recommendations	Erect fencing to protect from development related impacts (see site plan). Fencing should consist of chain wire mesh panels held in place with concrete feet, or similar, in accordance with AS 4970-2009 <i>Protection of trees on development sites</i> .	
Tree #	2

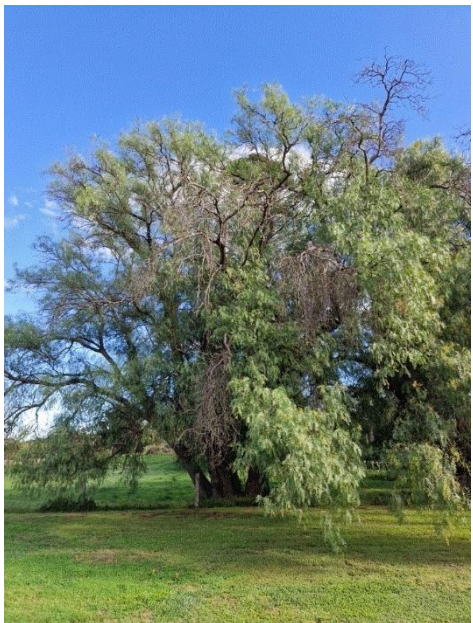
Species	<i>Schinus molle</i>	
Common name	Peppercorn Tree	
Type	Exotic	
DBH (cm)	110	
Height (m)	14	
Spread (m)	18	
Structure	Fair

Health	Fair	
Age	Mature	
Amenity value	High	
ULE (yrs)	15 > 40	
TPZ (m)	13.1	
SRZ (m)	3.8	
Notes	Growing within the neighbouring property to the west. 4 large stems from ground, potentially grown from cut stump. Areas of dieback throughout canopy. Major deadwood. Low canopy extends 10m into subject site.	
Impact assessment	Proposed driveway and garage footprint will result in a major 12.8% TPZ encroachment. Root disturbance as a result of these low impact works is expected to be minimal (see discussion). Some canopy pruning will be required to achieve clearance over the carport. The current condition (signs of stress) indicates the tree will be more susceptible to adverse impacts as a result of root disturbance or canopy loss.	
Recommendations	Pruning should be done by a qualified arborist in accordance with 4373-2007 <i>Pruning of amenity trees</i> . Gravel driveway/carport surface should be constructed on-grade within the TPZ using minimal compaction.

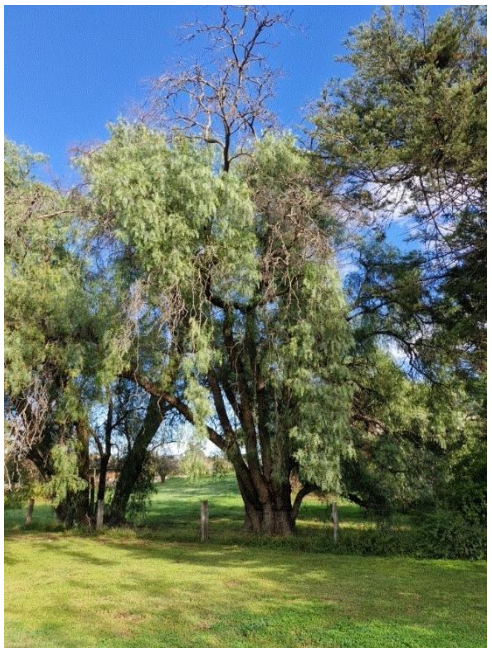
Tree #	3

Species	<i>Schinus molle</i>	
Common name	Peppercorn Tree	
Type	Exotic	
DBH (cm)	130	
Height (m)	12	
Spread (m)	16	
Structure	Fair	
Health	Fair	
Age	Mature	
Amenity value	High	
ULE (yrs)	15 > 40	
TPZ (m)	15.0	
SRZ (m)	3.9	
Notes	Growing within the neighbouring property to the west. 9 stems from ~1.5m, potentially from point of previous lopping. Areas of dieback throughout canopy. Major deadwood. 2 large low stems over subject site. Low canopy extends 10m into subject site.	
Impact assessment	Low. Proposed driveway and garage footprint will result in a minor 5.9% TPZ encroachment. Root disturbance as a result of these low impact works is expected to be minimal. Some canopy pruning will be required to achieve clearance over the carport. The current condition (signs of stress) indicates the tree will be more susceptible to adverse impacts as a result of root disturbance or canopy loss.	
Recommendations	As per Tree 2.

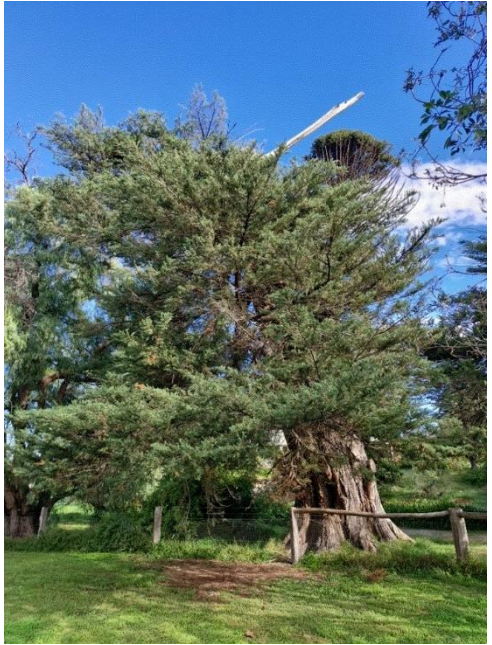
Tree #	4

Species	<i>Cupressus macrocarpa</i>	
Common name	Monterey Cypress	
Type	Exotic	
DBH (cm)	200	
Height (m)	12	
Spread (m)	6	
Structure	Poor	
Health	Fair	
Age	Senescent	
Amenity value	Medium	
ULE (yrs)	< 5	
TPZ (m)	15.0	
SRZ (m)	4.8	
Notes	Growing within the neighbouring property to the west. Remnants of a much larger tree comprised of 1 large stem, cut to 10-12m, and several live branches. Leaning over subject site. Extensive decay throughout lower trunk, with large split forming. Low canopy 7.5m into site. The calculated TPZ is likely to be excessive for the small live crown of this tree.	
Impact assessment	Low. Proposed works are outside of the TPZ; however, may be impacted by construction related activities (see discussion).	
Recommendations	Erect fencing to protect from development related.

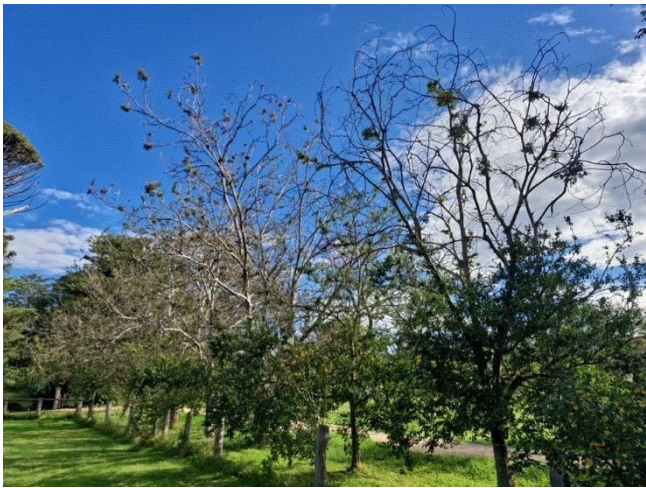
Tree #	5 (group of 7)

Species	<i>Ulmus parvifolia</i>	
Common name	Chinese Elm	
Type	Exotic	
DBH (cm)	30	
Height (m)	9	
Spread (m)	5	
Structure	Fair / good	
Health	Poor	
Age	Juvenile / semi-mature	
Amenity value	Medium	
ULE (yrs)	5 > 15	
TPZ (m)	3.6	
SRZ (m)	2.1	
Notes	7 trees in a row growing within the neighbouring property to the north. Extensive long-term canopy damage from possum browsing. Low canopies extend ~4m into subject site.	
Impact assessment	Low proposed works are outside of the TPZs

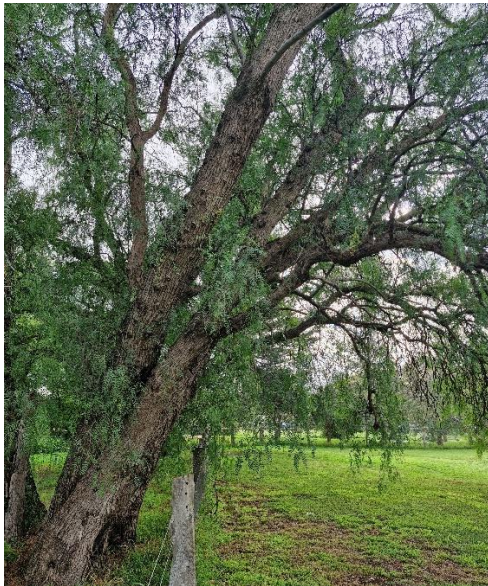
The canopies of Trees 2 and 3 extend 10.5m into the site, are low to the ground, and include large structural limbs.

Plate 2 - Large limbs (Tree 2) over the western boundary.

At ~6.3m from the boundary, the proposed carport will require some canopy pruning to both Tree 2 and 3 to achieve adequate clearance from the structure. This will not require the removal of any significant limbs and the canopy loss is expected to be within the tolerances of both trees.

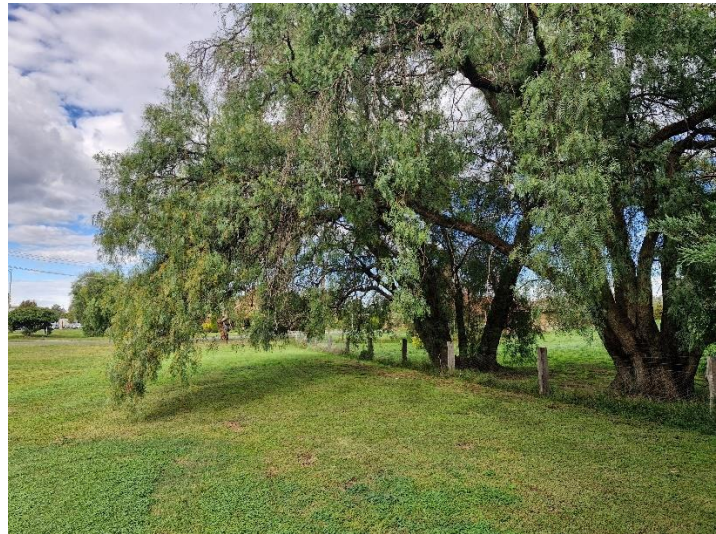
Plate 3 - Low canopies extending 10.5m into the subject site.

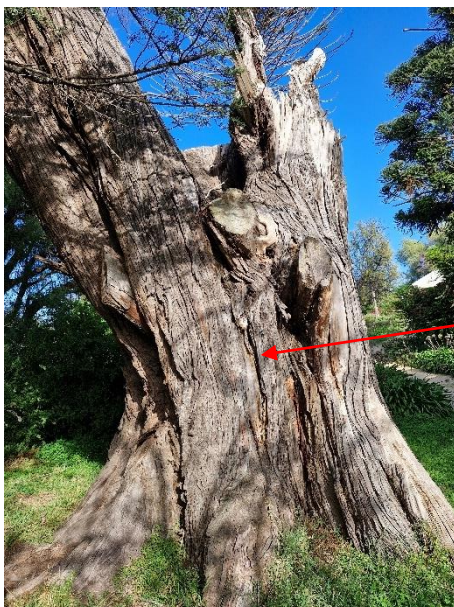
This tree displays structural defects that indicate an increased likelihood of failure. A large crack is evident within the lower decayed section of the trunk.

Plate 4 - Lower trunk with stem leaning towards subject site.

The remaining stem (cut to about 10-12m) has a lean and wight bias, a failure in the lower trunk would result in the stem falling into the subject site.

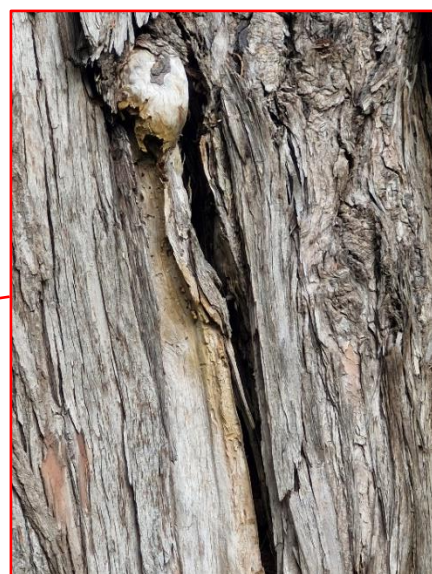
Plate 5 - Large crack in lower trunk, visible on both sides of tree.
