DEFECT 20: MORTAR LOSS ON THREE LAYERS OF BRICKS ABOVE WEST WATERWAY INVERT PROTECTION

DEFECT 21: LONGITUDINAL CRACK AT MIDSPAN OF THE BRIDGE ACROSS ENTIRE LENGTH

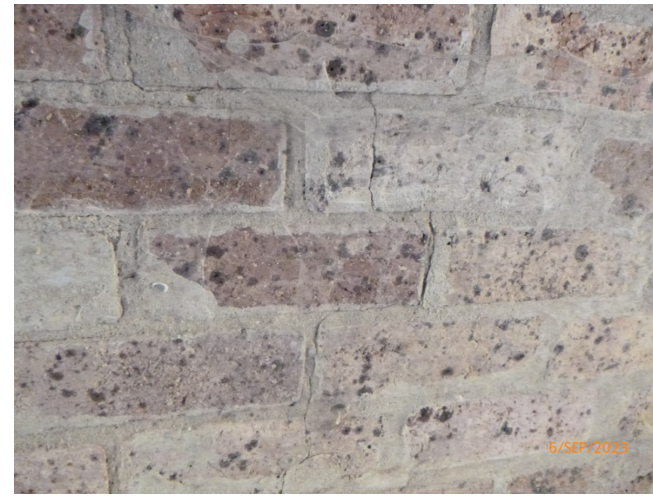
DEFECT 22: LONGITUDINAL CRACK FROM SOUTH ELEVATION ON WESTERN FACE OF ARCH

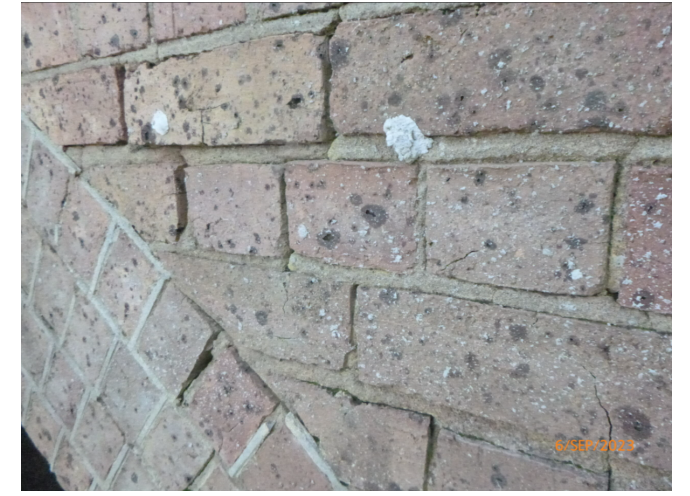
DEFECT 23: MORTAR LOSS BELOW WEST PARAPET ON SOUTH FACE OF RCH BRIDGE

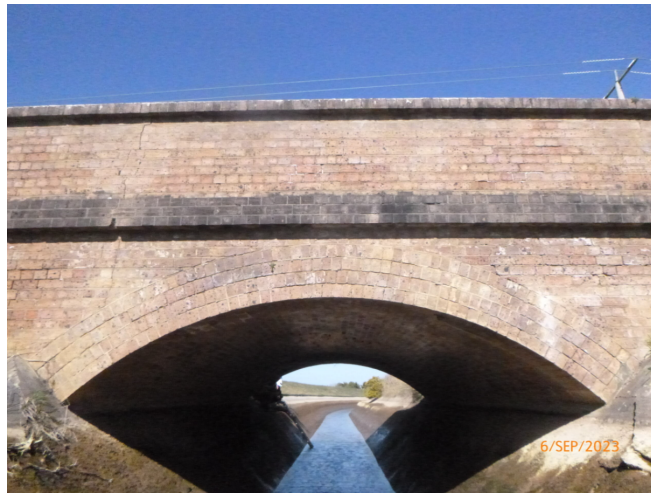
DEFECT 24: FULL VERTICAL CRACK ON THE NORTHERN SPANDREL WALL TOWARDS EAST ABUTMENT

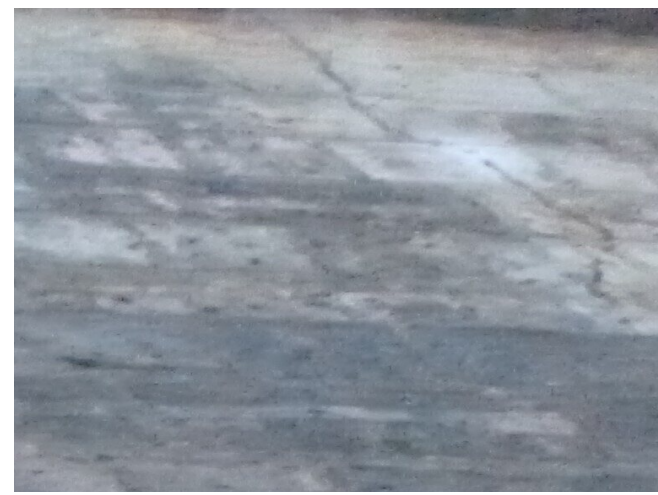
DEFECT 25: FULL VERTICAL CRACK ON THE SOUTHERN SPANDREL WALL TOWARDS EAST ABUTMENT

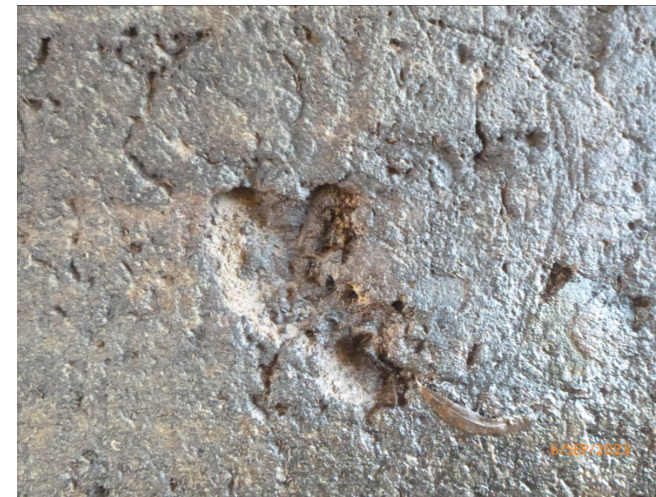
DEFECT 26: SPALLING OF CONCRETE ON EAST FACE WATERWAY INVERT PROTECTION

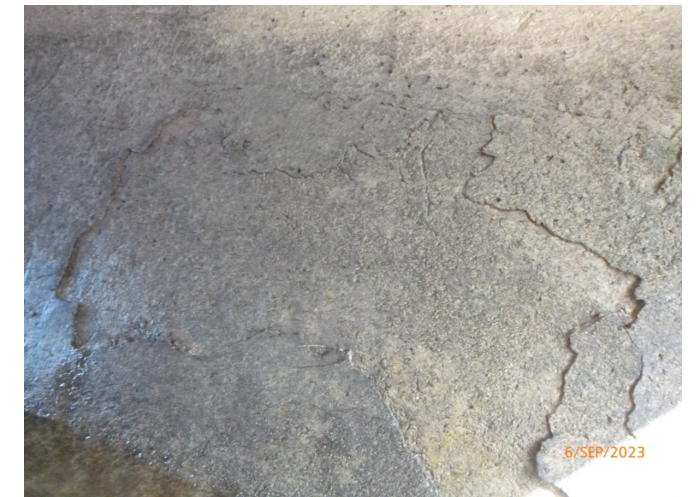
DEFECT 26: SPALLING OF CONCRETE 1300MM X 500MM ON WEST FACE WATERWAY INVERT PROTECTION

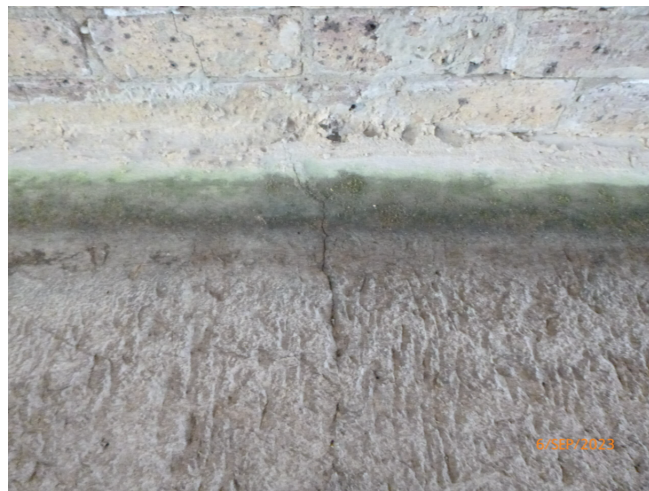
DEFECT 27: VERTICAL CRACK NOTED ON EAST FACE OF AQUEDUCT AT MIDSPAN

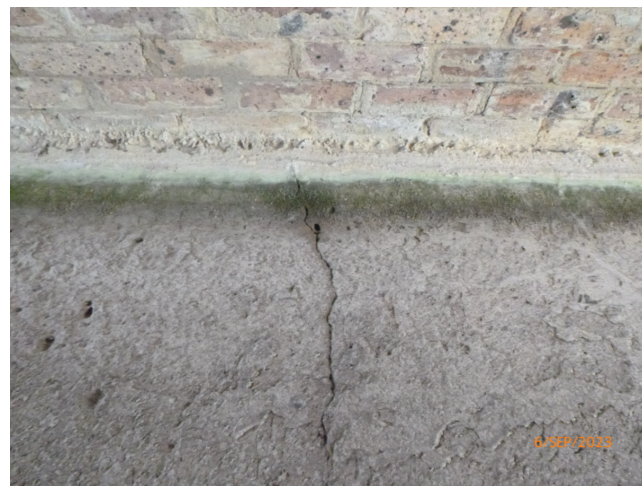
DEFECT 27: VERTICAL CRACK NOTED ON WEST FACE OF AQUEDUCT AT MIDSPAN
