Technical Memorandum

Project name	Bluestone Retaining Wall Protection	Date	11 October 2024
Document ID	S#233622-PRJ1301475-GEO-MEM-01	Revision	1
Client	Maribyrnong City Council	Pages	9
Site Address	47a Moreland Street, Footscray VIC 3011	Prepared by	Nigel Wan
Purpose	Develop a methodology to protect heritage wall	Reviewed by	Scott Emmett

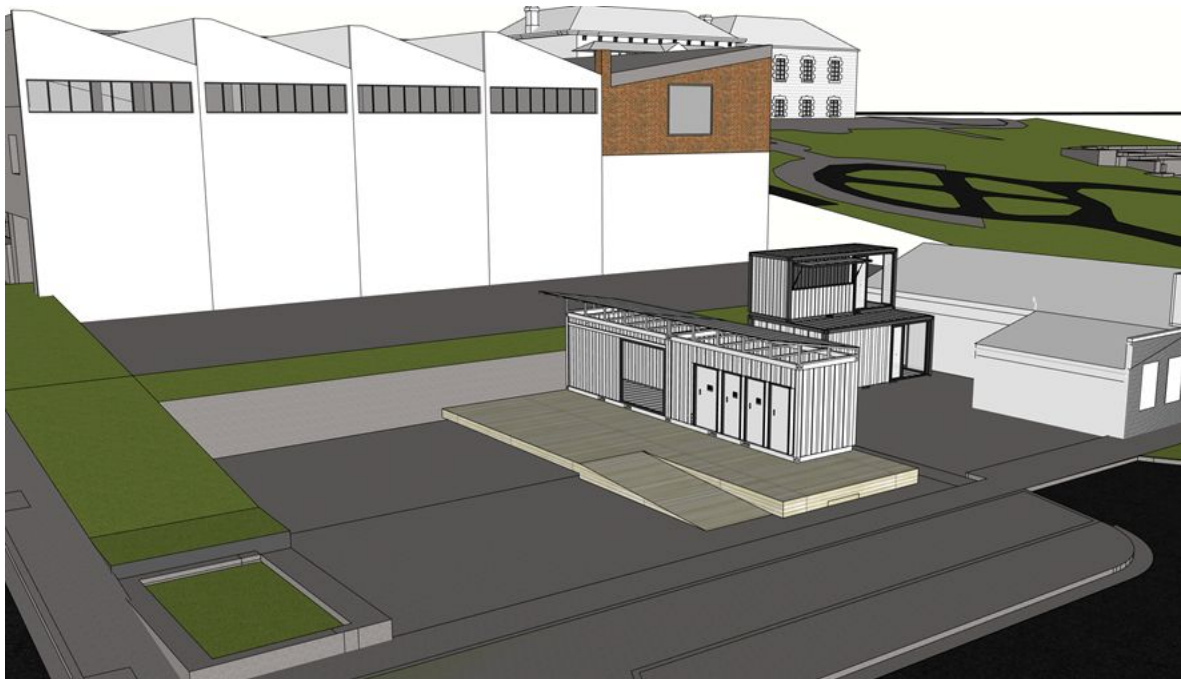
The proposed project is a retrofitted shipping container (see Figure 1) into a public toilet which will be placed on a raised deck perpendicular to the street front of Maribyrnong Street. There is an existing heritage listed bluestone retaining wall at the rear of the site, currently covered by building rubble. Heritage Victoria has requested a methodology for the protection of the bluestone retaining wall during the site clearing works for a planning permit to be issued.

Figure 1: Concept design of the proposed project

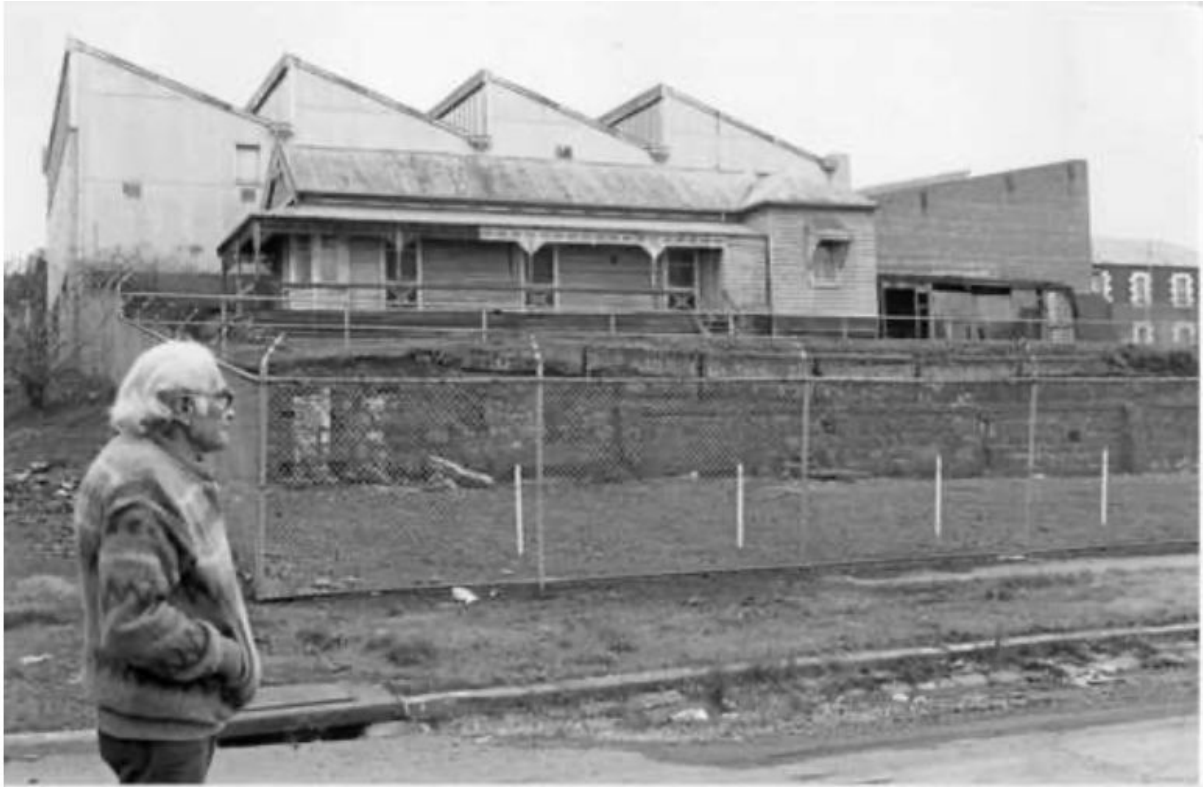
Figure 2: Excerpt from Biosis Report : Demolished Ship Inn, Maribyrnong Street 1980 (Footscray Historical Society) note the surviving rear bluestone retaining wall

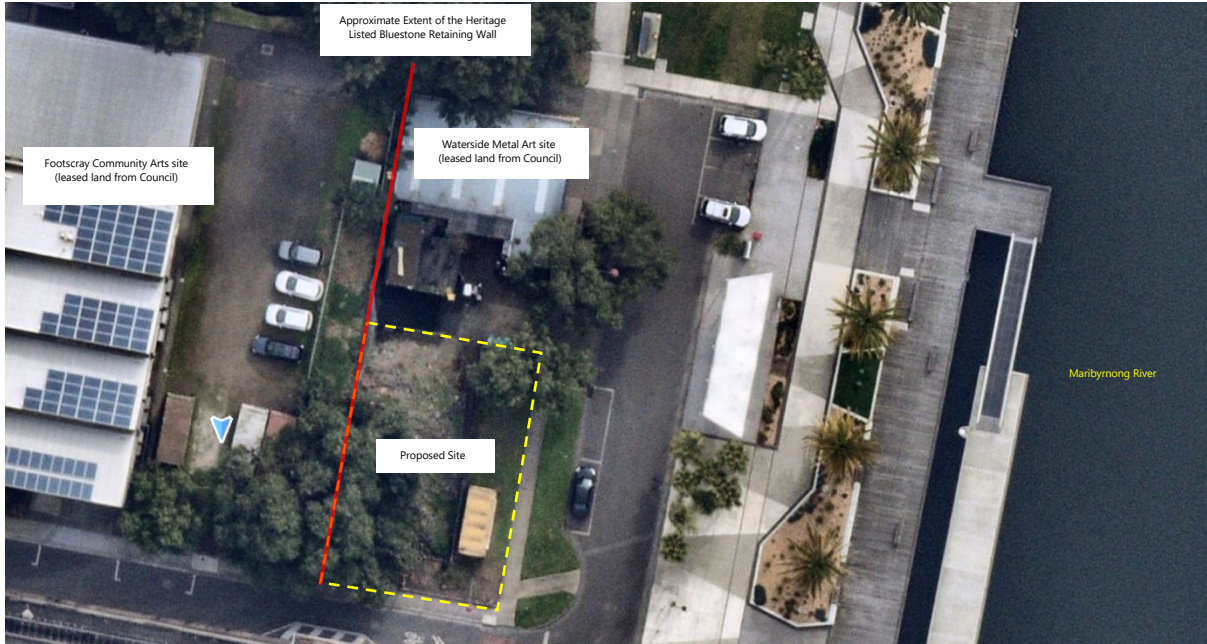
Figure 3: Nearmap Extract August 4, 2024 showing current site features with notation

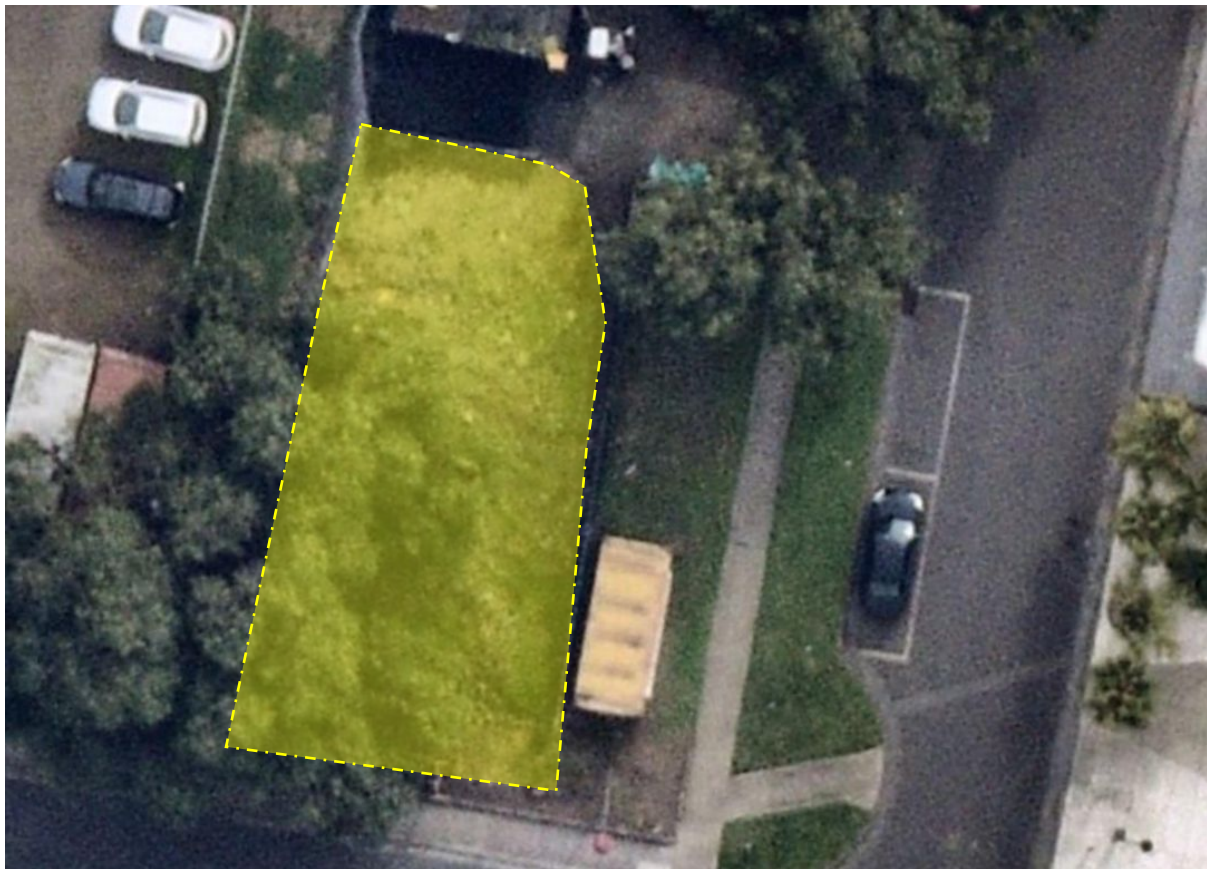
Figure 4: Nearmap Extract August 4, 2024 showing location of the fill rubble

The fill rubble is approximately 3.0m high at its peak. It appears to be comprised of a mixture of bluestone blocks, soil and rock fill, and potential contaminated including asbestos containing material (ACM). The bluestone retaining wall is completely covered by the fill rubble at the proposed site.

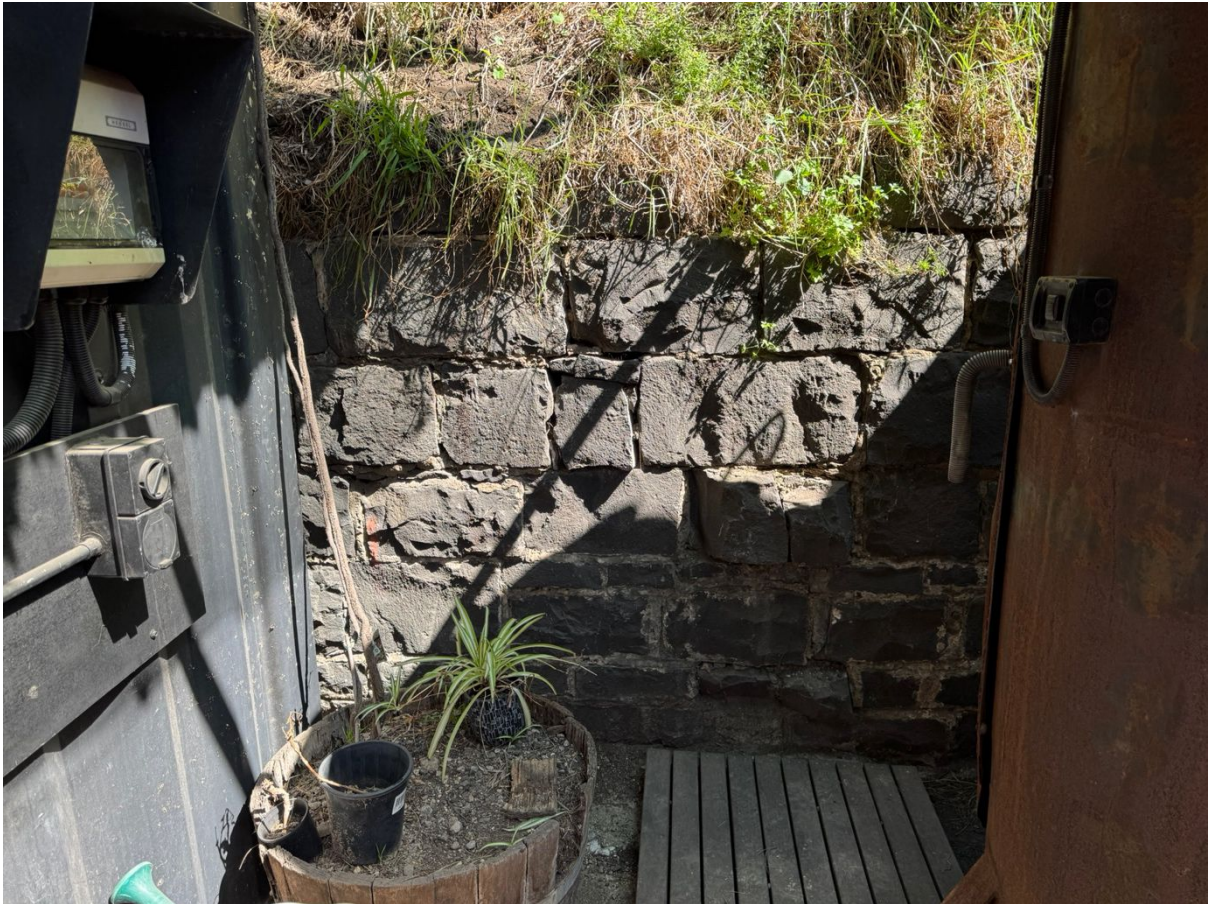
The heritage listed bluestone retaining wall appeared to be in good condition and is approximately 1.7 to 1.8m high. The bluestone blocks are each approximately 200 to 280mm thick.

Figure 5: Photograph of the exposed bluestone retaining wall within the Waterside Metal Art site

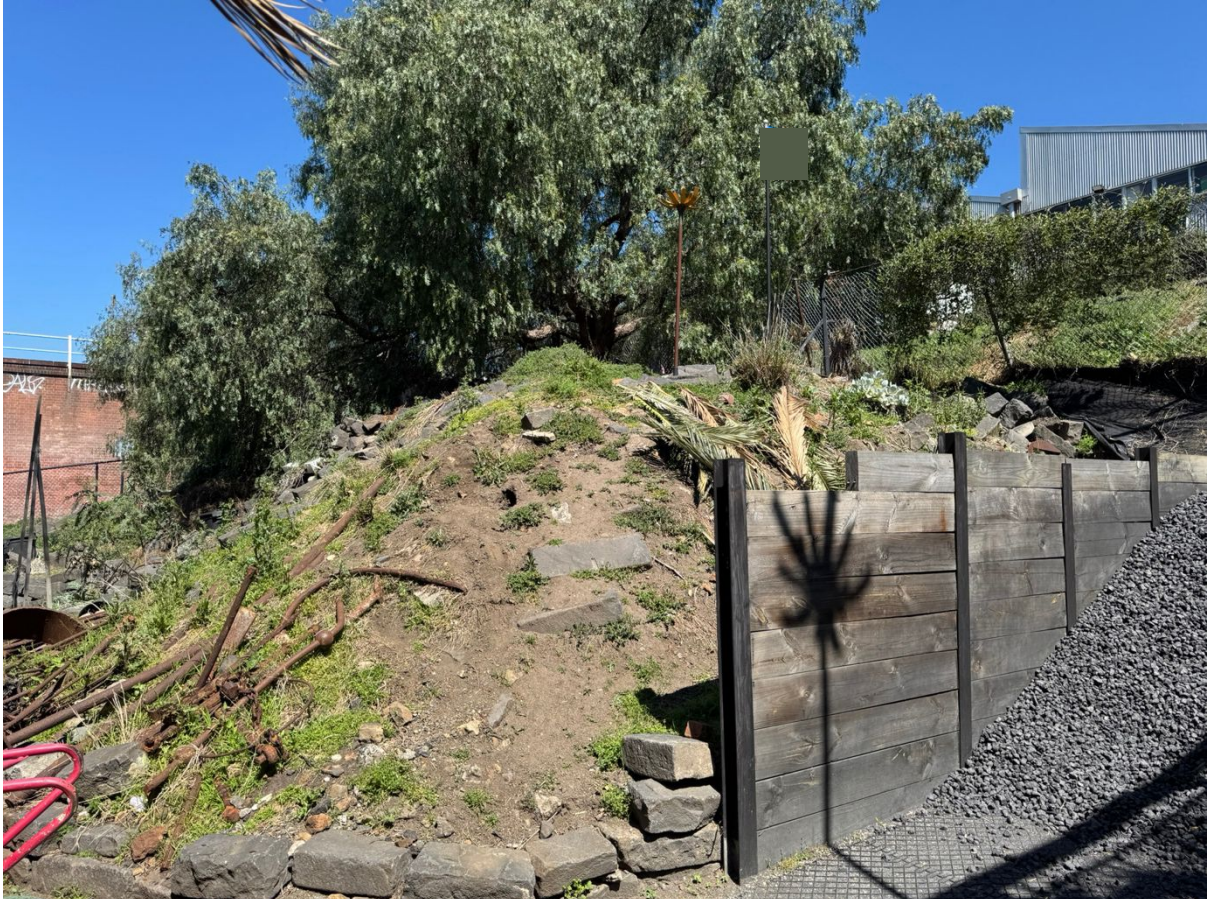
A large peppercorn tree was also observed at the south-western corner of the site abutting the bluestone wall causing (possible) localised damage to the wall.

Figure 6: Photograph of the fill and rubble, and large peppercorn tree (view from Waterside Metal Art site)

The localised area around the peppercorn tree should be assessed by a suitably qualified arborist and the extent of damage should be reviewed upon removal of the fill rubble stockpile surrounding the area for further advice at this stage.

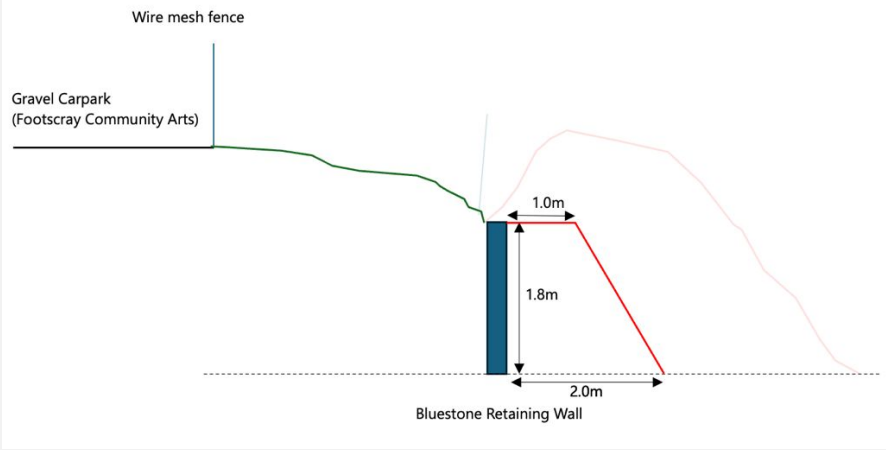
Step	Works Description
1	Removal of damaged and leaning wire mesh fence
2	Removal of fill and rubble to the top of retaining wall to create a level working platform
3	<p>Balance of the fill and rubble 2m away from the retaining wall can be removed if preferred</p>

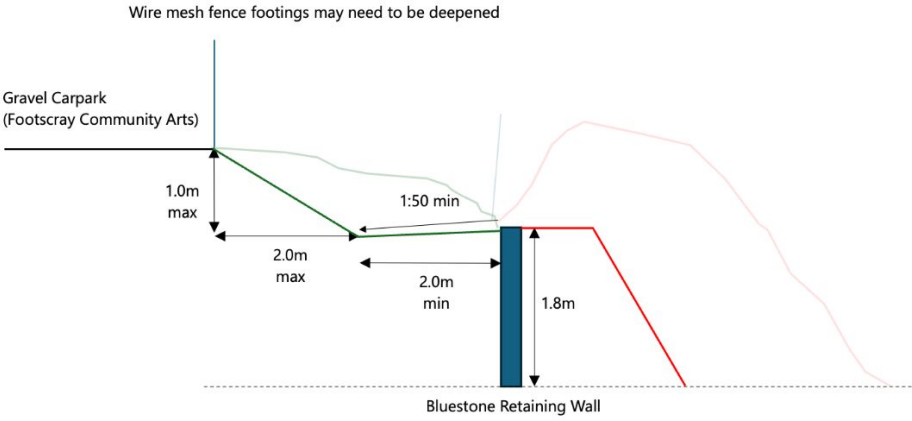
4	<p>Use a long reach excavator to re-profile the landscaping above the retaining wall to remove surcharge material with minimum dimensions as shown below</p>
