HERITAGE IMPACT STATEMENT

CULLYMONT | 4 SELWYN STREET | CANTERBURY

Final Report – 28 November 2024

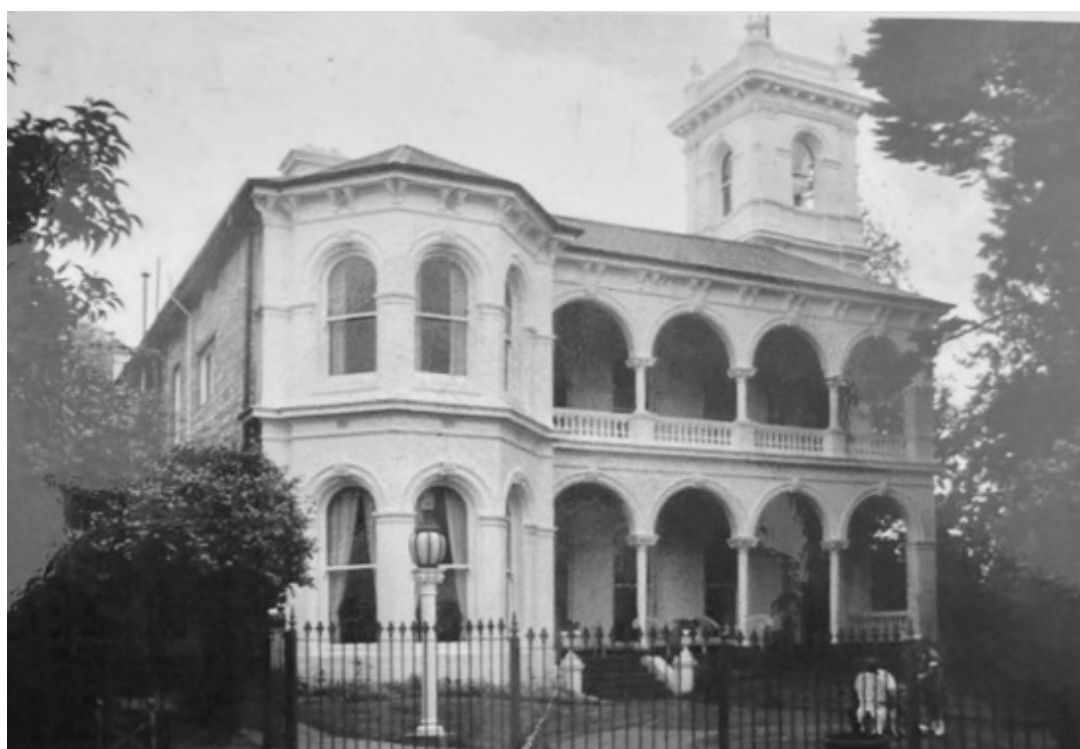
Figure 4 Cullymont – Subject Property c1980s - Looking south [south-west]. Pool and pool fence is visible in the foreground. Source: Canterbury Historical Group

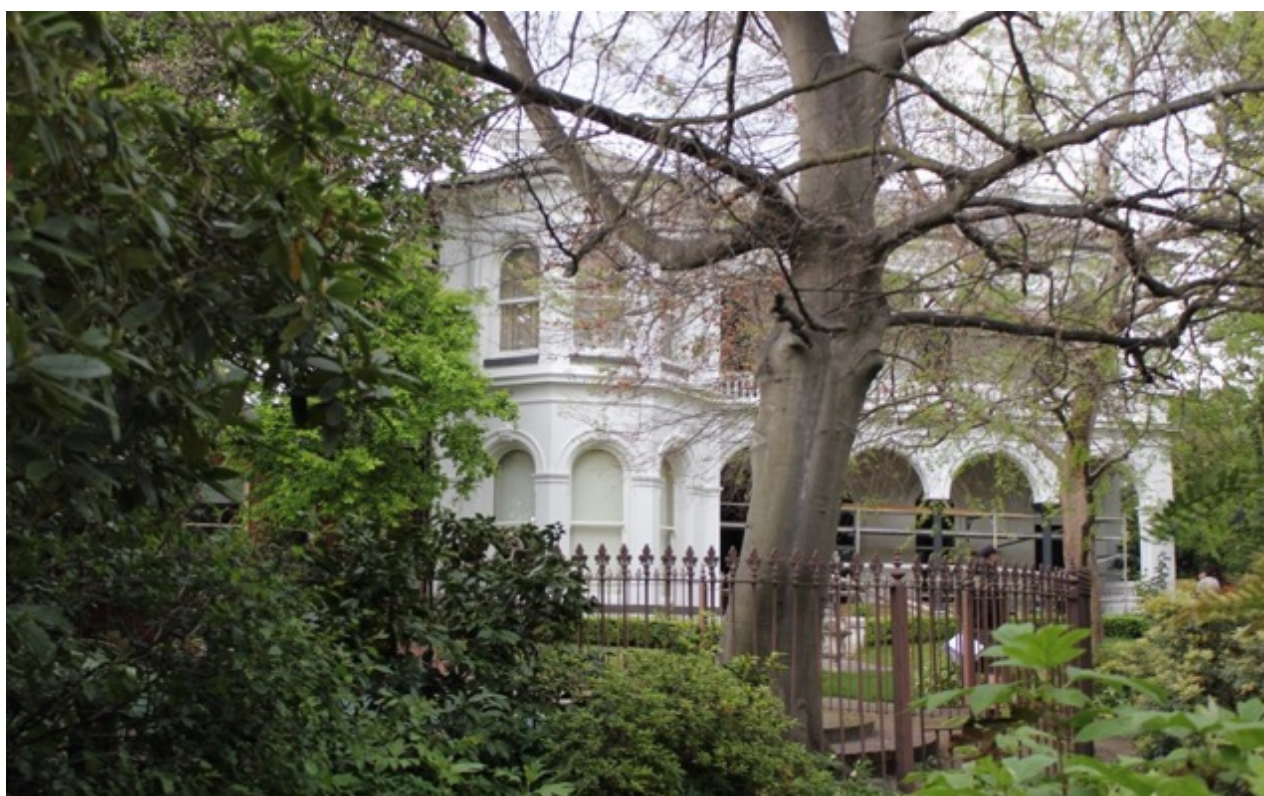
Figure 6 Cullymont as viewed within the garden – looking south [south-west]. The addition [c1980s] is just visible. [left – refer yellow window sash] - The extant *Fagus sylvatica* [Copper Beech] is visible within the pool fence-line. The *Ulmus parvifolia* [Chinese Elm] planted by The Patrick Family mid-1990s is visible beyond to the right. Source: LO + Co 2024

The non-original bayed addition built during the 1980s to the north of the ancillary wing remains [Figure 6].

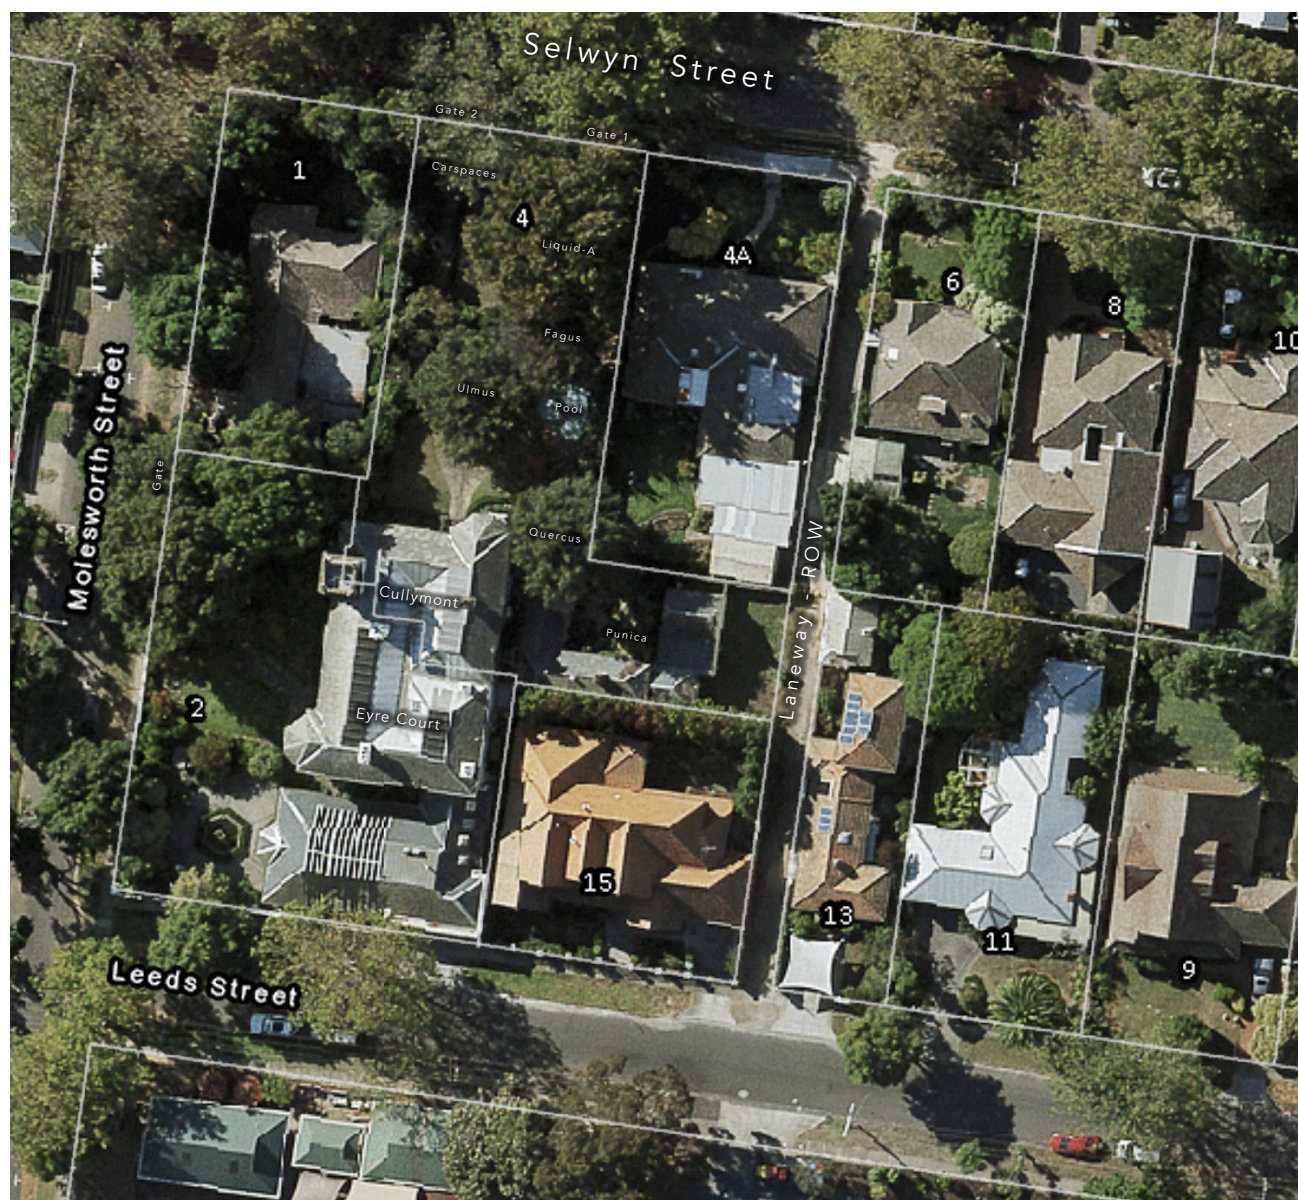
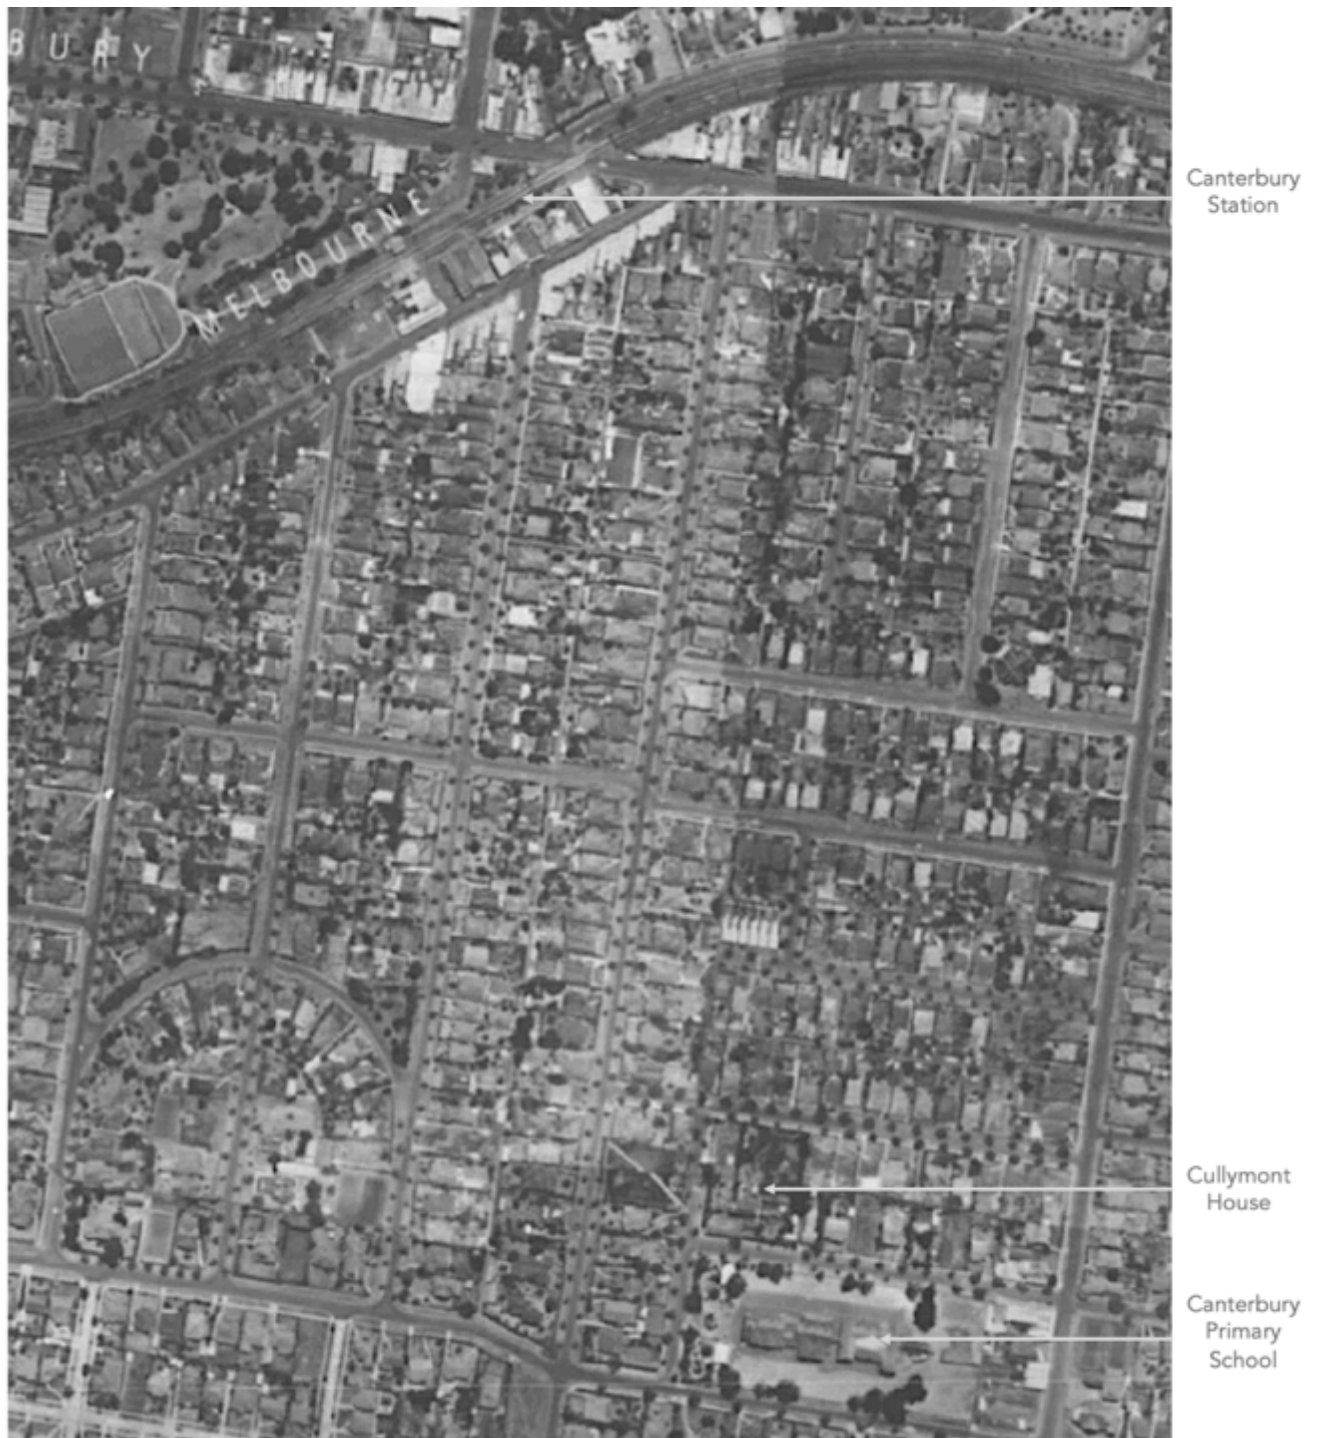
Figure 8 Aerial Map Canterbury c1945 Refer Cullymont [Subject Property] identified via arrow. Notable landscape elements to Cullymont include lawn areas to the Cullymont garden/front-yard, a path that commences at the verandah steps continues to the gateway [Gate 1], a focal feature fountain/sculpture located to the north of the house and what appears to be a parking bay to the north west corner of the yard, tree plantings are evident to the centre-north of the front garden which continues to the easyt laneway at that time.

Refer Figure 7 + Figure 8 – c2024 aerial image and c1945 image.

Notable elements to Cullymont include lawn areas to the Cullymont garden/front-yard, a path that commences at the verandah steps continues to the gateway fronting Selwyn Street [Gate 1], a focal feature fountain/sculpture located to the north of the house [within the lawn area] and what appears to be a parking bay to the north-west corner of the yard, tree plantings are evident to the centre-north of the front garden which continues to the east laneway at that time.

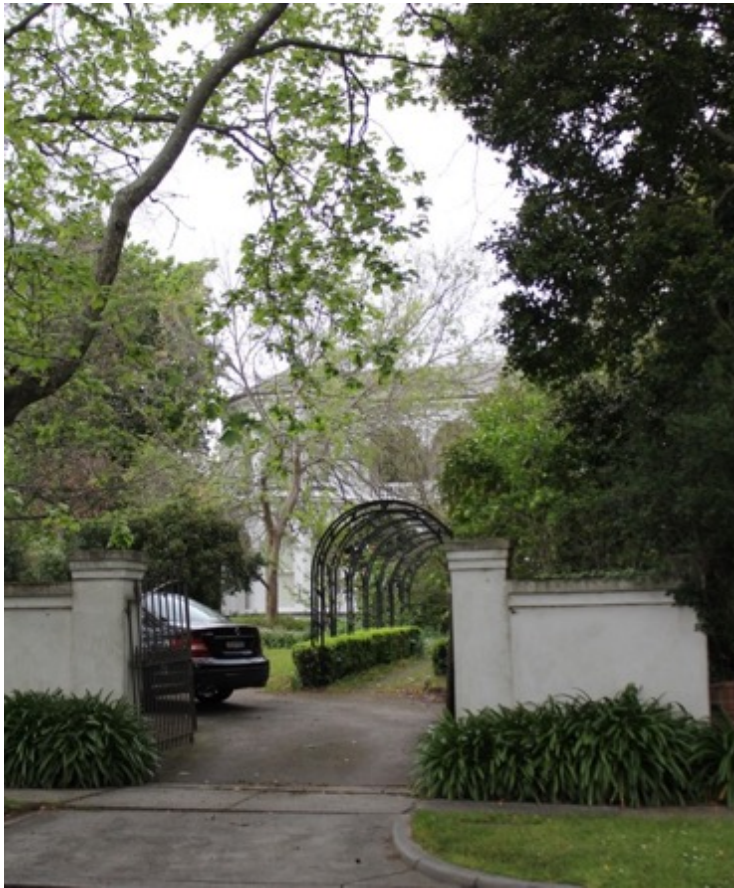
Figure 9 Cullymont – Subject Property
Vehicle Gate Entry – Gateway 2 - Looking south [left]
Arbour visible beyond

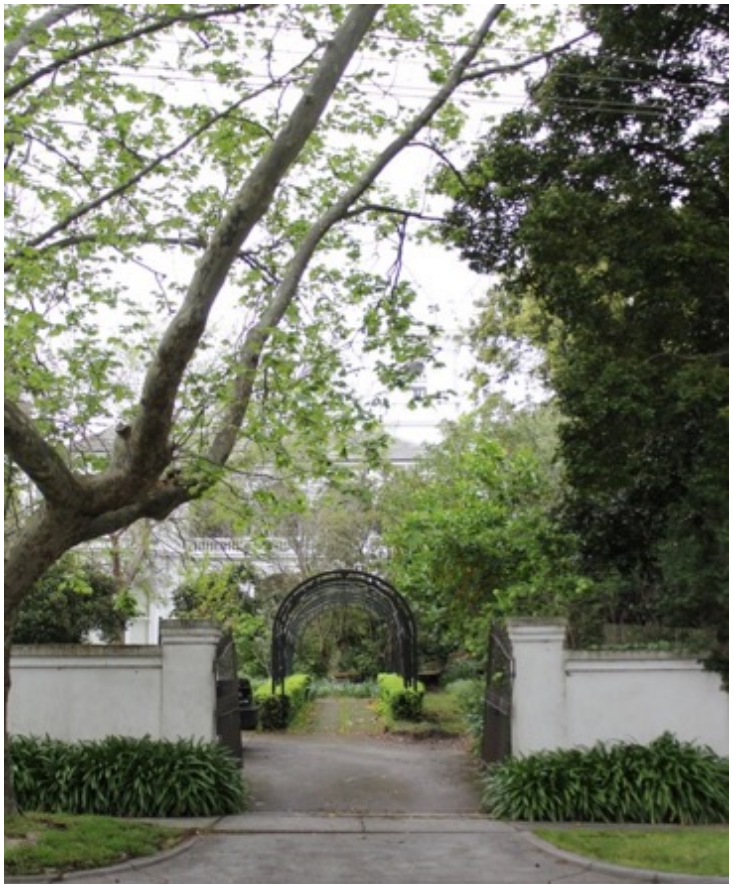
Figure 11 Cullymont – Subject Property
Arbour – Looking south [below]

- Remounting of the existing c1990s steel arbour. This will involve a slight shifting of the element to the east to allow the arbour axis to be aligned better with the arches to the Cullymont House verandah.

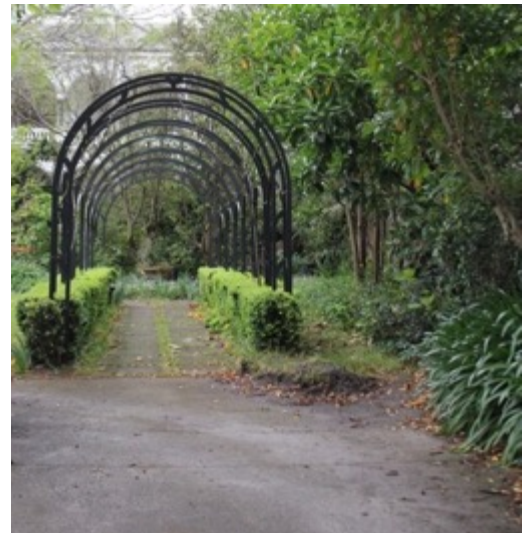
Figure 10 Cullymont – Subject Property
Vehicle Gate Entry – Gateway 2 - Looking south [left]
Cullymont House visible beyond

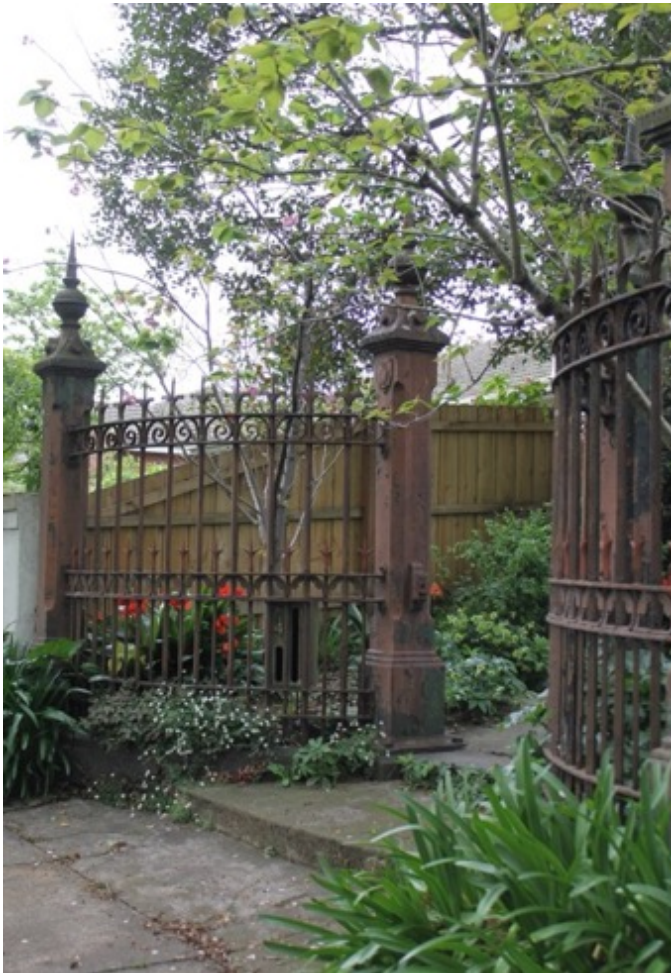
Figure 12 Cullymont – Subject Property
Gate Entry – Gateway 1 – Palisade gate + fencing
[cast-iron + wrought-iron] - Looking east [north-east] [left]

- The whole of Gate 1 including the cast + wrought gates, the gateposts/pilasters, curved metal [cast + wrought] fencing and all bluestone [basalt] stonework including the threshold plinths + fence base-plinths; and
- The steps to the front of the Cullymont House verandah too are 'Significant'.

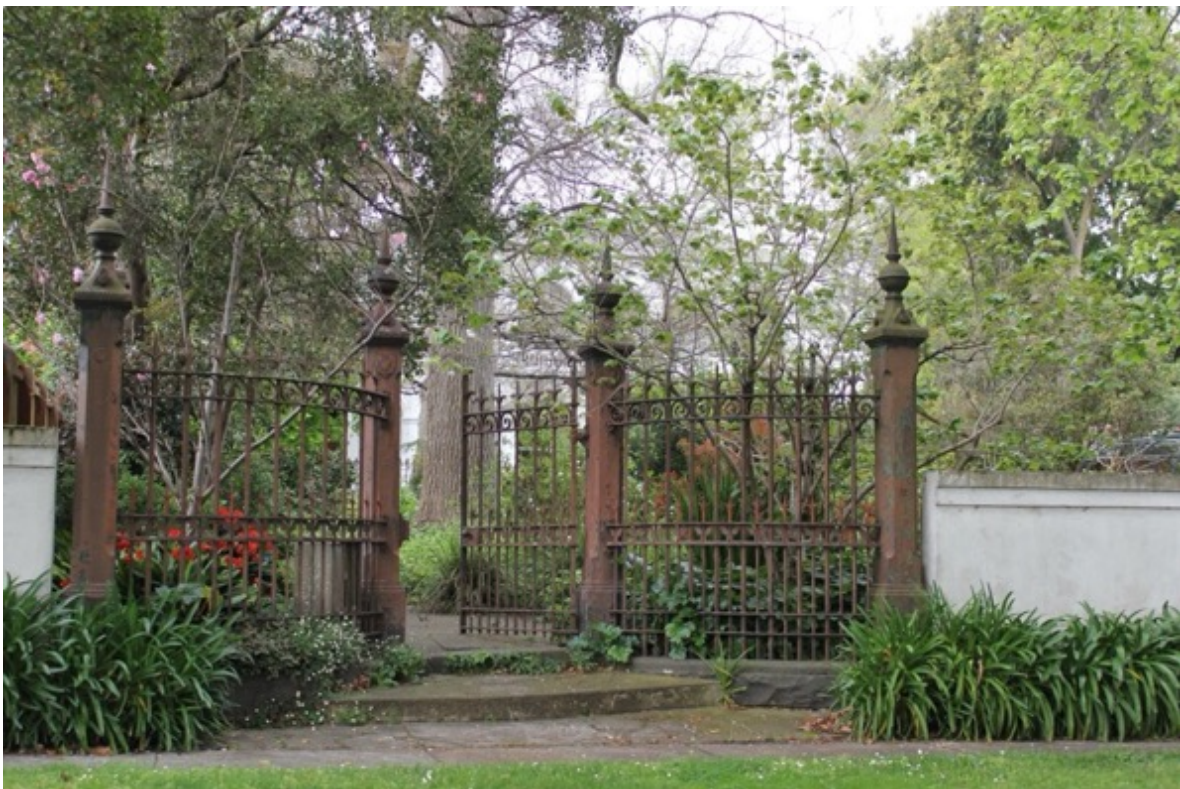
Figure 13 Cullymont – Subject Property
Gate Entry – Gateway 1 – Looking south [south-west]
[below]. The tall/slender cast-iron pilasters topped with
impressive, orbed finials display the Macully
'CULLYMONT' coat-of-arms [Refer inset]

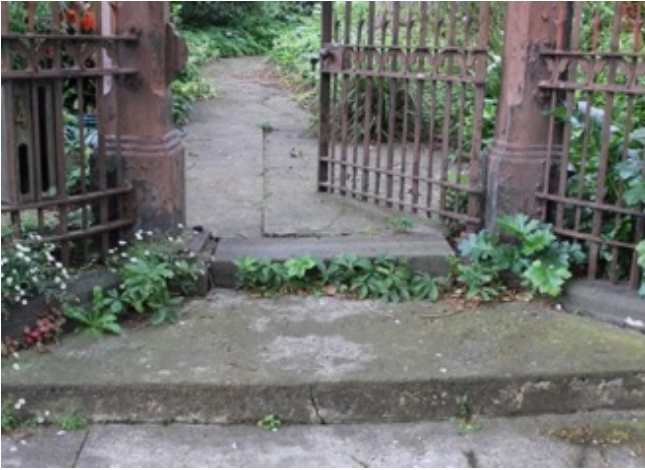
Figure 14 Cullymont – Subject Property
Gate Entry – Gateway 1 – Looking south [left]
Bluestone gateway threshold and plinthing visible.
Note: The concrete pavement to the paths is now
uneven, cracked and in some areas unstable

- Path and paving works – The concrete paving to the principal path will be lifted and replaced with replacement concrete, again with exposed aggregate surfacing.

- II. Where the principal path is to be replaced, the landscape contractor [Esjay Landscapes] shall initially lift the concrete paving in portions only – the substrate shall then be examined;

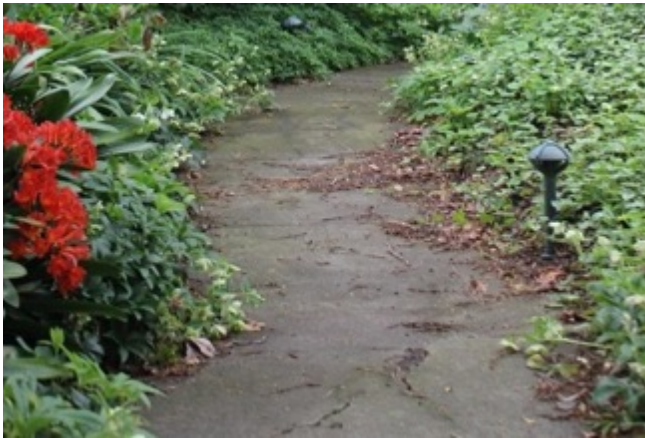
Figure 15 Cullymont – Subject Property
Concrete paved path visible – Looking south
[below left]

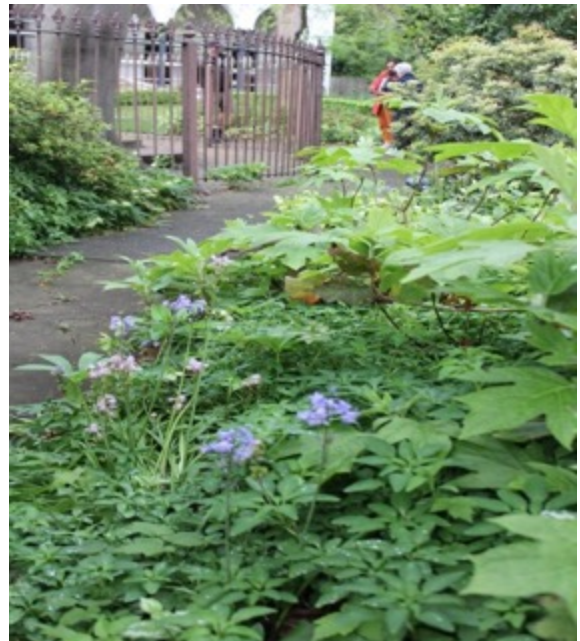
Figure 16 Cullymont – Subject Property
Path at pool fence – Looking south [south-west]
[below]

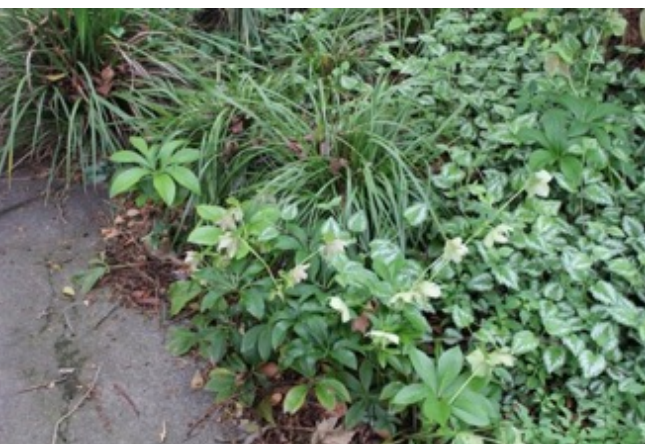
Figure 18 Cullymont – Subject Property
Looking east [left]
Swimming pool + pool fencing
Grassed [lawn] roundel - foreground

- Soil-works – including a general site cut of approximately 150mm – this will be required to restore and condition the soil substrate.
- All brick paving located in the vicinity of the extant swimming pool including the paving to the south end of the pool will be removed and stockpiled ready for reuse.
- The concrete paved paths will be lifted ready for replacement path paving.
- The paving to the extant non-original carpark located adjacent to Gate 2 will be removed ready for the new/proposed paving.
- A degree of plantings will be cut-back and removed.
- Concrete stepping stones to the former kitchen garden will be removed, ready for brick paving comprised of salvaged/stockpiled bricks.
- The extant pool fencing will be removed.
- The extant pool coping will be removed.
- The extant/redundant pool equipment including the pump and filter system will be relocated.

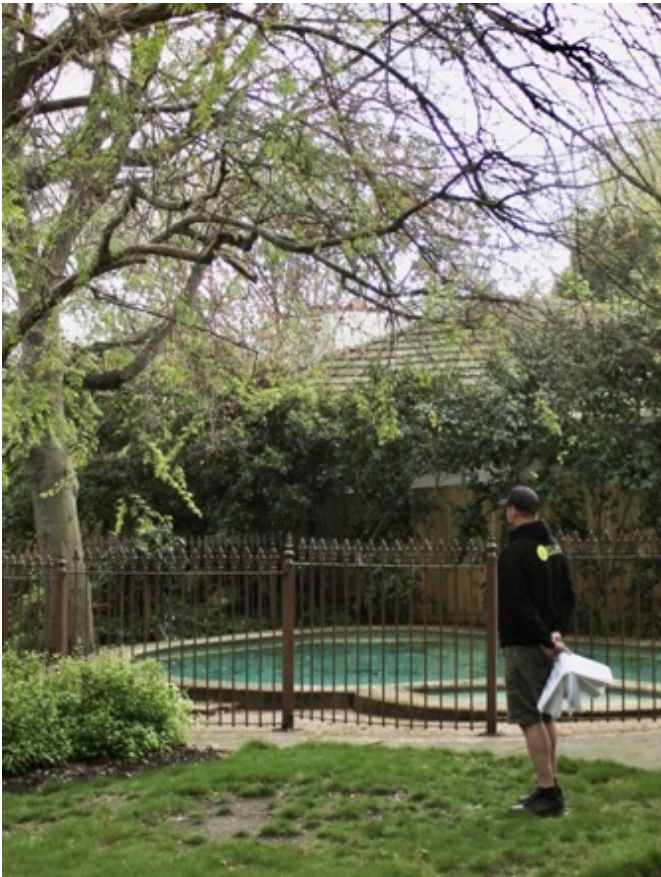
Figure 19 Cullymont – Subject Property
Swimming pool with exposed aggregate [pebble] edge with
stepped brick paving - Viewed within pool zone
Looking east [south-east] below

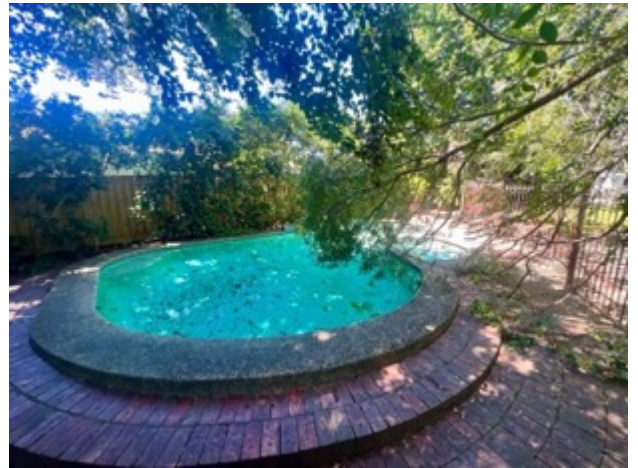
Figure 18 Cullymont – Subject Property
Swimming pool + pool fencing – Looking north [left]
Tree E09 - Liquid Amber [American sweetgum] and Tree E12
Fagus sly [Copper beech] are visible beyond the pool fence

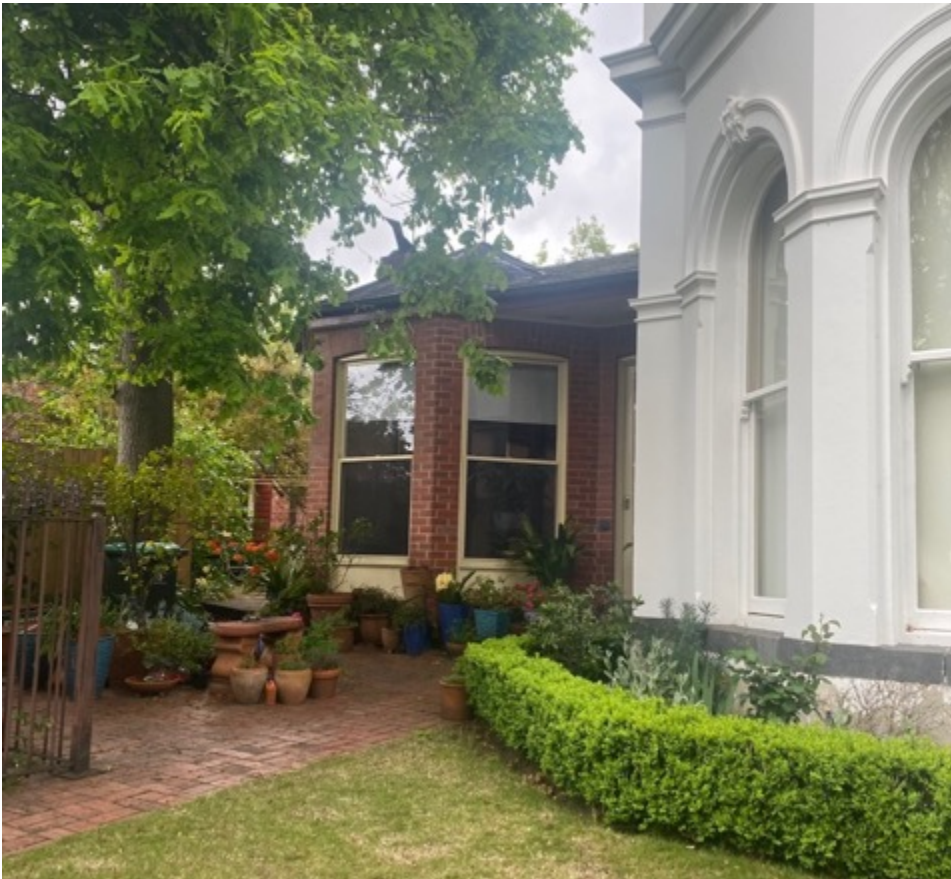
Figure 19 Cullymont – Subject Property
Projecting East Bay – Looking south-east
c1980s addition [red brick] visible [left]
Tree E25 visible to the left of the addition

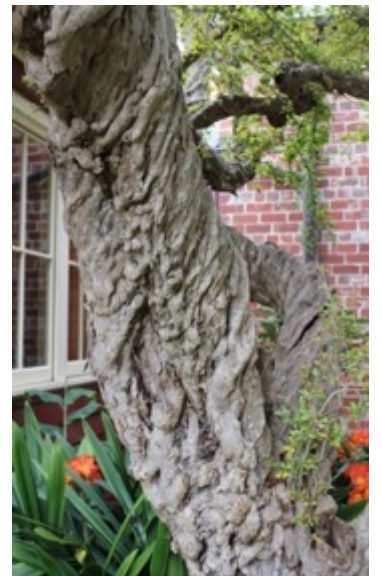
Figure 22 Cullymont – Subject Property
Tree E28 – Punica sp. [Pomegranate]
c1960s [above]. Infill [built-form] visible,
centre, between the rear wing and the
north-east out-building

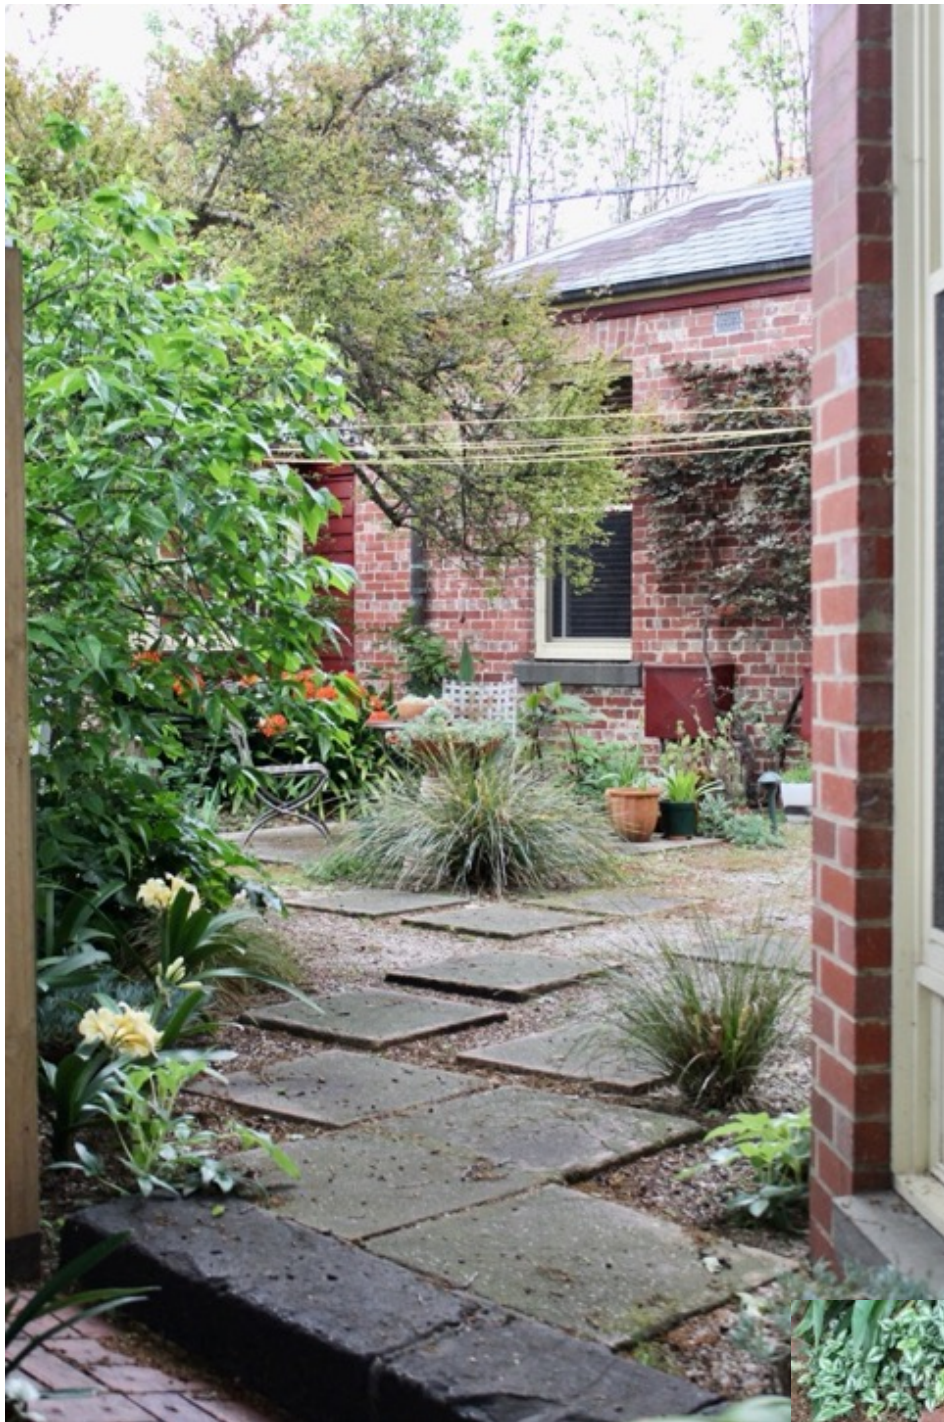
Figure 23 Cullymont – Subject Property
View of former kitchen garden - Looking south-east [left]
Tree E28 – Punica sp. visible to the left
Existing pavers + gravel form irregular surface for passage

- Remediation of the east courtyard including the introduction of stepping plinths/steppers in conjunction with gravel. The intention here is to provide for more unified/safe passage to and from the rear wing doorway to the front garden/grounds. The extant Punica [Pomegranate -E28] tree will be retained.

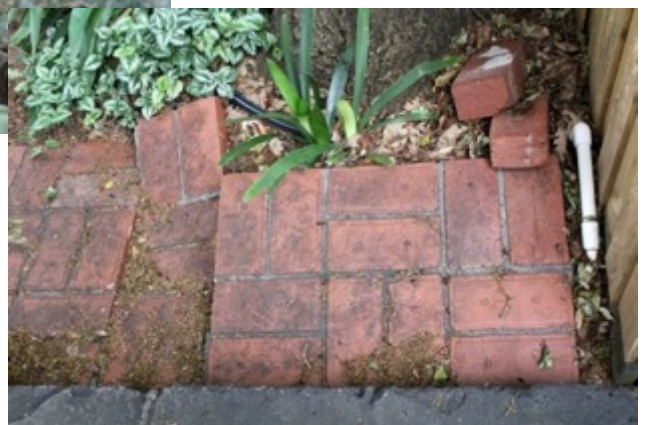
Figure 24 Cullymont – Subject Property
Threshold/step between former kitchen garden and the commencement of pool area paving [below]. The existing brick paving is subject to 'heave' resulting from the 'rise and fall' of the substrate [earth] and tree movement + growth [roots]
