Proposed Outdoor Performance Facility, 43-45 Moreland Street, Footscray

Cultural Heritage Due Diligence Assessment

Prepared for Footscray Community Arts

10 November 2023

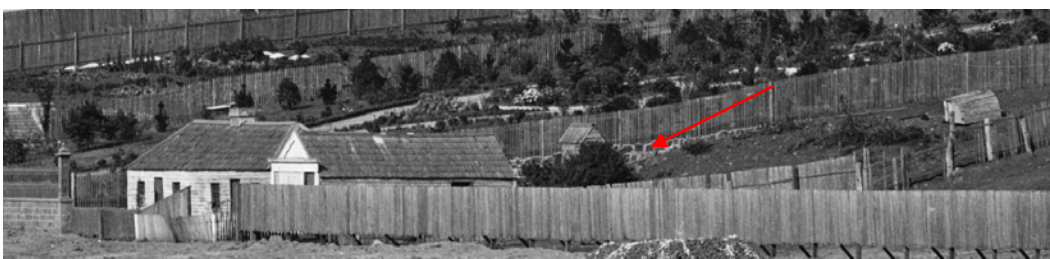
Figure 5 The river section and Moreland Street section of the study area with bluestone retaining wall, 1875 (Mitchell Library, state Library of New South Wales)

Figure 5 presents two earlier constructed timber dwellings standing alongside the entry to Henderson's Piggery (1B). The elevation of Henderson's Piggery is evidenced through a bluestone retaining wall located along the northern boundary (marked with a red arrow in Figure 5) showing that the river section of the study area has been subject to fill, probably to level out the driveway from Maribyrnong Street up toward the home's entry. This change is inferred in the abovementioned article which described the "inequality of surface (which) has been turned to the best account by the proprietor when planning the buildings".

tall trees in the riverbank section. A fence line is evident running in between Area 1B and 1E, possibly the remaining bluestone retaining wall and timber fence shown in Figure 5. Though some activity is evident in Area 1E, no significant structures are present at the amphitheatre site or riverbank section. In 1951 (Figure 13) it is evident that a more substantial horseshoe structure has been constructed on 1B with further evidence of the bluestone wall, tree planting and structured gardens including a driveway. Moreland Street and Maribyrnong Street area present, however do not have evidence of formal road construction.

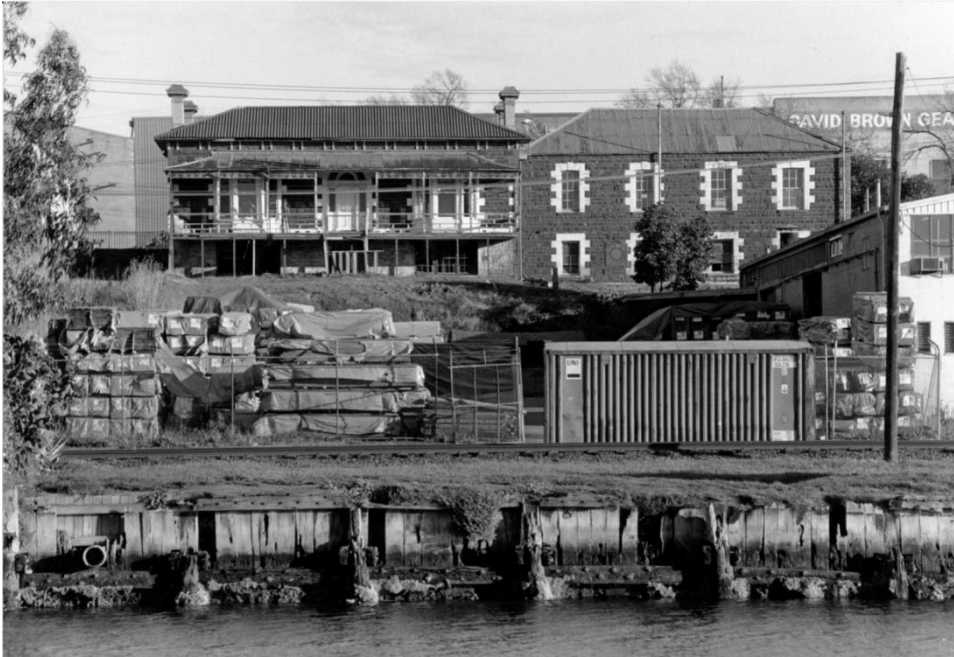
Figure 7 The study area, facing west showing excavated riverbank and homestead, approximately 1960s (Heritage Alliance, 2023)

Figure 7 to Figure 11 shows the chronology of the river section of the study area over time. This sequence suggests fill was instated for the establishment of the garden, then removed during the 1930s or 1940s to again exposed riverbank, with further impacts to make way for an additional warehouse in Area 1E which was built in the 1960s. By the early 1990s, once the property had been taken up by FCA, the riverbank in both Areas 1B and 1E was subject to fill after the demolition the 60's warehouse, at which point the amphitheatre was constructed and further cut into the study area to the west (Darren Gee, pers. comm., 25 October 2023).

In the period between 1968 and 1975 the study area has been redeveloped with the construction of a large commercial/industrial building and storage warehouse (evident in Figure 7). Majority of the study area has been developed and a small section has been left undisturbed, perhaps for a carpark and driveway to access the buildings. In 1975 it is evident that the horseshoe shaped building (1B, Moreland Street section) has been partially demolished. Moreland Street and Maribyrnong Street show evidence of formal road construction, vehicle usage, drainage lines, wharf construction, and leveling of the riverbank (Figure 14 and Figure 15).

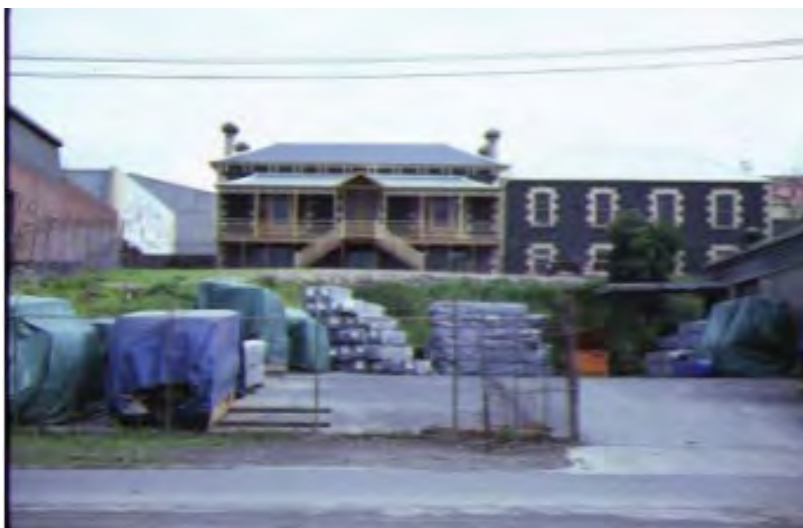
Figure 8 The study area prior to fill being instated at the riverbank and homestead, approximately end of 1980s (Victorian Heritage Database Report, 2023)

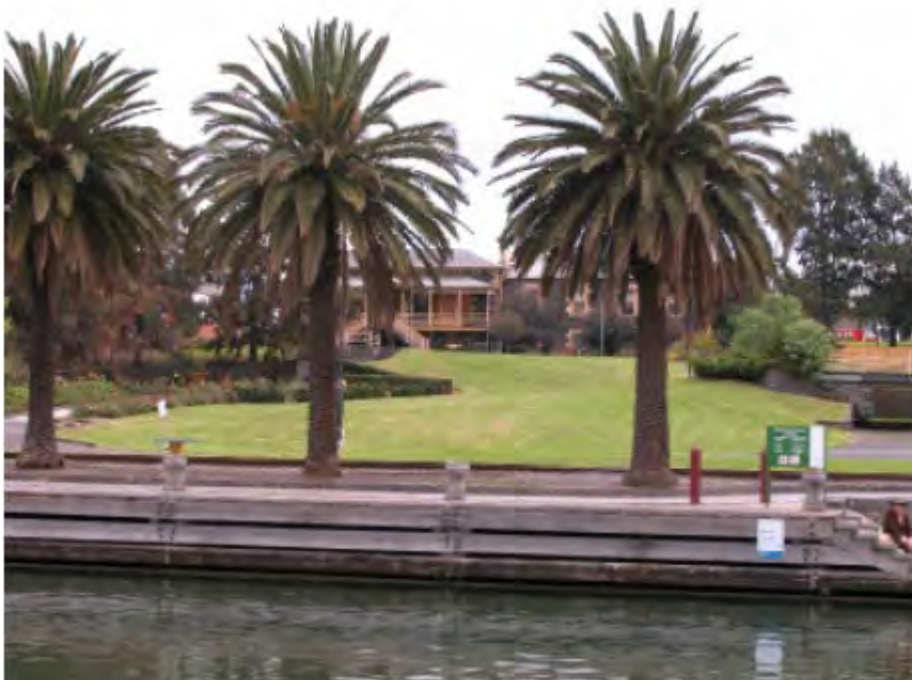
Figure 10 The study area appears raised along the river bank and homestead, approximately early 2000s (Victorian Heritage Database, 2023)

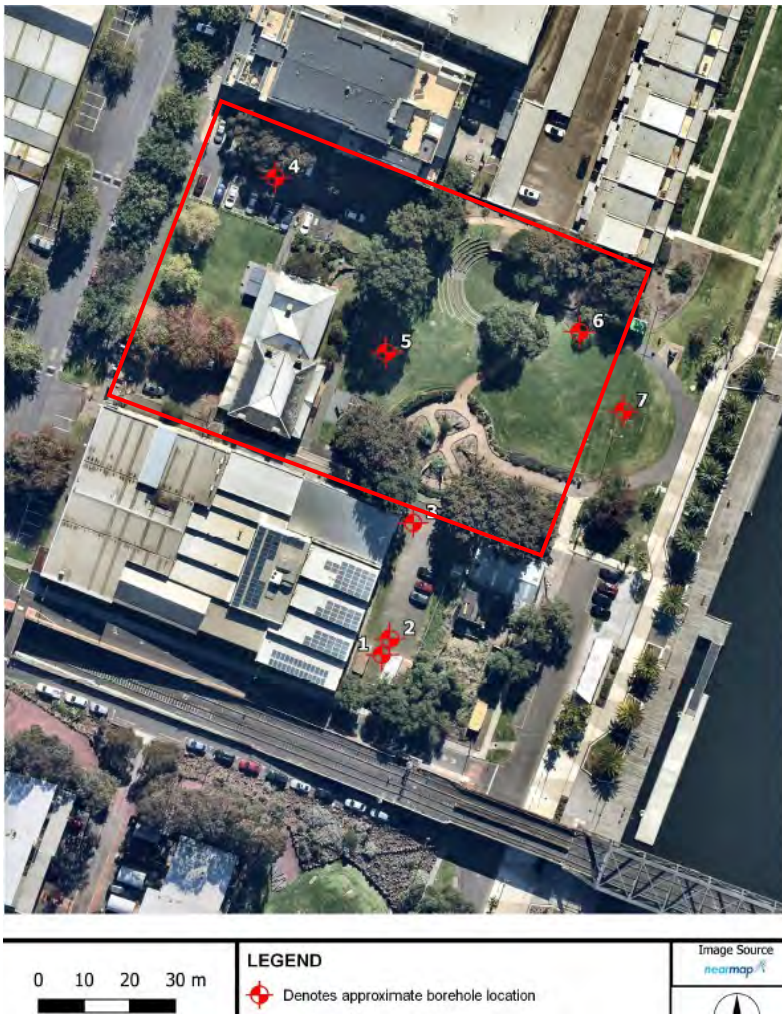
Figure 20 Borehole testing location within the study area (red) (GeoAust Geotechnical Engineers Pty Ltd, 2023)

Boreholes 1 to 3 were noted as having a pavement layer (concrete/asphalt/crushed rock) overlaying natural basaltic clay deposits. These were located outside the study area to the south, in property number 47.

Boreholes 4 to 7 were noted as having fill present between 0 metres (ground surface) and up to 2.7 metres depth. The fill comprised a mixture of low to high plasticity clayey silt, high plasticity clay, fine to medium grained silty sand and fine to coarse grained gravel. The fill contained varying quantities of rubble and basalt cobbles. The study noted that the fill appeared to have been placed in an uncontrolled manner and that it was unlikely to have been properly compacted in layers at the time of placement. The fill layer was followed by a natural layer of very stiff to hard clayey silt and weathered basalt. Borehole 7 is located outside the study area, to the east.

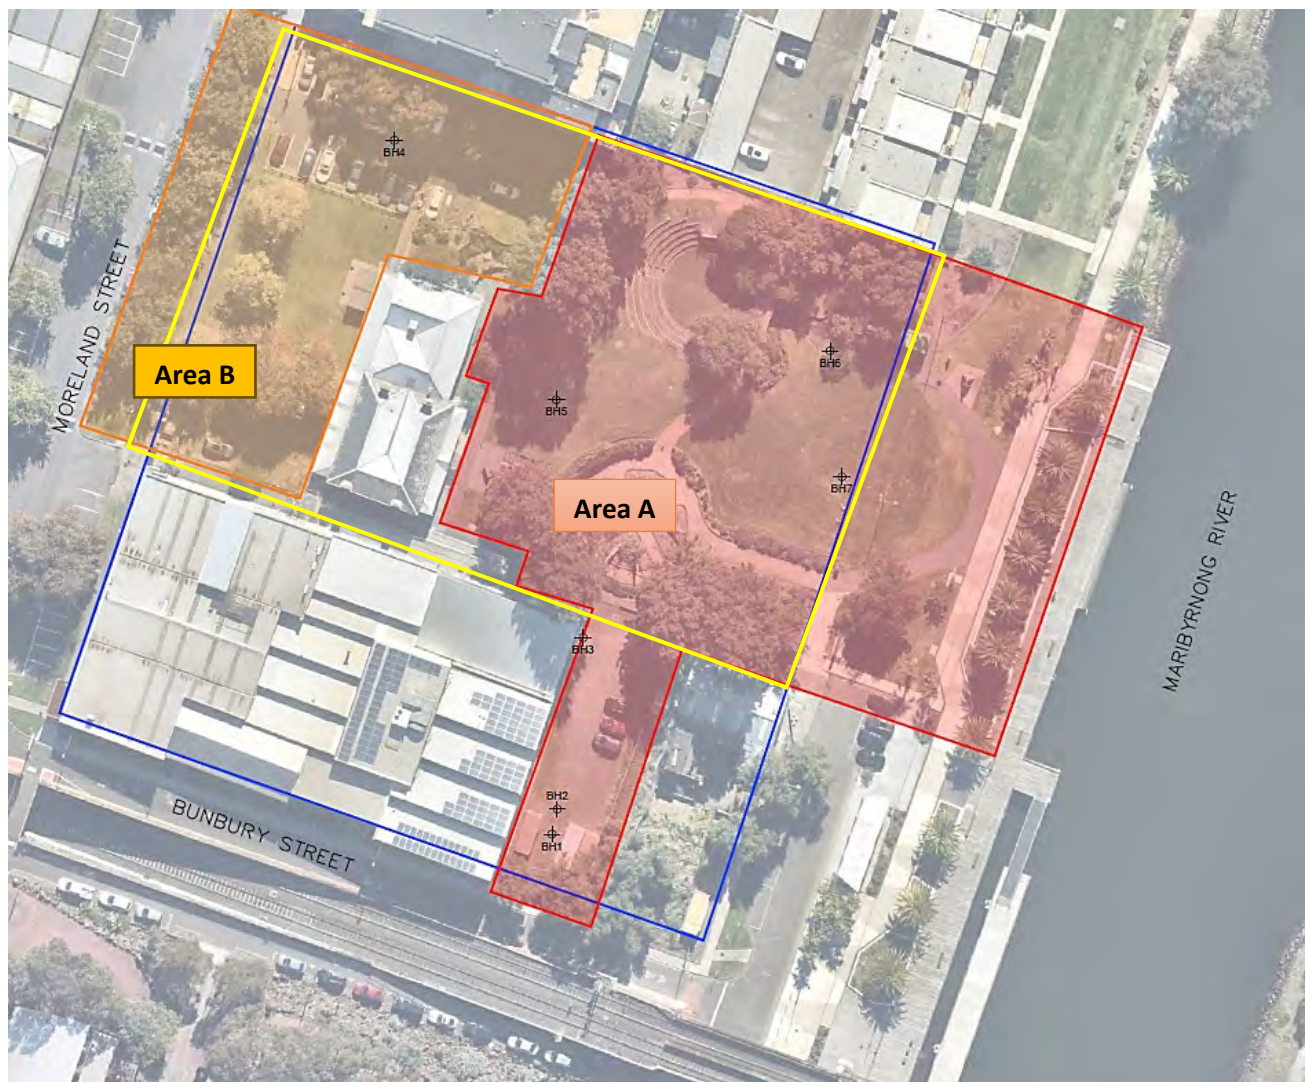
Figure 21 Compass Environmental report showing the location of boreholes within the study area (yellow) (Compass Environments 2023: 35)

Fill material was encountered at all locations across the two investigation areas, Area A and Area B (Figure 21), with the fill material in Area A ranging in thickness between approximately 0.25 and 2.2 metres (bgl). The fill material across Area A generally comprised brown/dark brown/grey, low to high plasticity silty clay with fine to coarse-grained sand. Inclusions of concrete and brick fragments were observed within the fill material at location BH3 and BH7, with inclusions of brick and glass fragments observed within the fill material at location BH5 and BH6. No odour or staining were identified at any of the sample locations, except for a slight oily/hydrocarbon odour and black staining within the fill material at BH7 (from 1.25 to 1.95 metres below ground level). No visible asbestos containing material were encountered at the investigation locations.

Underlying natural soils were encountered at all locations within Area A, and generally comprised light brown/grey, clayey silt/silty clay. The depth of these soils occurred between 2.2-4.8 metres for BH5, 2-3 metres for BH6 and 2.8-3 metres for BH7. The natural soils described in this study are usually referred to as sterile clays in archaeological assessments in Victoria. Basalt rock was encountered between approximately 0.8 to 4.9 metres bgl at all locations within Area A. No odour or staining were encountered within the natural soils within Area A. The underlying natural soils encountered in Area B, and generally comprised mottled grey/yellow/brown, low plasticity clayey silt with trace fine to coarse-grained basalt gravels. Basalt rock was encountered at approximately 2.2 metres bgl.

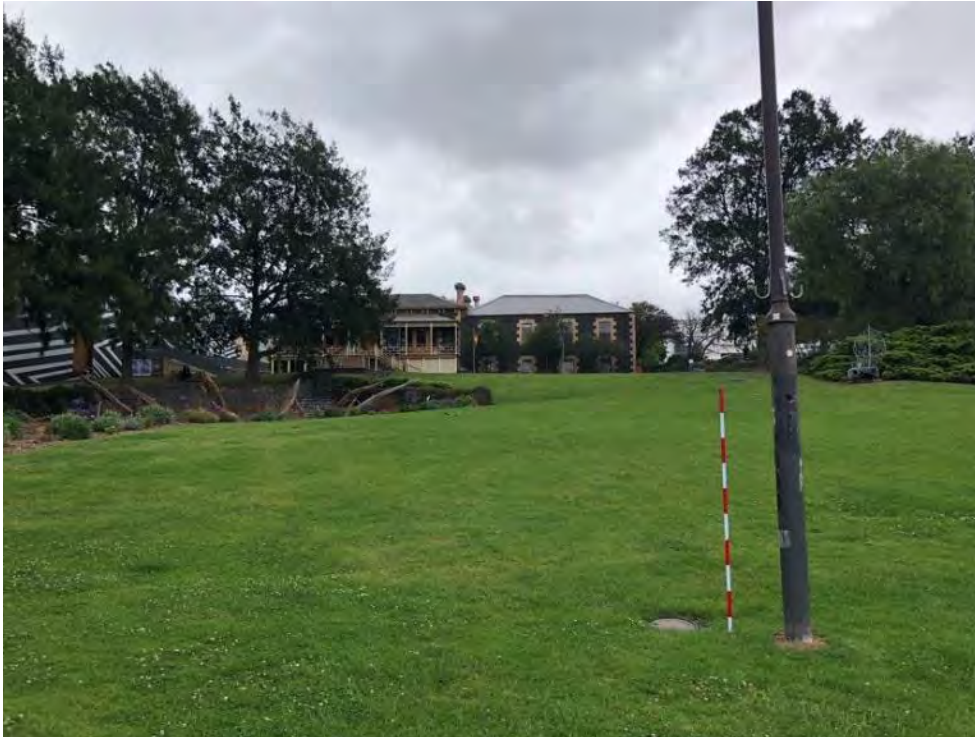
Photograph 1 The back of Henderson House, photo facing west (W. Hernandez 13/10/2023)

The study area consists of two historic buildings associated with the historic listing, Henderson House (H0183) (Photograph 1). The bluestone buildings, front yard and parking area along Moreland Street are on the western and most elevated section of the study area. The upper end of the study area affords great views of the Maribyrnong River and the CBD in the distance to the east (Photograph 2). The land slopes down towards the river, from the eastern side (back side) of the historic buildings until reaching a public footpath and timber wharf along the river itself. The eastern section of the study area has been highly modified, and although the land appears to be naturally sloping, this is likely due to the extensive modification and development of the property over the last 150 years. No natural landforms associated with alluvial terraces or volcanic plain were observed and numerous underground assets were noted throughout (Photograph 3) (see BYDA results 2.2.2).

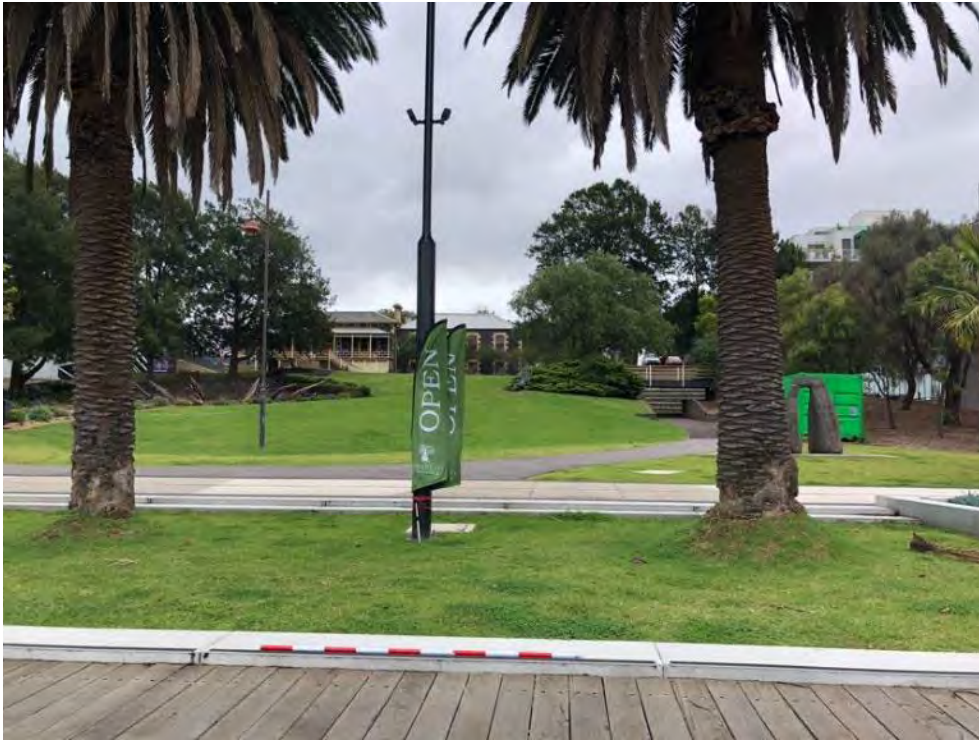
Photograph 3 View of the eastern section of the study area from the wharf, facing west (W. Hernandez 13/10/2023)

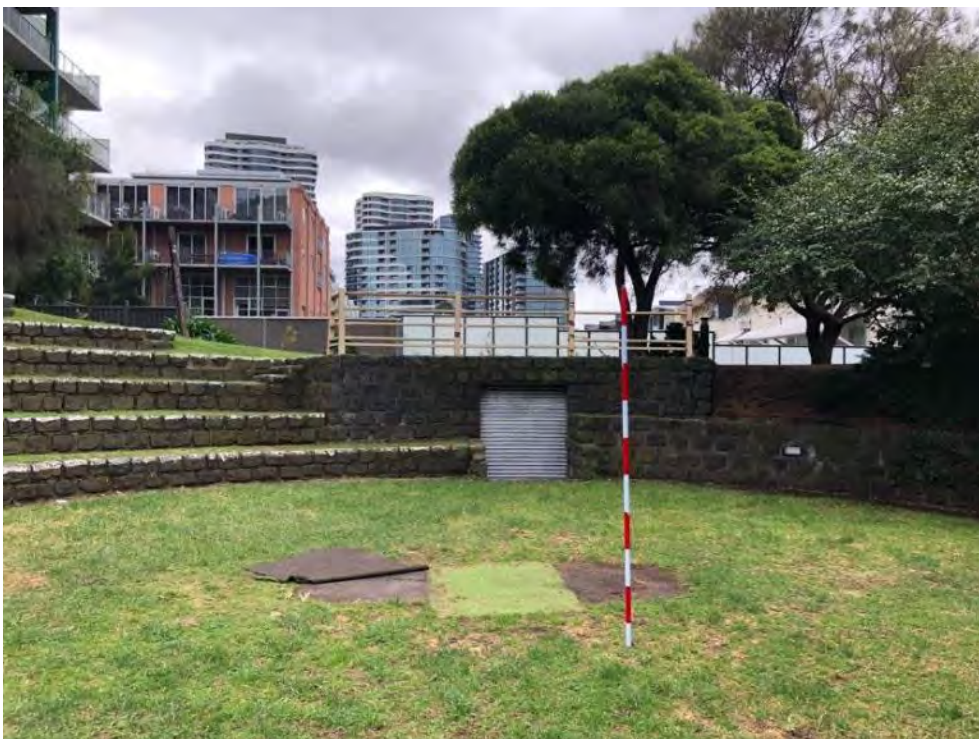
Photograph 4 Amphitheatre and storage shed, facing north (W. Hernandez 13/10/2023)

There is an outdoor amphitheatre area with a small storage shed in the mid-north section of the study area (Photograph 4). There are several gravel/paved and bitumen footpaths and a pedestrian bridge connecting the amphitheatre with the historic houses to the south west, and Maribyrnong River Walkway to the east (Photograph 5 **Error! Reference source not found.**). The Walkway consists of concreted pavement which runs parallel to the river (outside the study area) and is a continuation of Maribyrnong Street. The Walkway was previously accessed by vehicles and a cable tram system and the original cargo tram tracks have been left in place along the footpath as a reminder of the history of the area. This section along the river is outside the study area, however given there is no boundary fence along the eastern boundary of the property, there is always access to the FCA grounds from the Maribyrnong River Walkway.

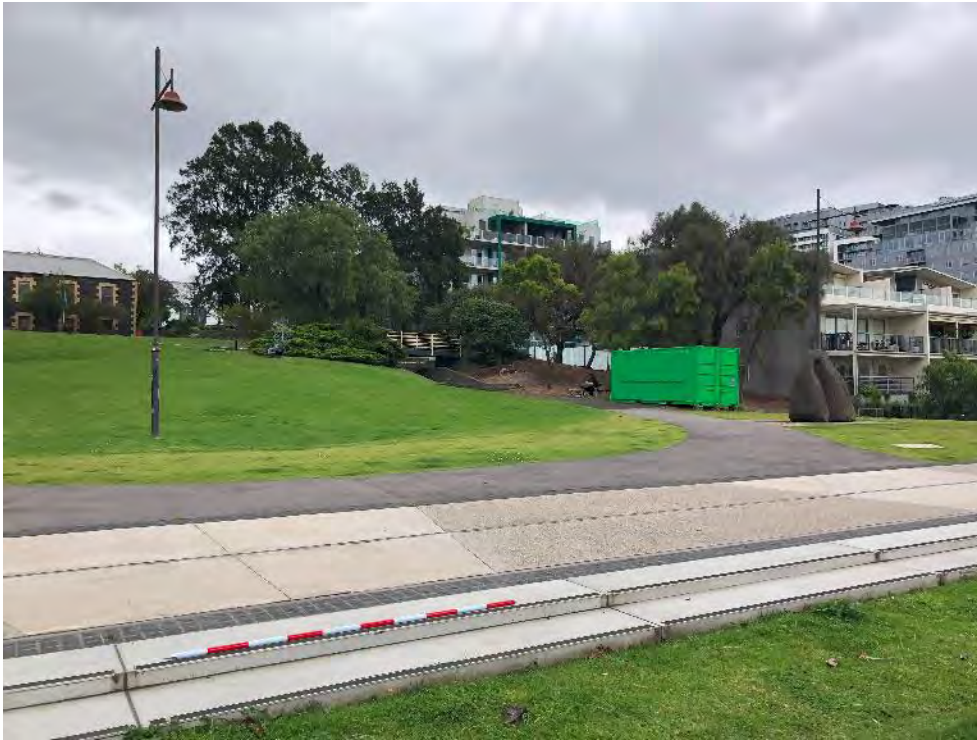
Photograph 5 Pedestrian bridge above amphitheatre location in the distance, view from the Maribyrnong River Walkway, facing north west (W. Hernandez 13/10/2023)

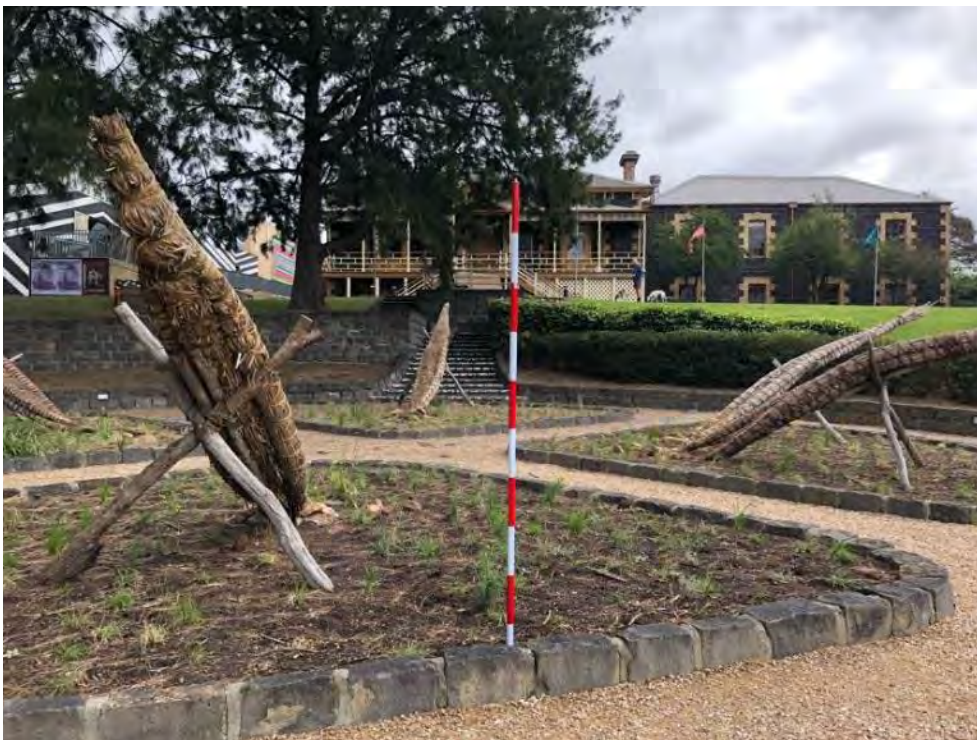
Photograph 6 Bluestone retaining walls, garden beds, art installations and gravel paths, facing west (W. Hernandez 13/10/2023)

The study area has been subject to landscaping and gardening works throughout, particularly to the east of the historic buildings (Photograph 6). The trees within the property are relatively young (post European settlement era) and comprise species such as Norfolk Island Pines (*Araucaria heterophylla*) and Pin Oak (*Quercus palustris*). There are four River Sheoaks (*Casuarina cunninghamiana*) along the southern boundary of the study area (Photograph 7) and it is likely these trees were planted around the time Henderson's buildings were constructed (Figure 6). No culturally significant mature native trees or vegetation were noted throughout the property. There are several areas with bluestone retaining walls, garden beds, access steps and installations of art work and a shipment container (Photograph 5 and Photograph 6). The remainder of the study area consists of lawns which are used as a gathering space (either for sitting or standing) during FCA events.

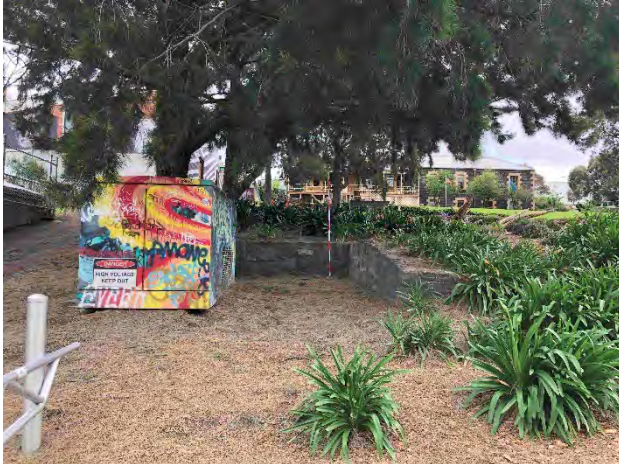
Photograph 8 High voltage electricity, south west corner, facing west (W. Hernandez 13/10/2023)

Disturbances noted included the presence of underground/above ground utilities (Photograph 8 to Photograph 11); the construction of garden beds, retaining walls, access stairs (Photograph 12), gravel/paved/bitumen footpaths, amphitheatre, pedestrian bridge (Photograph 13 and Photograph 14); and the presence of fill and debris noted around tree roots and garden areas (Photograph 15 and Photograph 16). Concreted and bitumen laneways have been installed along the outer southern boundary of the study area (Photograph 17 and Photograph 18).

The installation of utilities and drainages would have involved extensive trenching, and the construction of footpaths also would have involved clearing and levelling.

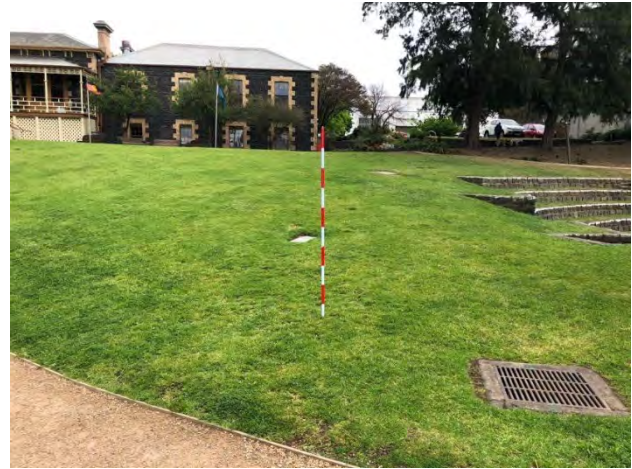
Photograph 9 Drainage pit and telecommunications, central eastern section, facing west (W. Hernandez 13/10/2023)

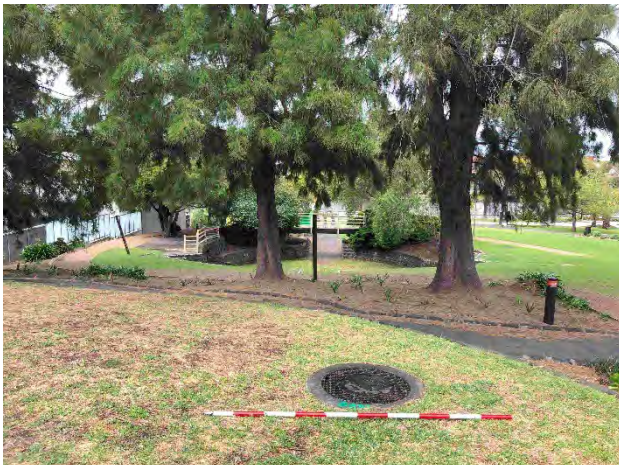
Photograph 10 Sewer assets, north west section, facing east (W. Hernandez 13/10/2023)

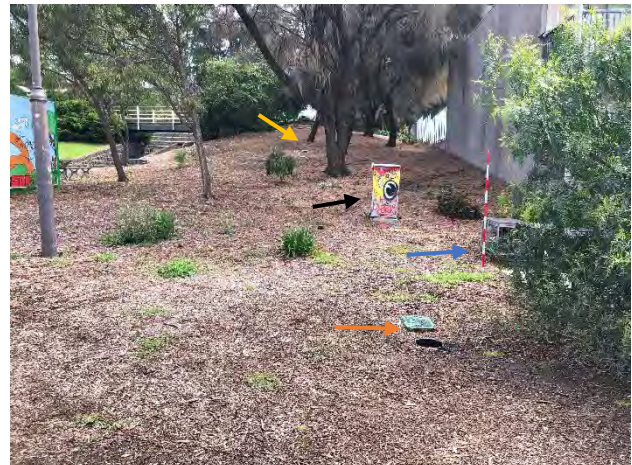
Photograph 11 Multiple underground assets; water (yellow), telecommunications (black), electricity (orange), gas (blue). North east corner, facing west (W. Hernandez 13/10/2023)

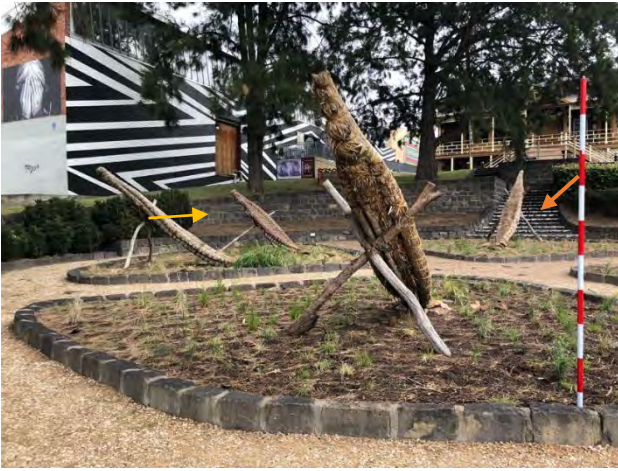
Photograph 12 Retaining walls (yellow), garden beds, access stairs (orange), facing south west (W. Hernandez 13/10/2023)

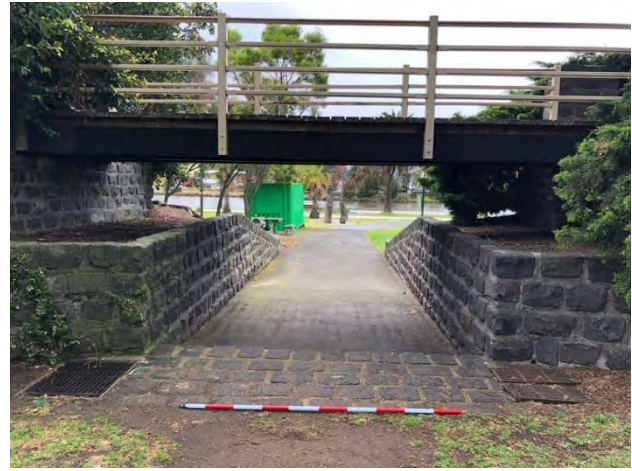
Photograph 13 Drainages, bluestone pavement and bitumen footpath under the pedestrian bridge, taken from the northern exit point of the amphitheatre (W. Hernandez 13/10/2023)

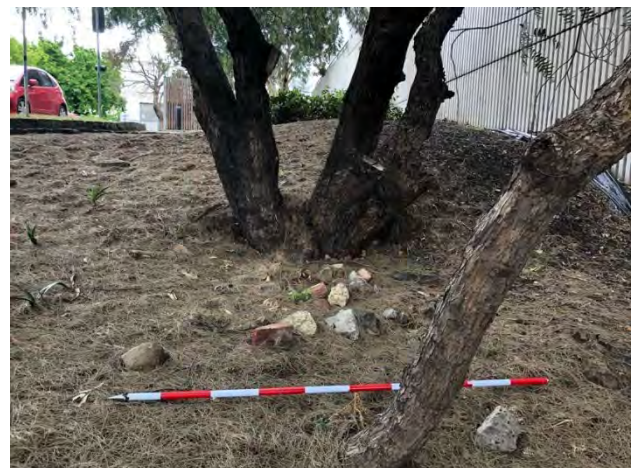
Photograph 15 Fill and construction debris along the northern boundary, adjacent to carpark, facing west (W. Hernandez 13/10/2023)

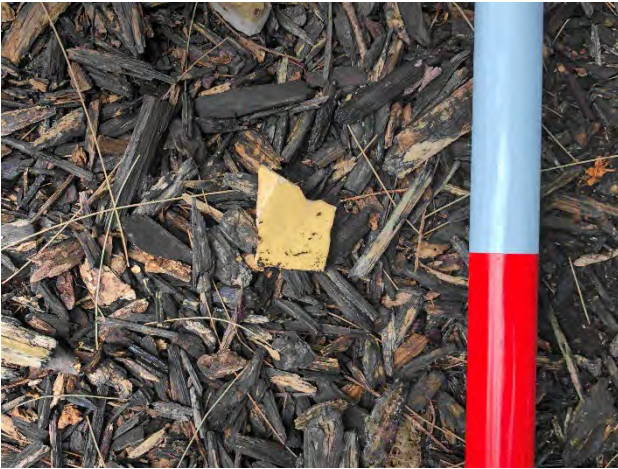
Photograph 16 Ceramic fragment found near fill and debris, northern boundary of the study area (W. Hernandez 13/10/2023)

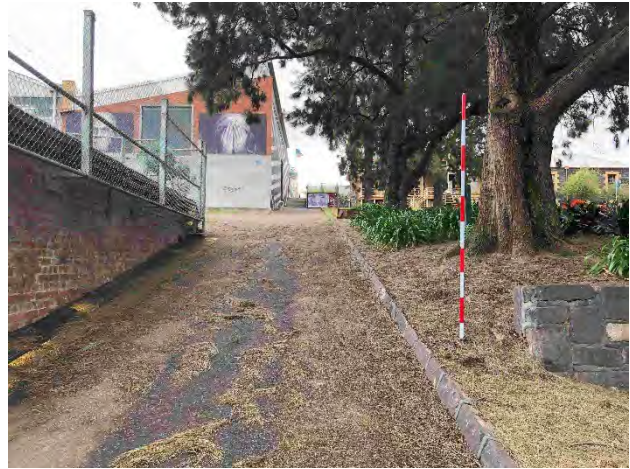
Photograph 17 Driveway/lane directly outside the southern boundary of the study area, facing west (W. Hernandez 13/10/2023)

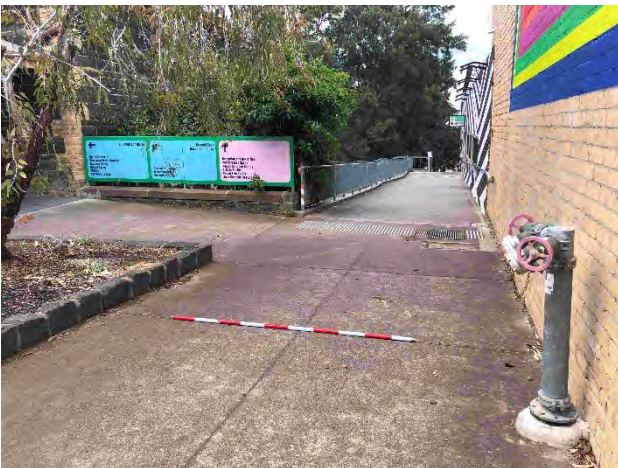
Photograph 18 Laneway pedestrian entrance to the grounds south of the study area, south west corner, facing east

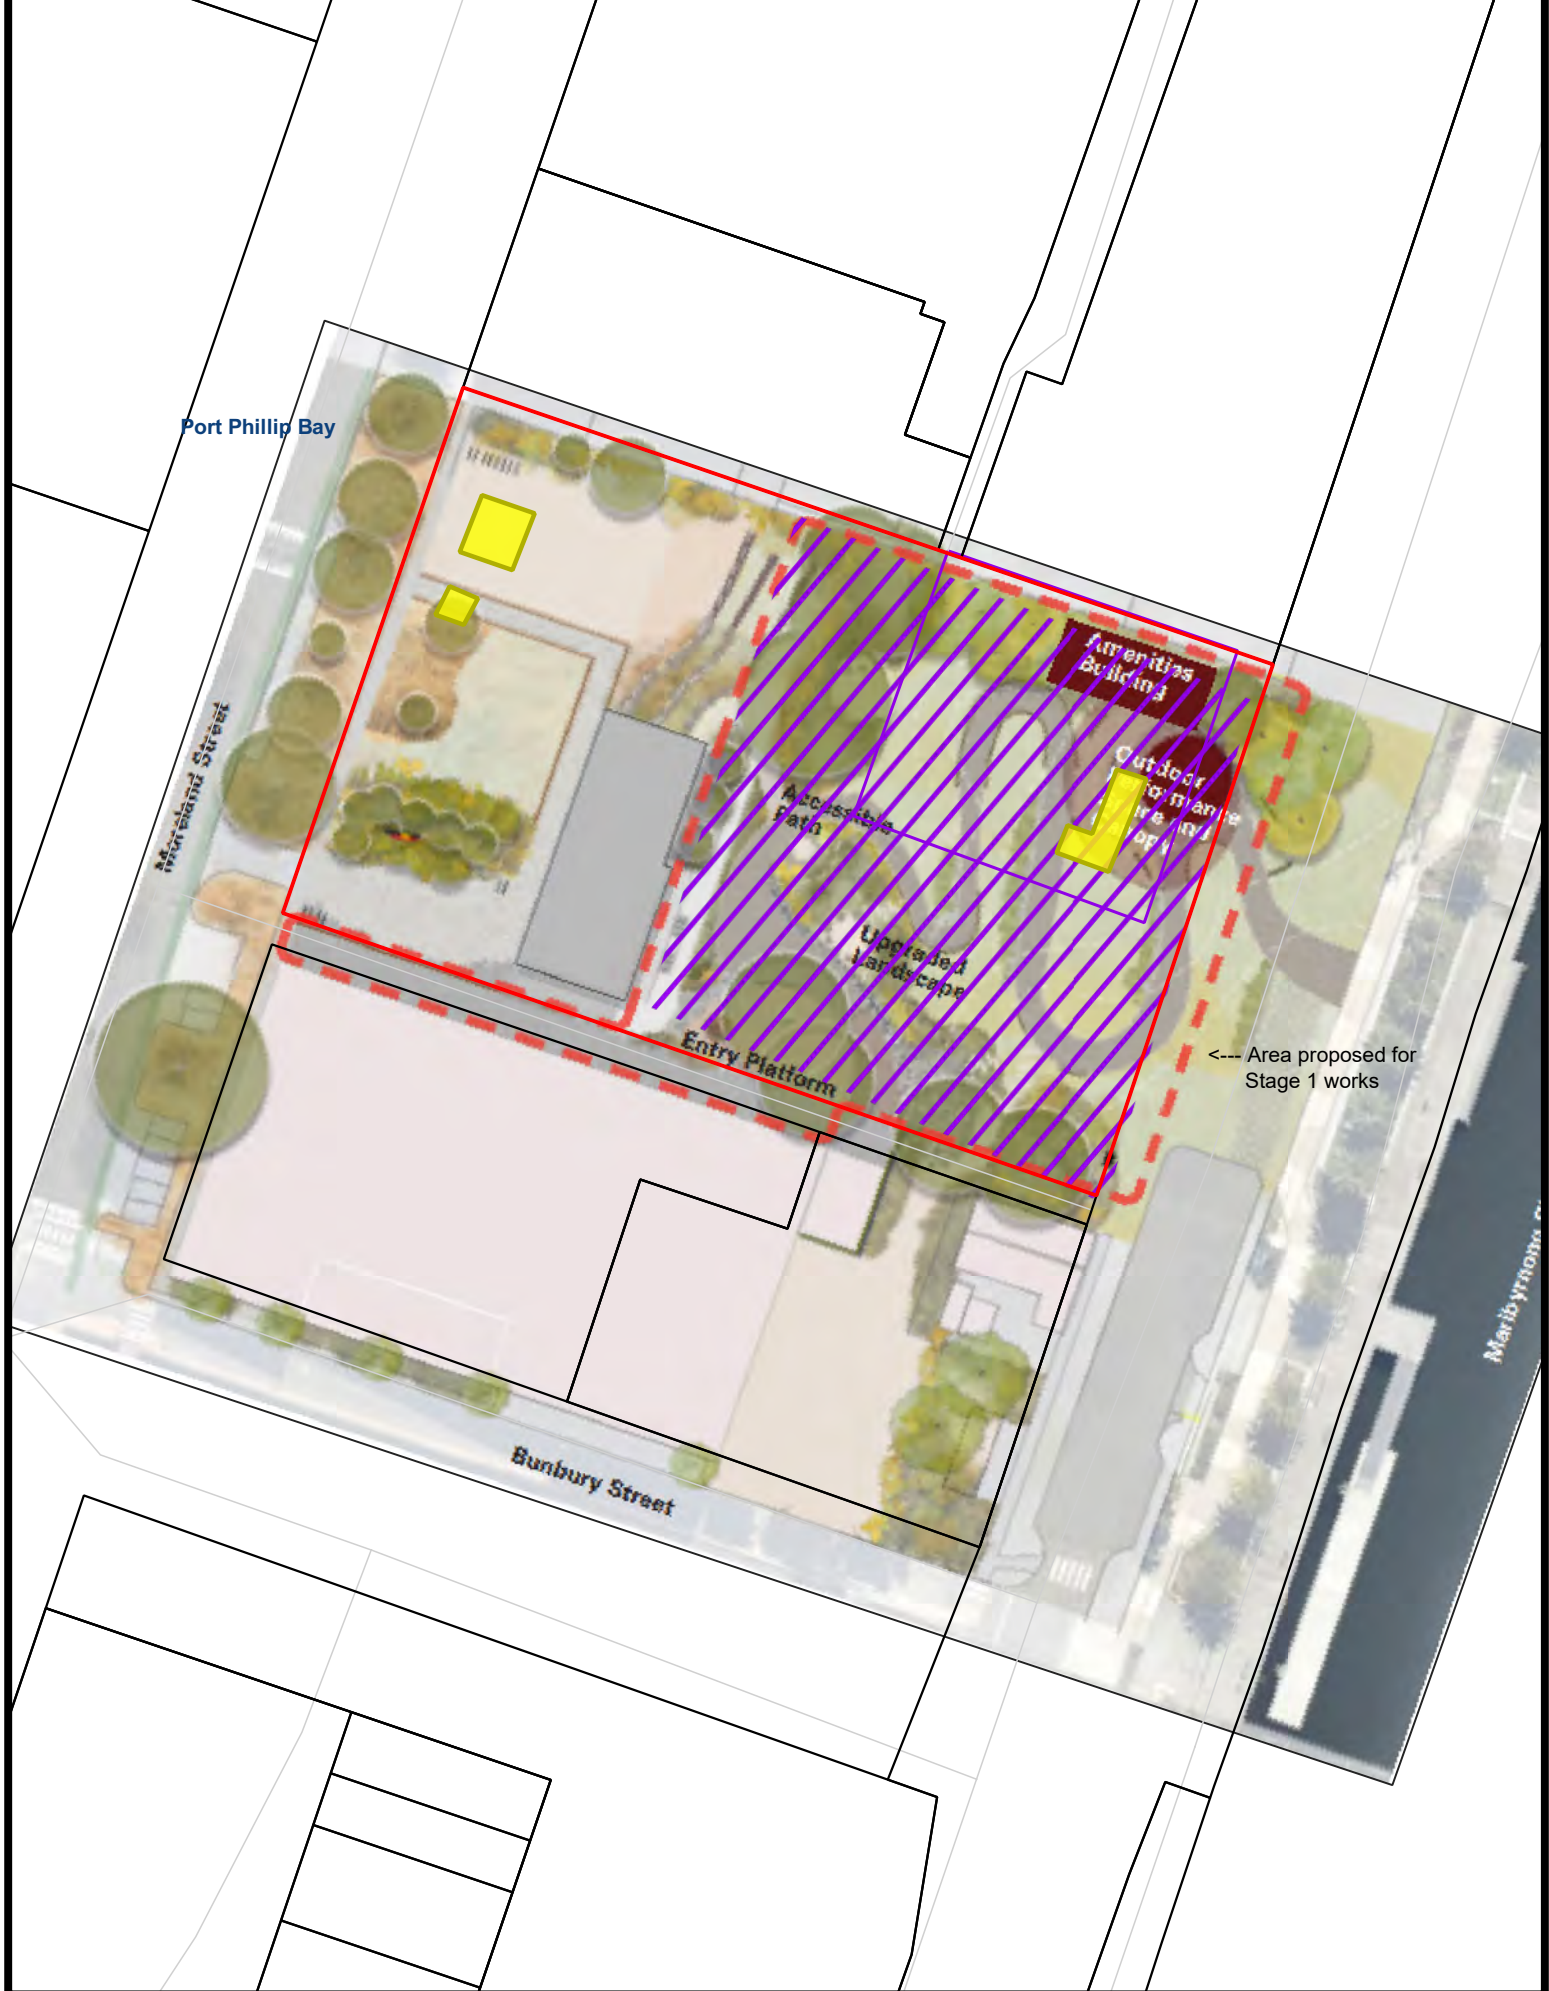
Map 5: Areas of Archaeological Potential

Although archaeology was not visible on the surface during the inspection, there is potential for historical archaeological remains to be present within the study area, particularly in the Stage 1 works area proposed for the construction of a new outdoor performance facility (Map 5).
