Front facade, showing the Rialto building on the right hand side and the Winfield building on the left hand side.

General (including preliminary, protection and stabilisation works)

- The following schedule is based on a visual inspection of the building facade carried out from street level only and the upper levels of the Winfield Building (where accessible). There may be additional works required in concealed locations and at parapet level and above that are not mentioned below. Allowances should be made for undiscovered conditions.

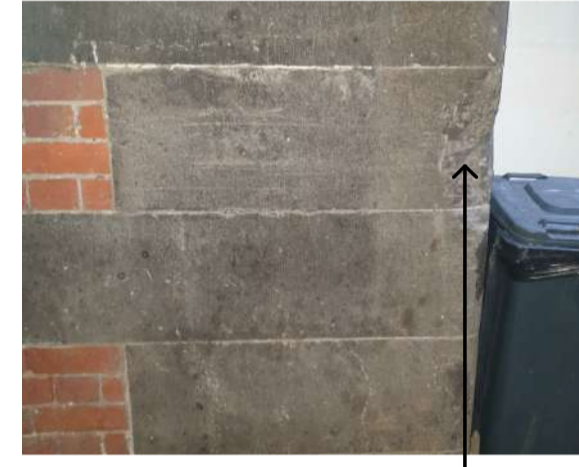
- 11a. Existing damage to bluestone wall to west laneway and other locations to be retained as evidence of impact damage from historical use by delivery carriages/trucks.

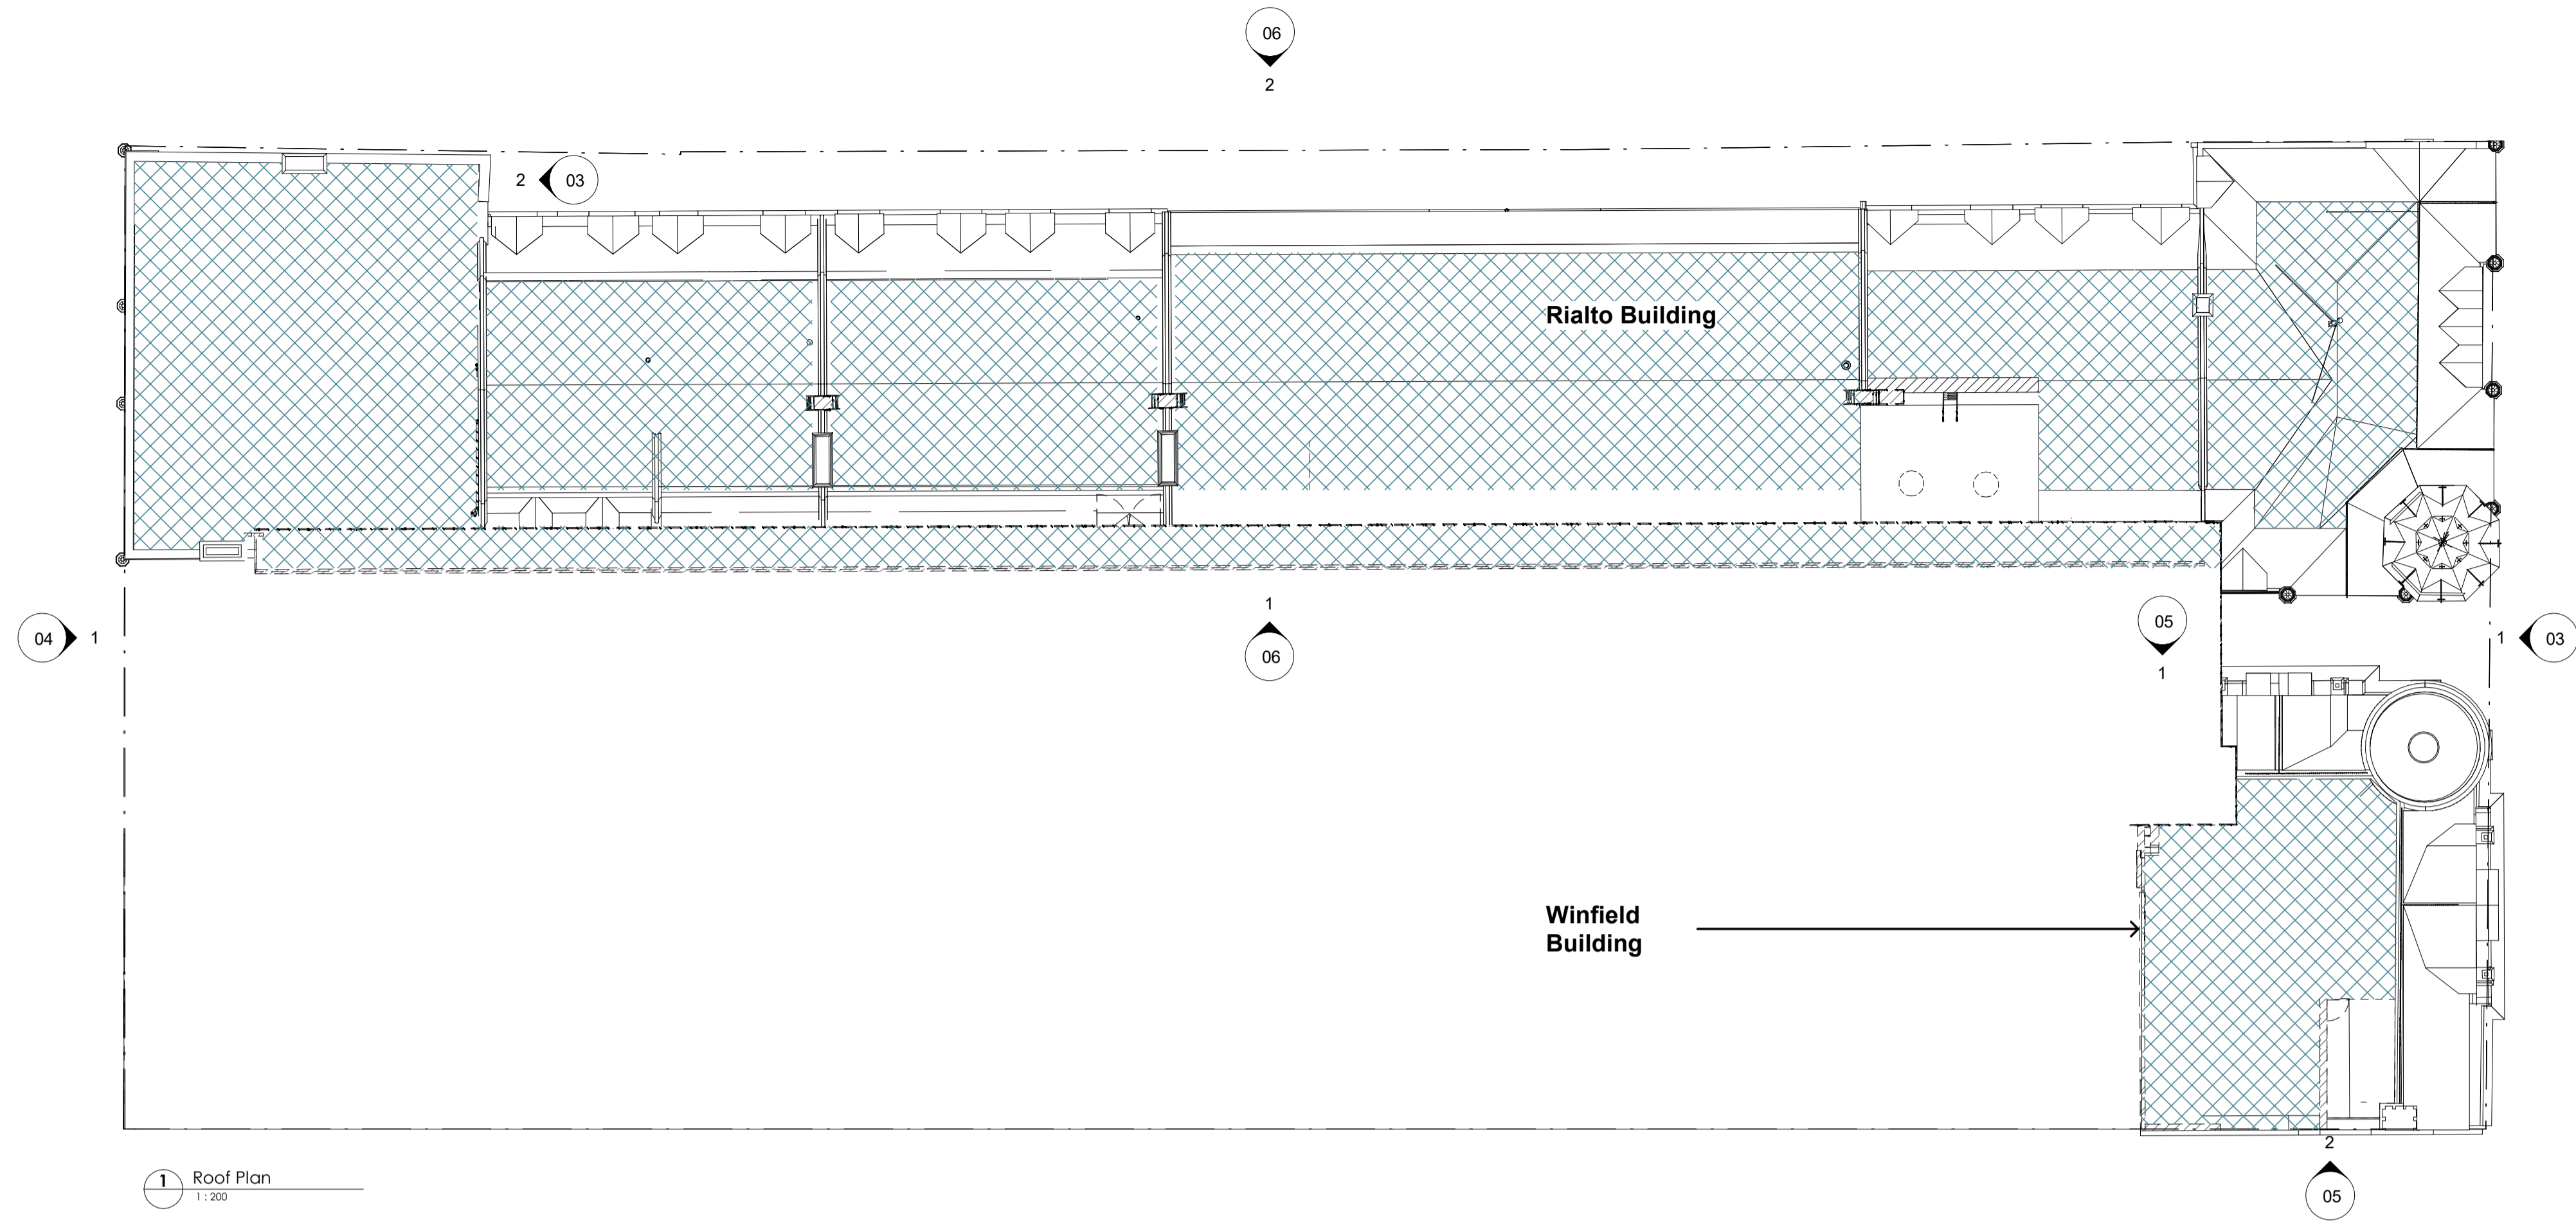
Areas of metal roof cladding to be replaced (indicative areas only shown, ensure all metal roofing is replaced) See 1d on sheet 01 for details.

Areas of brickwork to be repointed (further investigation may be required in other locations). See 3h on sheet 01 for details.

- 1c. Repair or replace concrete finials to the Rialto Building to match existing – ensure finials are secured with pinning to engineer's detail.
- 1d. Allow to replace all existing corrugated steel roof cladding with new Z600 galvanised corrugated steel cladding.

- 3h. Rake out any loose/degraded mortar and any existing poorly matched mortar repairs to a nominal minimum depth of 20mm. Do not cut, grind or alter the thickness of joints. Repoint to match original mortar colour with joints struck to match existing brickwork. Pointing repairs to use a soft (hydrated) lime mortar no stronger than the original mortar. Contractor is to prepare samples of repointing for approval of the project heritage consultant prior to undertaking the whole of this work. Areas marked with hatch require re-pointing but allow for additional areas. A sample of brick repairs and repointing is to be prepared for review by project heritage consultant prior to proceeding with the whole of this work.
- 3i. Make good brickwork where 1980s addition is to be demolished.

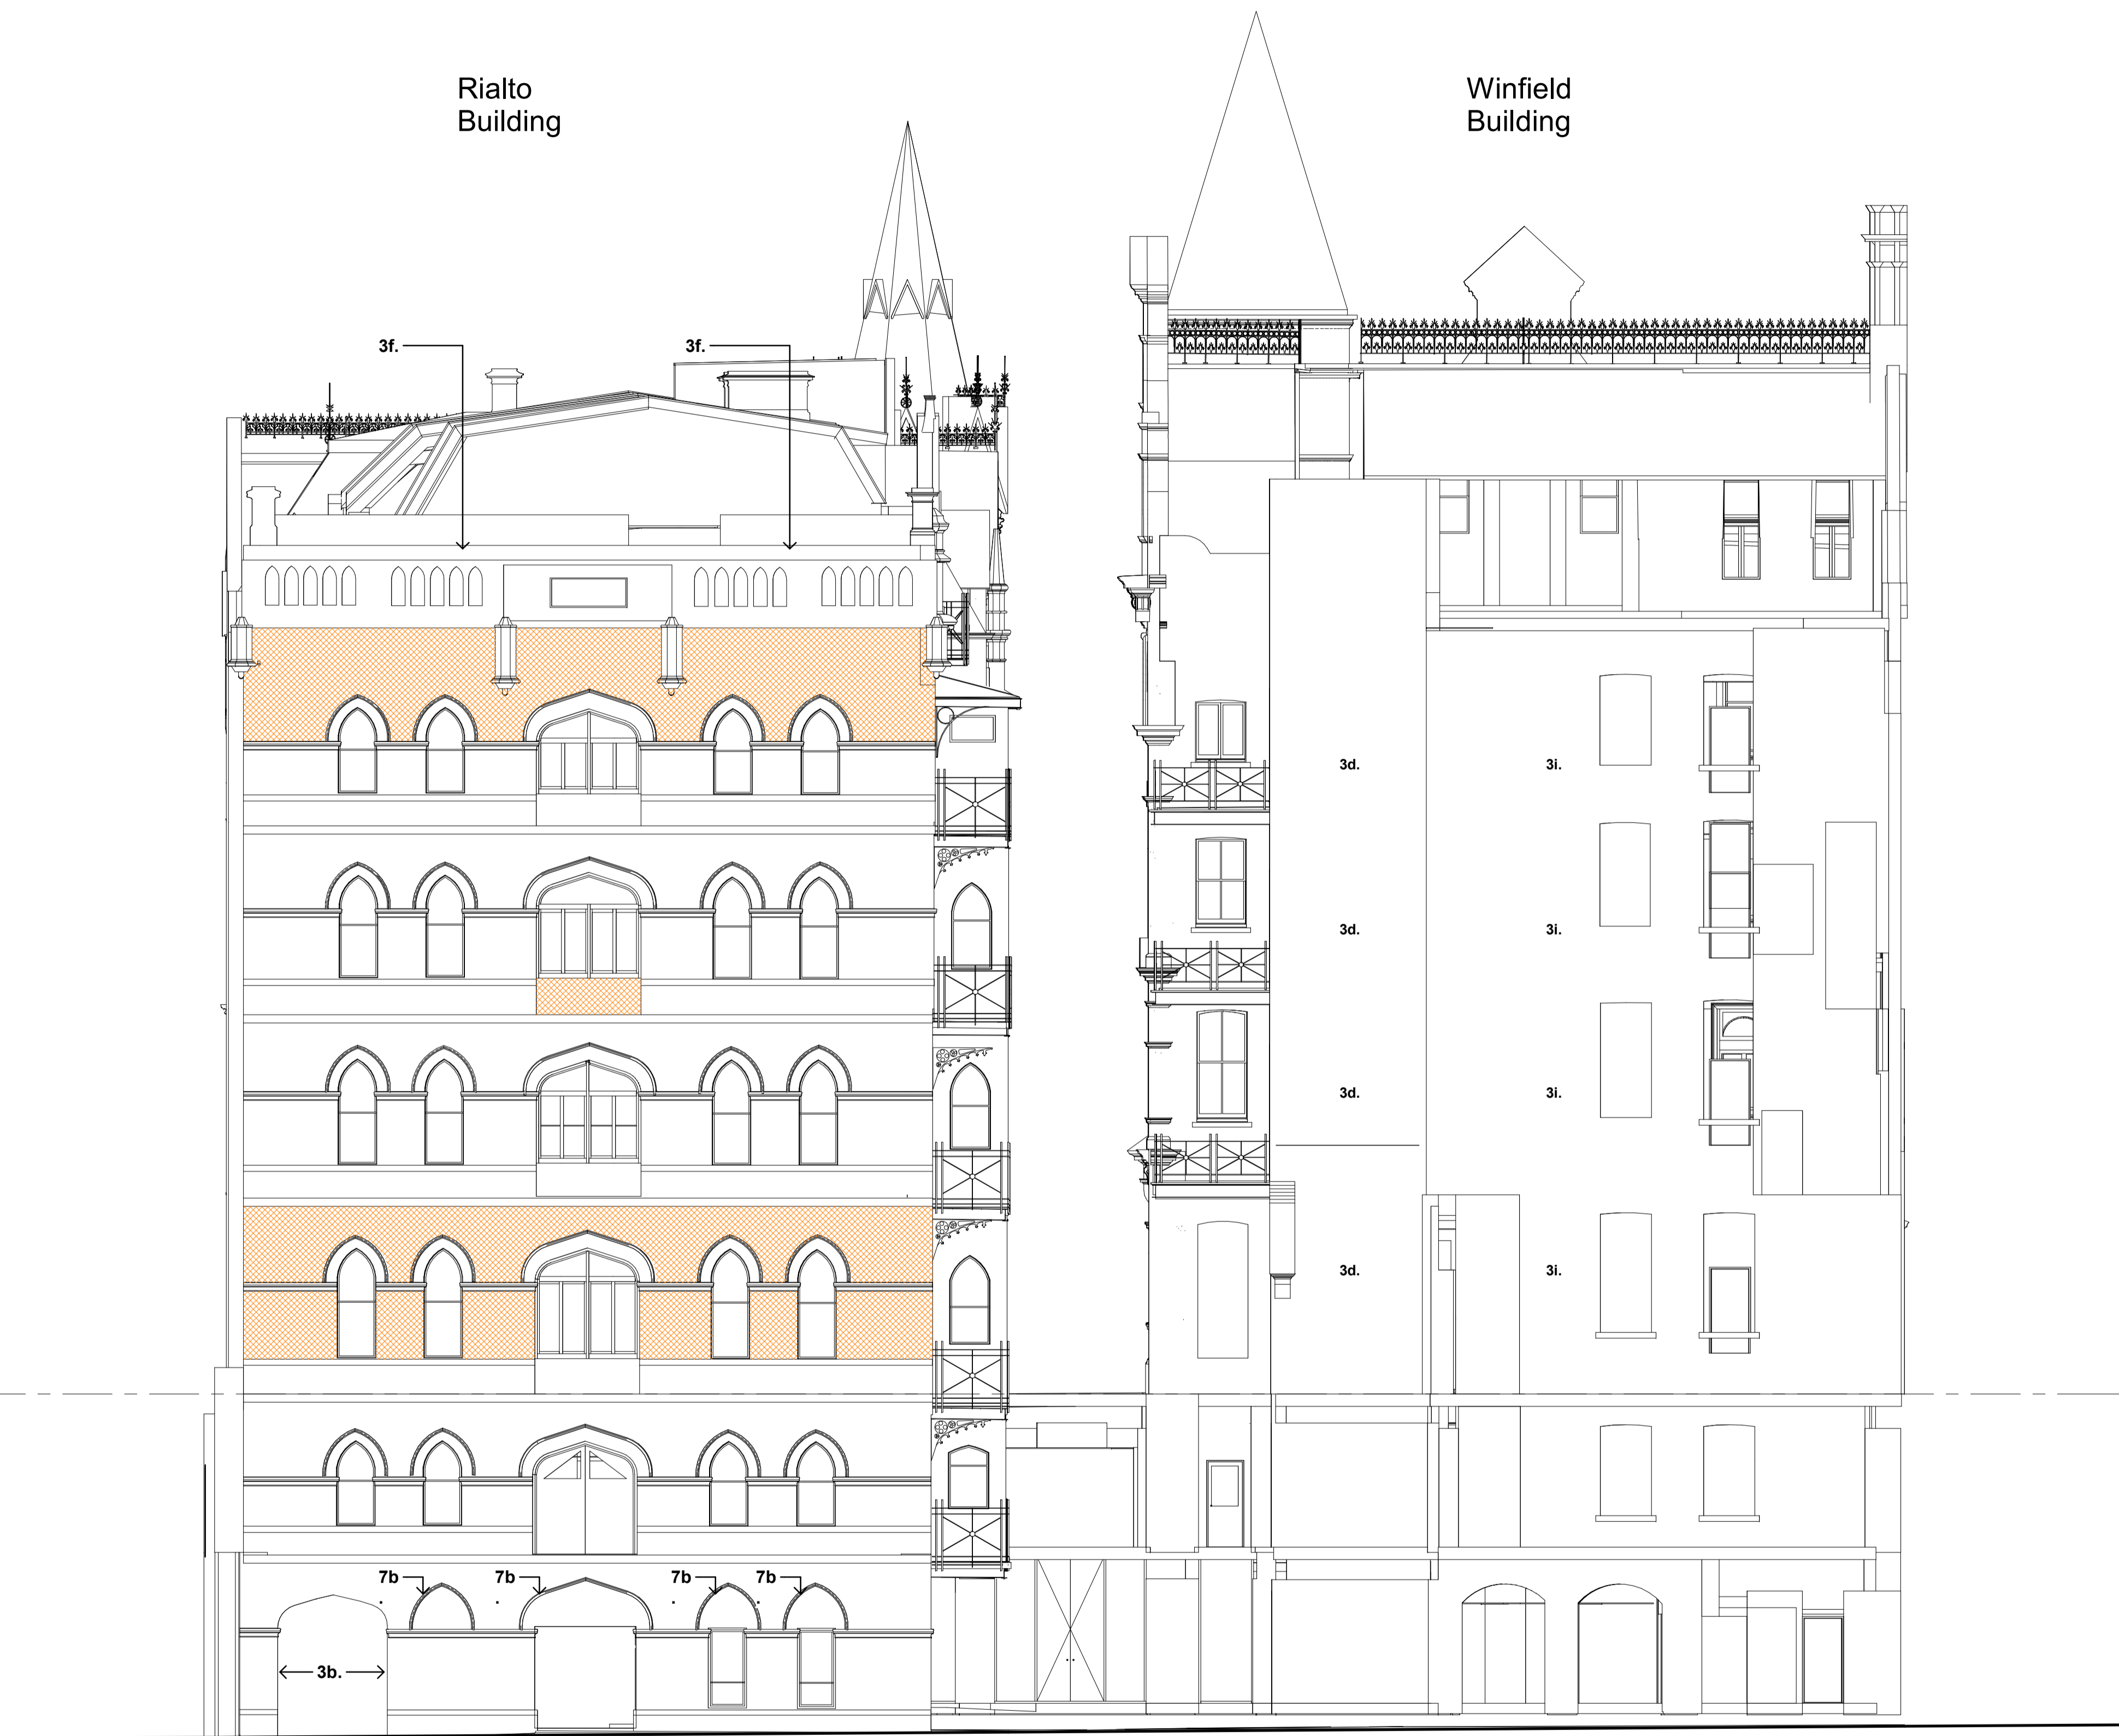
1 South Elevation
02 1:100

Areas of brickwork to be repointed (further investigation may be required in other locations). See 3h on sheet 01 for details.

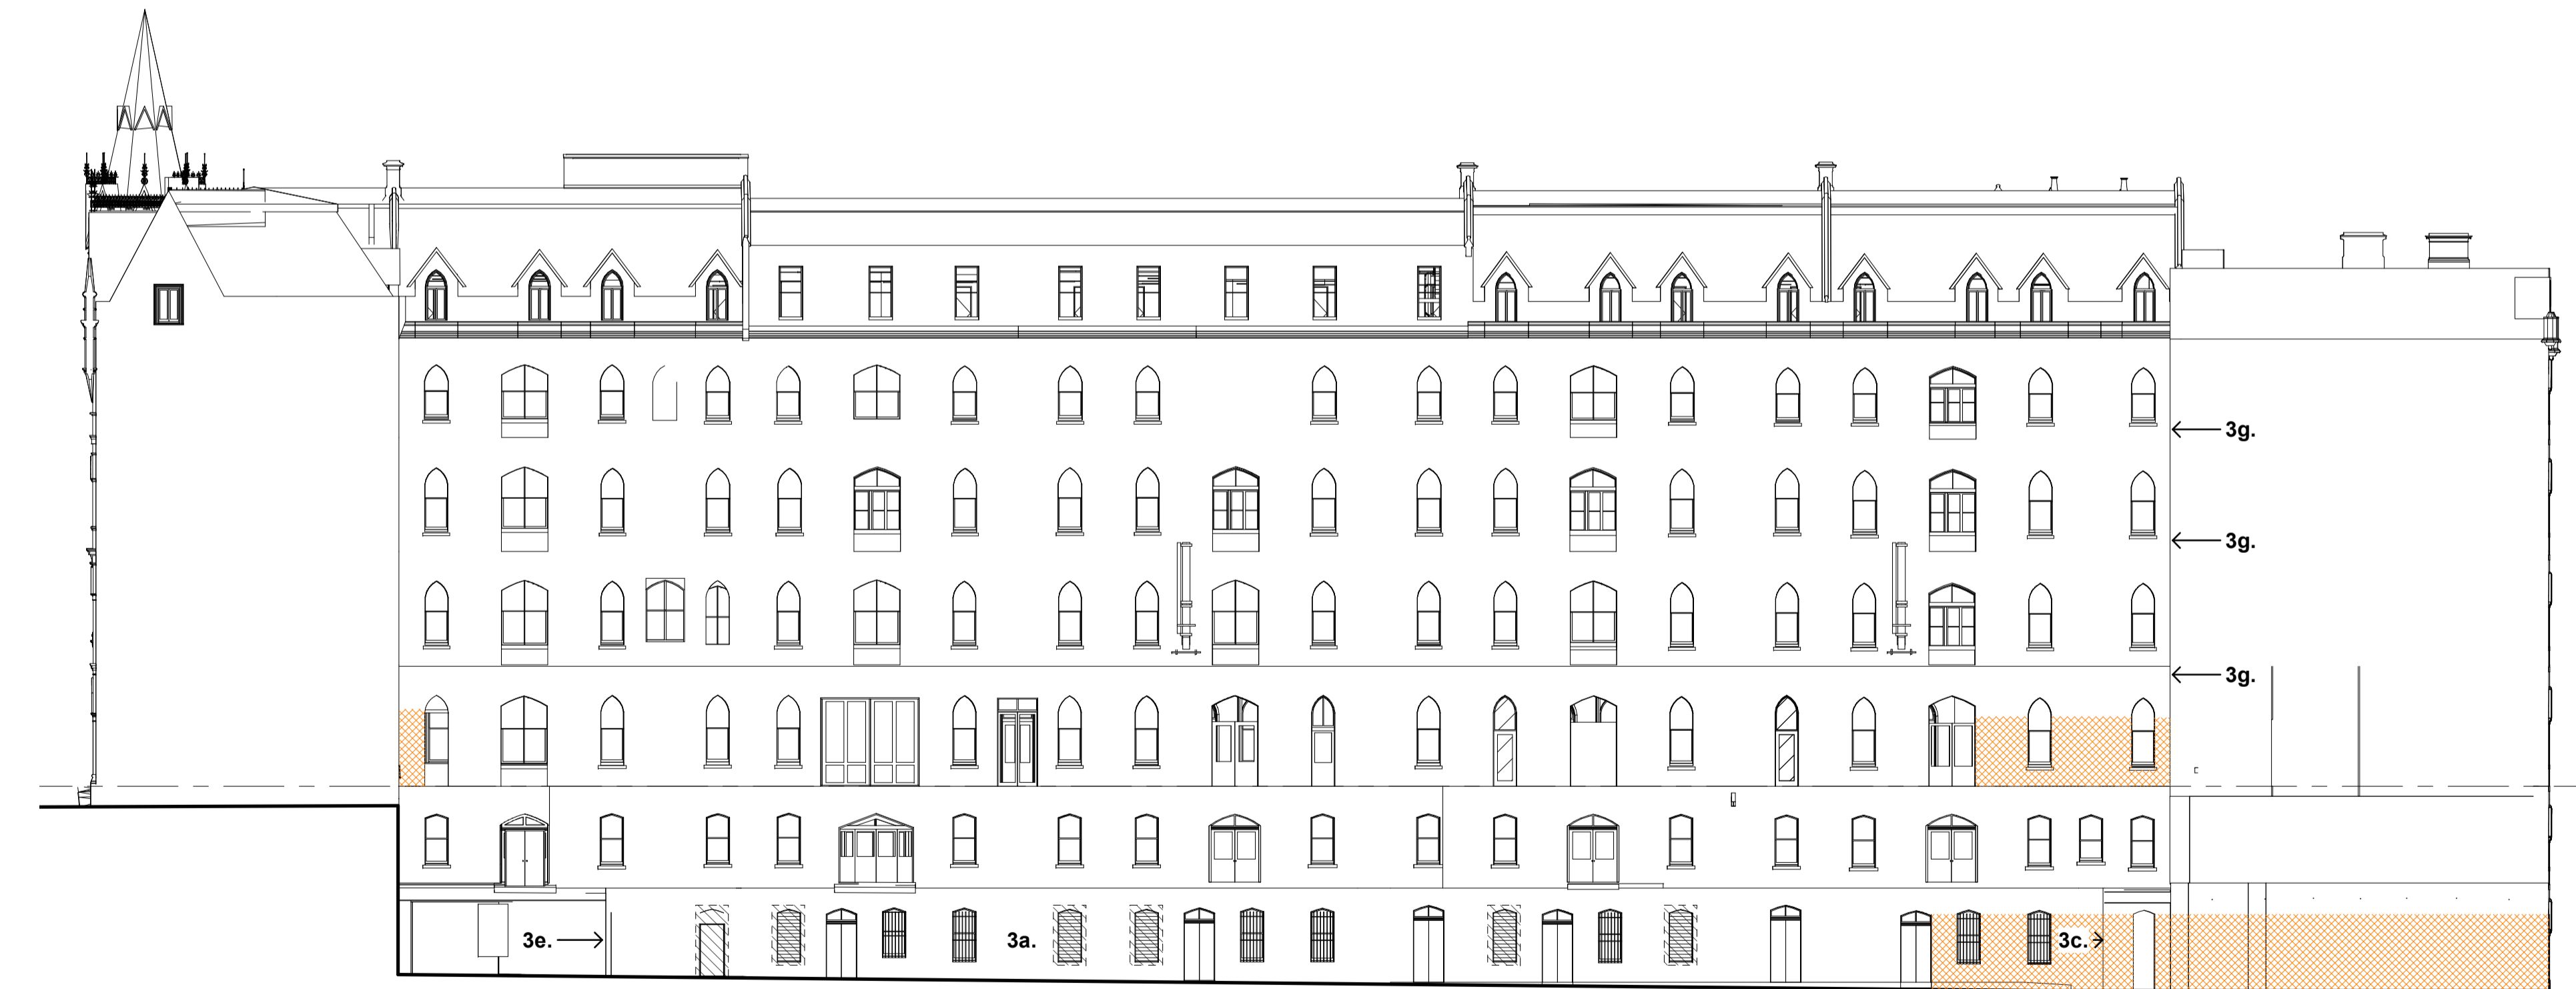
- Areas of brickwork to be repointed (further investigation may be required in other locations). See 3h on sheet 01 for details.
- Areas of metal roof cladding to be replaced (indicative areas only shown, ensure all metal roofing is replaced). See 1d on sheet 01 for details.
