Heritage Impact Statement

St Jude's Anglican Church
2 Keppel Street, Carlton

Permit Application

March 2024

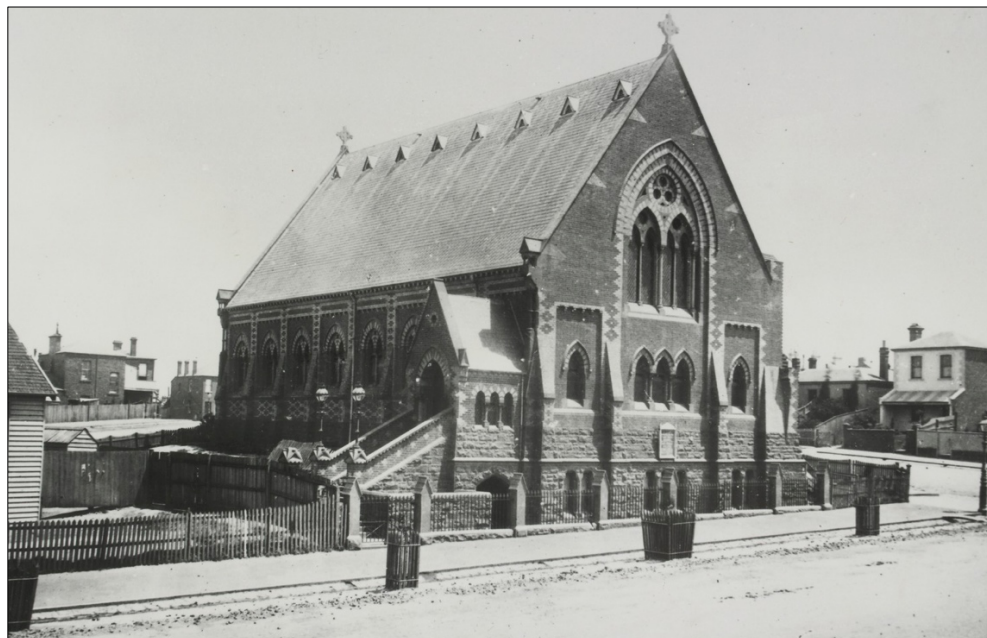
Figure 4 St Jude's Anglican Church viewed from Lygon Street, 1876 Source: State Library of Victoria .

The church as originally designed by Reed was to feature a tower to the north-east corner, however the great cost meant that this element was never realised. As a result, for many years the eastern side of the north elevation had a somewhat unfinished character (see Figure 4). A more modest bellcote and porch were erected instead in 1935.

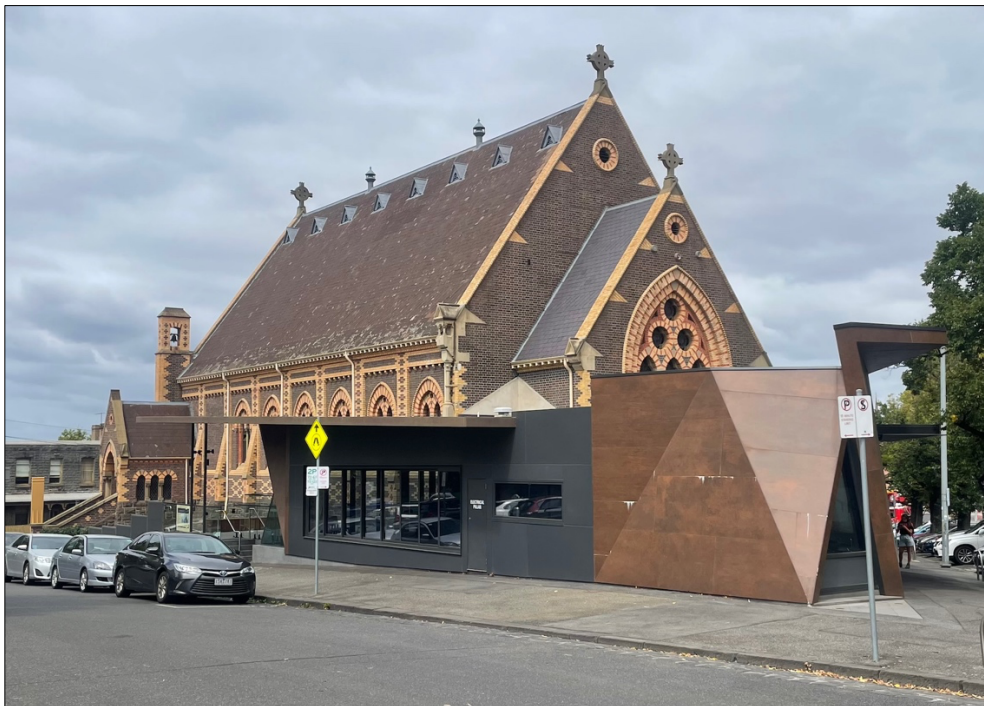
Figure 5 *St Jude's Anglican Church showing recent additions on the corner of Keppel and Palmerston Streets.*

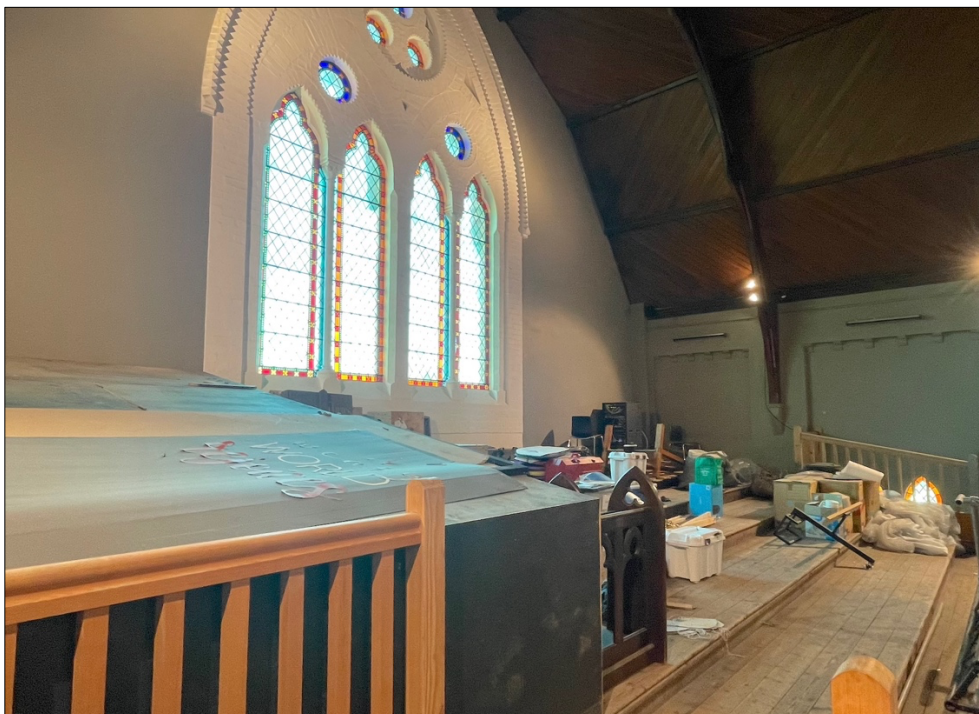
Figure 7 The gallery. It is proposed that the Fuller organ be installed in two sections either side of the stained glass window.

The organ is to be refurbished and installed in the gallery in two sections, placed either side of the stained glass window at the east end of the church. The two sections will be housed in new timber cases of polished oak to harmonise with the existing church joinery. The casework and façade pipes are supported by timber posts, which are to be carefully placed at points in the gallery that are structurally capable of supporting the additional weight. New pipework will have the traditional spotted metal finish.

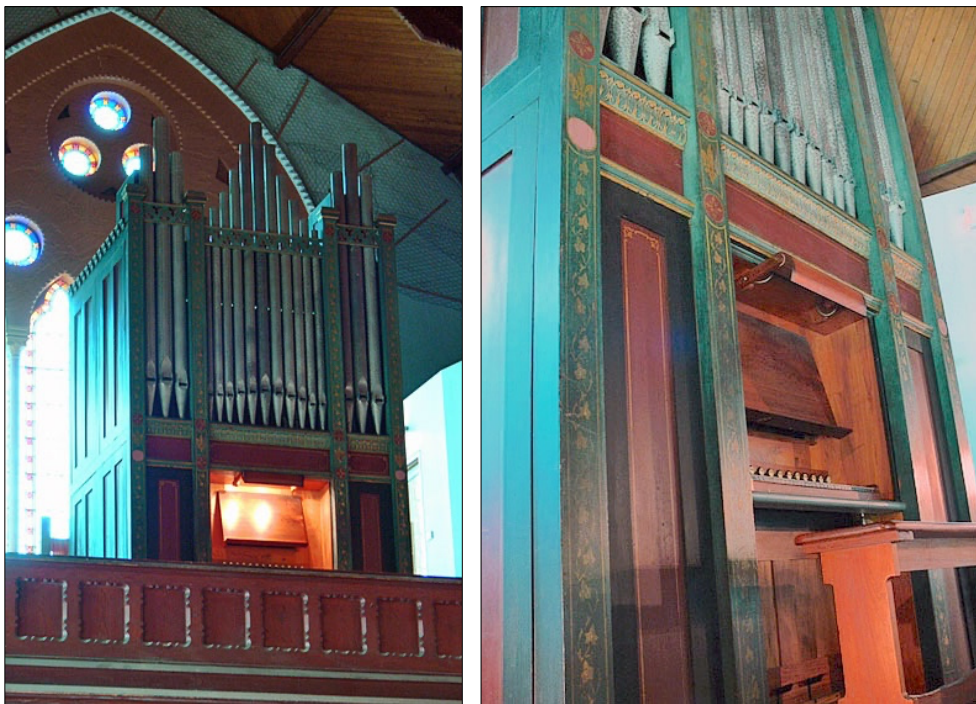
Figure 8 Photographs of the organ prior to the 2014 fire. Source: www.ohta.org.au

The instrument was fully restored by Knud Smenge in 1989-90 at which time the organ was returned to its original location in the centre of the rear gallery. The casework had been covered with thick brown varnish, was cleaned back with spirit solvent to reveal an elaborate original decorative scheme that included panels painted in turquoise and Egyptian red with gilt trailing ivy leaves and fleur-de-lys. The gold paint was also removed from the façade pipes to reveal the spotted metal beneath. Some of the console panels were remade in new blackwood to match the original where they had been damaged by electricians.

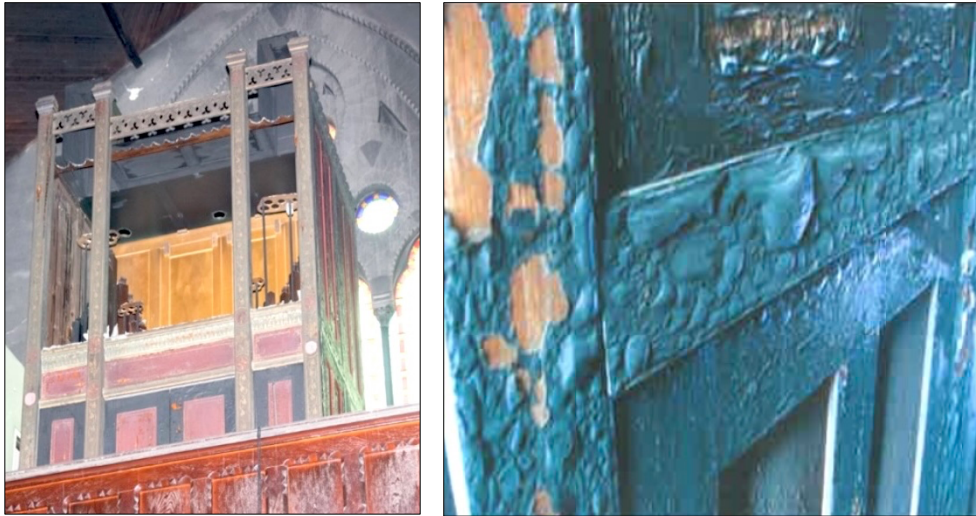
Figure 9 Photographs of the fire damaged organ, showing much of the lead pipework destroyed and blistered paintwork to the casing.

The current state of the case paintwork is extremely poor. The extreme heat of the fire has destroyed the paint's adhesion to the shellacked finish underneath. So extensive is this damage that any handling of the case parts causes the remaining paint to flake off, presenting health and safety concerns and spreading toxic paint chemicals through the clean church interior.

The heat of the fire has altered the chemistry of the pigments permanently on nearly all of the visible surfaces, save for those areas where the case faced away from the heat source.

The pipe work of this organ has melted, and the most important historical aspect (the voicing) of this instrument has been irretrievably lost. Ingots of pipe metal have been saved and there are trays of melted pipe bodies and feet. The remains of the metal pipes and languids have been annealed by the heat. It is uncertain that they would not eventually sag under their own weight if incorporated in a restoration. Pipe restoration would be fiercely expensive to do with the end result being a reproduction and not original. The instrument had also been regulated and re-voiced by Knud Smenge during the last major work on the organ.

The painted decoration would not be able to be saved, due to pigment damage, crazing, crawling, and extremely poor adhesion. The original unique decoration is not repairable but can only be replicated.

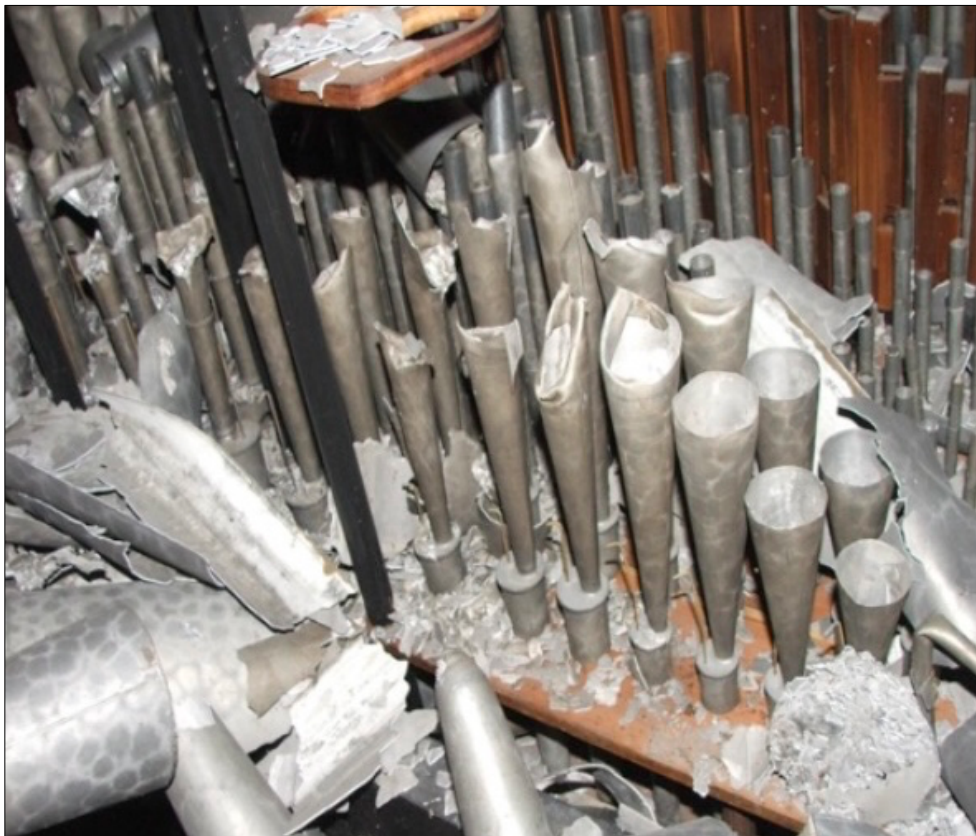
Figure 10 Photograph of the largely destroyed lead pipework.

The organ's original voice and sound has been lost and cannot be restored. It can only be replicated.
