Tree Protection Management Plan 'Ascension of Polka Dots on the Trees' Art Installation – St. Kilda Road, Melbourne.

2 October 2024

Tree Logic Ref. 013763

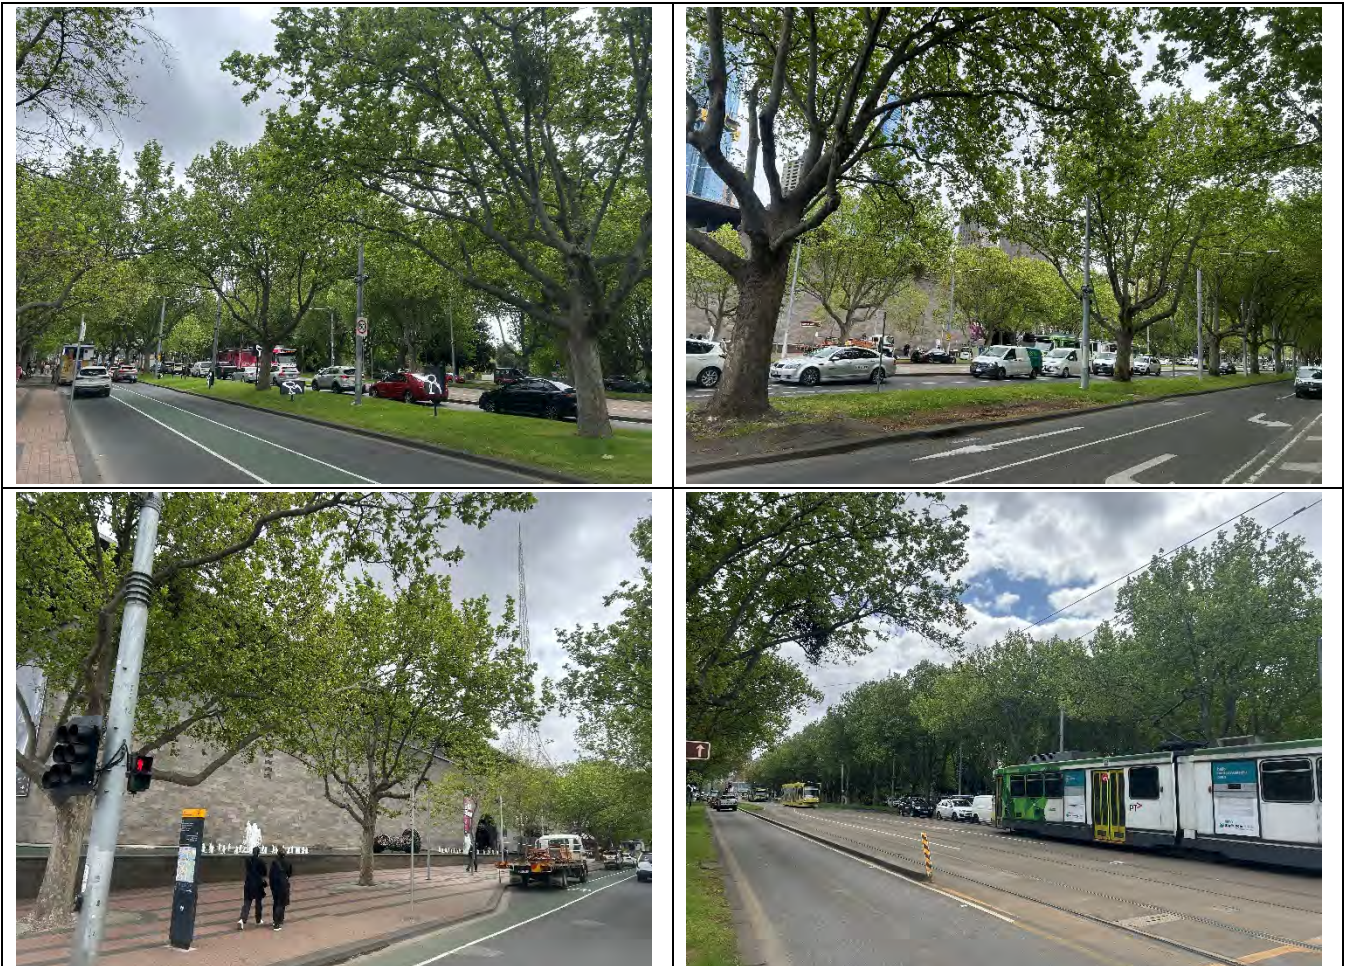
Figure 1 (upper left): View facing north showing showing trees growing within the centre median strip closest to the National Gallery of Victoria.

Figure 2 (upper right): View facing north-west from Linlithgow Avenue showing the Plane trees growing within the centre median strip on the east side of St Kilda Road.
