VICTORIA TRADES HALL - STAGE 3 WORKS

HERITAGE IMPACT STATEMENT

54 Victoria Street, Carlton

June 2024

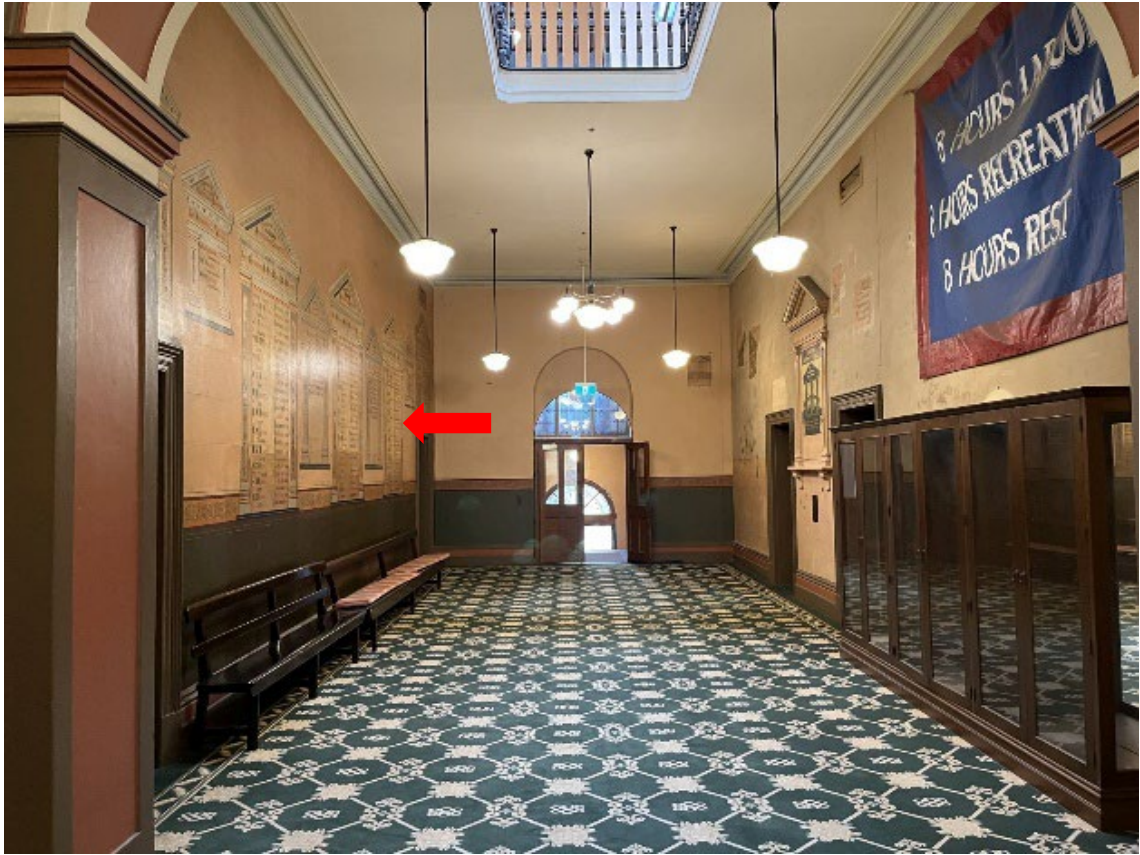
Figure 10 Reconstructed and exposed honour roll on east wall of entry hall (G46); recently replaced broadloom carpet with the entwined '888' symbology

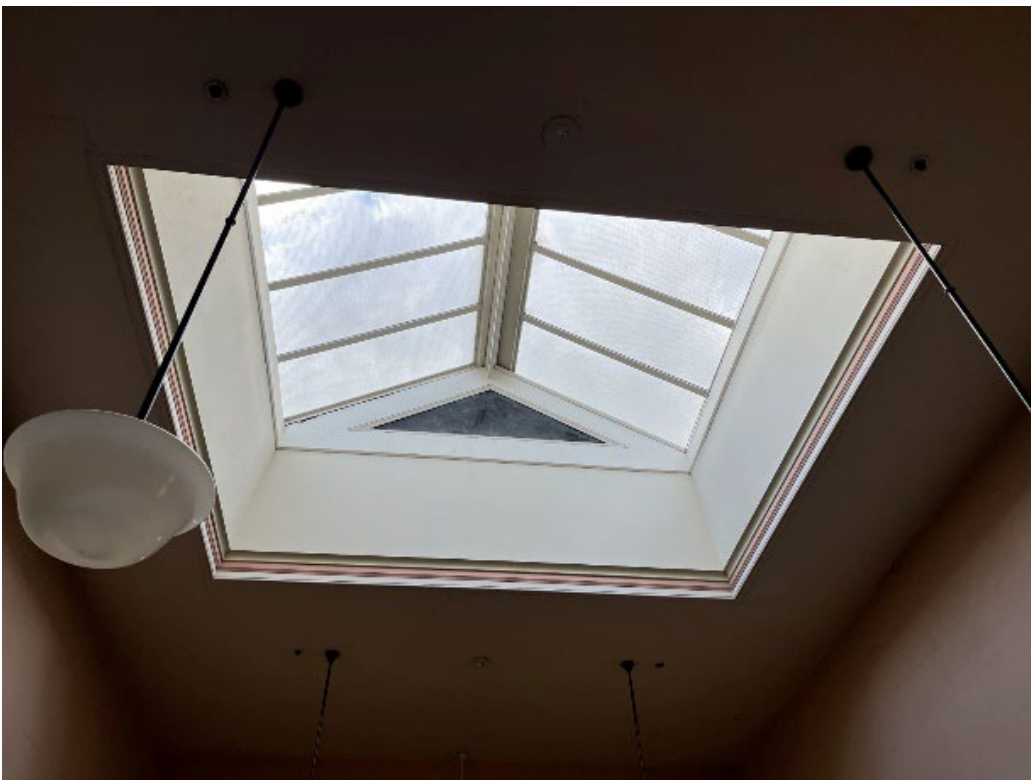
Figure 12 Typical skylight viewed from viewed from F34

- Remove glazing and flashings to skylights on roof of Caretaker's Cottage (Stage 9), Stage 1 and Stage 8 (Figure 12). Skylight mullions and galvanised framing on Stage 1 and Stage 8 are to be retained (refer to Drawing No. A-103 and No. A-203).

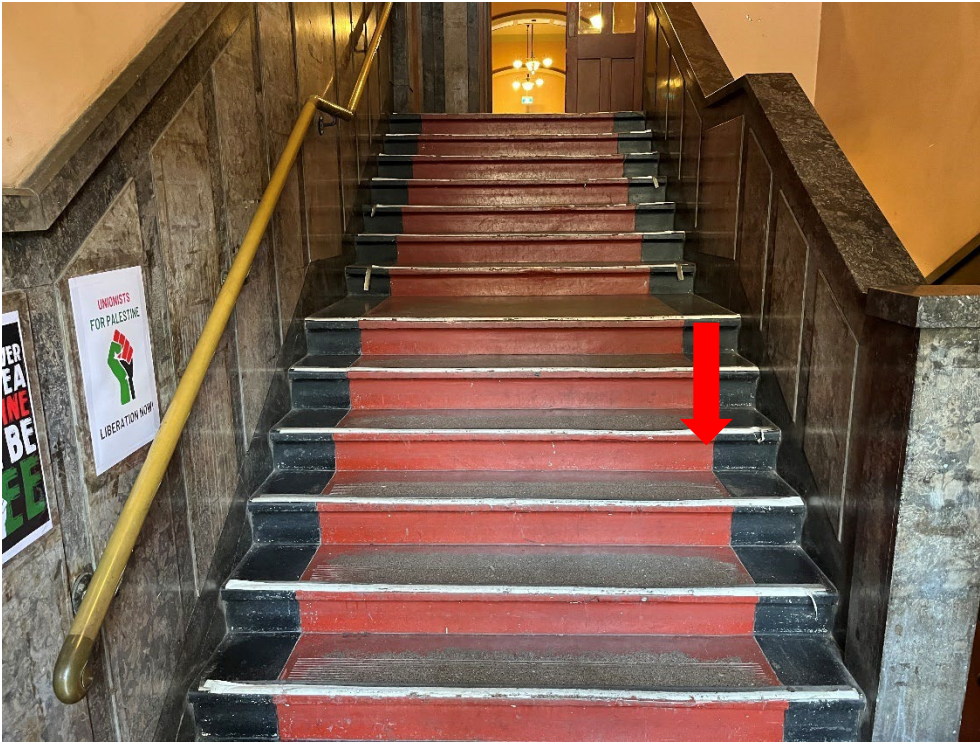
Figure 17 Ground level entry stairs to Victoria Street wing showing location of proposed handrail to be fixed to concrete floor

- Installation of new 40mm diameter bronze handrail with bronze posts fixed to all flights of stairs in Stage 9 main entry (Figure 17, refer to Drawing No. A-201 and A-300)

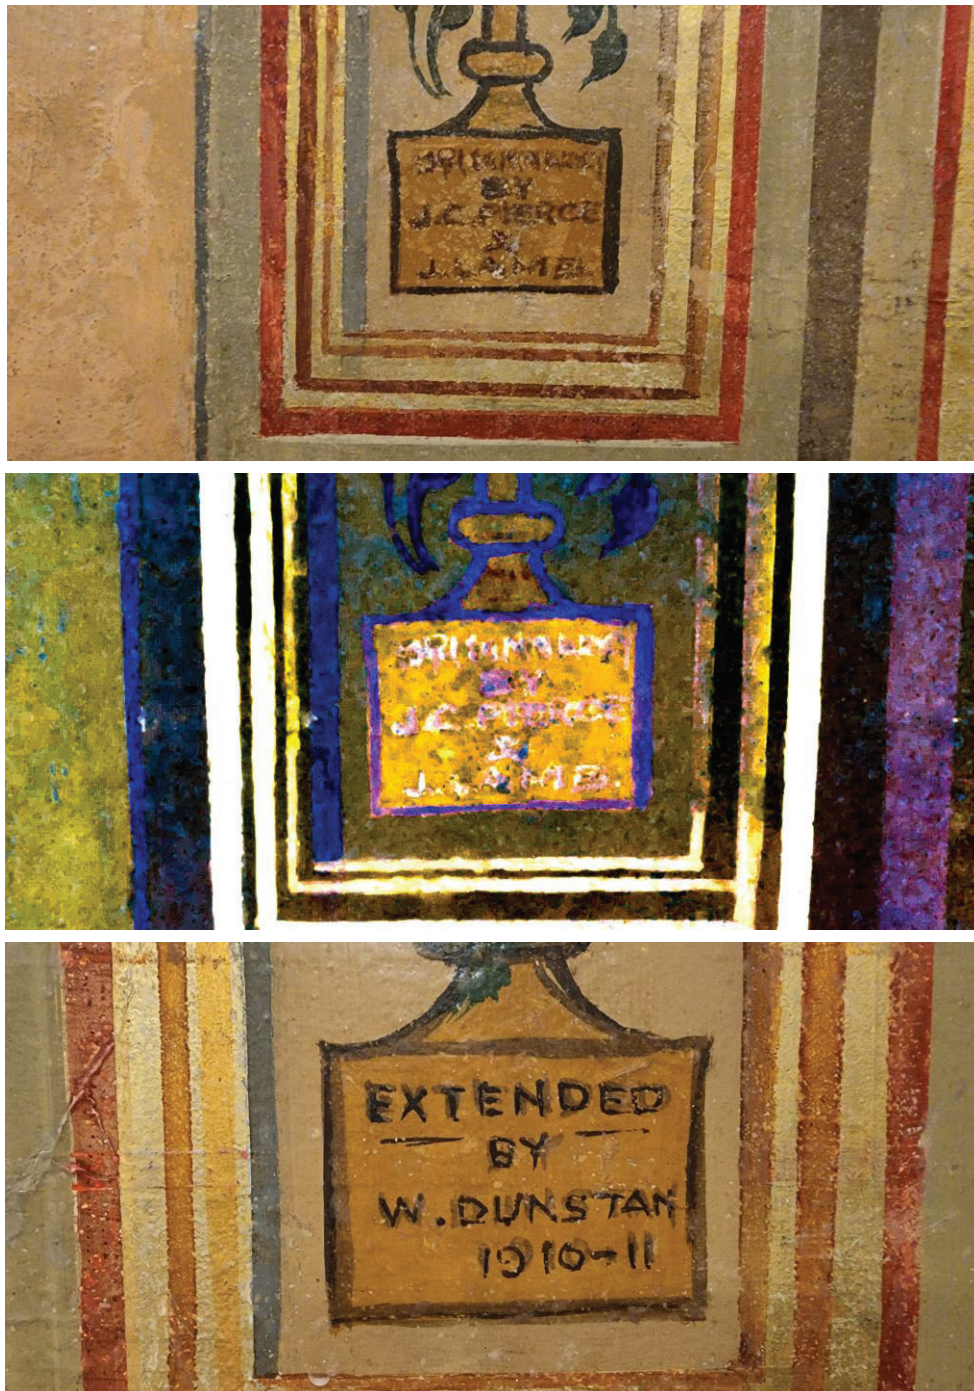
Figure 2 The East wall plaques have been signed twice. The upper image gives the name of the original sign writers Pierce and Lamb. The B of Lamb appears to have been obscured by 1990s retouching as is the upper word. The central image gives a false colour rendition clarifying both Lamb and the upper word "Originally". The word Originally is significant as it implies that Dunstan, who extended the plaques in 1910-11 (lower image) is more likely the painter of the first signwriters' signatures.

Figure 2 shows the signatures of the various signwriters involved on the East wall. The upper image names Pierce and Lamb, but curiously prefixed with “Originally”, suggesting that they did not sign the work themselves but that it is more likely Dunstan in 1910-11 or an earlier painter who recorded the first painters. Both signature panels have been extensively overpainted in the 1990s, rather poorly, as can be seen in the Dunstan inscription and to such an extent that the Pierce and Lamb signature panel is obscured.

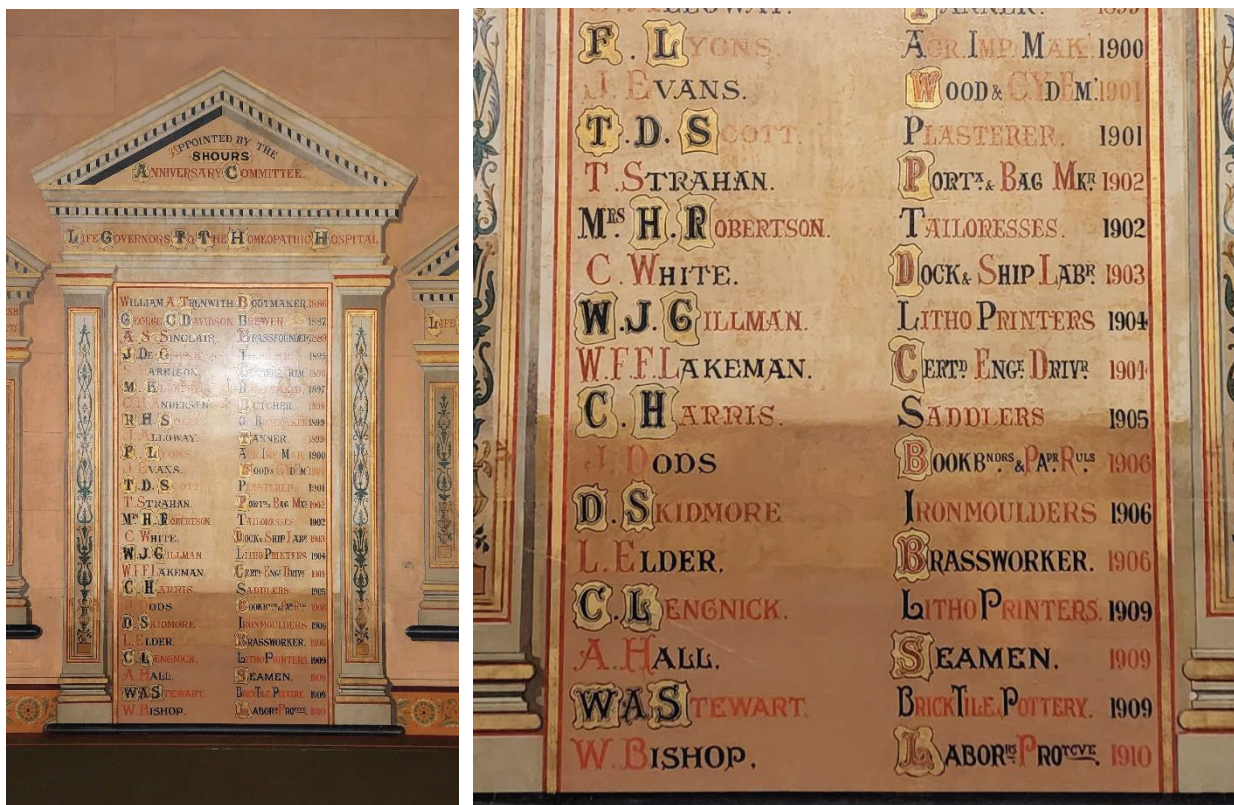
Figure 3 Panel on the east wall with detail of the lower section where Dunstan has extended the names and dates.

Figure 3 makes clear where Dunstan’s work commenced, with a clear demarcation between the lighter yellow earlier work and his browner addition beneath. Font analysis shows substantial differences in letter types for almost every letter between the upper yellow section and Dunstan’s brown section below. The Pierce font is closer to the classical Roman font with conventional serifs, whereas the Dunstan font embellishes with curlicues of his own invention. There are some stylistic idiosyncrasies between the cartouches onto which the leading majuscules are applied as well.

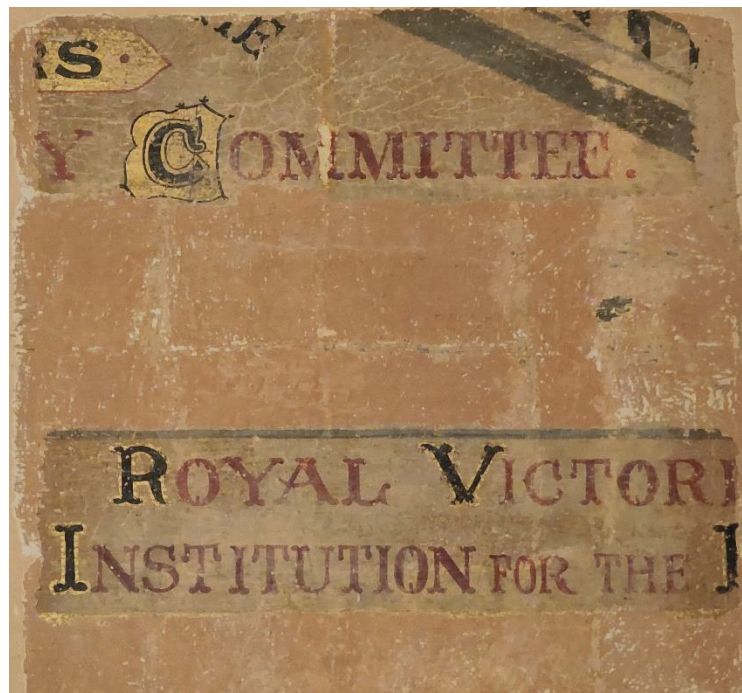
Figure 6 A revealed detail of the western plaque on the south wall. The font is consistent with the upper east wall plaques.

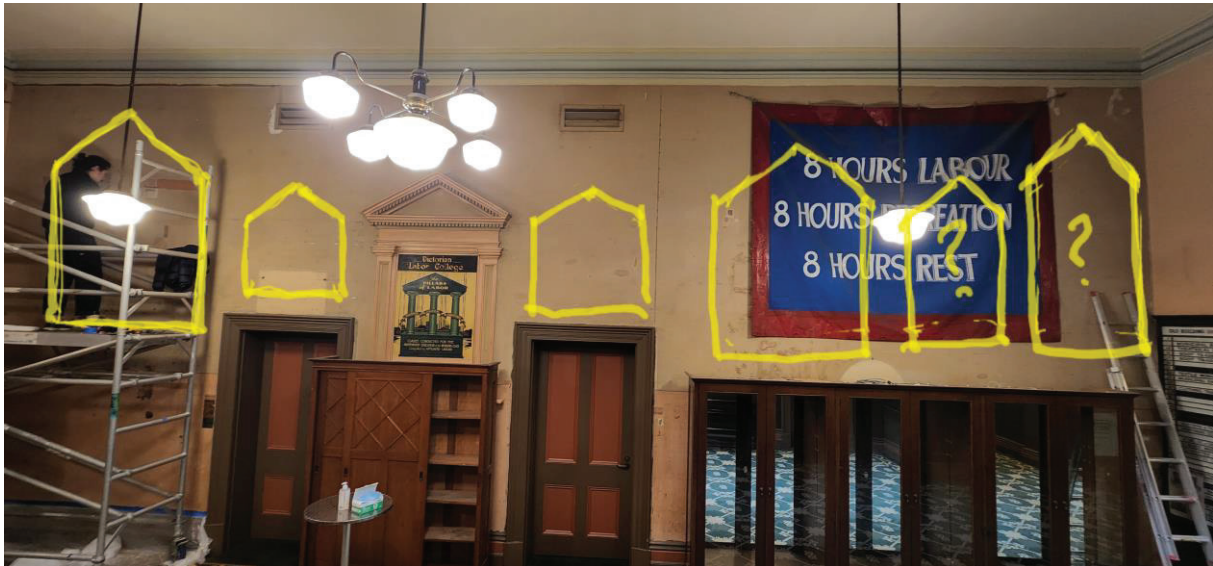
The west wall has been the main focus of this study due to prior evidence of the scheme. Various windows have been exposed in the 1990s to reveal plaques matching those on the east wall. A raking light survey has confirmed that plaques run along the entire length of the west wall as indicated in figure 7. The southern end of the wall was less distinct than the four obvious plaques marked while the second from the right has been assumed.

Figure 7 Raking light has confirmed plaques in the layout suggested in this markup.

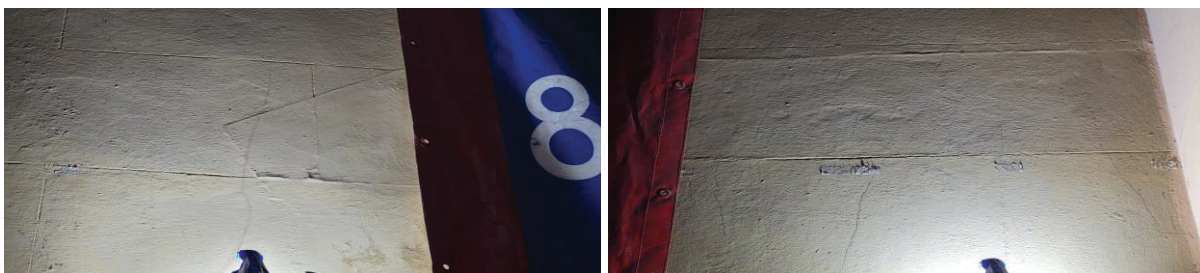
Figure 8 Raking light has identified the four plaques to the left of figure 7 and that at the far right. The images here are of the panels either side of the banner. The left-hand plaque is clearly evident whereas the right hand one is there but less distinct with just a faint indication of the right-hand pediment visible.

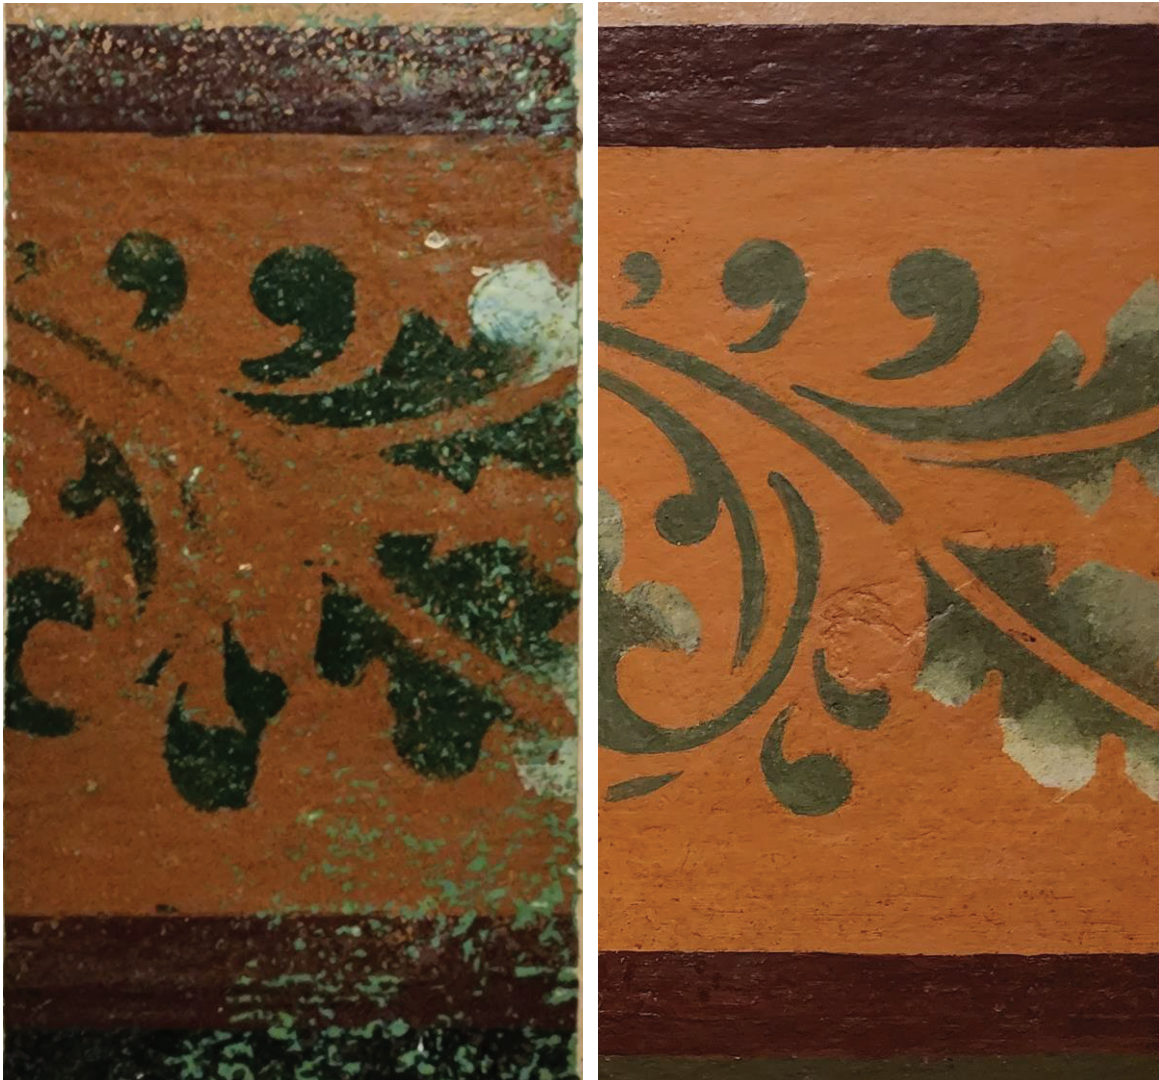
Figure 10 Comparison between the original stencil on the west wall (right) and the extant stencil on the east wall. It is noted that the highlighting of foliage on the east wall is absent from the exposed original on the west wall.

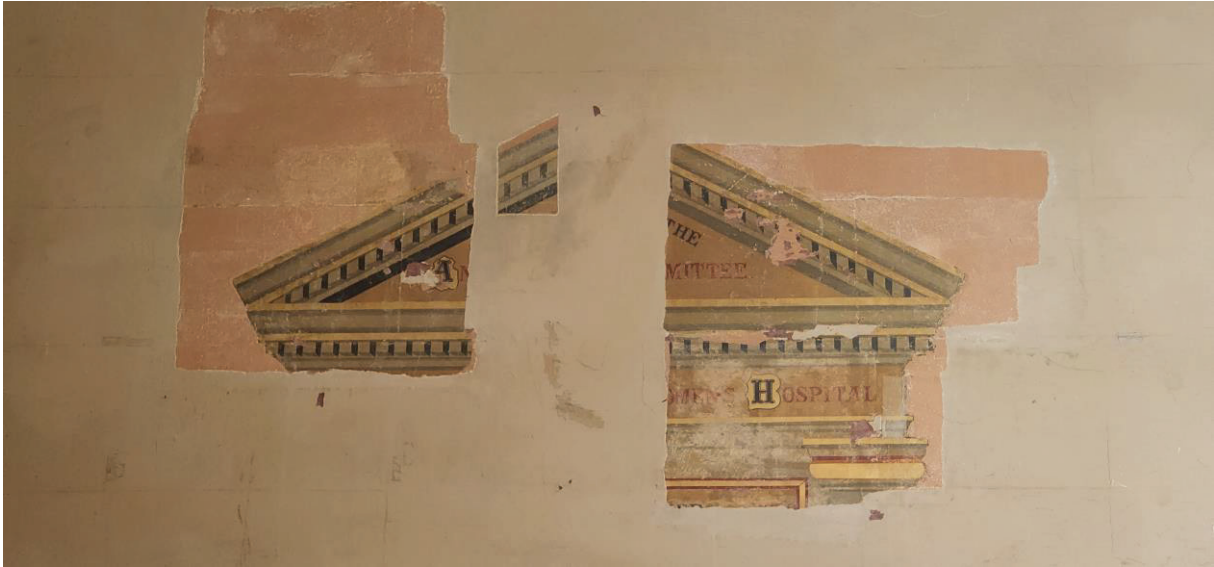
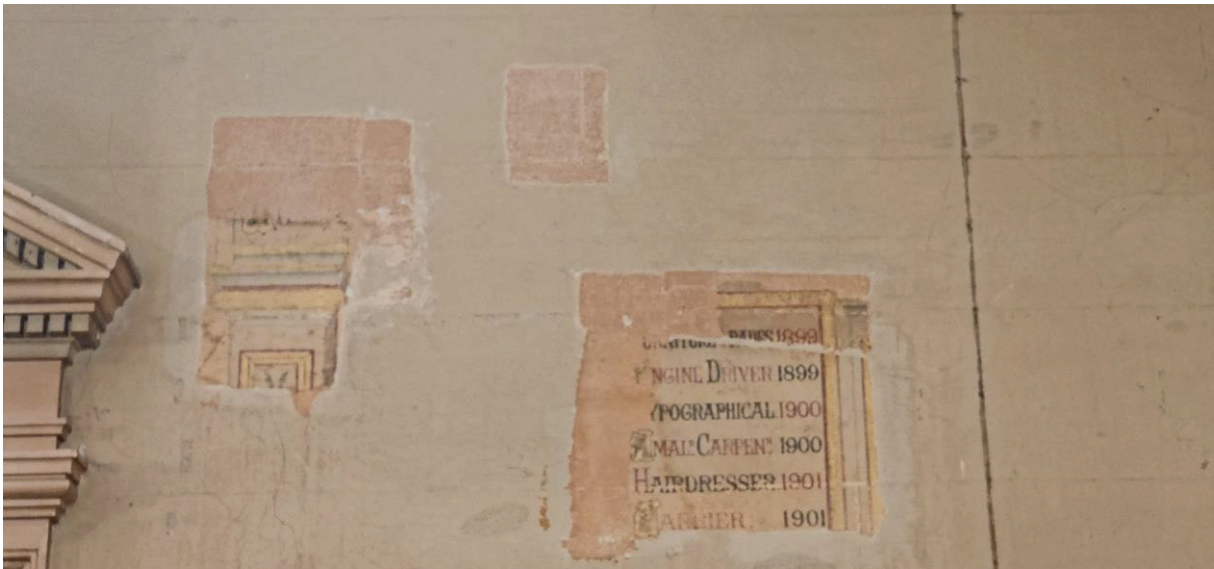
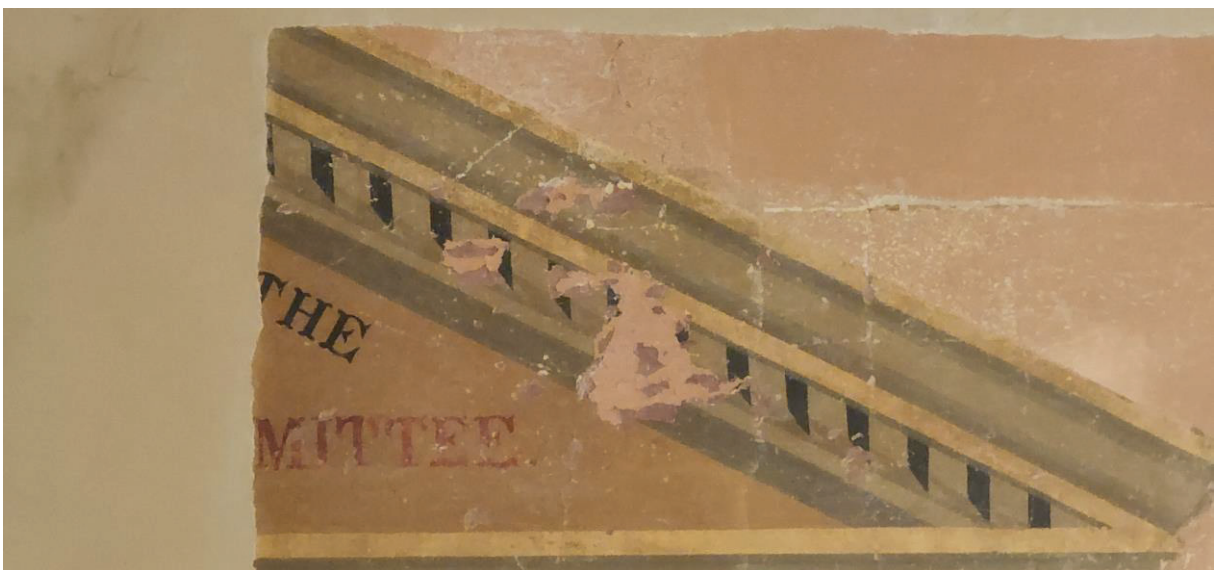
Figure 14 Paint removal areas on the west wall.

The results, particularly on the gold, have been impressive in terms of full retention without damage. This is not immediately obvious for the test areas, as much of these areas have been the subject of various prior less successful trials. The following areas have been exposed on the west wall, with the less successful results on the south wall pictured in figure 6. The less satisfactory results in the south wall are the result of insufficient time to adapt the west wall technique to the changed overpaint sequences. It is believed that further refinement will produce a satisfactory result on the south wall to match that of the west wall.

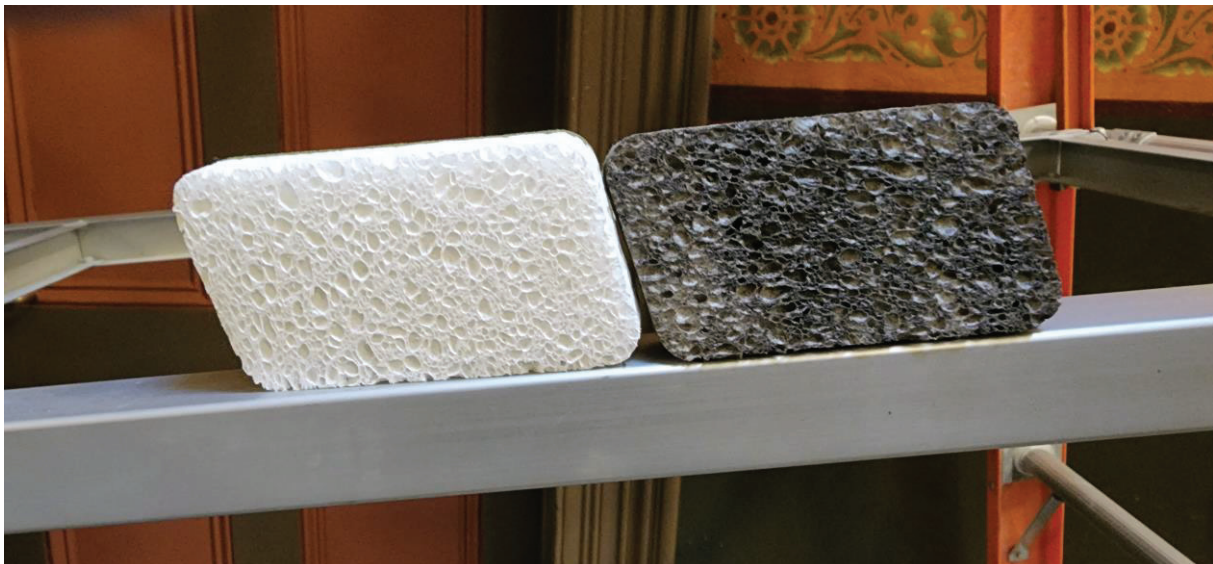
Cleaning trials indicated there would be no dramatic change to the appearance of the painting and hence an efficient cleaning with sponges was undertaken. The key requirement was to change the sponges at regular intervals before they became noticeably soiled, to avoid redeposition of soiling into the painting. While there was no appreciable change to the surface appearance, figure 15 indicates the level of soiling. Sponges were constantly rinsed and changed.

Figure 15 Comparison between clean and soiled sponge on east wall.
