Assessment of 23 trees within the Avenue  
of Honour, Bacchus Marsh

## **Health and condition review**

**Prepared For:** Moorabool Shire  
Council  
Att: Ross Holton  
PO Box 18, Ballan,  
VIC 3342

**4 February 2020**

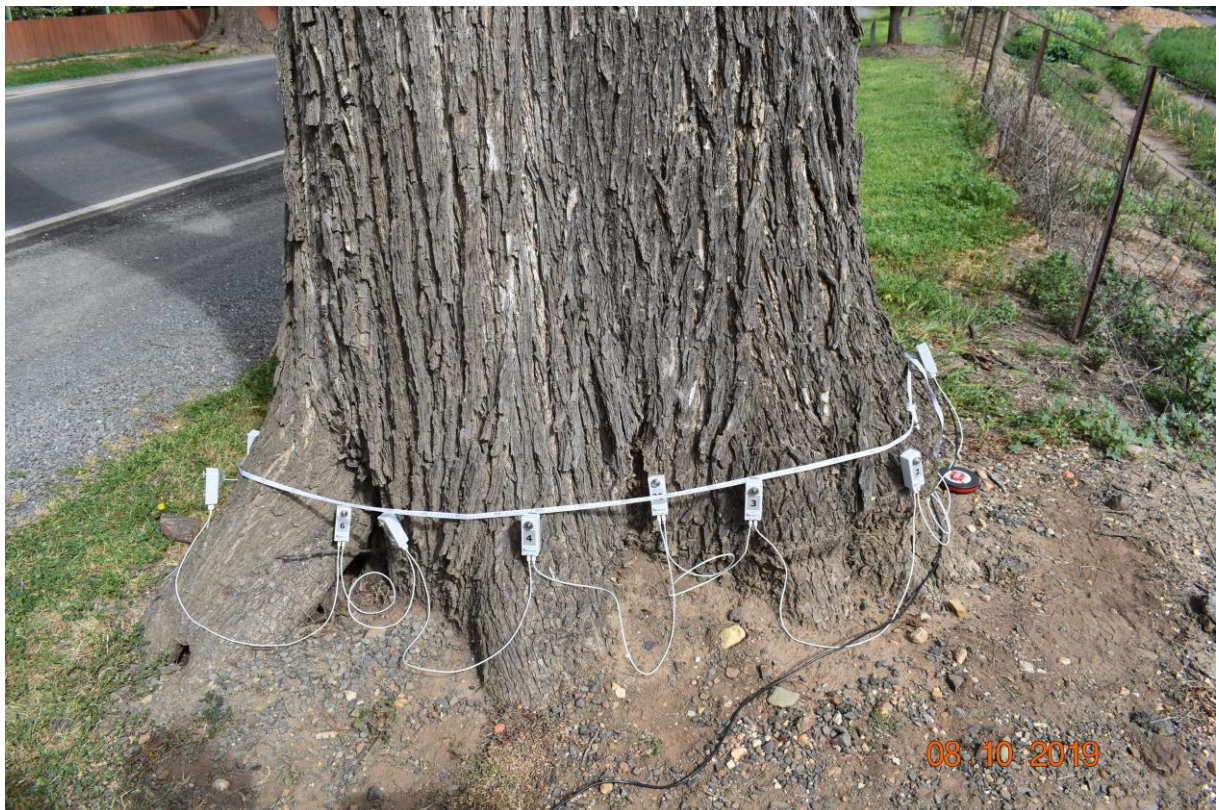
Figure 8: Arbotom® sensors around the subject tree.

Sensors are placed around the subject tree's stem at the location of concern (Figure 8).
