PROJECT 1-19 CLARENDON ST

DRAWING EXTERNAL REPAIR WORK  
- SOUTH ELEVATION

EXTERNAL REPAIR WORK - EAST ELEVATION

| A | HW RFI 01 | NOV 2024 |
|---|---|---|
| DRAWING | EXTERNAL REPAIR WORK - WEST ELEVATION | |

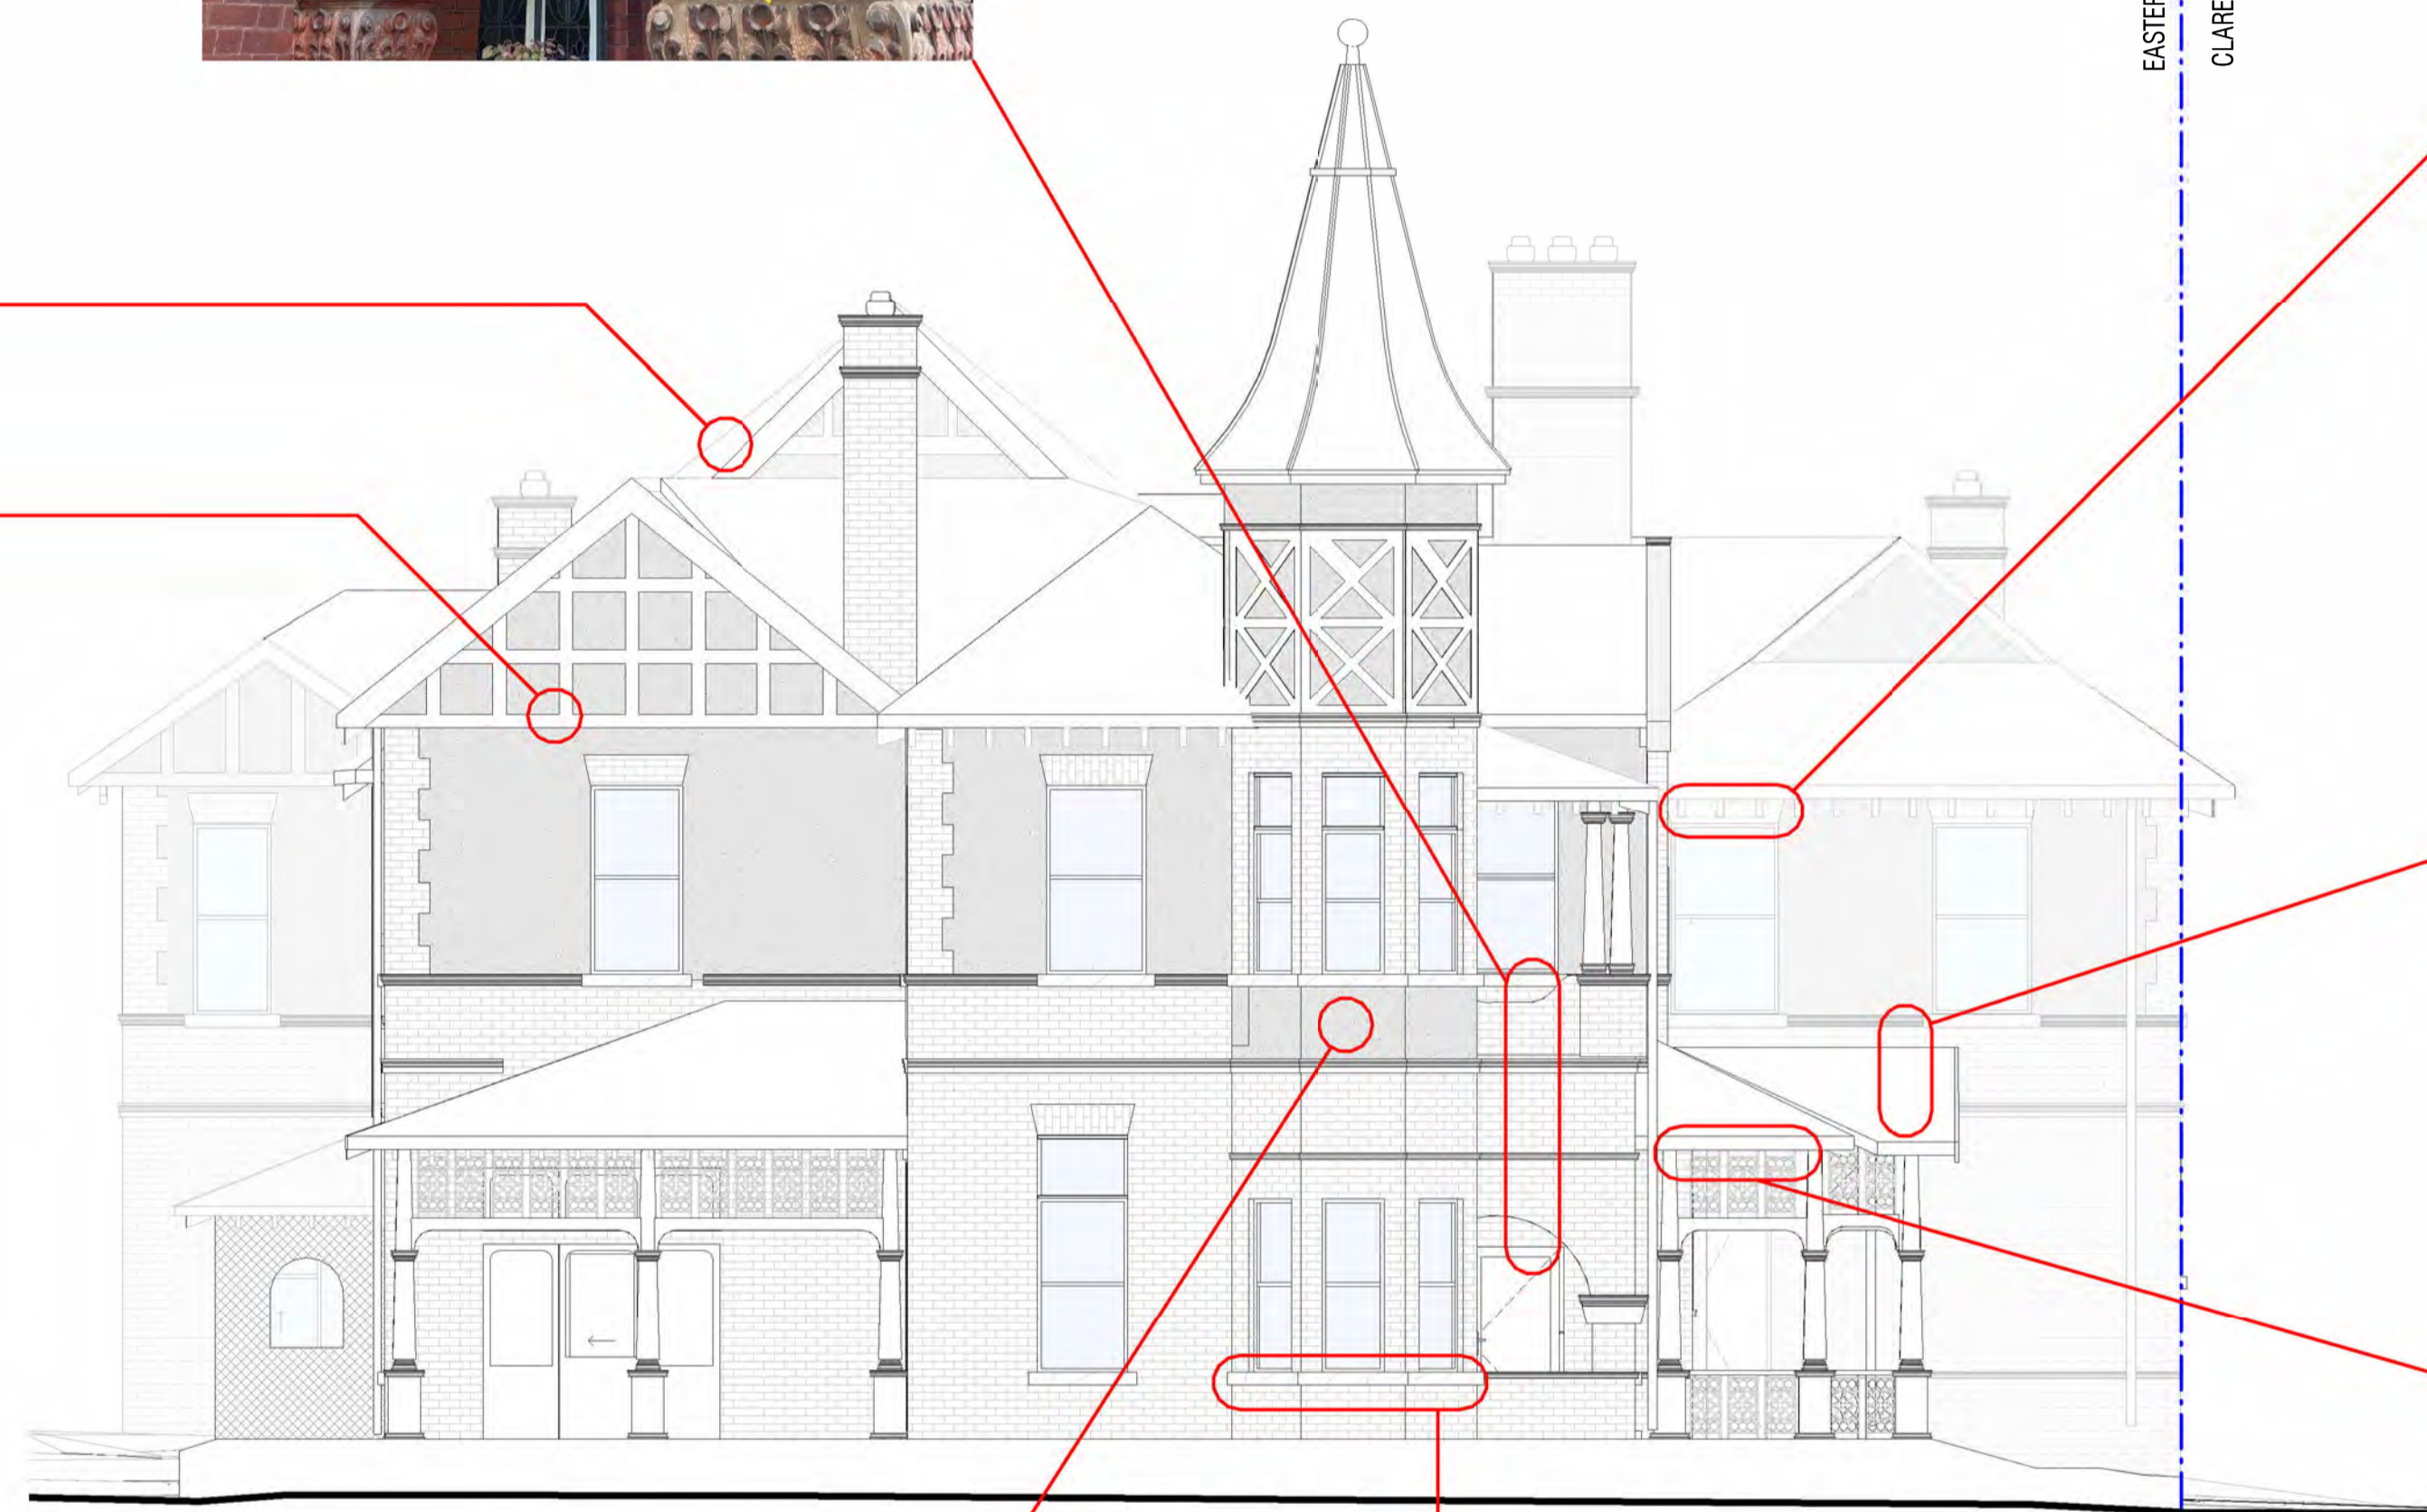
TIMBER STRAPPING SHOWING SIGNS OF ROT. REPAIR REQUIRED

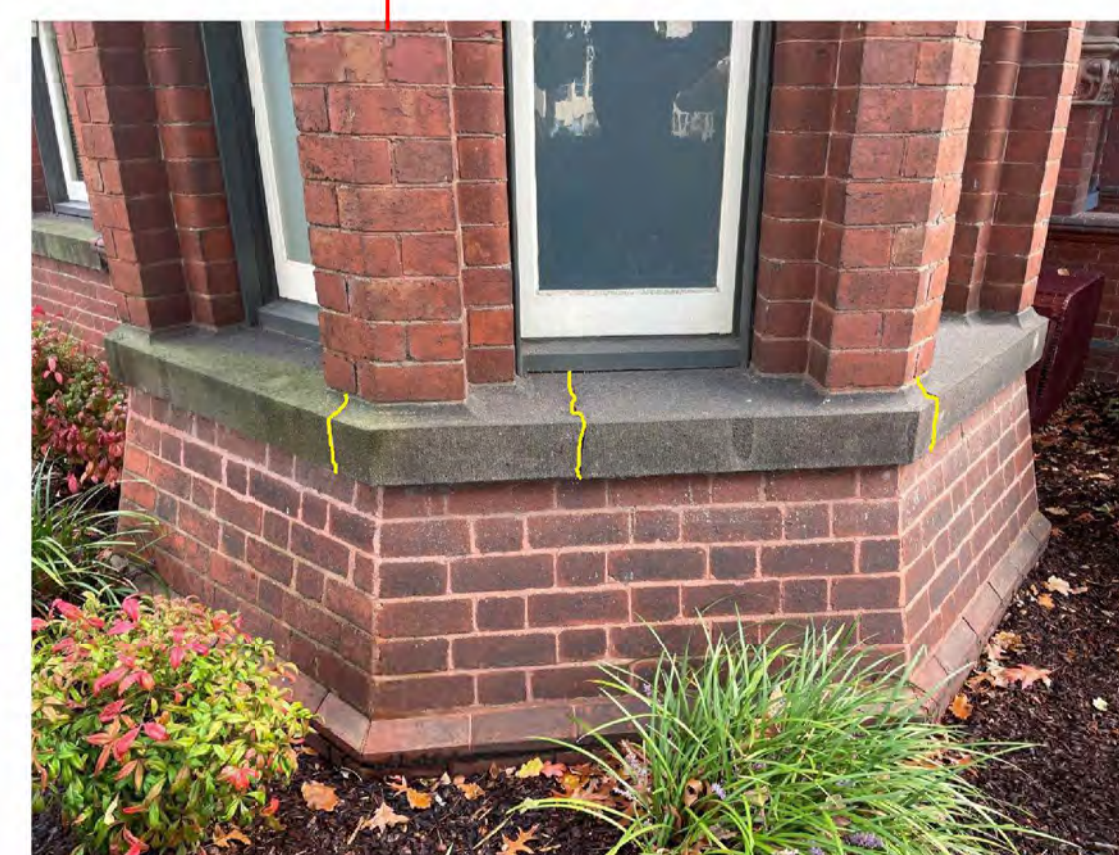
CRACKED SILL AROUND BAY WINDOW

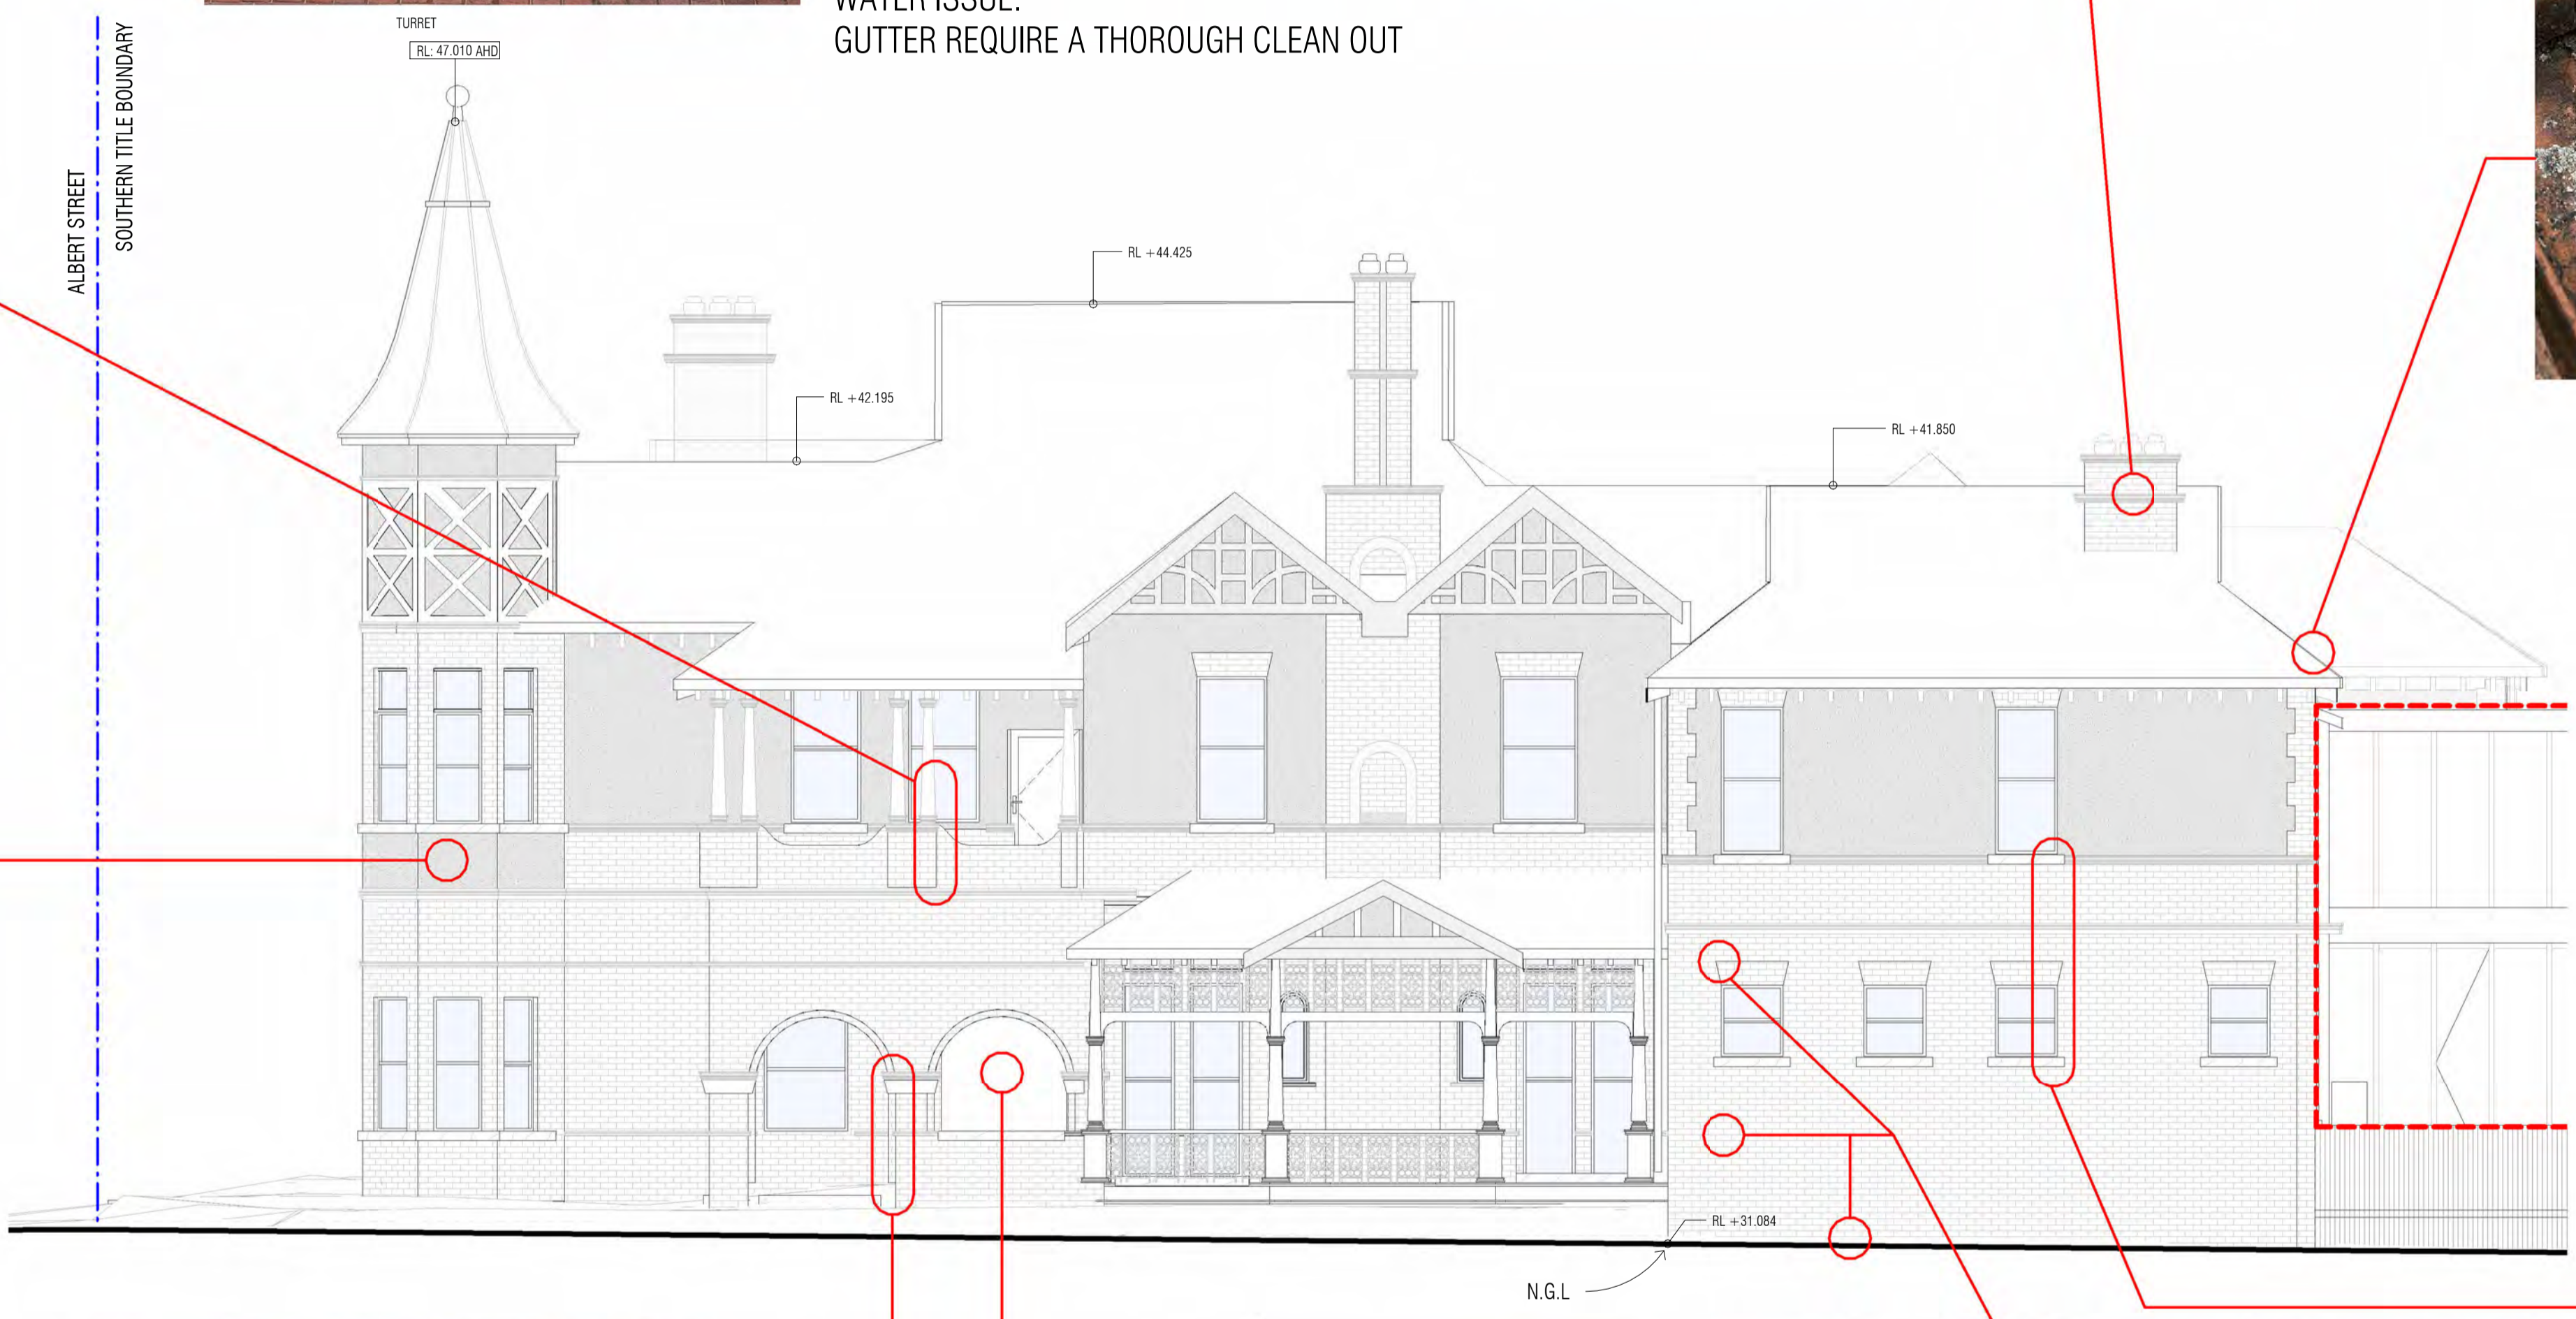
WATER DAMAGE BEHIND TERRACOTTA  
TILES. TILES CRACKING

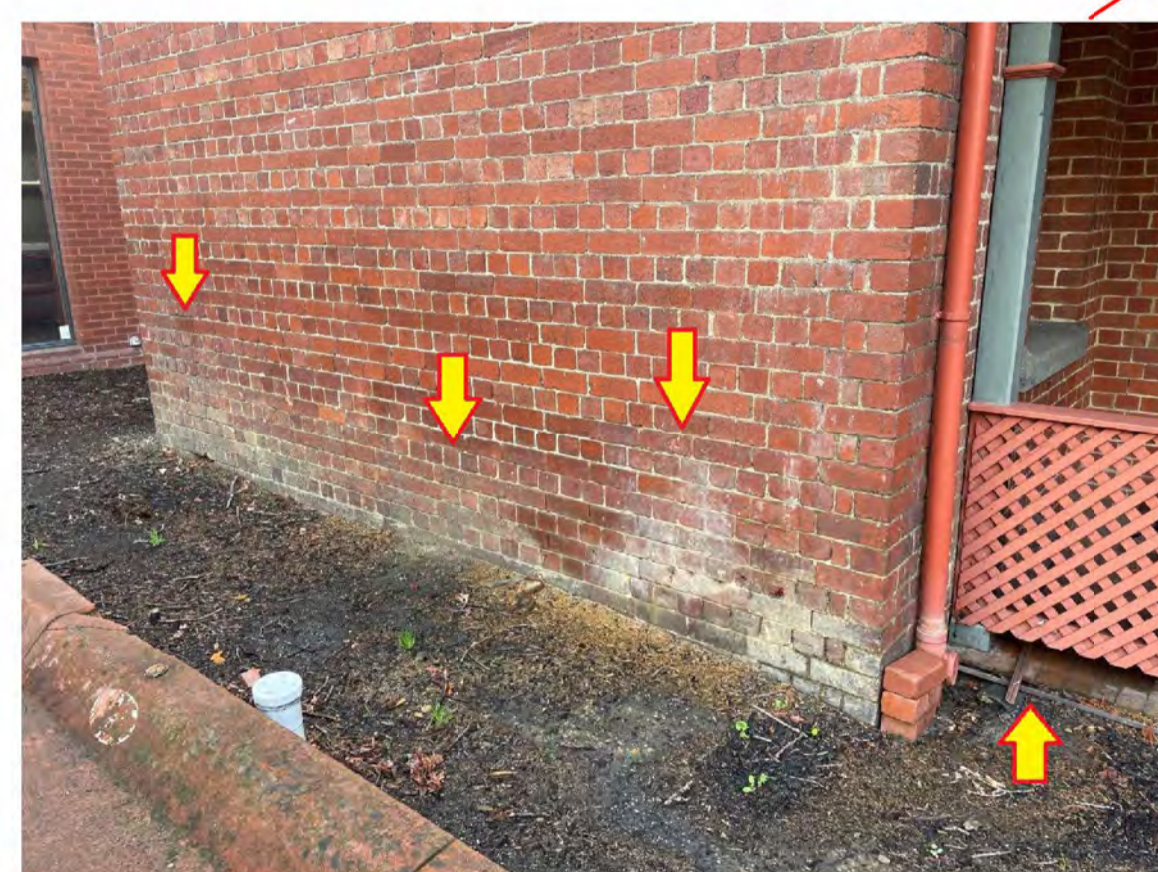
NO SUB-FLOOR VENTILATION  
RISING DAMP UP THE WALL WITH SALT DAMAGE

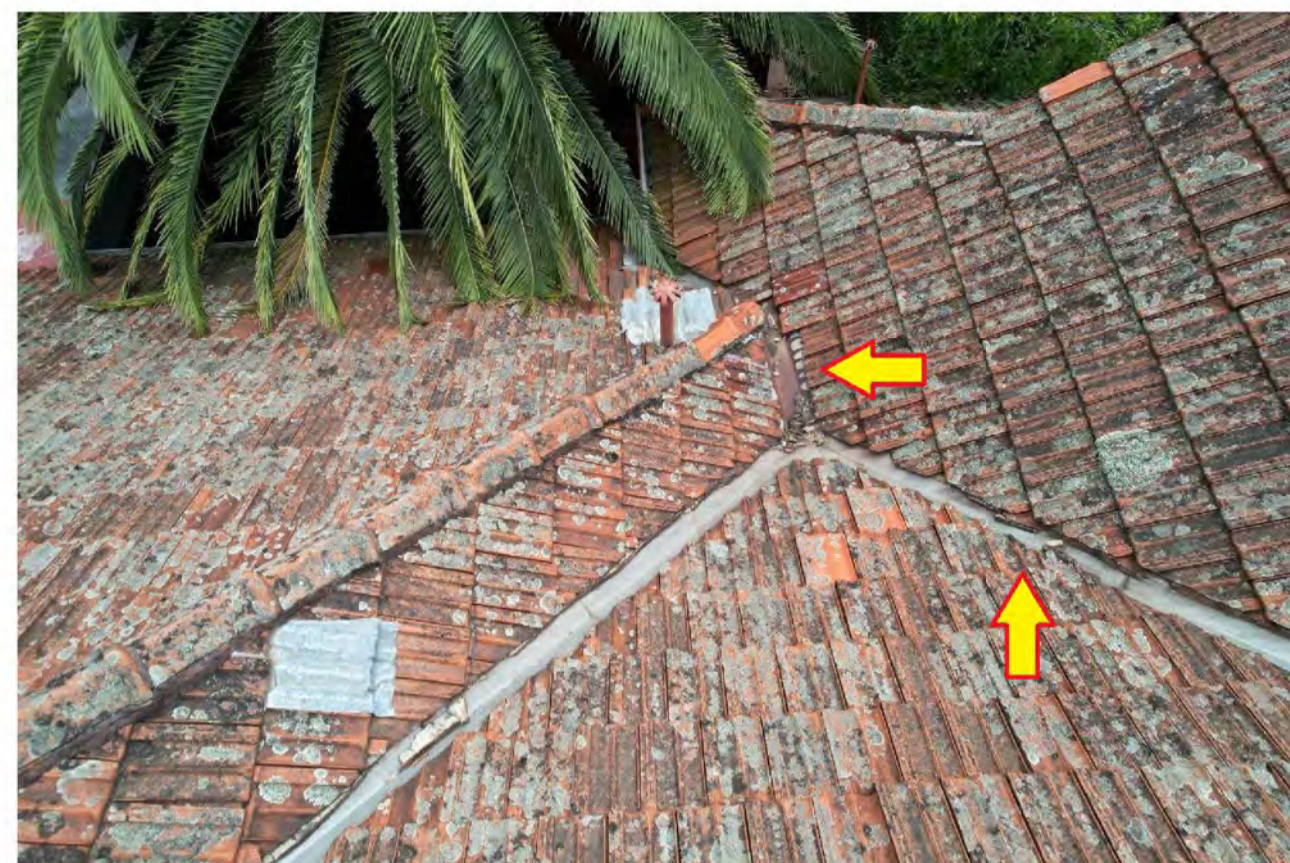
NOT ENOUGH CLEARANCE FOR VALLEY GUTTERS  
DEBRIS IN ROOF GUTTER BLOCKING DRAINAGE

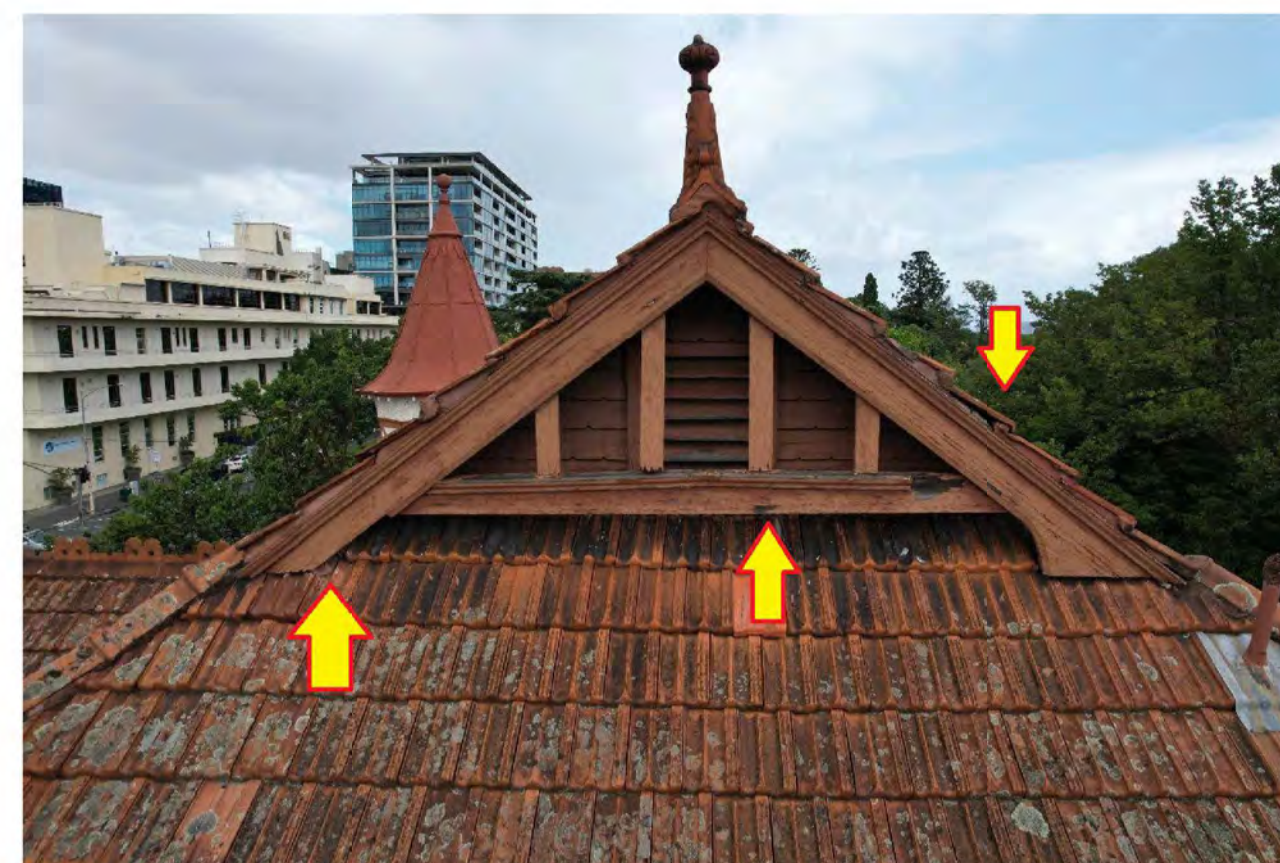
GAPS BETWEEN ROOF TILE TO  
GABLE ENDS CAUSING WATER ISSUE

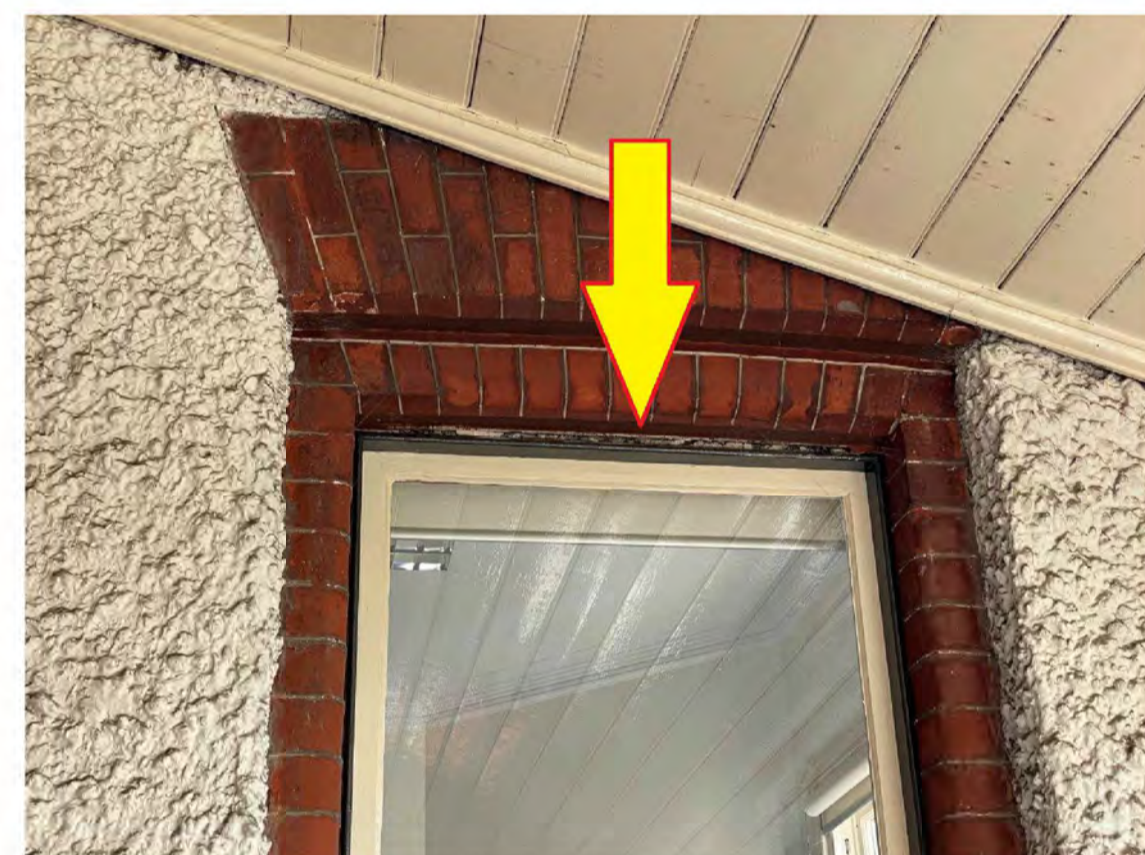
STRUCTURAL REVIEW REQUIRED TO ALL WINDOW LINTELS

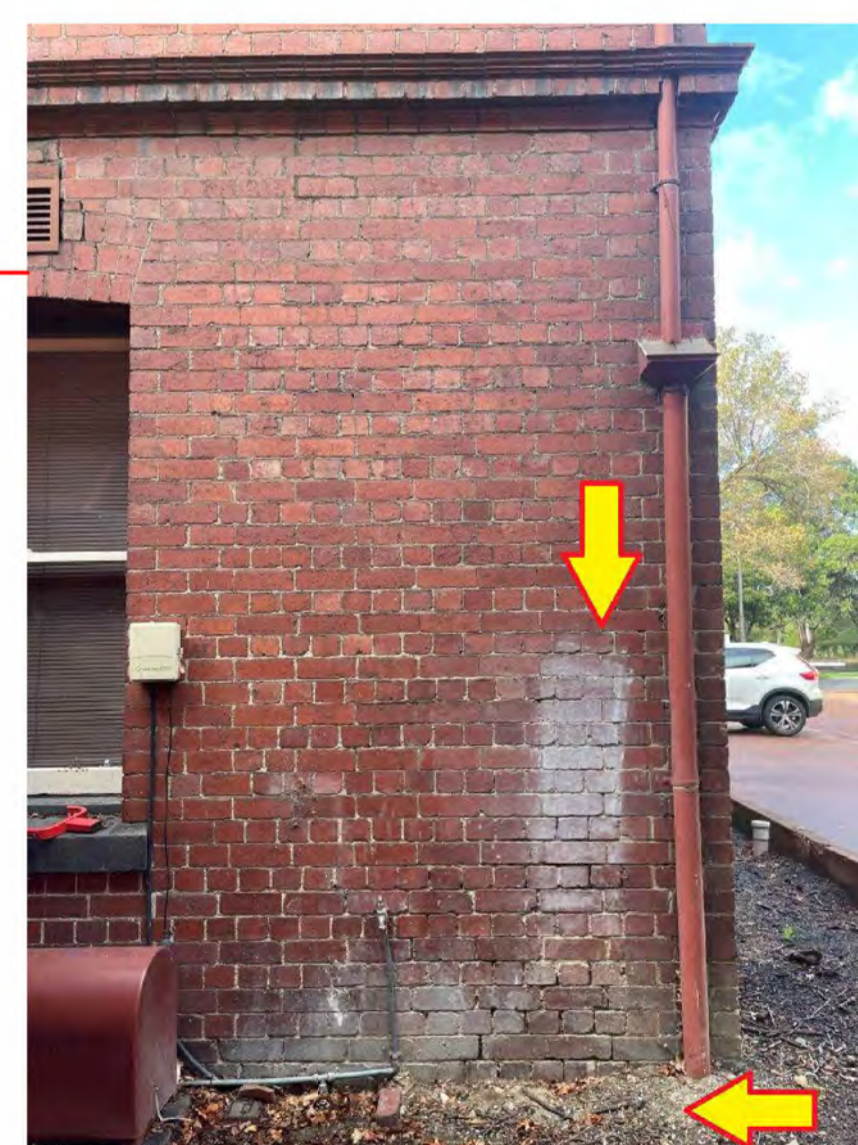
RISING DAMP  
NOT ENOUGH SUB-FLOOR VENTILATION

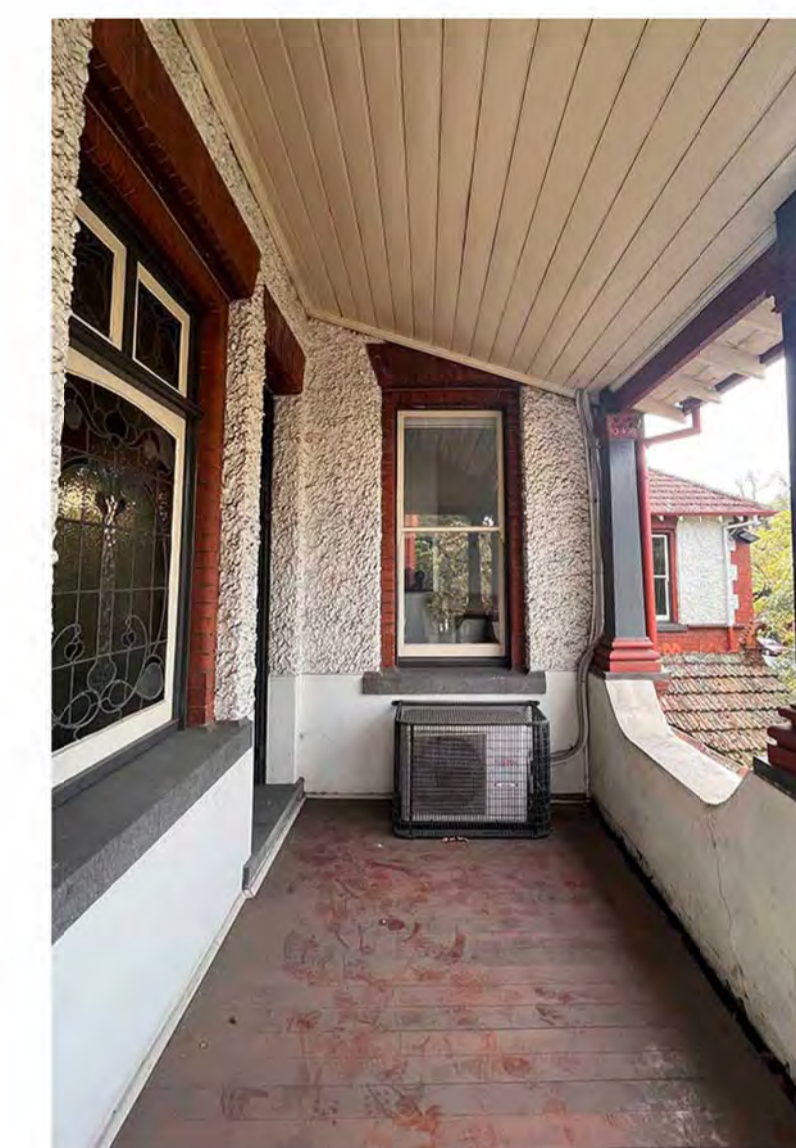
SITE PHOTO #5  
• LEVEL 01 FRONT VERANDAH DOES NOT COMPLY DUE TO FLOOR SLOPE AND RAILING HEIGHT. DOES NOT HAVE COMPLIANT WATERPROOFING

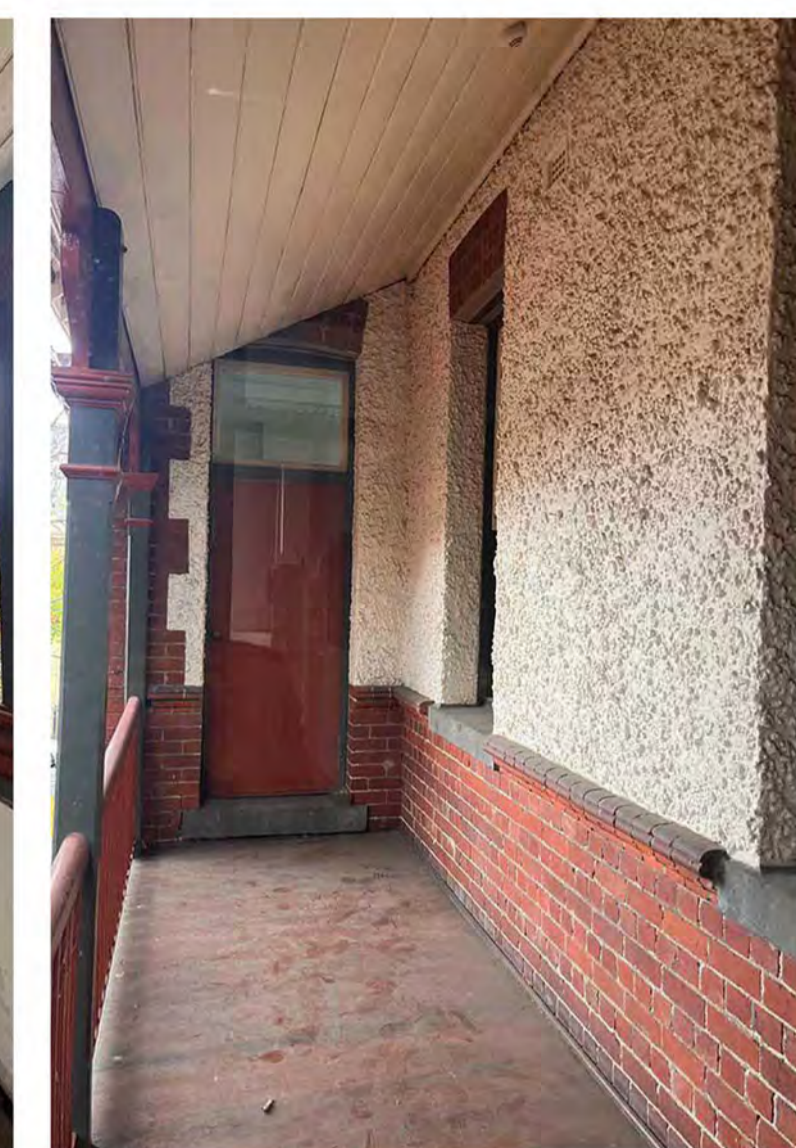
SITE PHOTO #6  
• LEVEL 01 NORTH VERANDAH NON-COMPLIANT DUE TO FLOOR SLOPE AND LOW BALUSTRADE. ALLOWS FALLING DANGER.

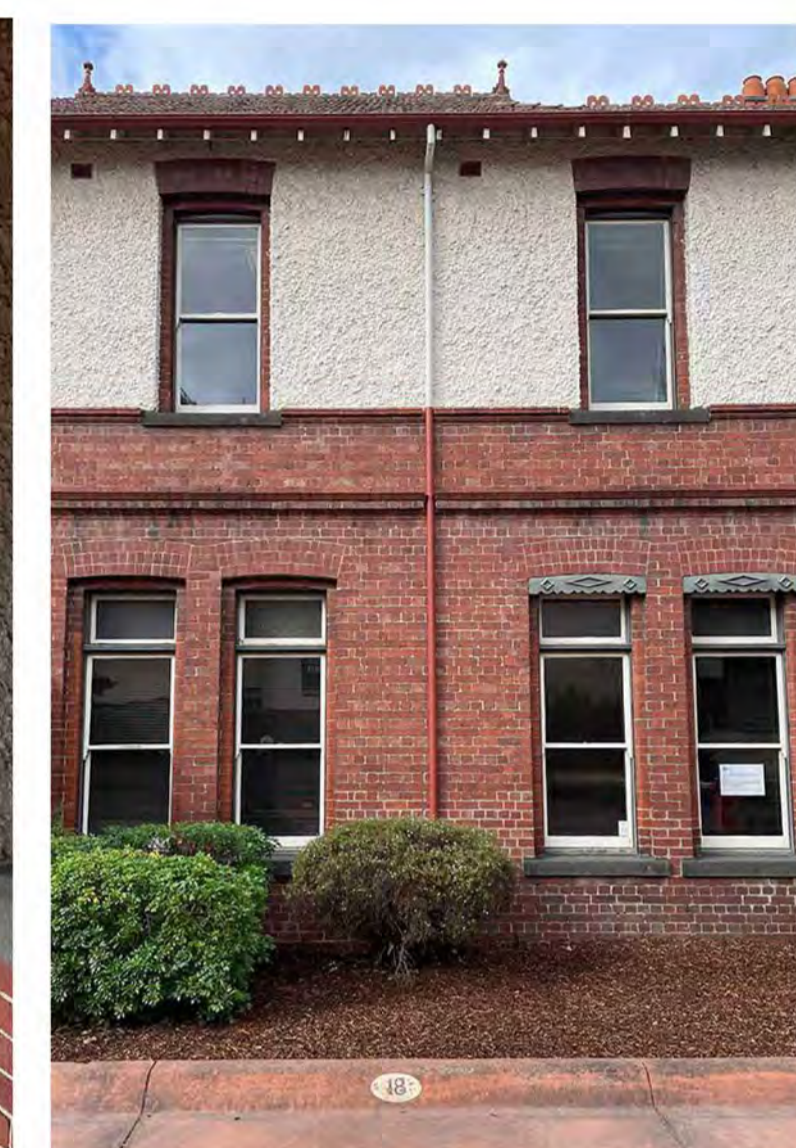
SITE PHOTO #7  
• ENERGY EFFICIENCY TO EXISTING SINGLE GLAZED WINDOWS NON-COMPLIANT.

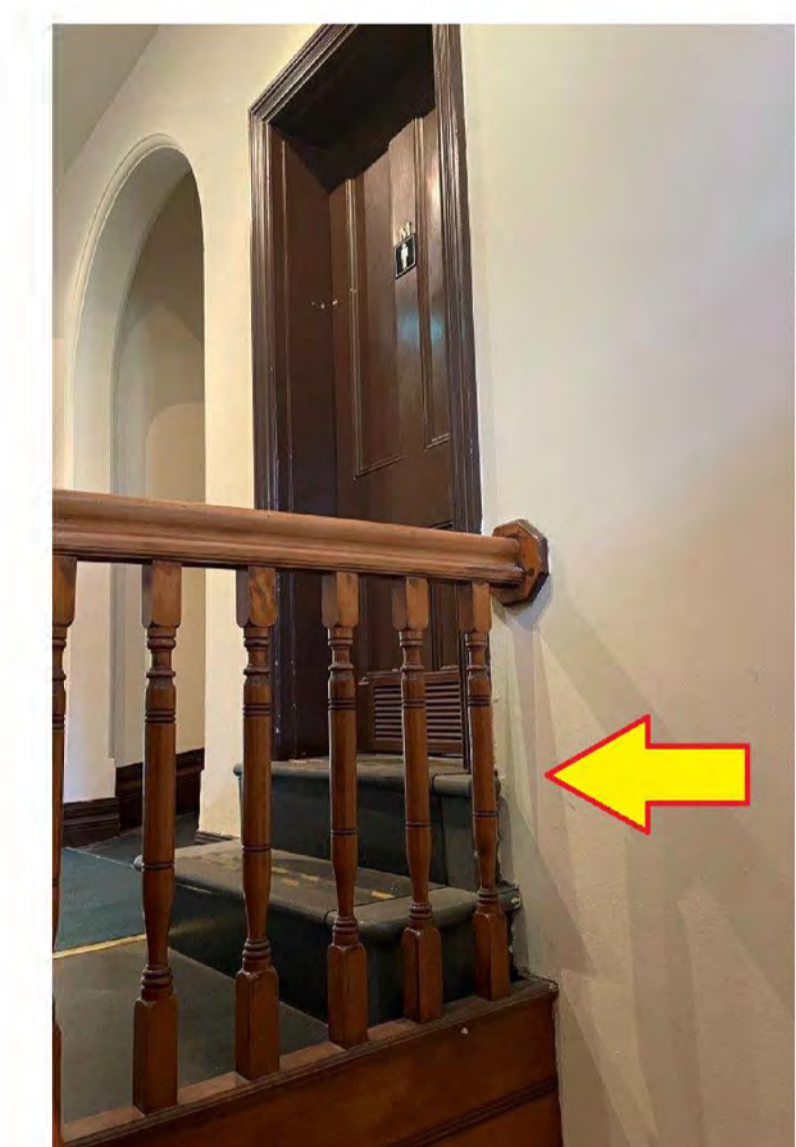
SITE PHOTO #1  
• REMOVE STAIR & NON-ORIGINAL WC ON LANDING TO OPEN UP WINDOWS TO HALLWAY.  
• EXTG. STAIR BALUSTRADE NON-COMPLIANT. HANDRAIL TOO LOW.  
• REMOVE NON-ORIGINAL FLOORING.

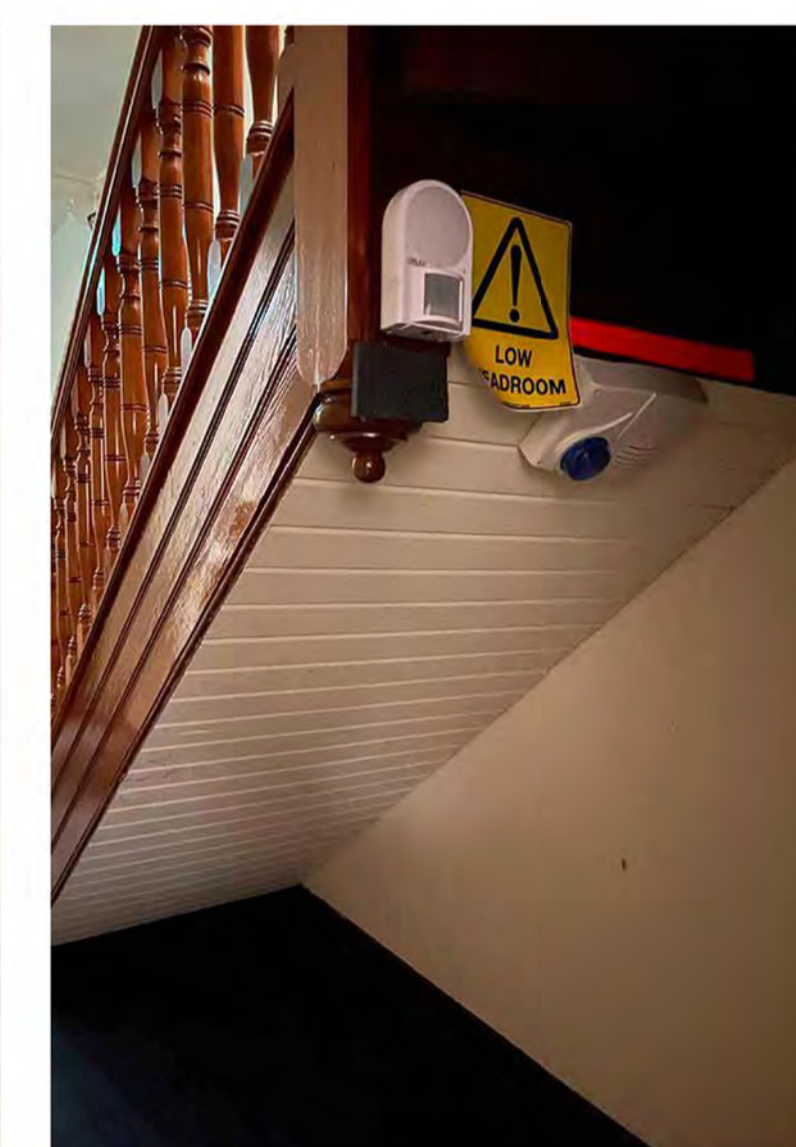
SITE PHOTO #2  
• EXISTING LOW HEADROOM CLEARANCE UNDER STAIR

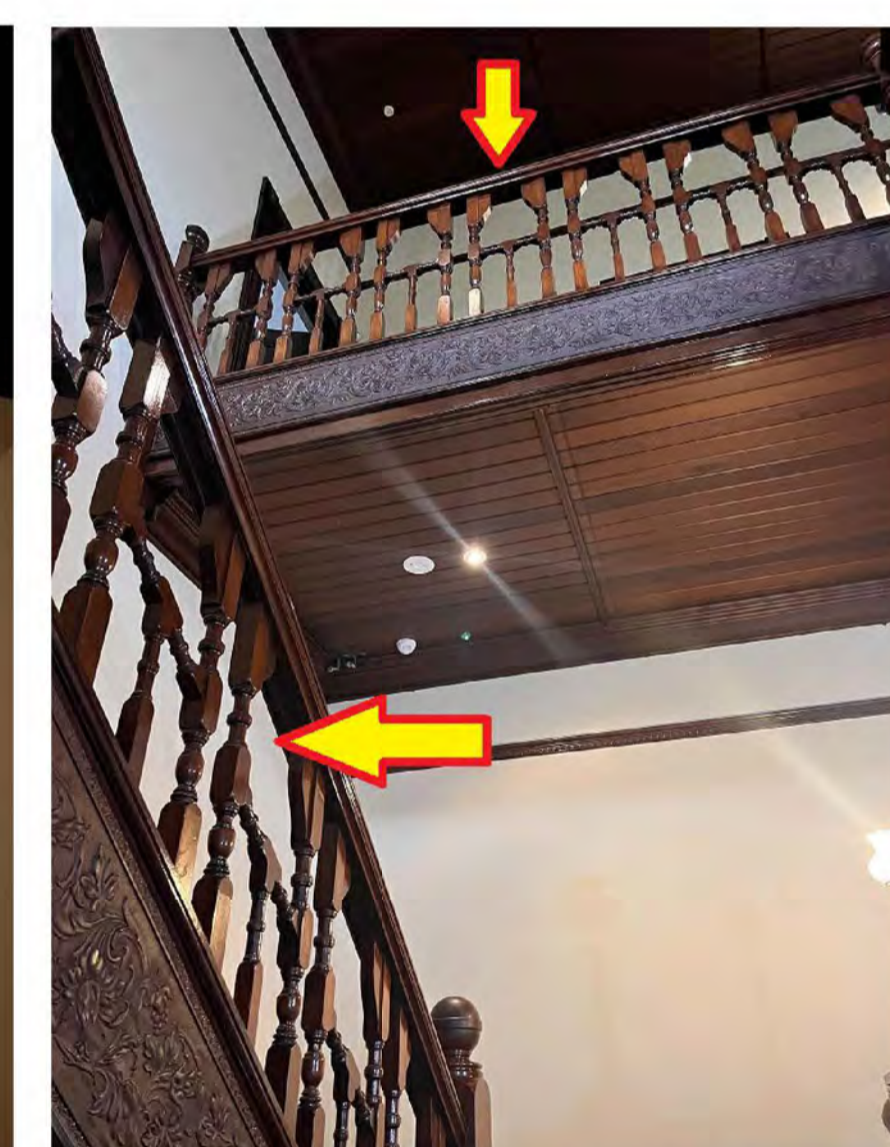
SITE PHOTO #3  
• GAP BETWEEN BALUSTERS LARGER THAN MINIMUM REQUIRED 125mm  
• BALUSTRADE UNDER 1m PRESENTING FALLING DANGER

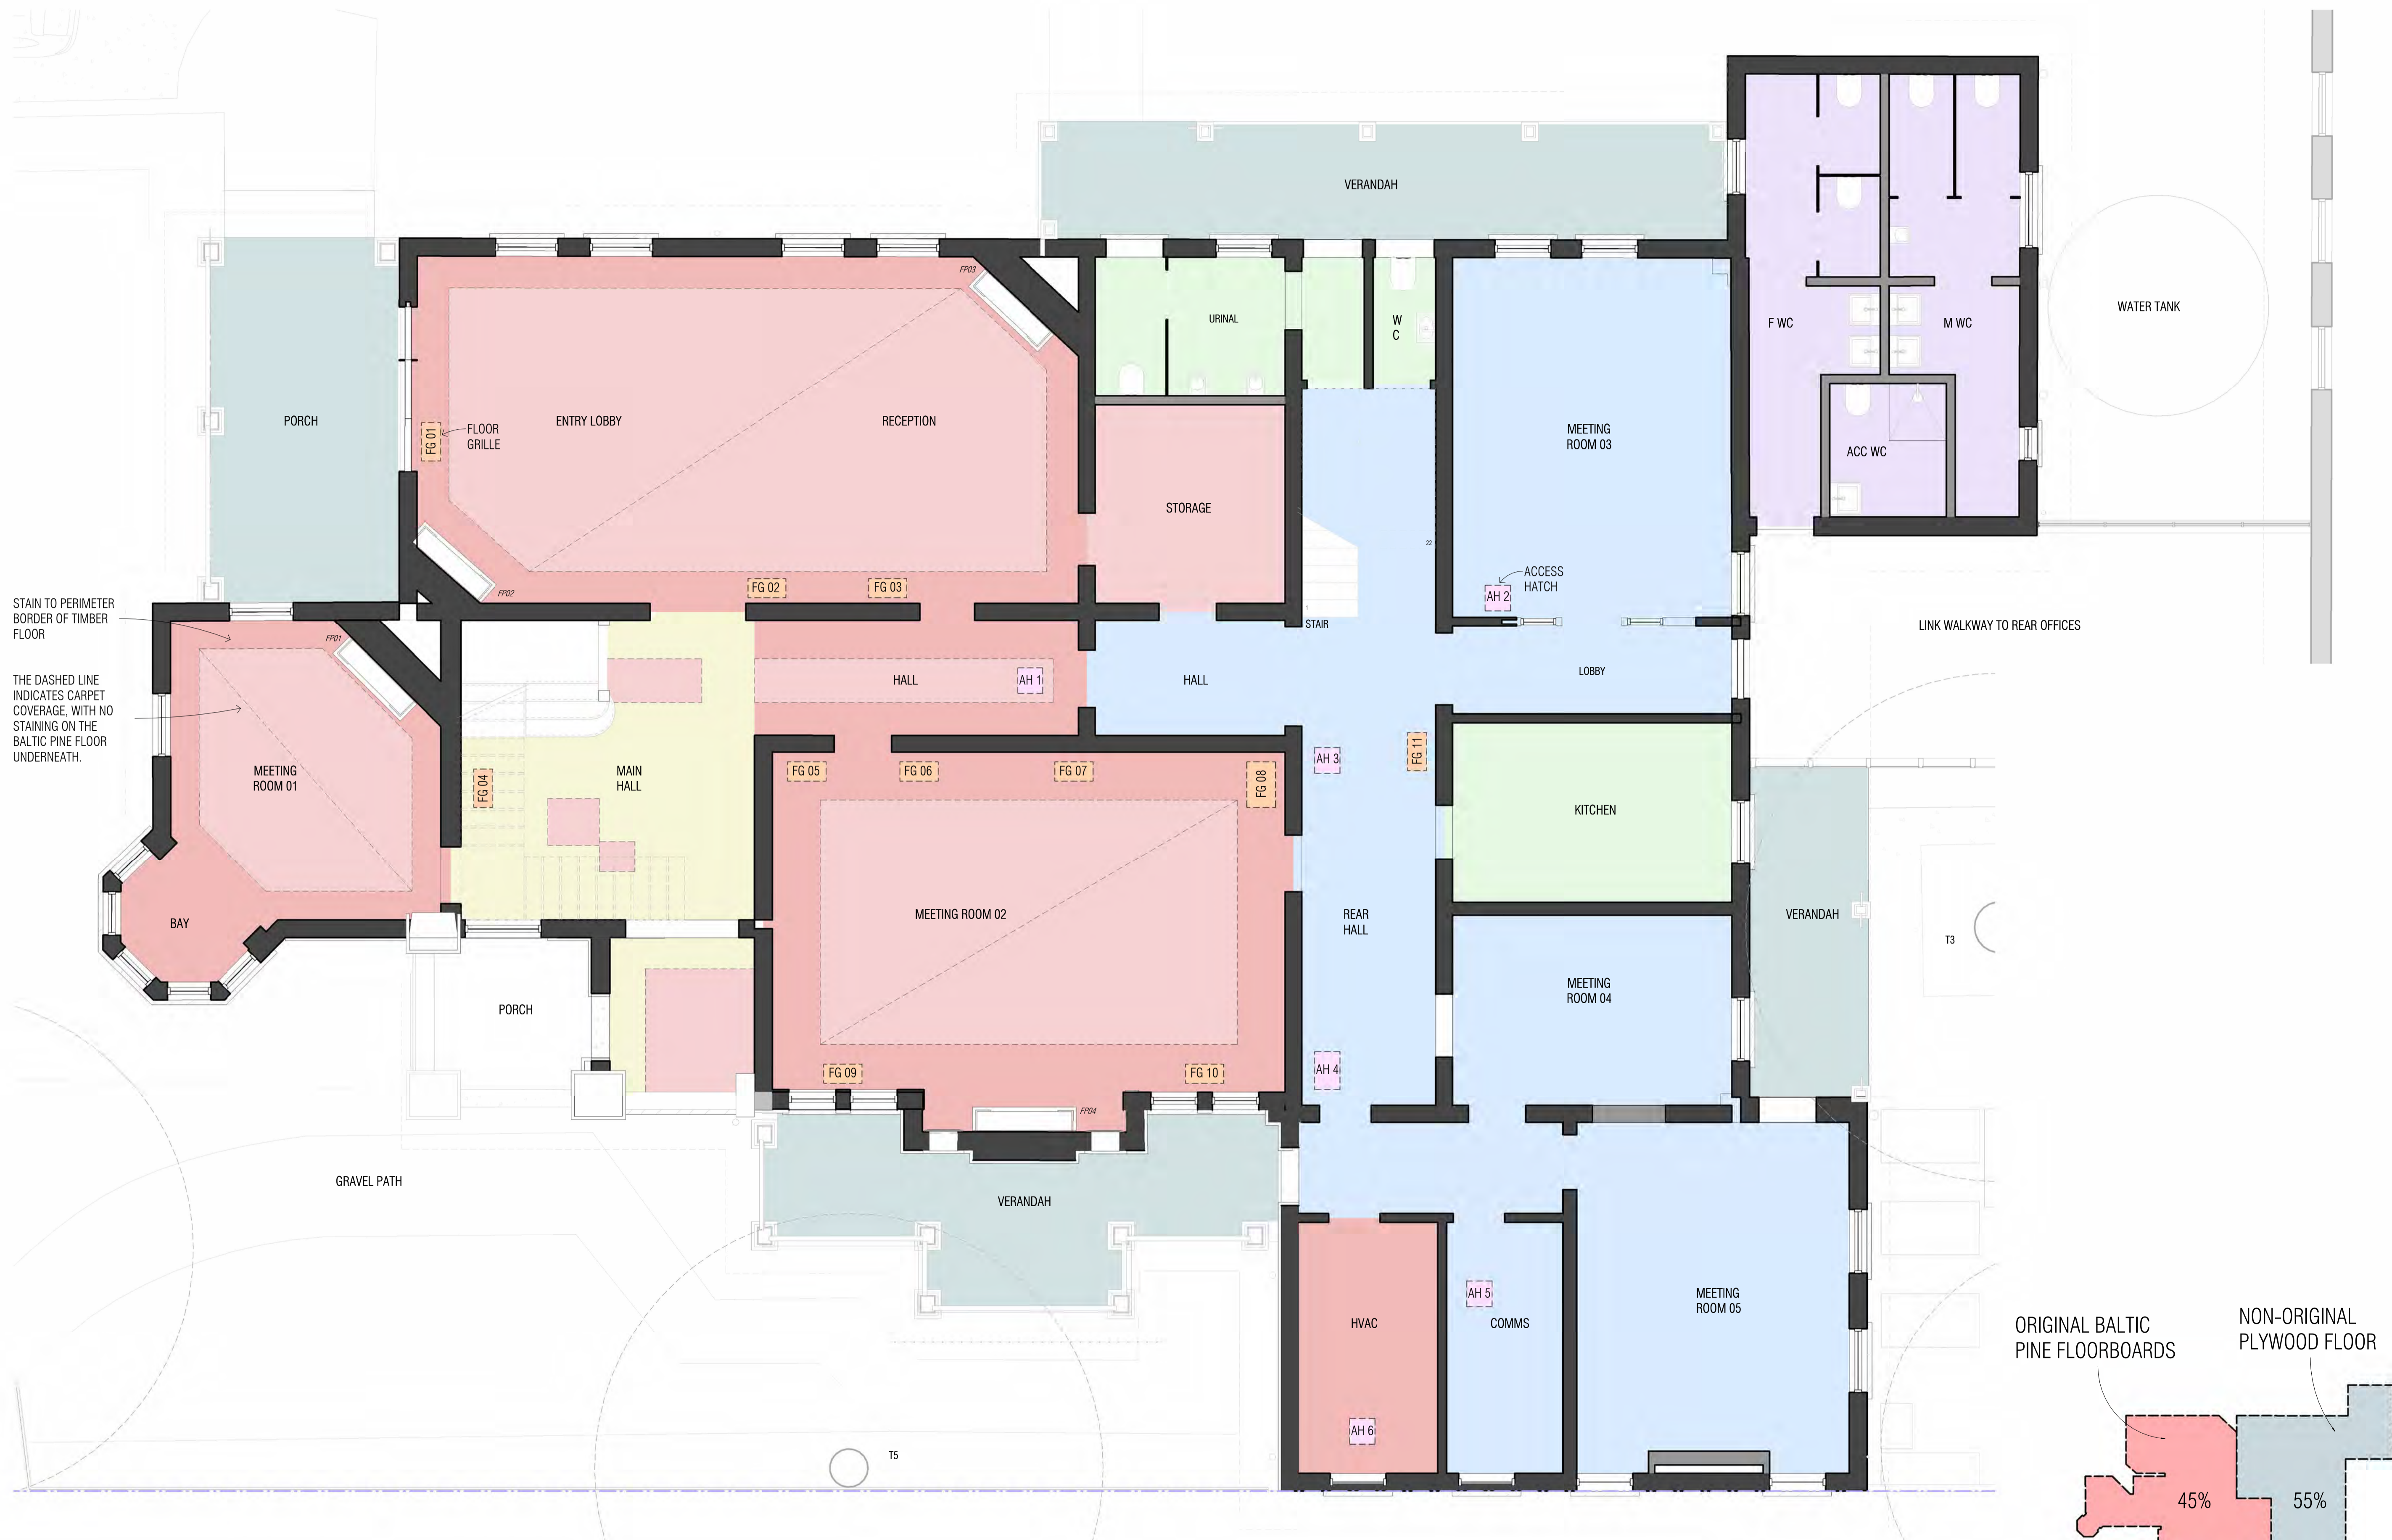
STAIN TO PERIMETER BORDER OF TIMBER FLOOR

THE DASHED LINE INDICATES CARPET COVERAGE, WITH NO STAINING ON THE BALTIC PINE FLOOR UNDERNEATH.
