PROJECT 1-19 CLARENDON ST

DRAWING EXTERNAL REPAIR WORK  
- SOUTH ELEVATION

EXTERNAL REPAIR WORK - EAST ELEVATION

| A | HW RFI 01 | NOV 2024 |
|---|---|---|
| DRAWING | EXTERNAL REPAIR WORK - WEST ELEVATION | |

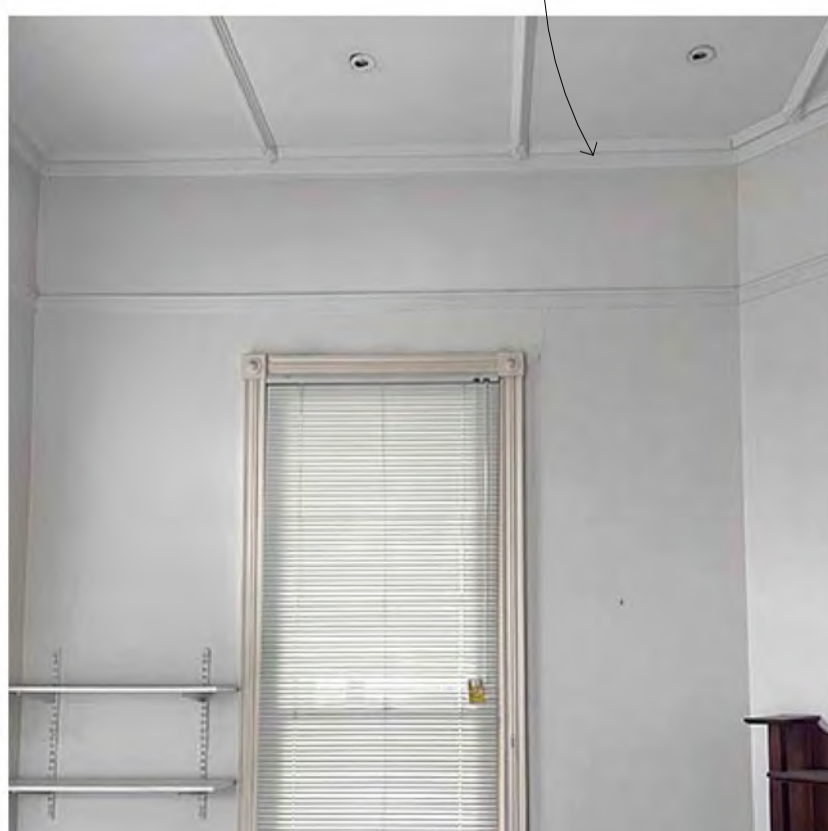
ROOM: OFFICE 01  
CORNICE: ORIGINAL CORNICE

NON-ORIGINAL CORNICE INSTALLED IN OFFICE 01

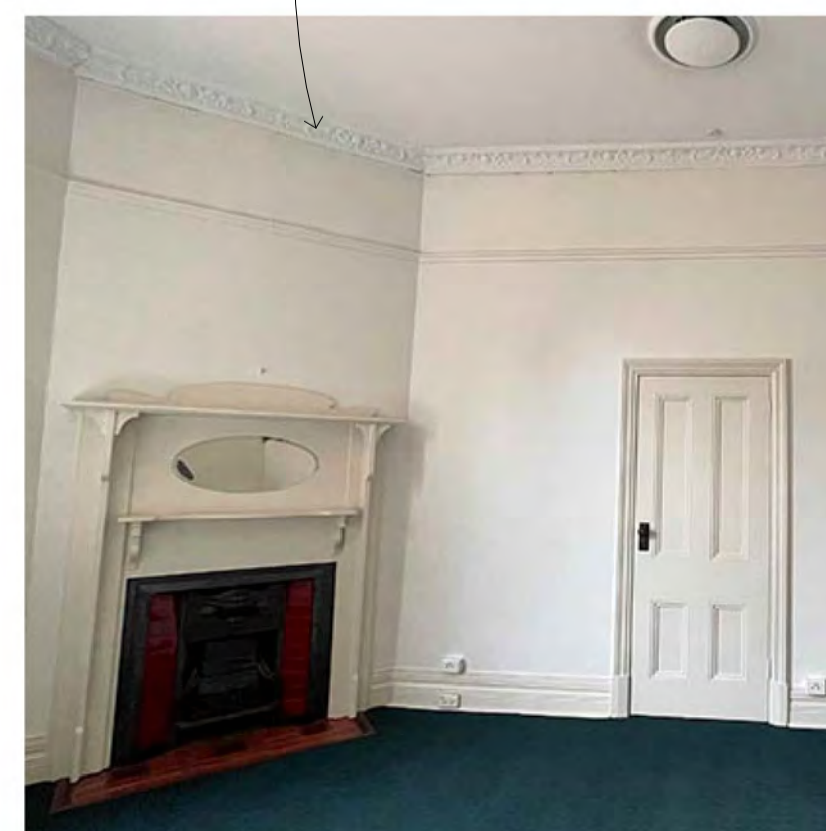
ROOM: OFFICE 08  
CORNICE: NON-ORIGINAL CORNICE

NON-ORIGINAL CORNICE INSTALLED IN OFFICE 08

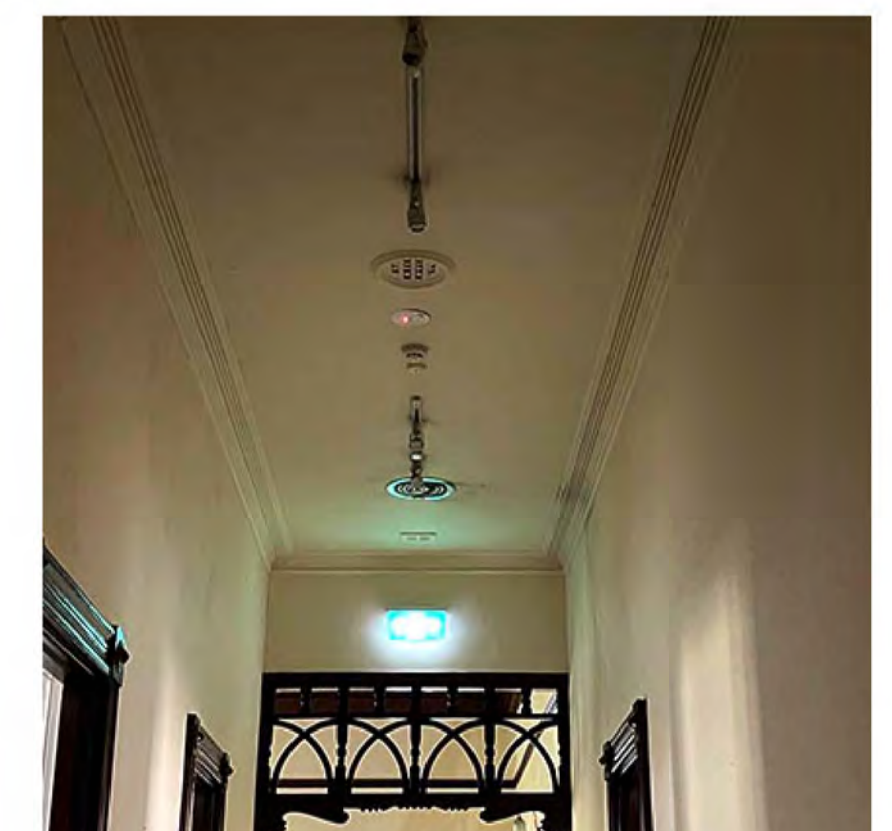
ROOM: HALL  
CORNICE: ORIGINAL CORNICE

NON-ORIGINAL CORNICE INSTALLED IN HALL

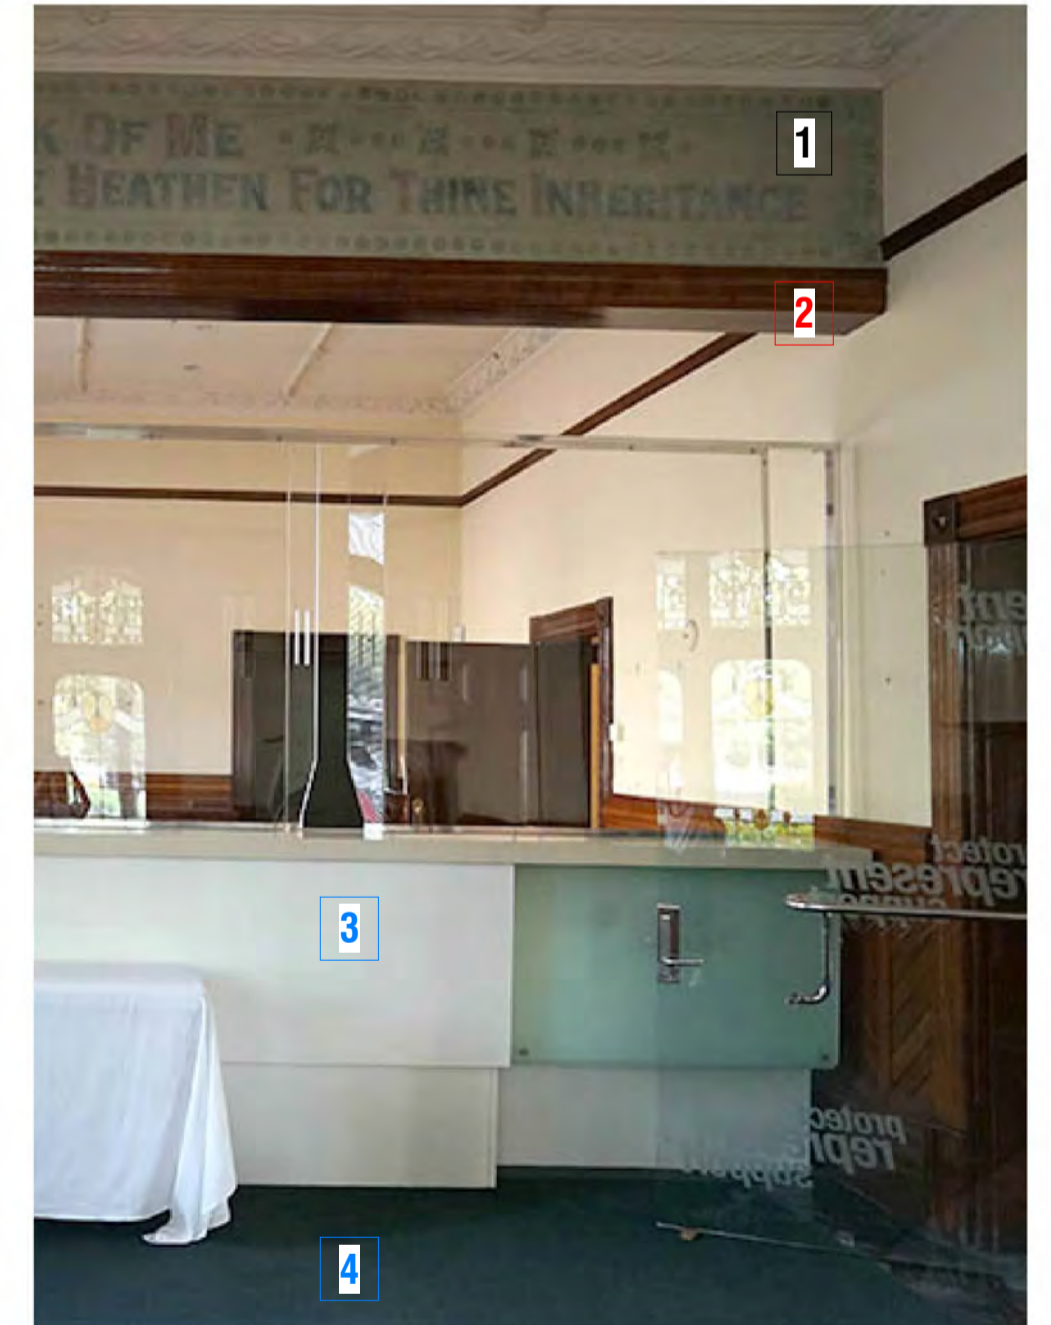
PHOTO - CURRENT VIEW TOWARDS RECEPTION DESK

1. MURAL TEXT TO BEAM. TBC IF ORIGINAL
2. CURRENT TIMBER BEAM TRIM. TBC IF ORIGINAL. NO PARTITION TRACK VISIBLE. APPEARS TO BE DIFFERENT TO ORIGINAL DRAWING. LOWER THAN DADO RAIL. FINISH: VARNISH.
3. LATER ADDITIONS TO BE REMOVED - RECEPTION DESK PARTITION SCREENS. GLASS PIVOT DOOR
4. NON-ORIGINAL CARPET OVER ORIGINAL BALTIC FLOORING. REMOVE RUG

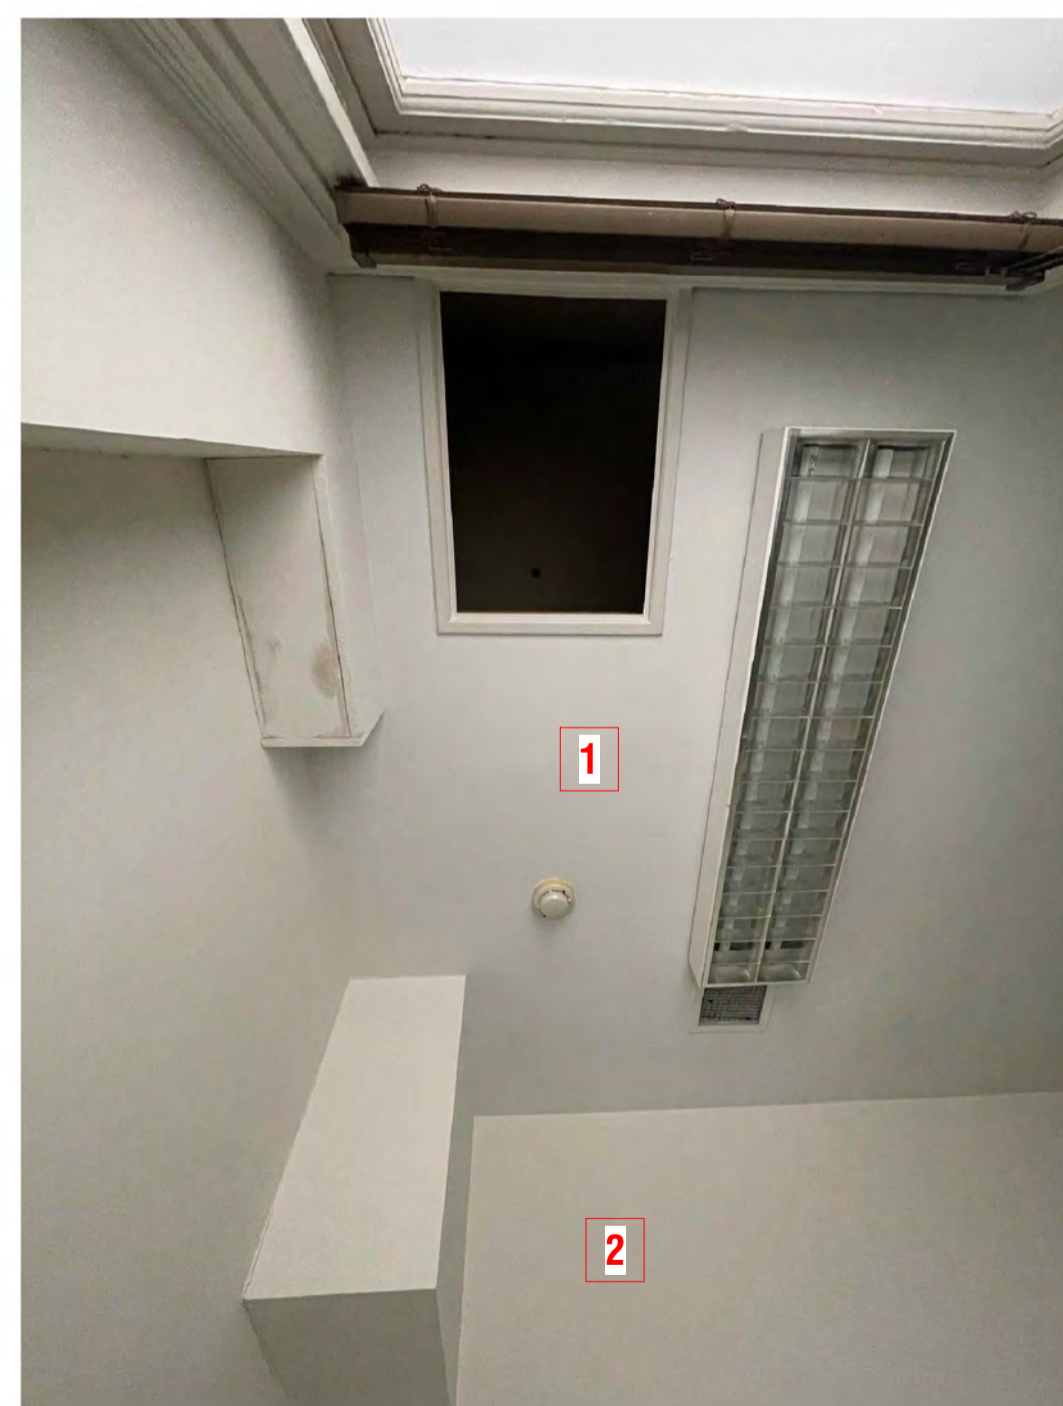
PHOTO - CURRENT URINAL CEILING

1. NON-ORIGINAL CEILING WITH ACCESS HATCH / LIGHT FIXTURES. REMOVE
2. NON-ORIGINAL WALL PARTITION. REMOVE

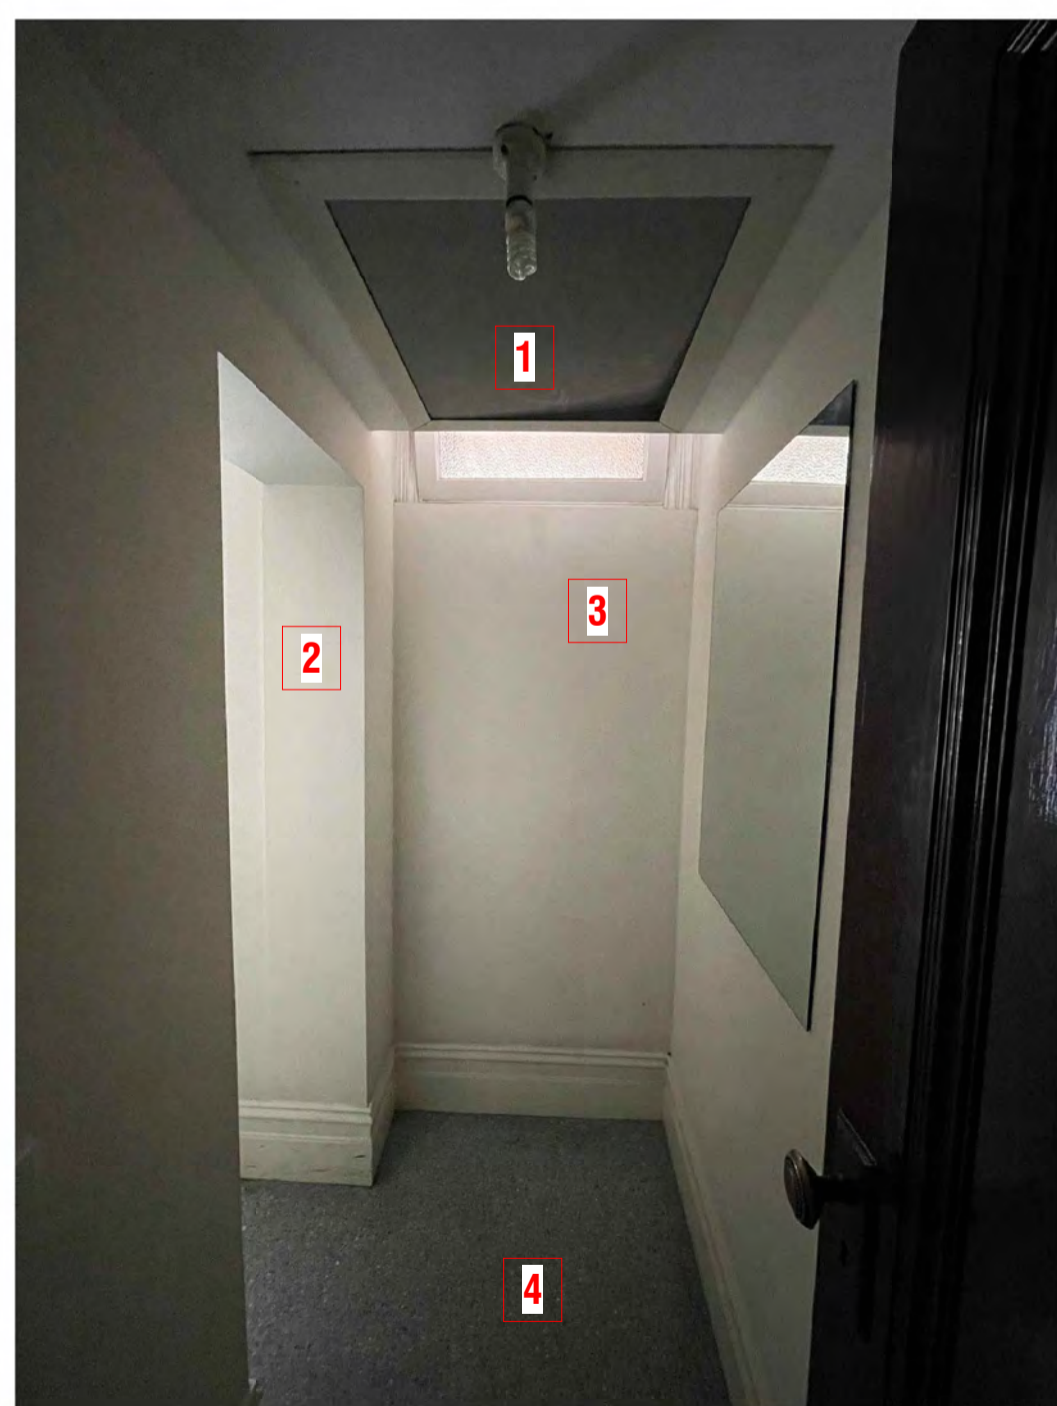
PHOTO - CURRENT URINAL ENTRY

1. NON-ORIGINAL FALSE CEILING WITH ACCESS HATCH AND LIGHTING. REMOVE
2. NON-ORIGINAL WALL OPENING. TO REMAIN.
3. NON-ORIGINAL WALL BEHIND EXTERNAL DOOR. REMOVE
4. NON-ORIGINAL VINYL FLOORING IN BATHROOM AREA. REMOVE

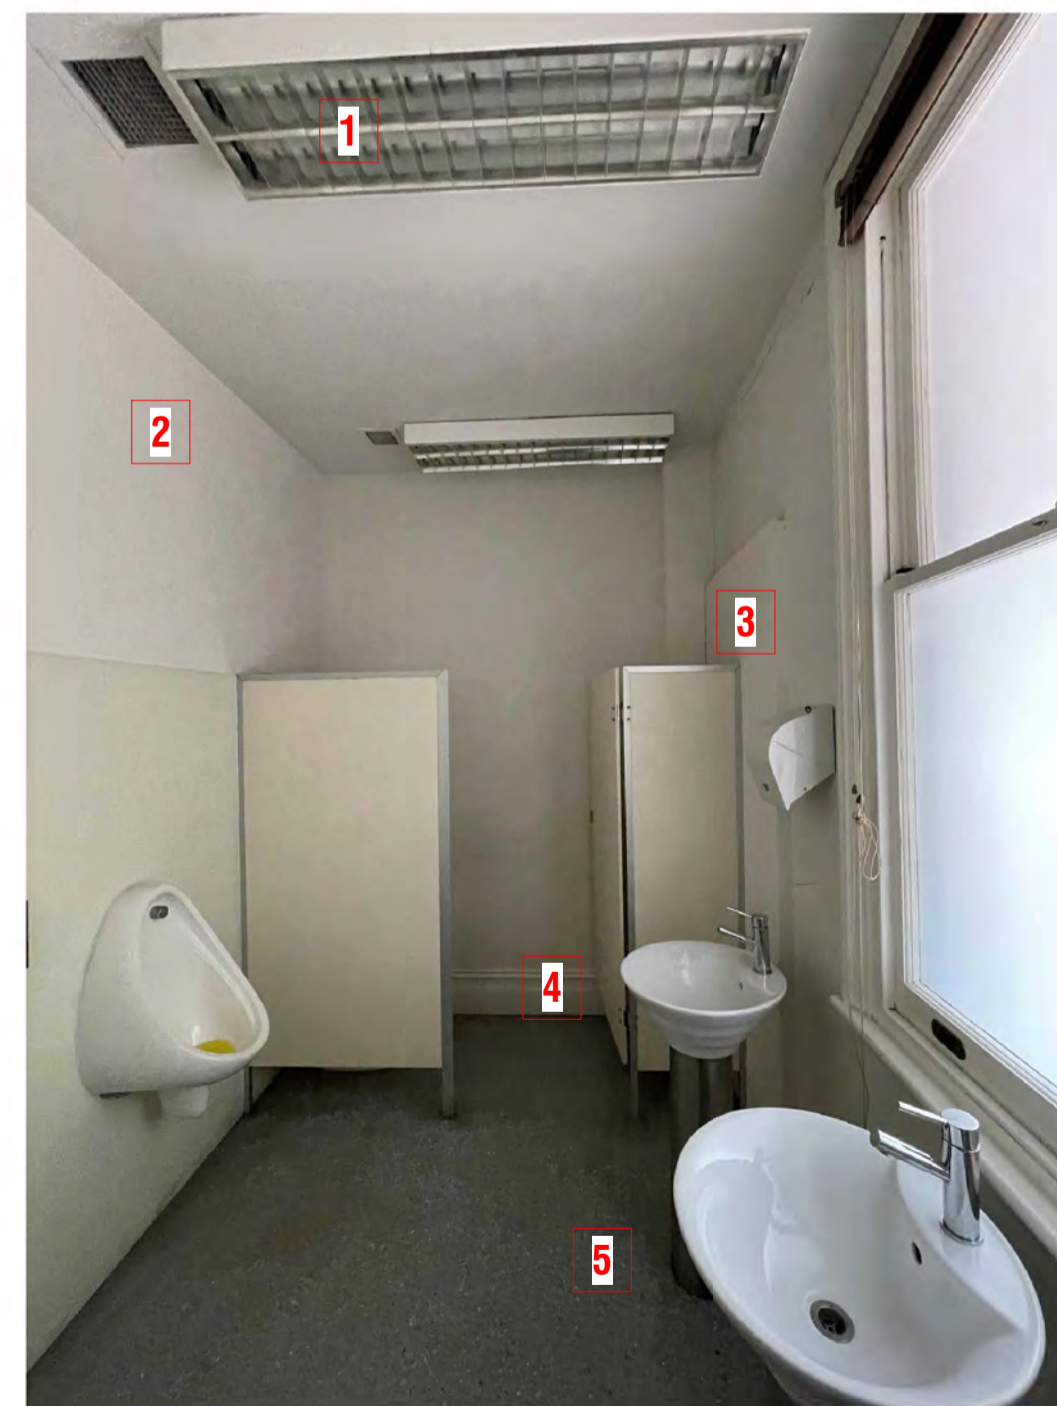
PHOTO - CURRENT VIEW INTO URINAL

1. NON-ORIGINAL FALSE CEILING AND LIGHTS. REMOVE
2. NON-ORIGINAL WALL PARTITION. REMOVE
3. NON-ORIGINAL PARTITION BLOCKING BEHIND ORIGINAL EXTERNAL DOOR. REMOVE
5. NON-ORIGINAL URINAL / BATHROOM FIXTURES & FITTINGS / VINYL FLOORING. REMOVE

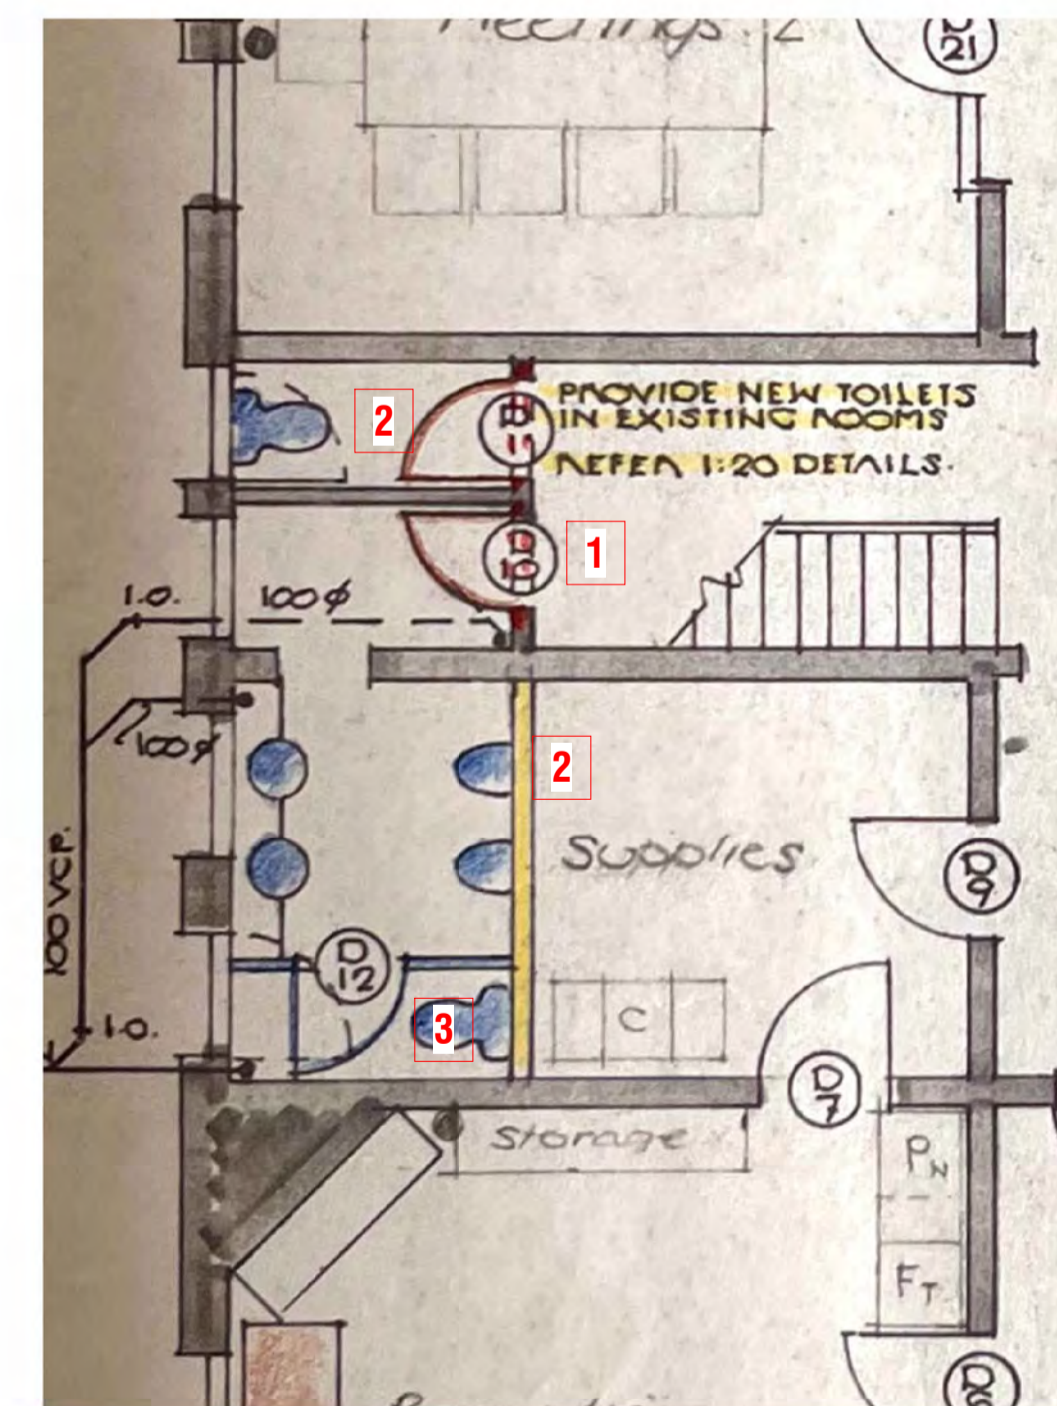
1. NON-ORIGINAL INTERNAL DOORS. REMOVE
2. NON-ORIGINAL WALL. REMOVE
3. NON-ORIGINAL URINAL / BATHROOM FIXTURES & FITTINGS. REMOVE

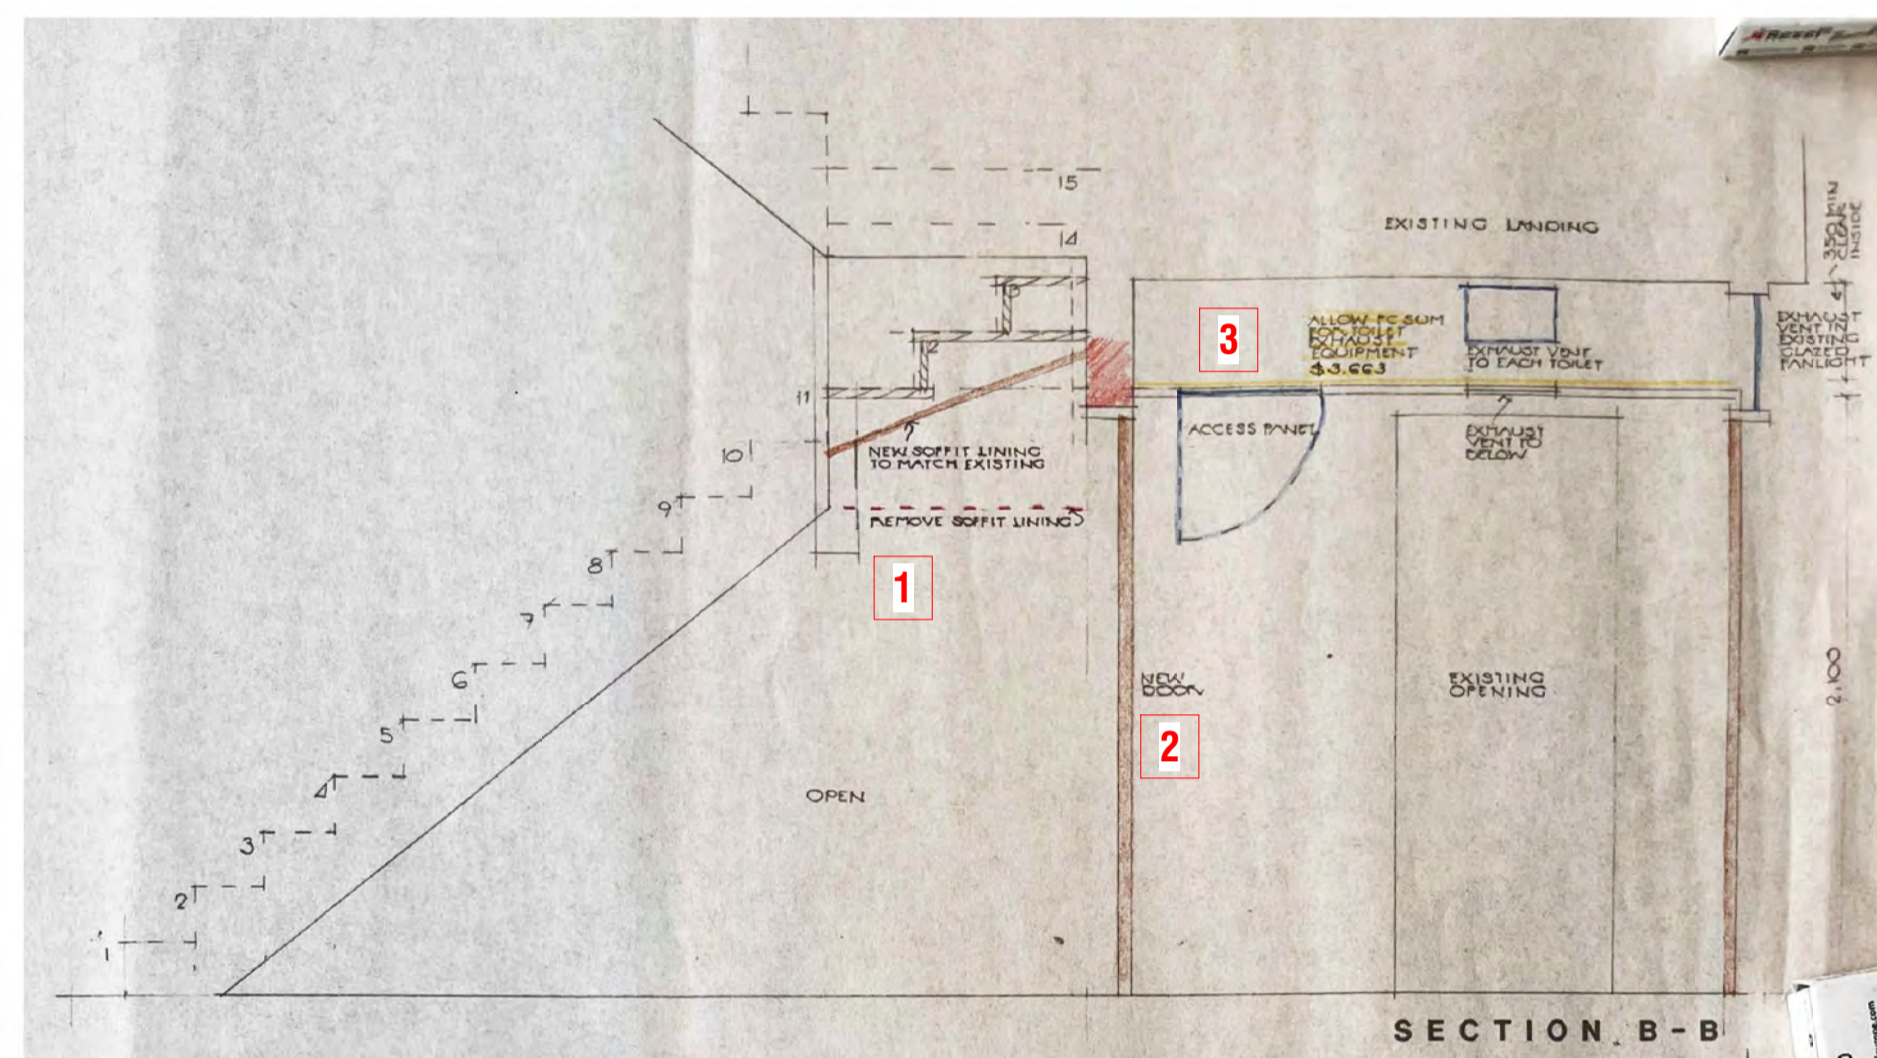
CURRENT PART SECTION / WALL ELEVATION UNDER STAIR  
YEAR: 2001

- 1. NON-ORIGINAL STAIR WINDER / SOFFIT. REMOVE
- 2. NON-ORIGINAL DOORS. REMOVE
- 3. NON-ORIGINAL CEILING. REMOVE
- 4. NON-ORIGINAL EXHAUST VENT. REMOVE

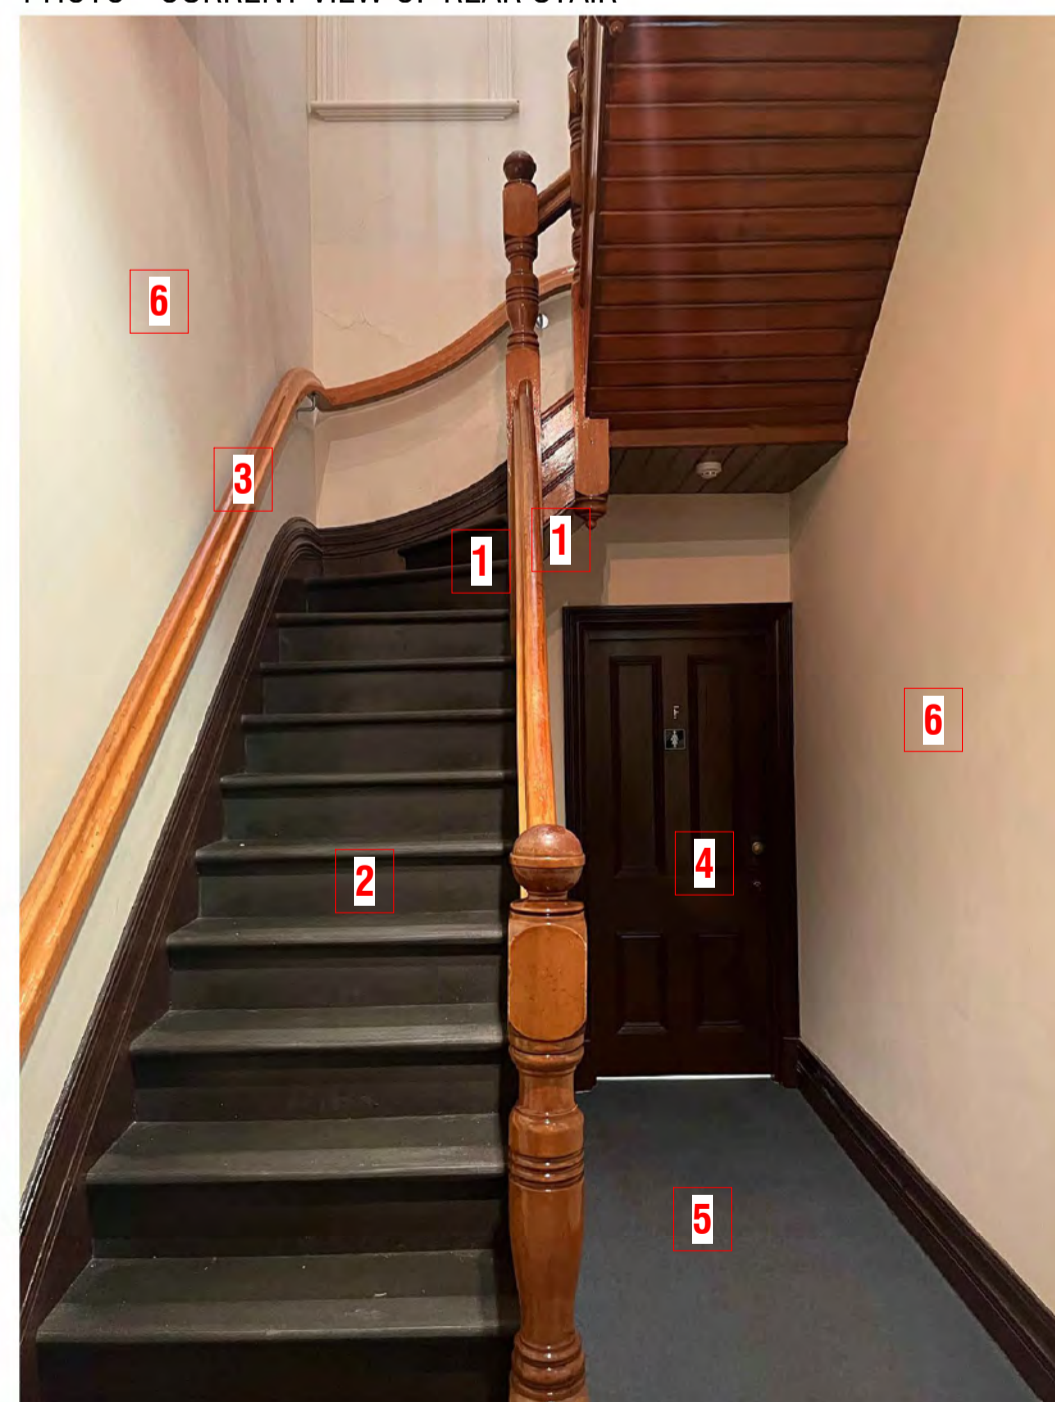
PHOTO - CURRENT VIEW OF REAR STAIR

- 1. POTENTIALLY NON-ORIGINAL STAIR WINDER AND SOFFIT
- 2. NON-ORIGINAL VINYL FLOORING COVER TO STAIR TREAD & RISERS
- 3. NON-ORIGINAL HANDRAIL
- 4. NON-ORIGINAL DOORS. REMOVE
- 5. NON-ORIGINAL CARPET. REMOVE

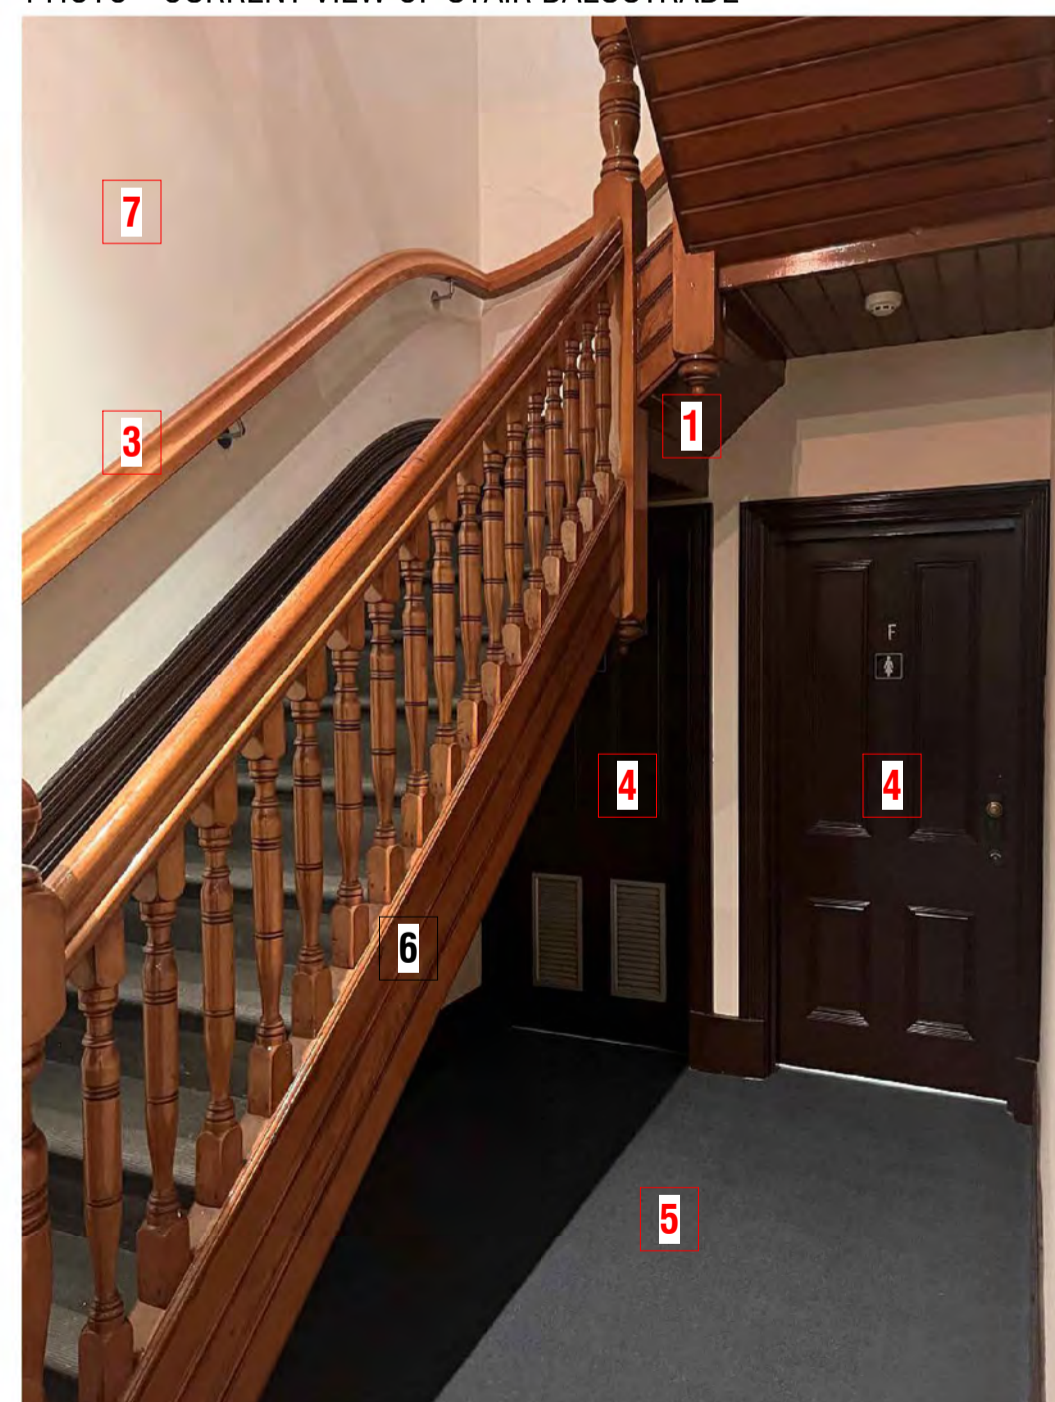
PHOTO - CURRENT VIEW OF STAIR BALUSTRADE

- 6. TIMBER BALUSTRADE / HANDRAIL / STRINGER.  
TBC IF ORIGINAL.  
TIMBER TYPE: HUON PINE  
TIMBER FINISH: VARNISH. TBC IF ORIGINAL

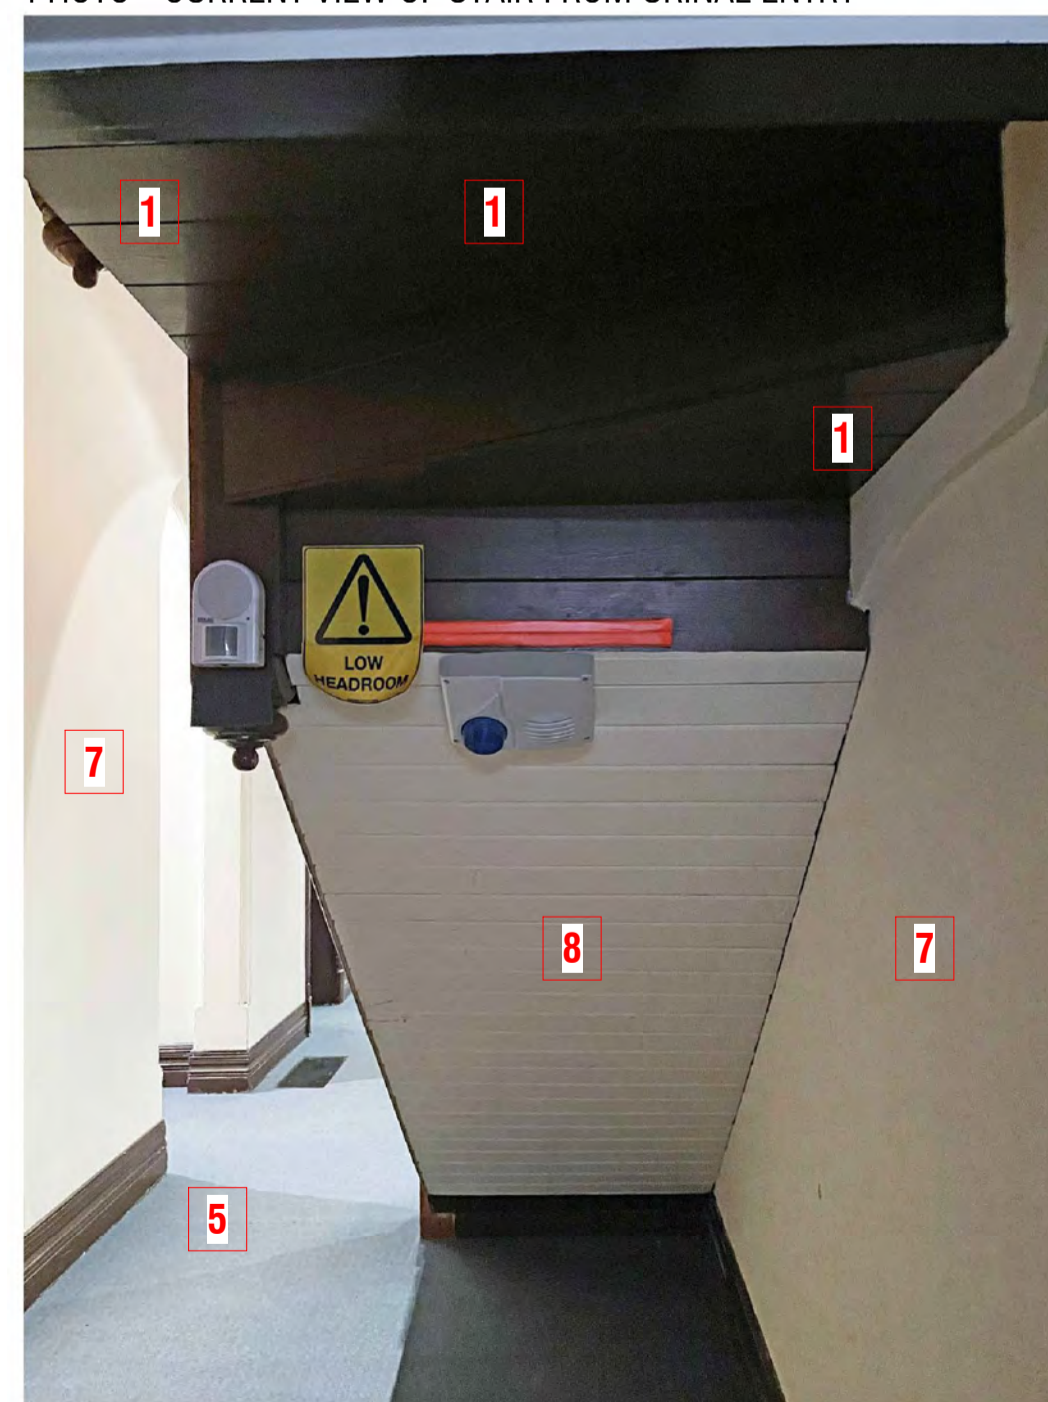
PHOTO - CURRENT VIEW OF STAIR FROM URINAL ENTRY

- 7. CURRENT PAINT COLOUR: LIGHT TONE PAINT. TYPE UNKNOWN.
- 8. PROPOSED PAINT COLOUR: LIGHT TONE DISTEMPER PAINT  
PAINT FINISH TO UNDERSIDE OF STAIR.  
DOES NOT APPEAR TO BE ORIGINAL

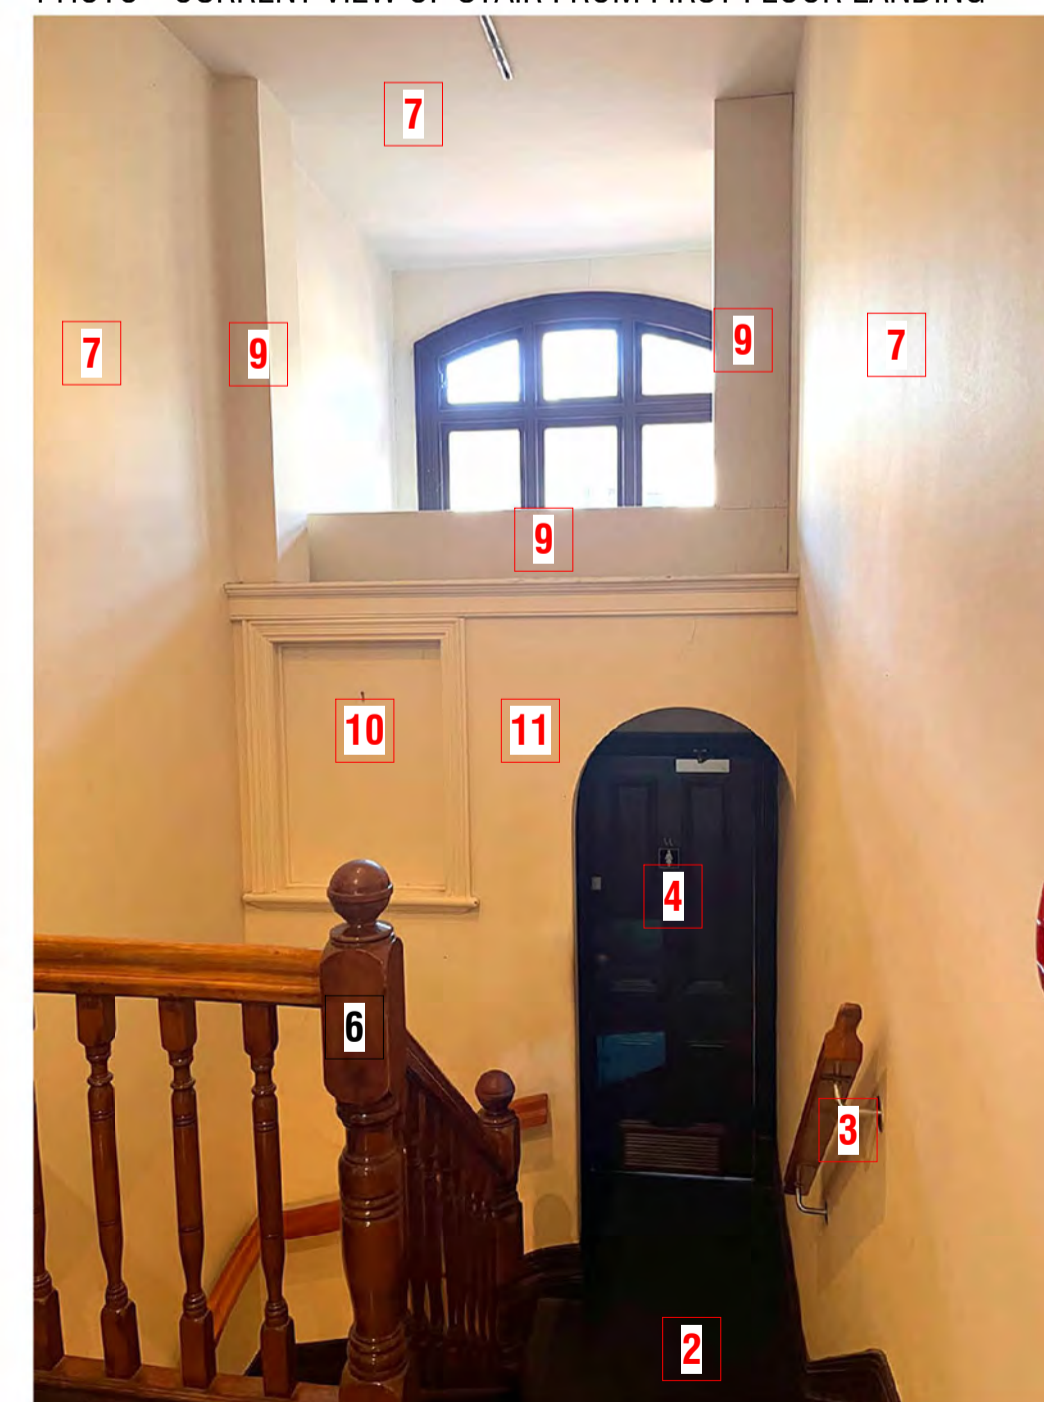
PHOTO - CURRENT VIEW OF STAIR FROM FIRST FLOOR LANDING

- 9. NON-ORIGINAL DUCTWORK. REMOVE
- 10. NON-ORIGINAL WALL OPENING. REMOVE
- 11. REMOVE WALL. POTENTIALLY ORIGINAL.

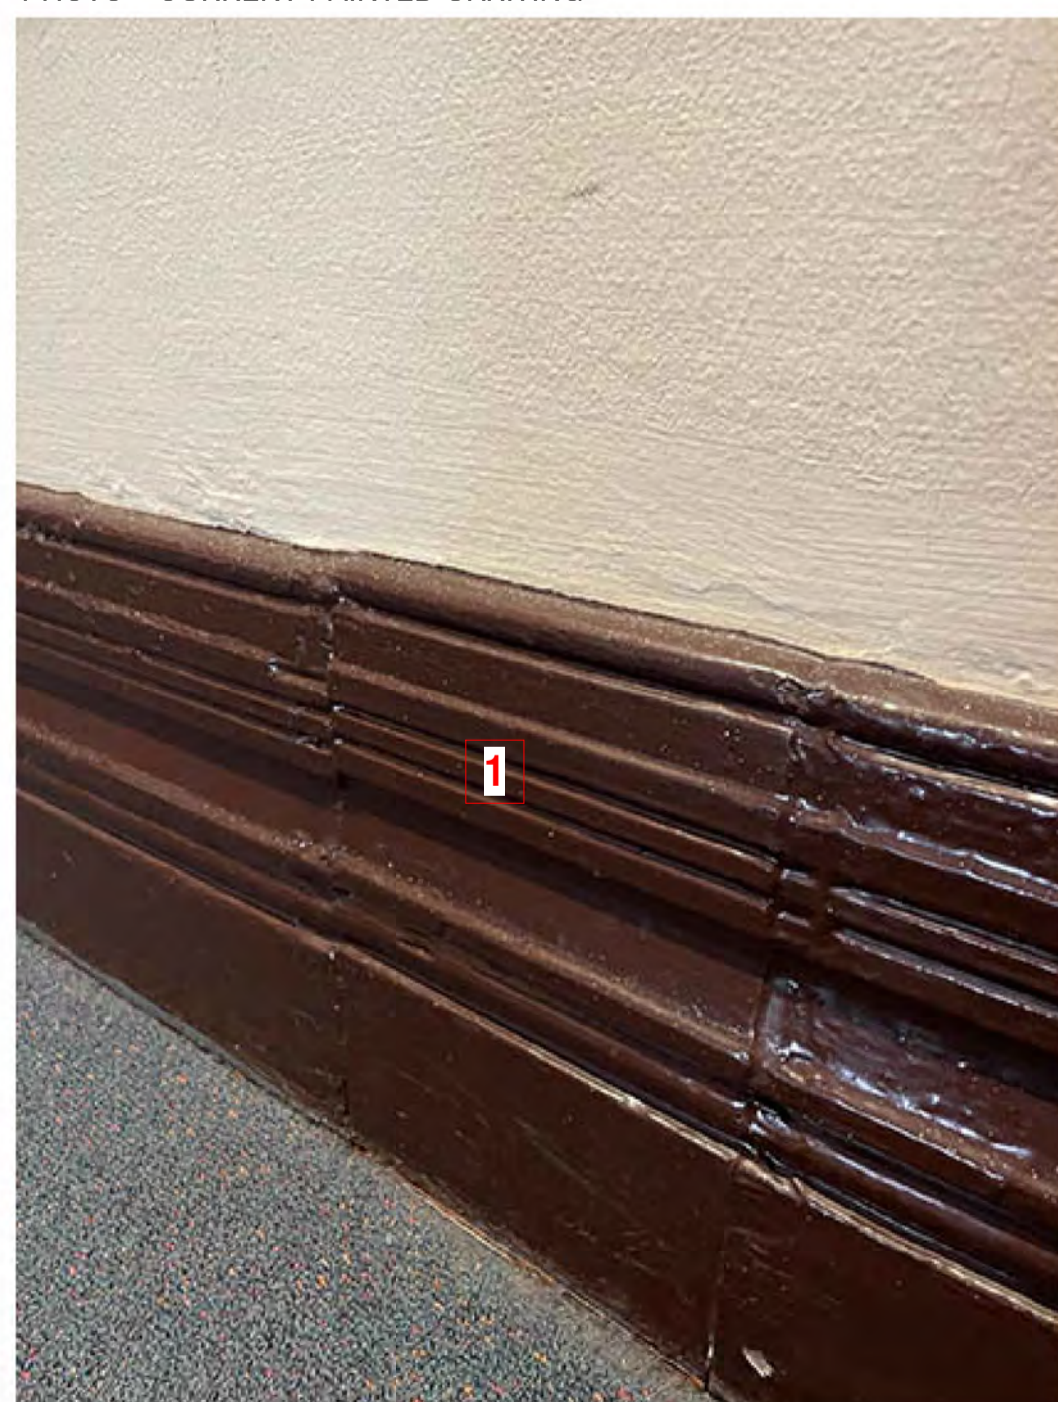
PHOTO - CURRENT PAINTED SKIRTING

- PATCHED SKIRTING WHERE WALL REMOVED TO HALLWAY

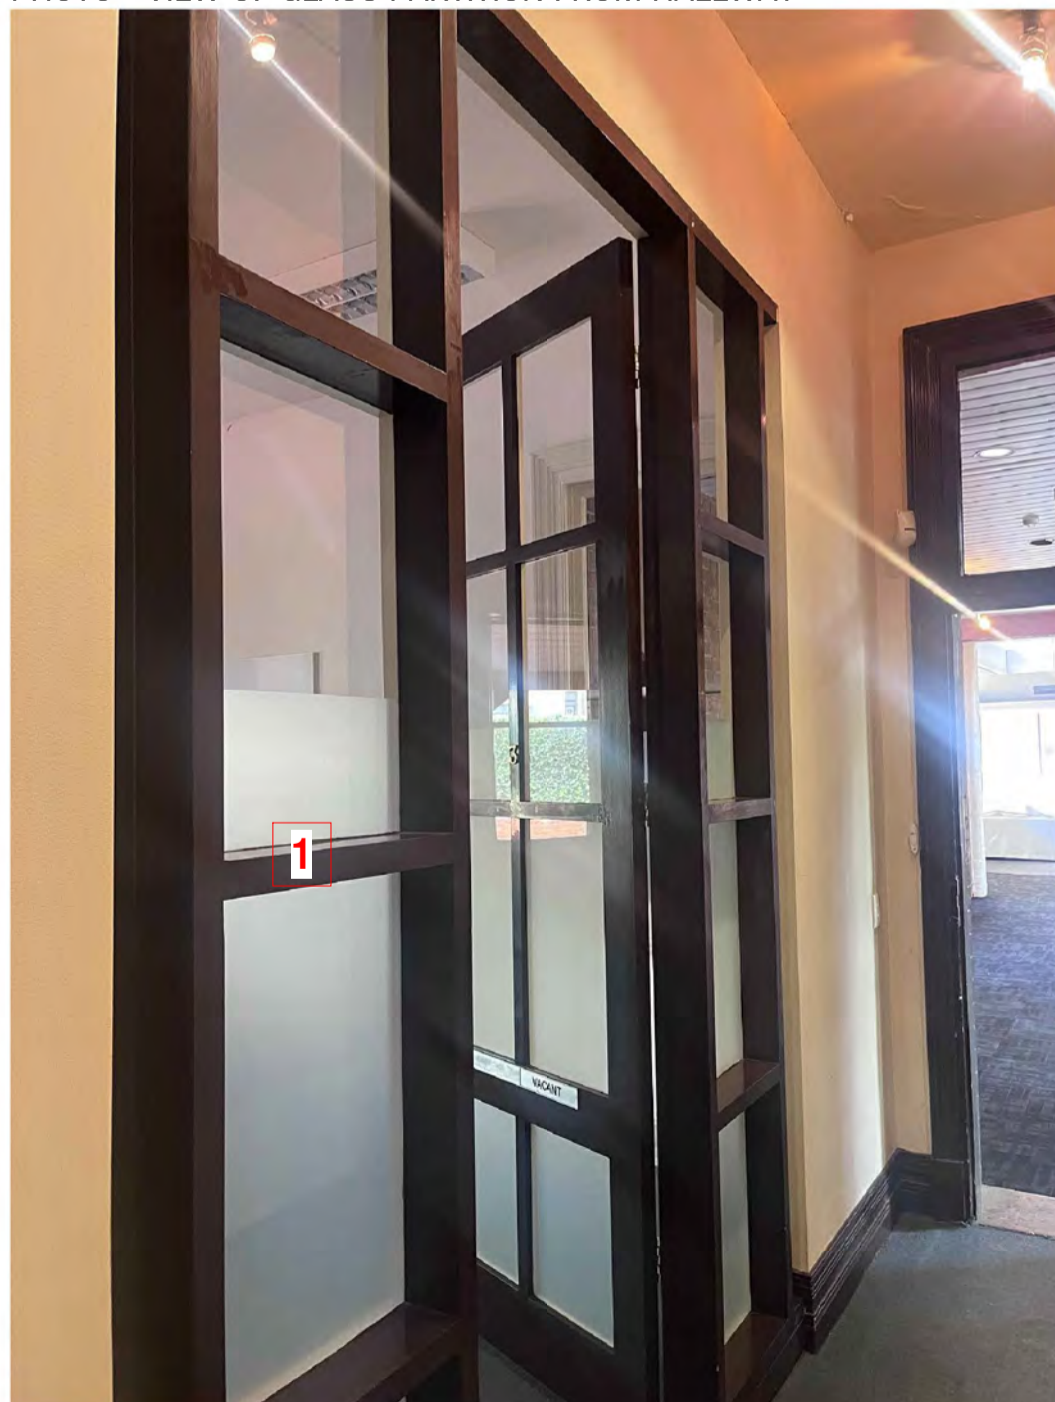
PHOTO - VIEW OF GLASS PARTITION FROM HALLWAY

- NON-ORIGINAL GLAZED PARTITION AND DOOR. REMOVE
- NON-ORIGINAL FILM TO WINDOW. REMOVE
- SKIRTING TO WALL. TBC IF ORIGINAL
- NON-ORIGINAL ALUMINIUM WIRING CONDUIT SKIRTING TO WALLS ON ALL 3 SIDES. REMOVE

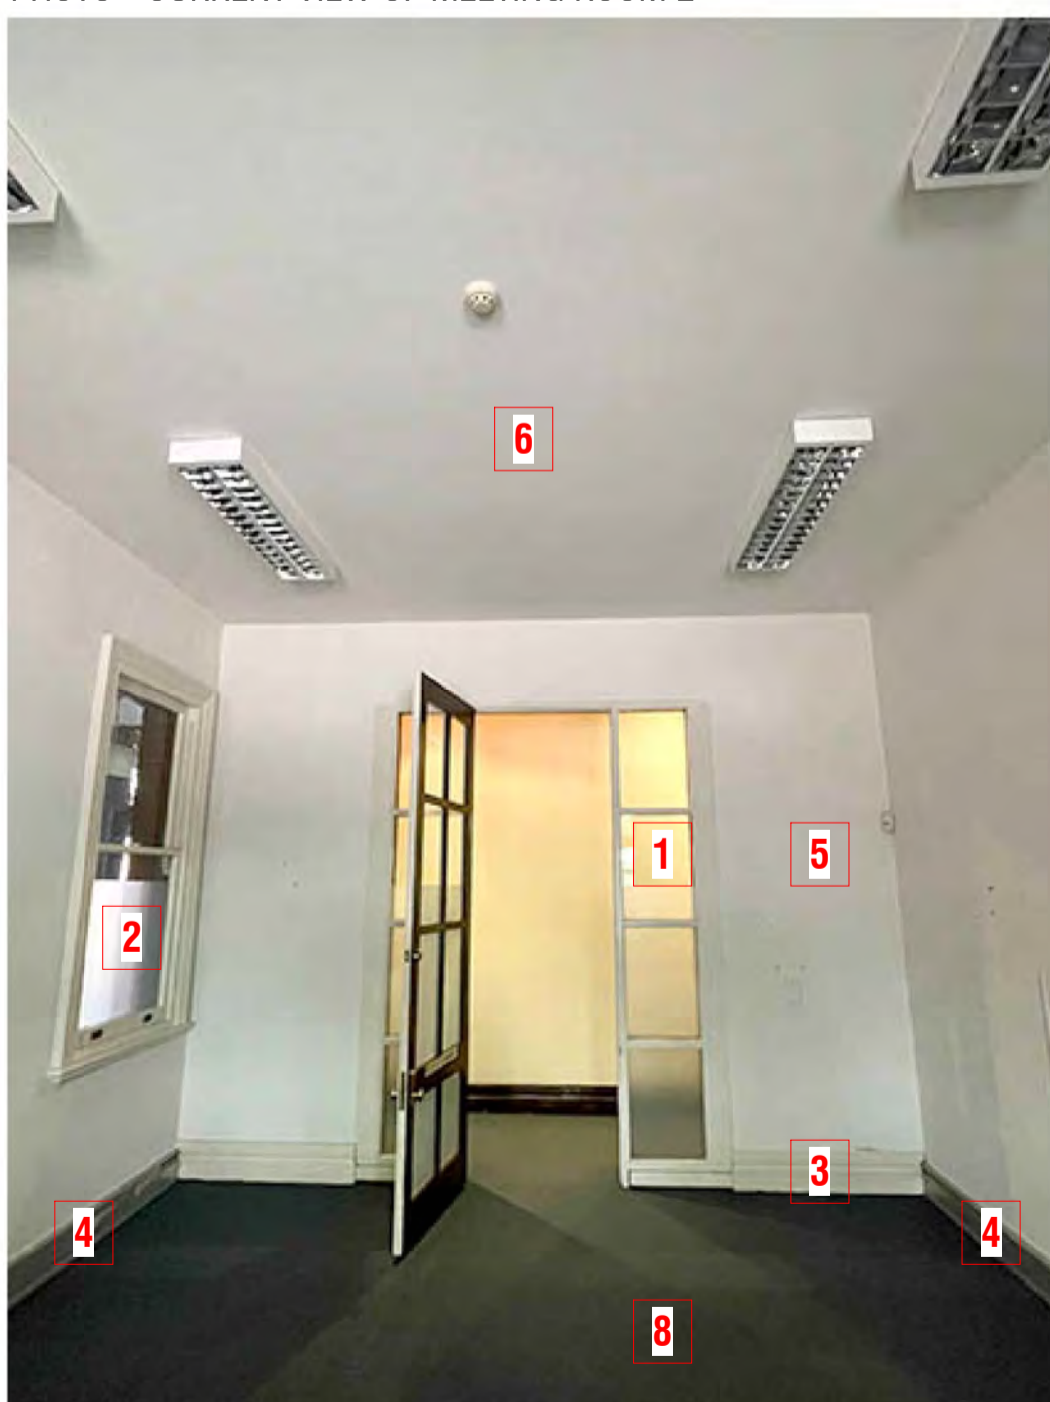
PHOTO - CURRENT VIEW OF MEETING ROOM 2

- CURRENT PAINT COLOUR: LIGHT WHITE TONE PAINT TO WALLS / CEILING / ARCHITRAVE AND SKIRTING. PROPOSED PAINT COLOUR: LIGHT TONE DISTEMPER PAINT
- NON ORIGINAL CEILING AND LIGHTS. REMOVE.
