PROJECT 1-19 CLARENDON ST

DRAWING EXTERNAL REPAIR WORK  
- SOUTH ELEVATION

EXTERNAL REPAIR WORK - EAST ELEVATION

| A | HW RFI 01 | NOV 2024 |
|---|---|---|
| DRAWING | EXTERNAL REPAIR WORK - WEST ELEVATION | |

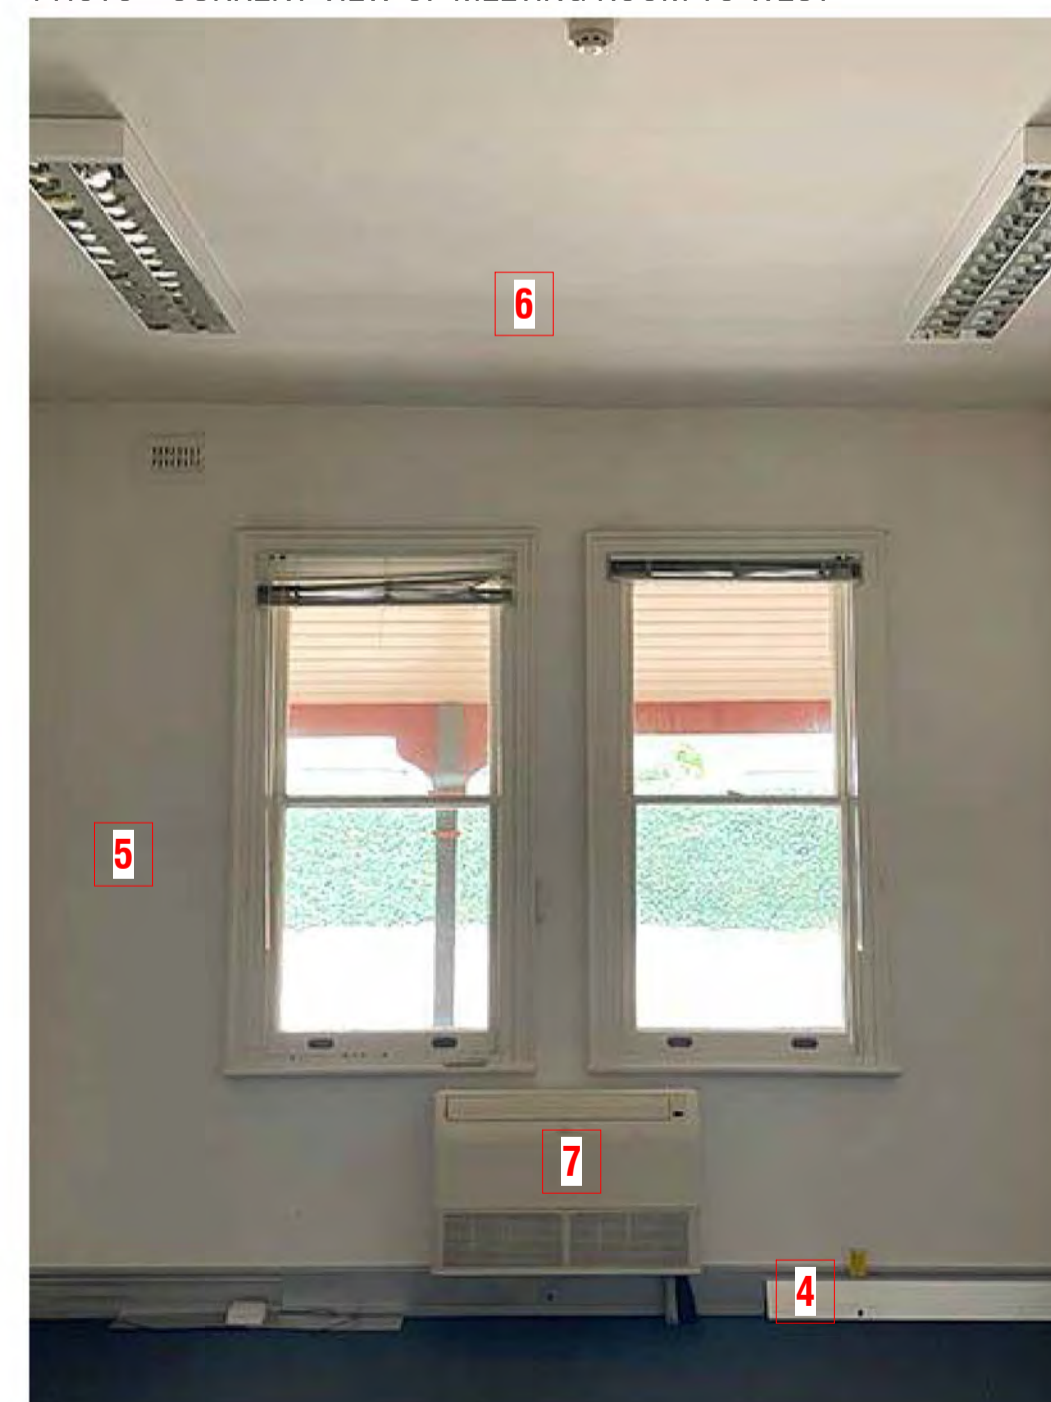
PHOTO - CURRENT VIEW OF MEETING ROOM TO WEST

- NON-ORIGINAL HEATING WALL UNIT. REMOVE.

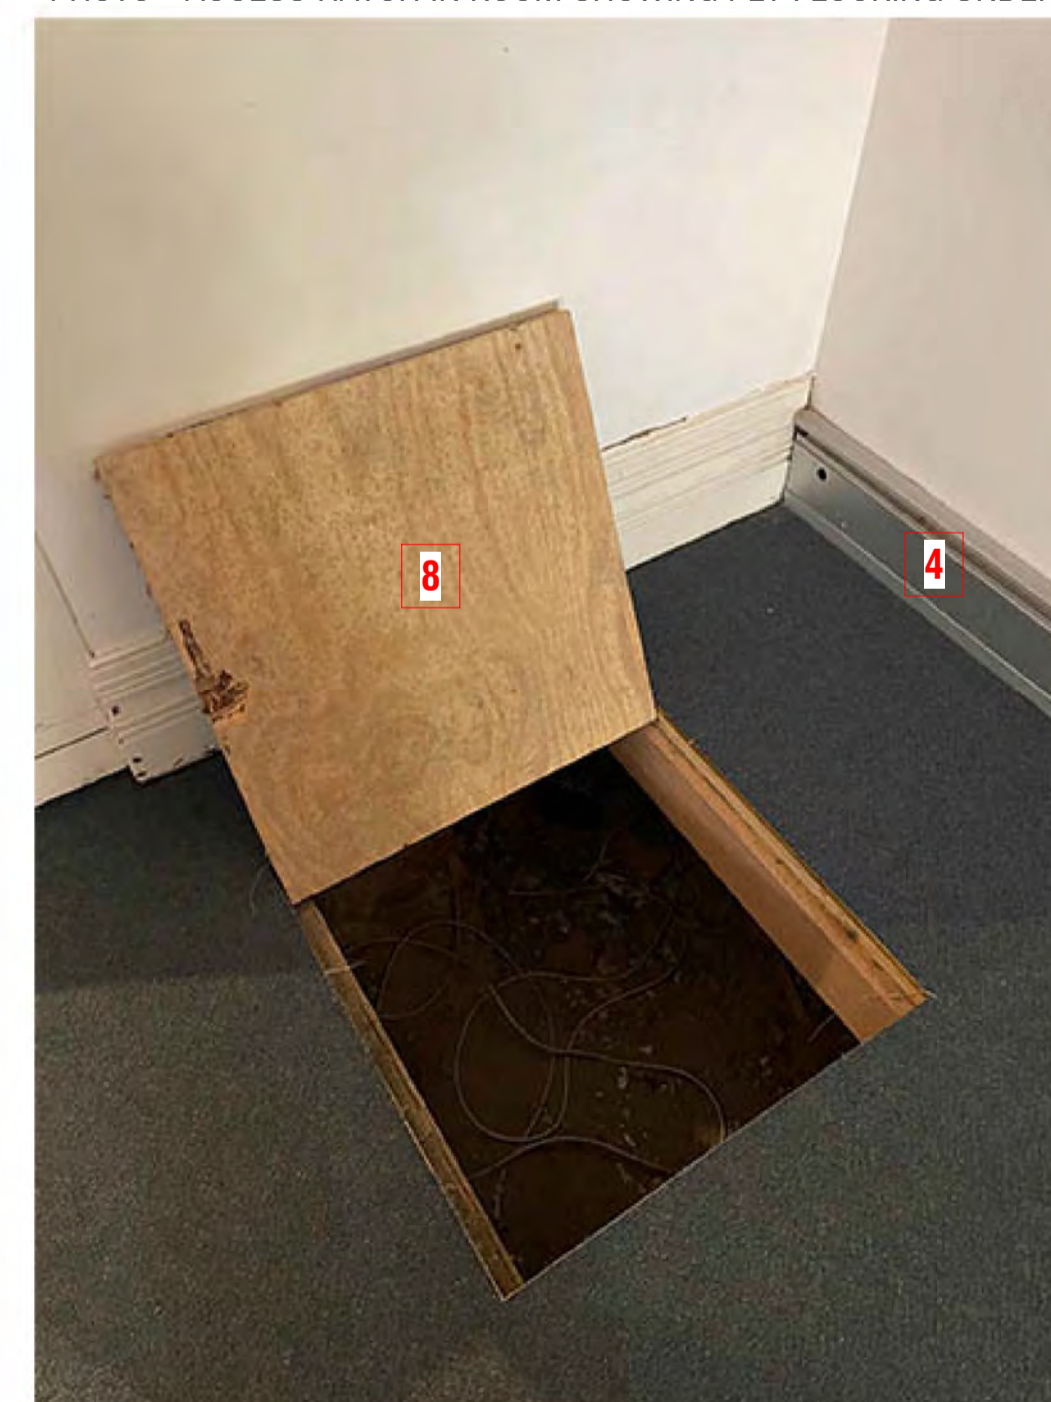
PHOTO - ACCESS HATCH IN ROOM SHOWING PLY FLOORING UNDER

- NON-ORIGINAL CARPET AND PLY FLOORING UNDER. REMOVE.

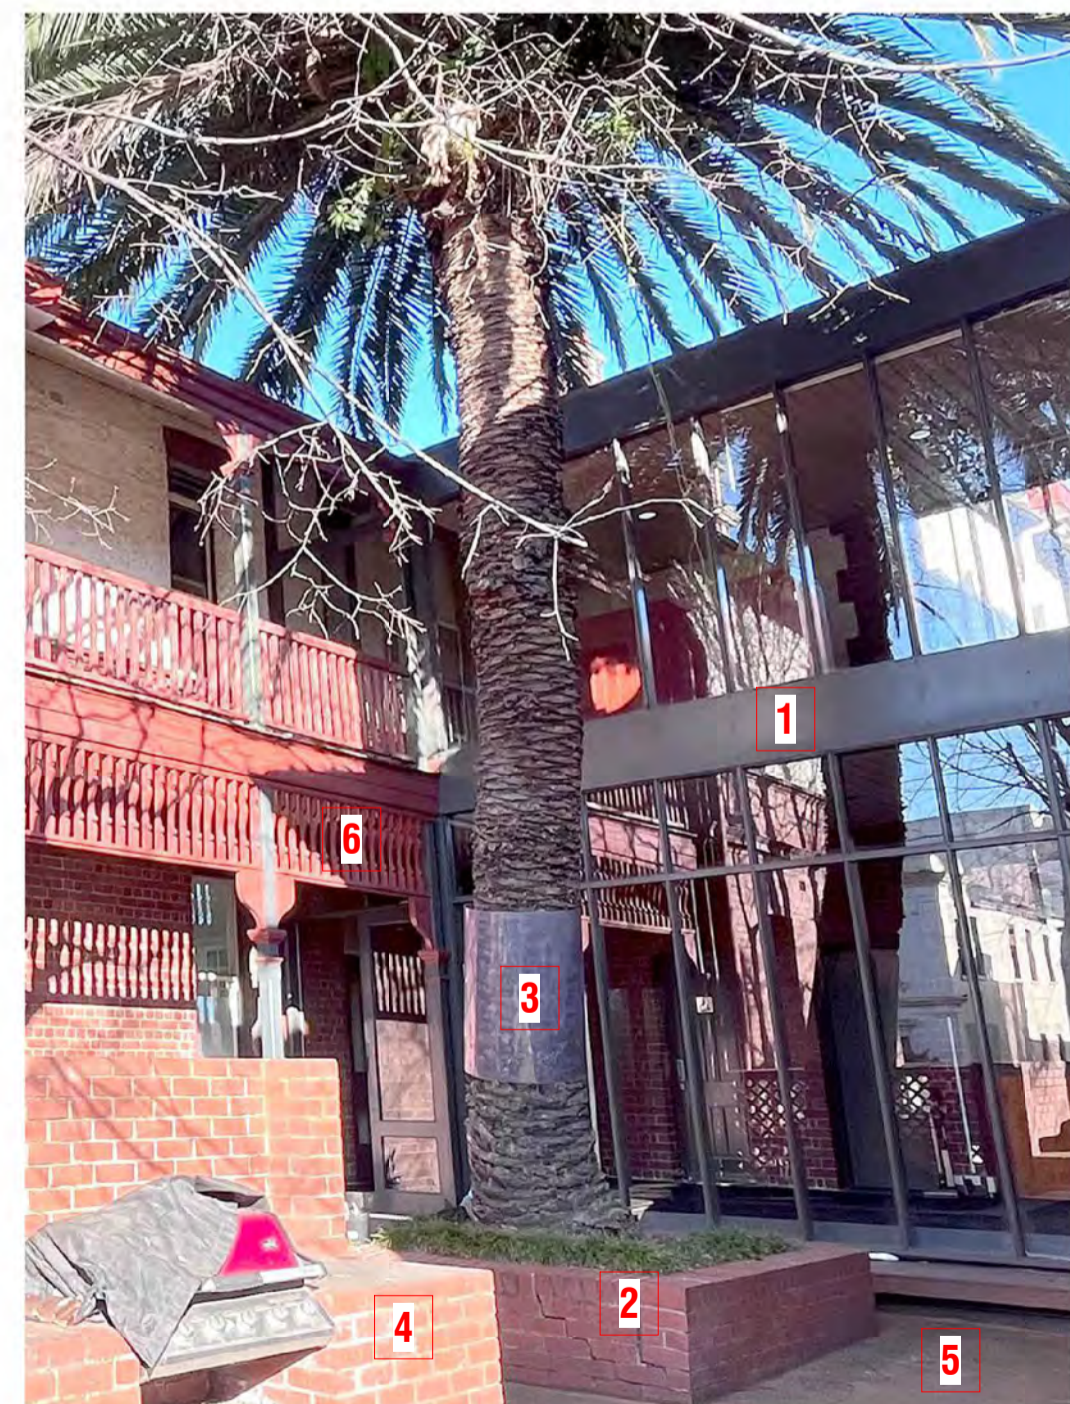
PHOTO - VIEW TOWARDS CURRENT BUILDING LINK

- 1. NON-ORIGINAL 2-STORY BUILDING LINK. REMOVE
- 2. NON-ORIGINAL RAISED PLANTER. REMOVE
- 3. NON-ORIGINAL PALM TREE. RELOCATE
- 4. NON-ORIGINAL BBQ. REMOVE
- 5. NON-ORIGINAL PAVED SURFACES. REMOVE
- 6. REINSTATE 2-STORY DOUBLE VERANDAH

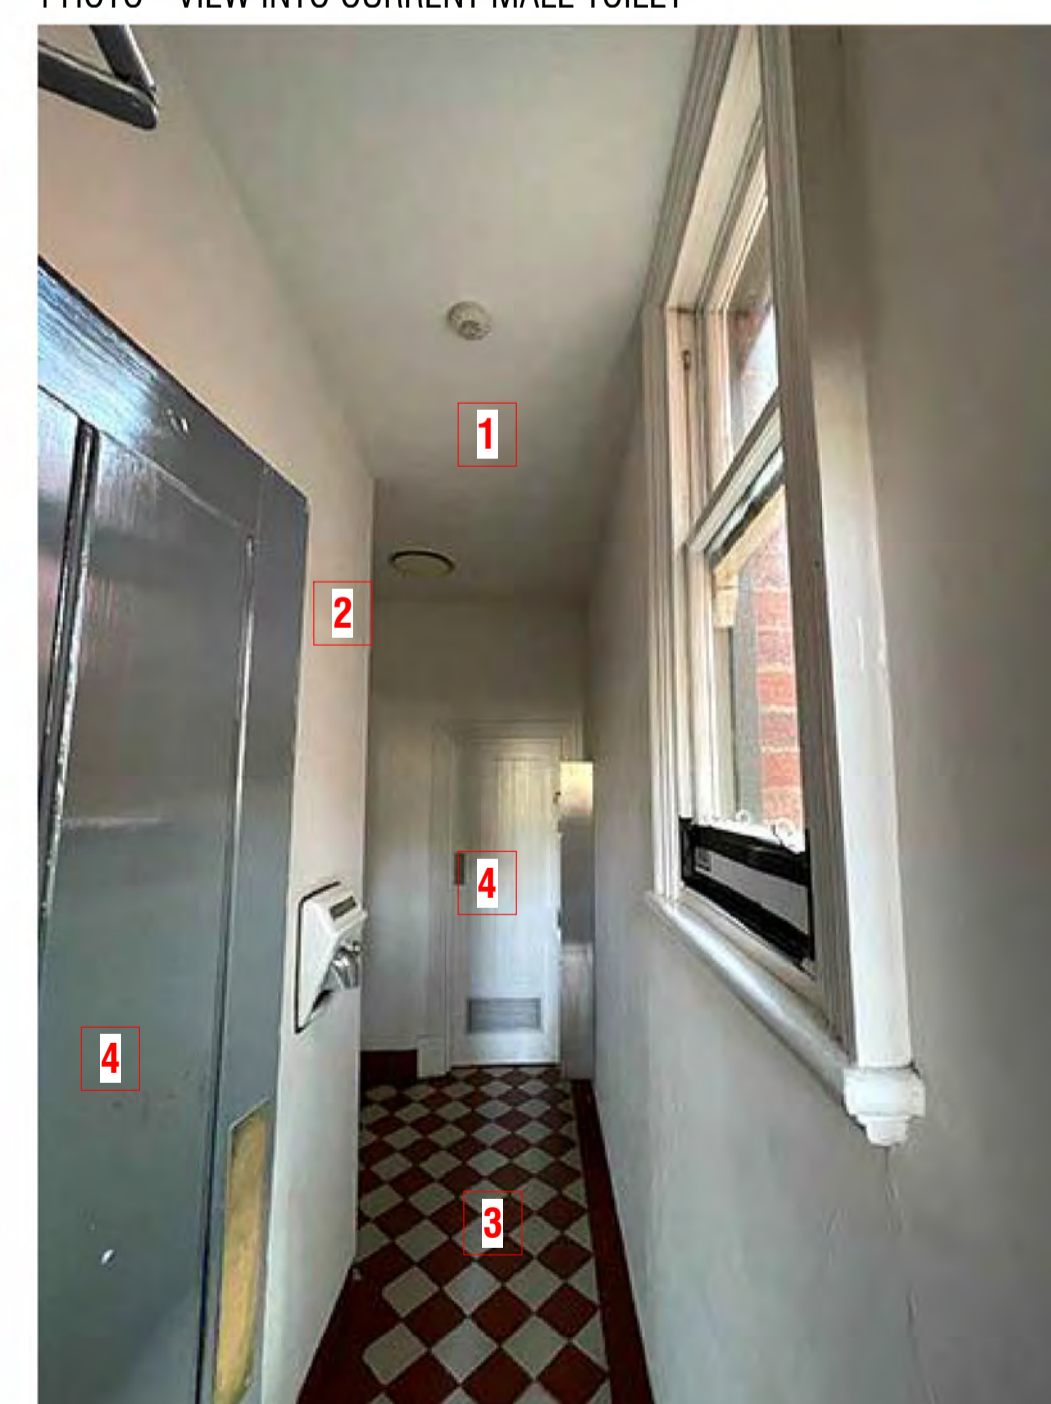
PHOTO - VIEW INTO CURRENT MALE TOILET

- 1. NON-ORIGINAL CEILING. REMOVE
- 2. NON-ORIGINAL WALL PARTITIONS. REMOVE
- 3. NON-ORIGINAL TILES. REMOVE
- 4. NON-ORIGINAL DOORS. REMOVE
- 5. NON-ORIGINAL PAINT FINISHES. REPAINT

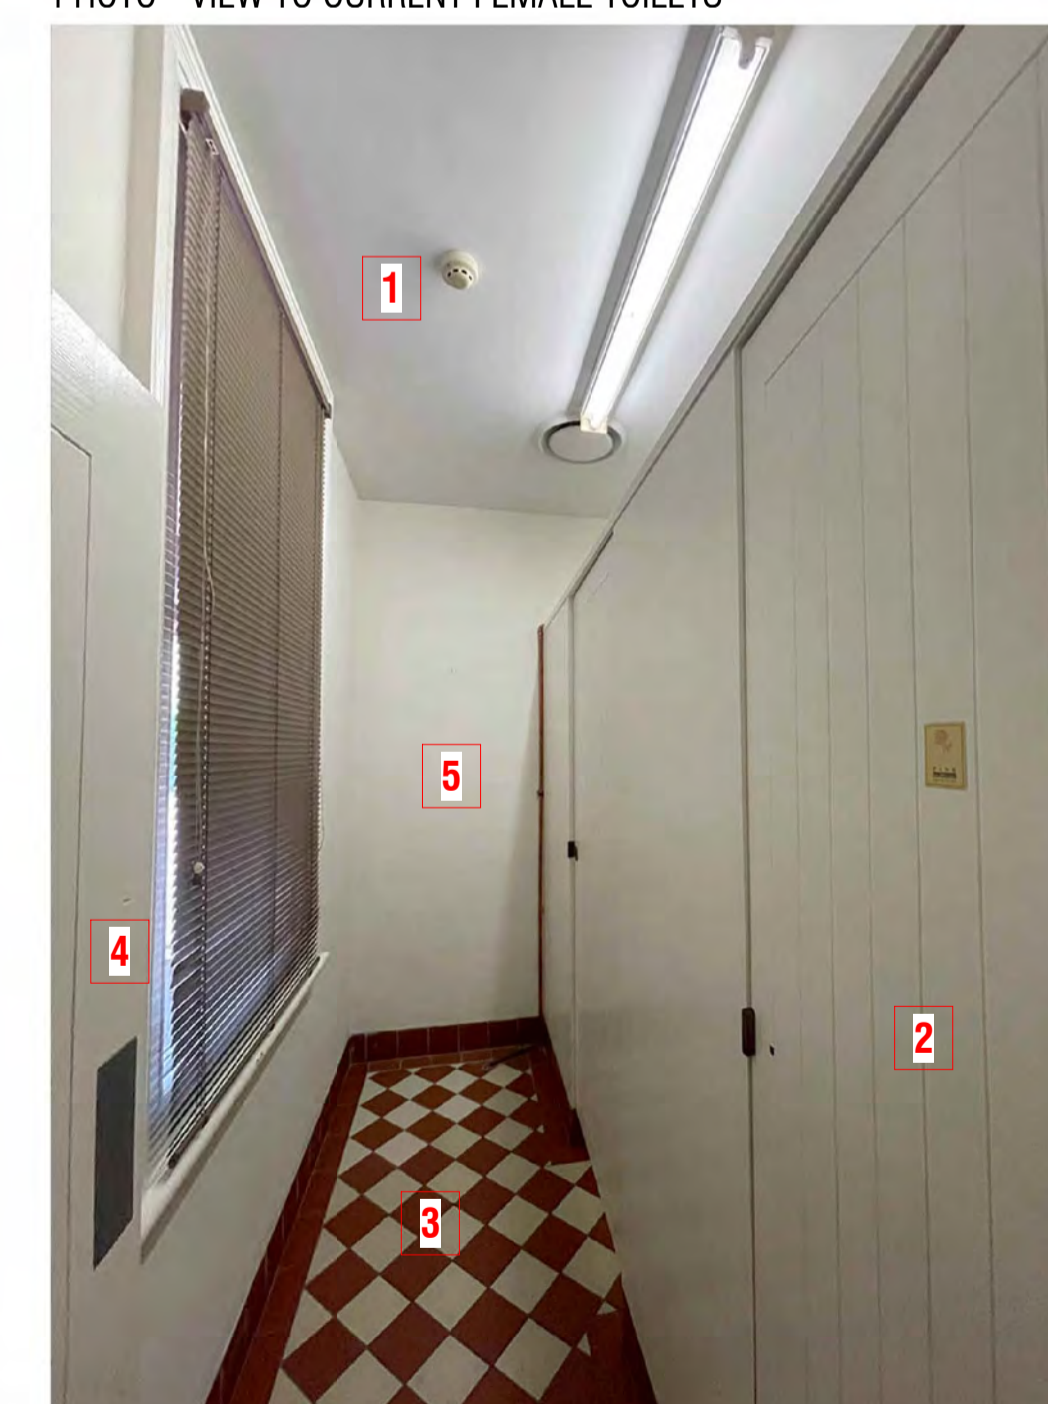
PHOTO - VIEW TO CURRENT FEMALE TOILETS

- 1. NON-ORIGINAL CEILING. REMOVE
- 2. NON-ORIGINAL WALL PARTITIONS. REMOVE
- 3. NON-ORIGINAL TILES. REMOVE
- 4. NON-ORIGINAL DOORS. REMOVE
- 5. NON-ORIGINAL PAINT FINISHES. REPAINT

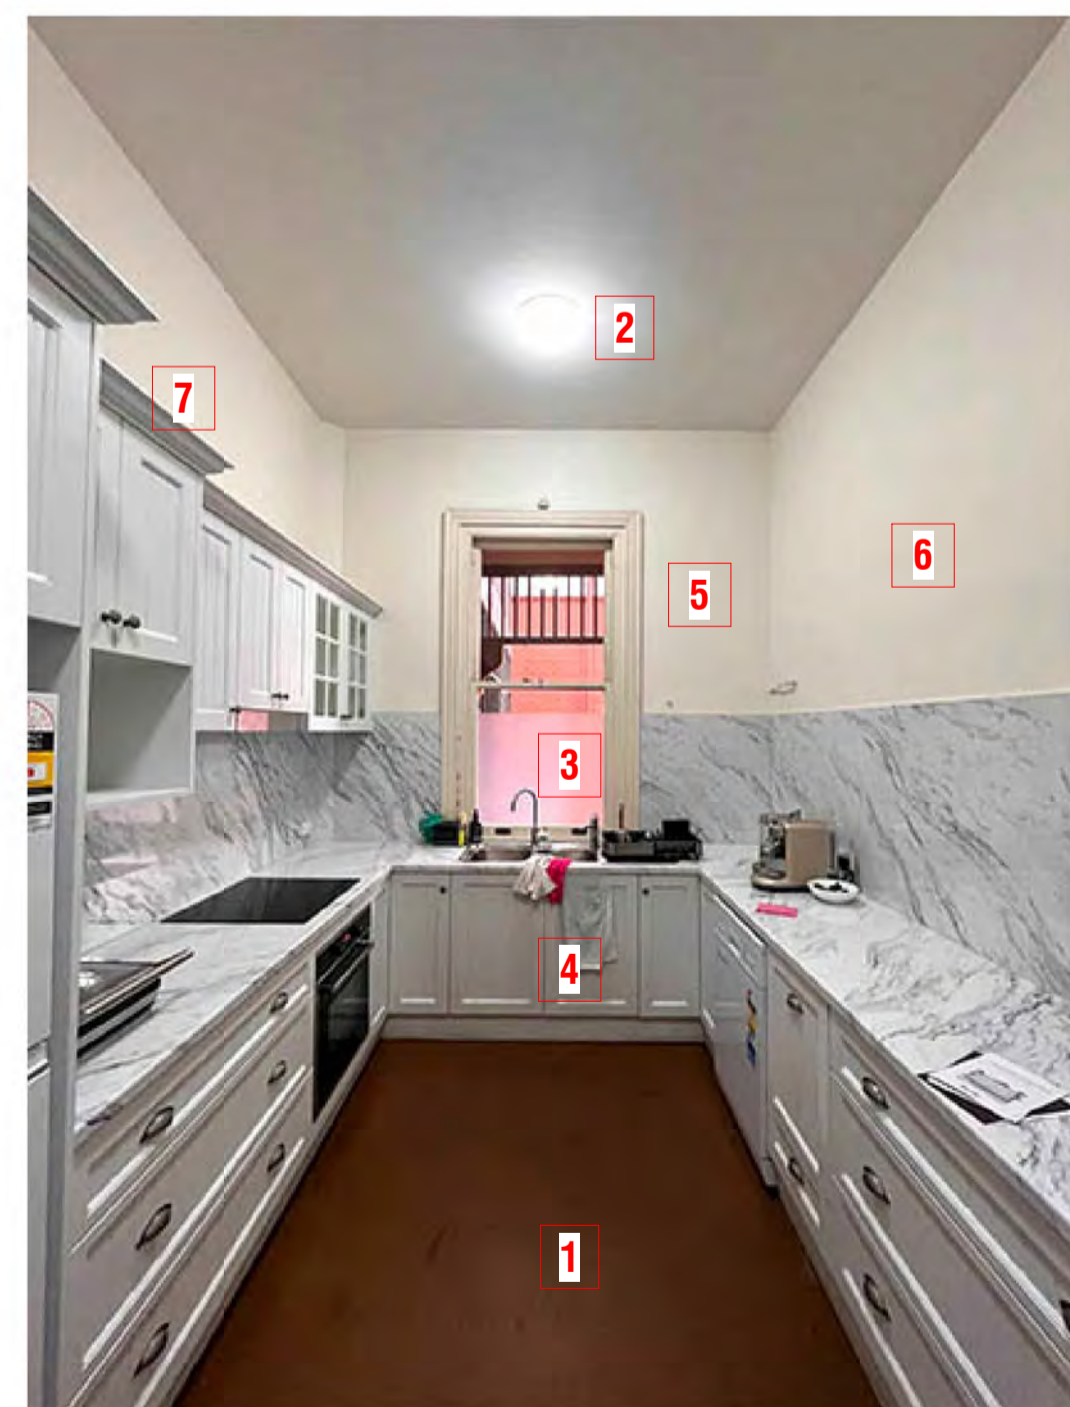
PHOTO - CURRENT VIEW OF KITCHEN

1. NON-ORIGINAL VINYL FLOORING. REMOVE
2. NON-ORIGINAL CEILING AND LIGHT. REMOVE
3. NON-ORIGINAL FILM ON WINDOW. REMOVE
4. NON-ORIGINAL JOINERY. REMOVE
5. NON-ORIGINAL PAINT FINISHES. REPAINT
6. NEW PORTAL OPENING TO WALL. REFER PLAN
7. NEW PORTAL OPENING TO WALL. REFER PLAN

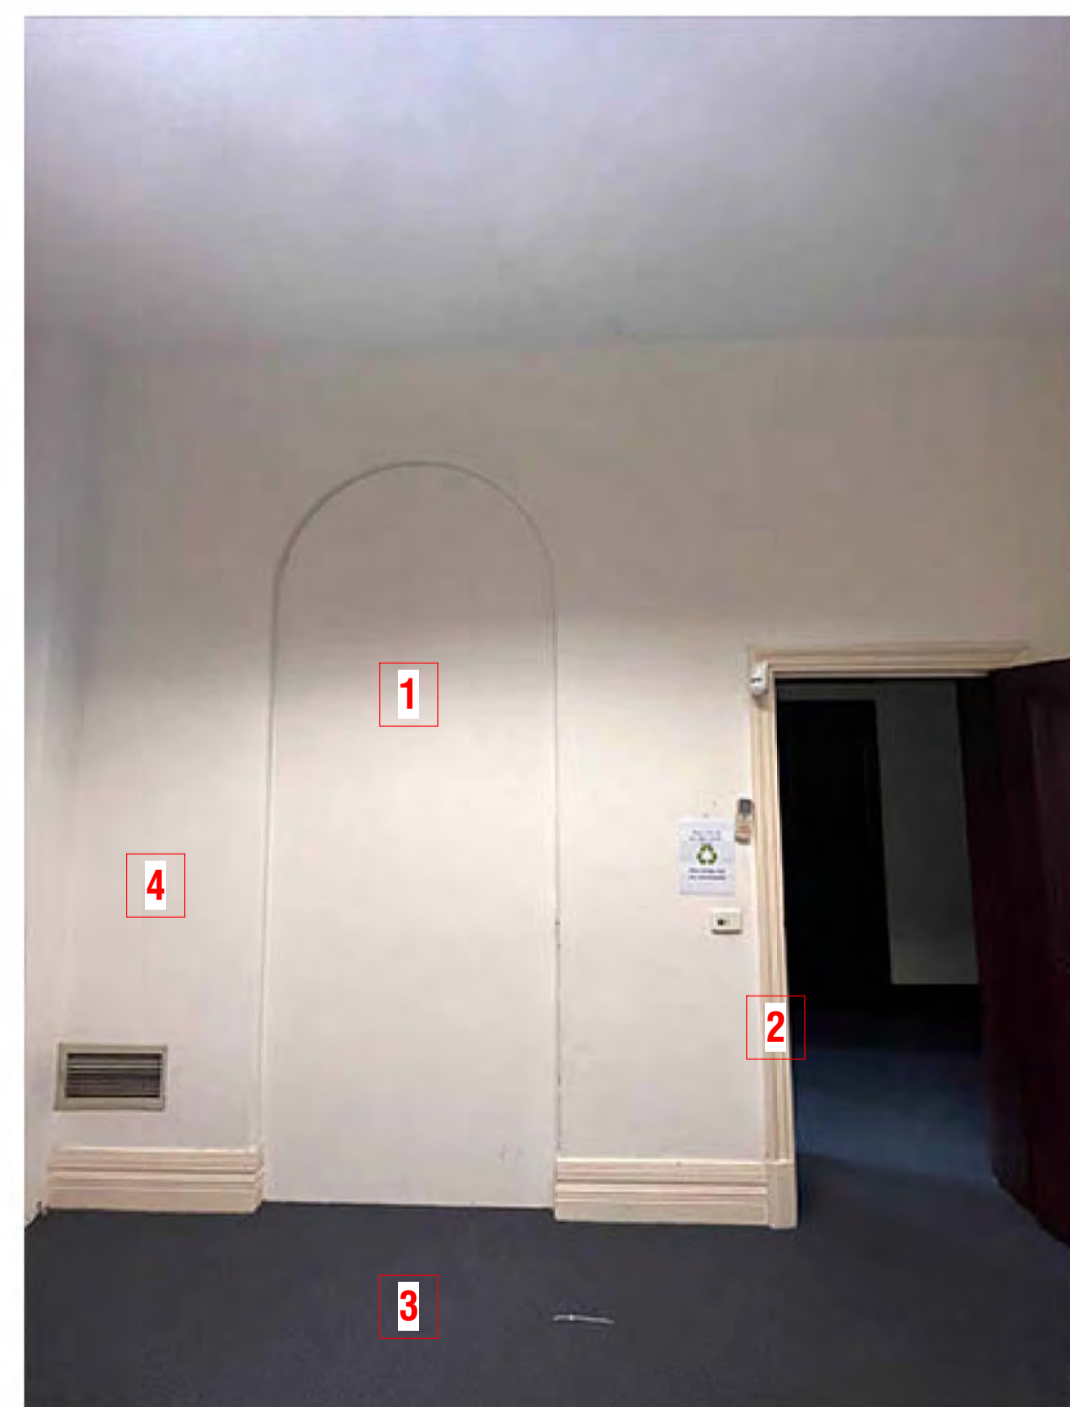
PHOTO - CURRENT VIEW OF MEETING ROOM 4

1. NON-ORIGINAL INFILL TO WALL. REMOVE.
2. NON ORIGINAL DOOR / ARCHITRAVE. REMOVE AND INFILL.
3. NON-ORIGINAL CARPET. REMOVE
4. NON-ORIGINAL PAINT FINISH TO WALL / CEILING / SKIRT. REPAINT

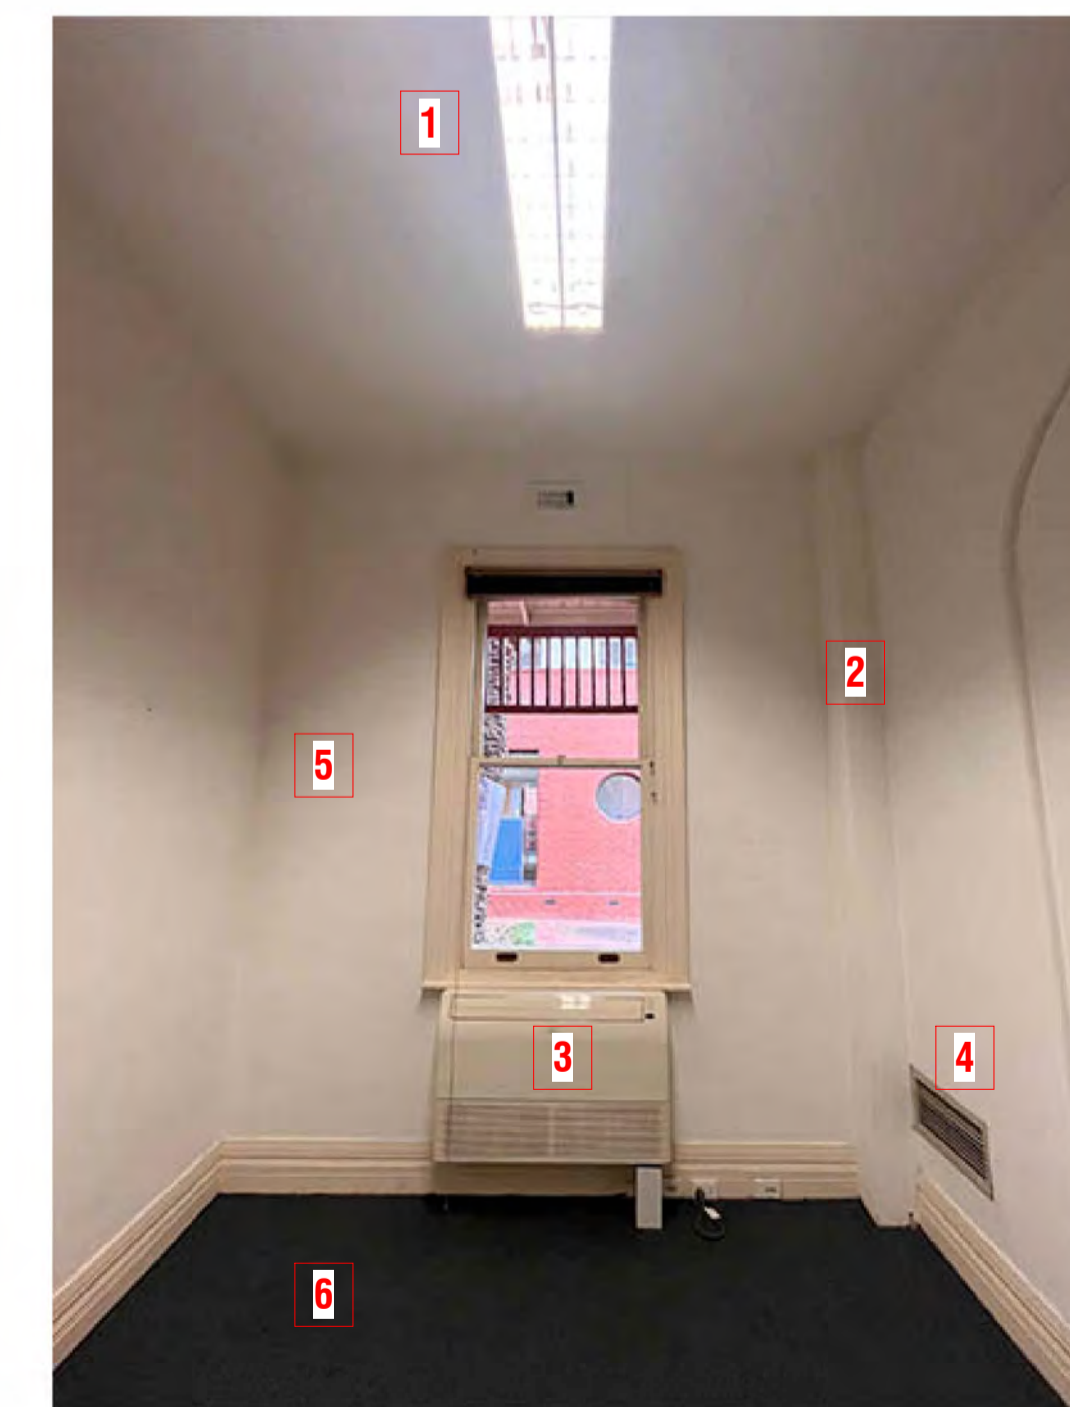
PHOTO - CURRENT VIEW OF MEETING ROOM 4 TO NORTH

1. NON-ORIGINAL CEILING AND LIGHTS. REMOVE
2. NON-ORIGINAL SERVICES DUCT. REMOVE
3. NON-ORIGINAL HEATING PANEL AND DUCT. REMOVE
4. NON-ORIGINAL VENT IN WALL. REMOVE AND PATCH WALL.
5. NON-ORIGINAL PAINT FINISHES. REPAINT
6. NON-ORIGINAL CARPET. REMOVE

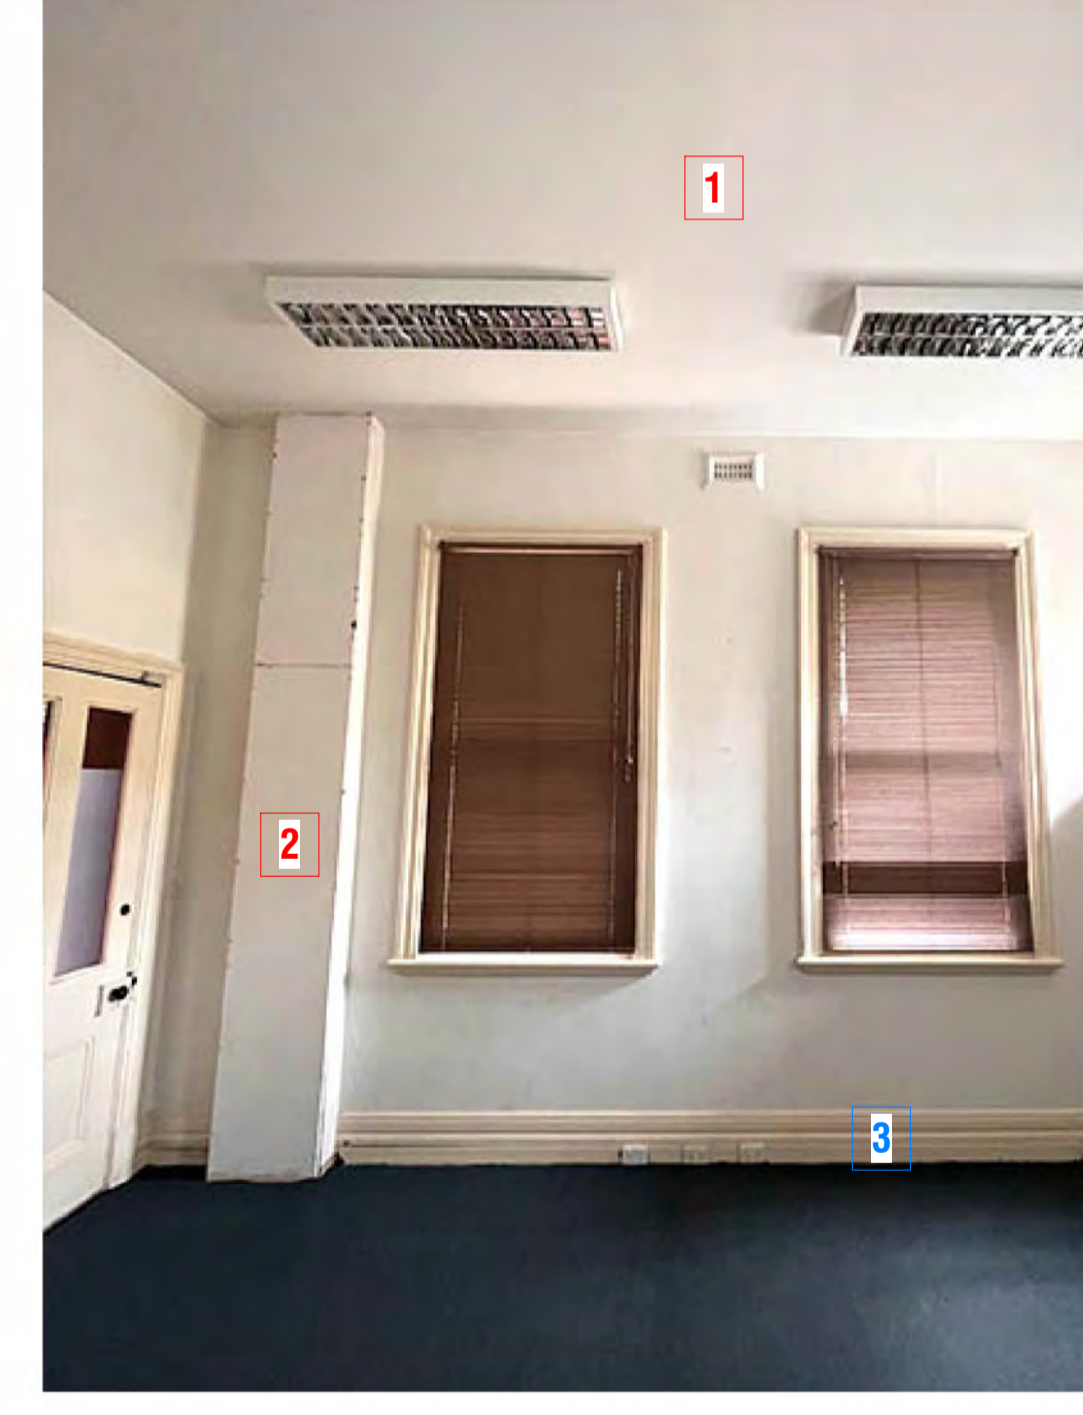
PHOTO - VIEW INTO MEETING ROOM 3 TO NORTH

- 1. POTENTIALLY NON-ORIGINAL CEILING AND LIGHT FITTINGS. REMOVE.
- 2. NON-ORIGINAL WIRING DUCT ENCLOSURE. REMOVE
- 3. NON-ORIGINAL PAINT FINISHES TO CEILING / WALL / SKIRT / ARCH REPAINT

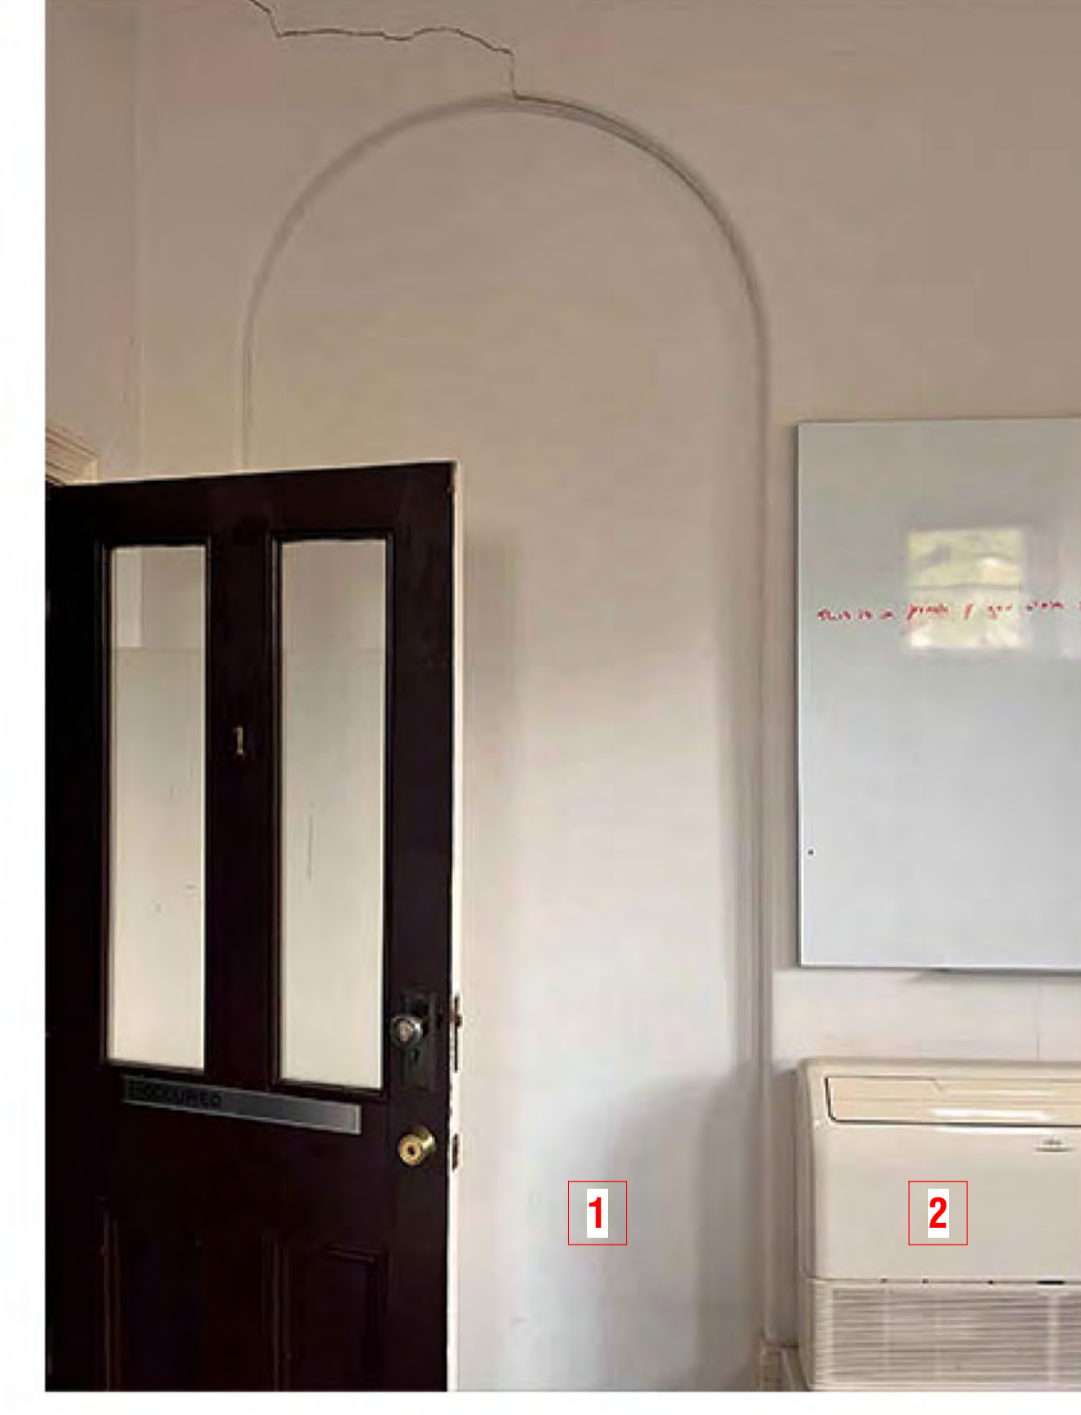
PHOTO - VIEW TO FILLED IN ARCH OPENING

- 1. NON-ORIGINAL WALL INFILL. REMOVE
- 2. NON-ORIGINAL WALL HEATING PANEL. REMOVE

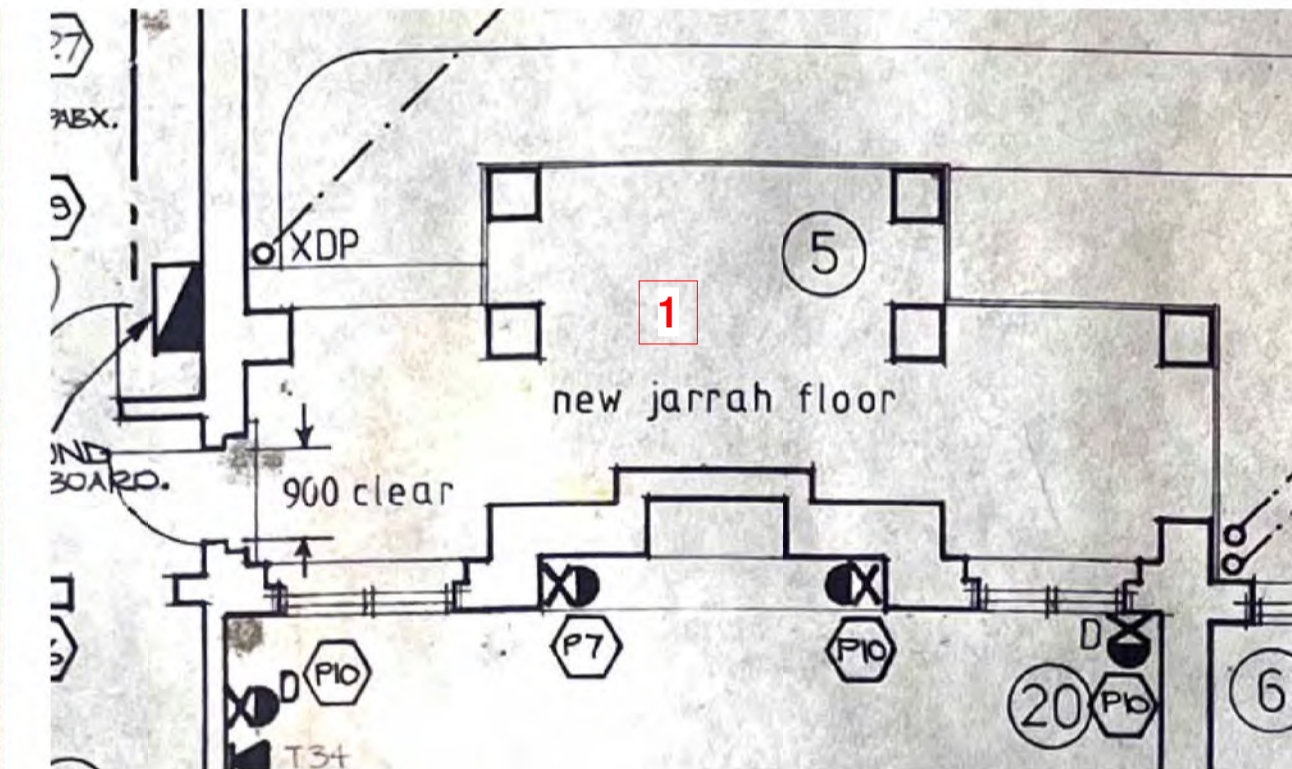
PHOTO - VIEW OF CURRENT BOARDROOM

1. NON-ORIGINAL JARRAH FLOORING NOTED IN 2001 RENOVATION DRAWINGS

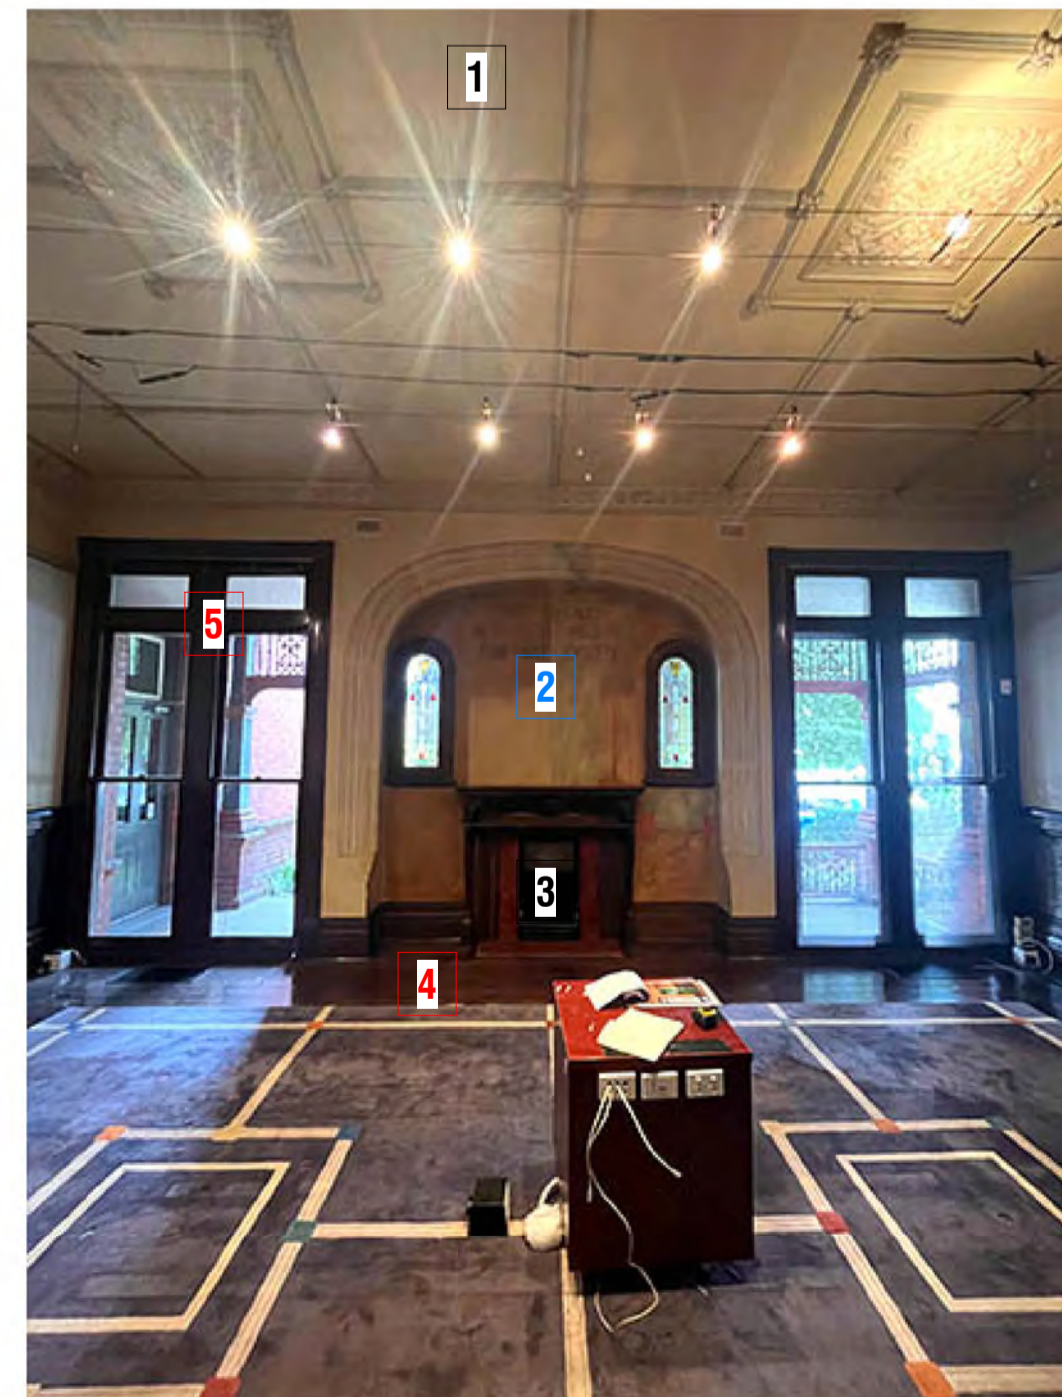
PHOTO - CURRENT VIEW CLOSE-UP OF ALCOVE

1. ORIGINAL CEILING TO REMAIN  
CURRENT PAINT COLOUR: LIGHT TONE CREAM. TYPE UNKNOWN.  
TO BE CONFIRMED IF ORIGINAL PAINT.  
PROPOSED PAINT COLOUR: LIGHT TONE DISTEMPER PAINT

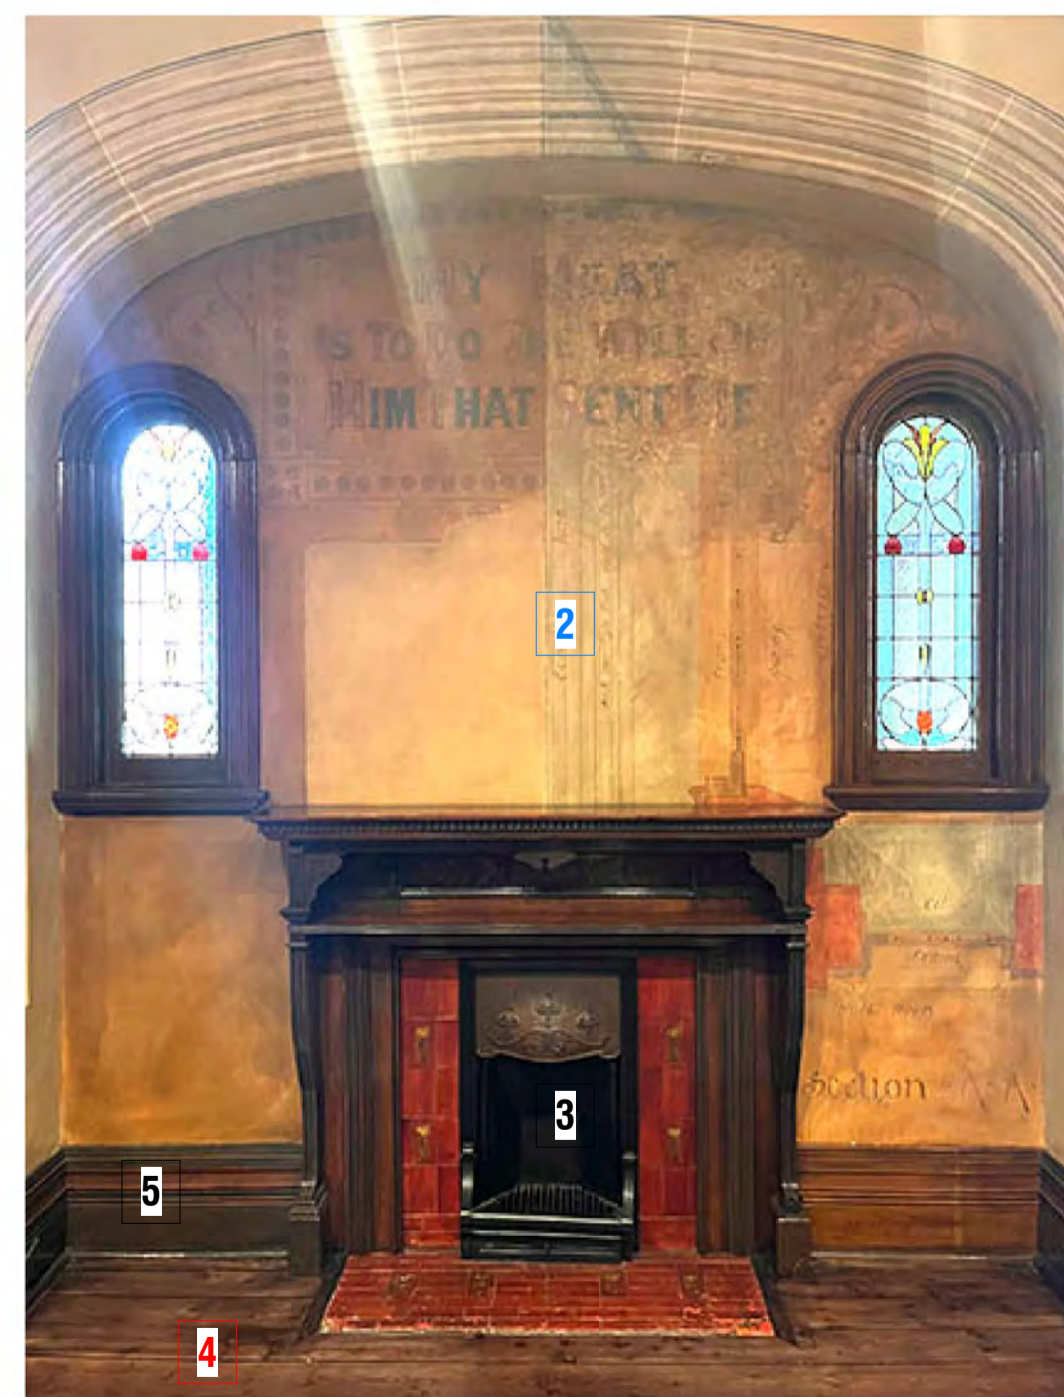
PHOTO - CURRENT VIEW OF PRESSED METAL WAINSCOTTING

2. POTENTIAL LATER WALL MURAL ADDITION. TBC. COVER OVER  
3. ORIGINAL FIREPLACE TO REMAIN  
4. ORIGINAL BALTIC PINE FLOOR. INSTALL NEW TIMBER FLOORING OVER  
5. TIMBER SKIRTING / ARCHITRAVES TO REMAIN.  
TIMBER TYPE: RED CEDAR  
FINISH: CLEAR VARNISH. TBC IF ORIGINAL

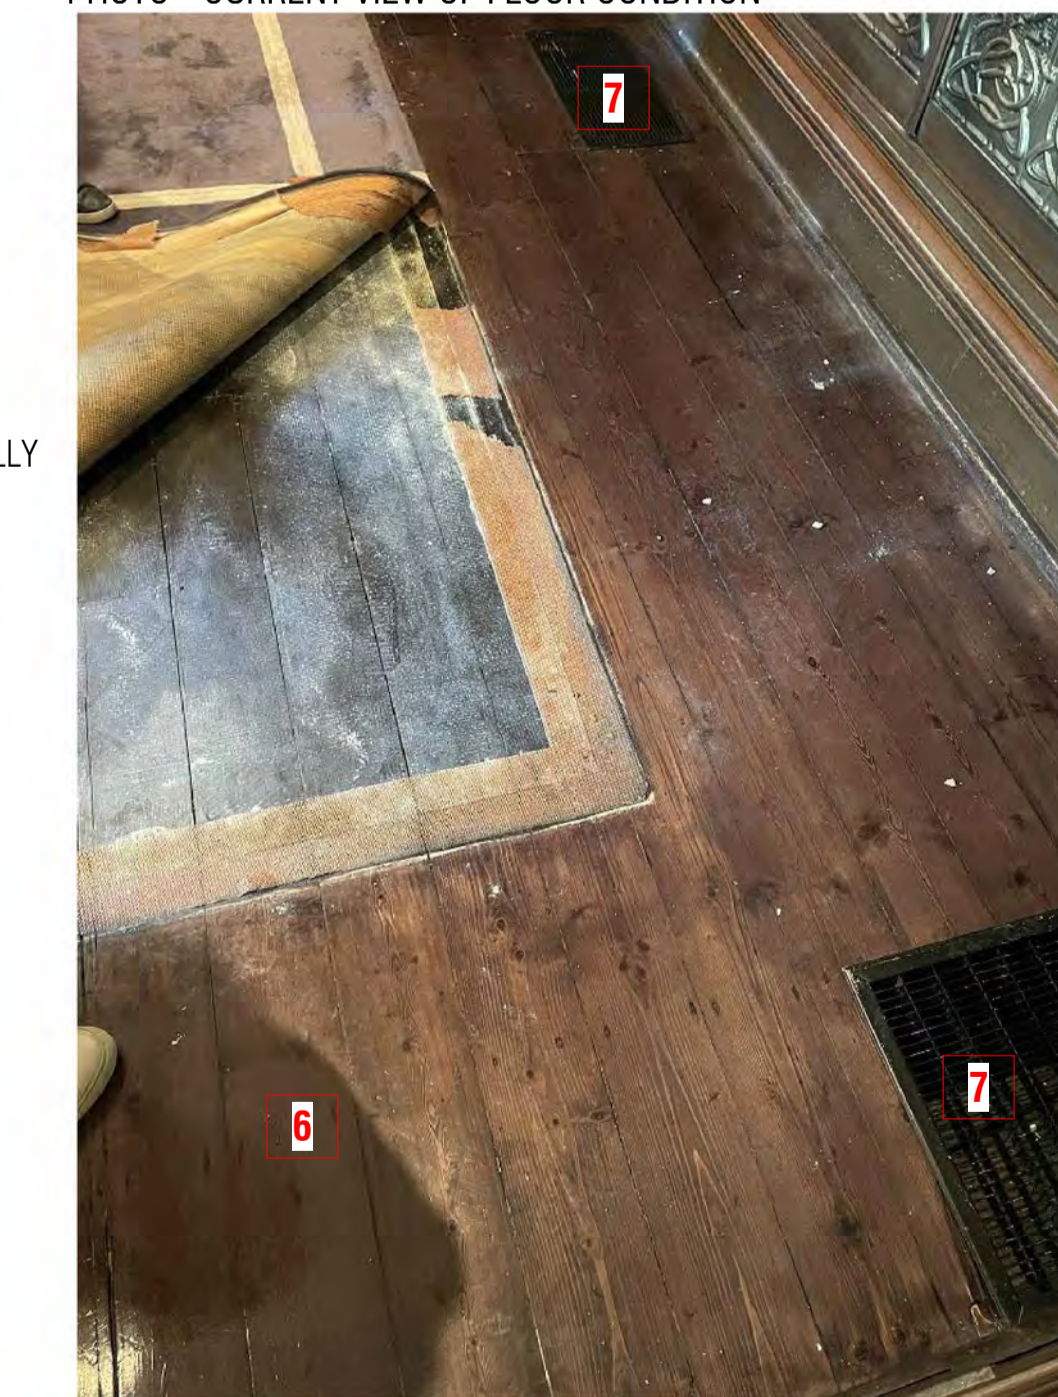
PHOTO - CURRENT VIEW OF FLOOR CONDITION

1. NON-ORIGINAL TIMBER LEDGE. REMOVE  
2. PRESSED METAL WAINSCOTTING. TBC IF LEFT UNPAINTED ORIGINALLY  
3. PRESSED METAL BOARDER AROUND WAINSCOTTING. PAINTED. TBC IF ORIGINAL  
4. DADO / TIMBER SKIRT / ARCHITRAVES TO REMAIN. TIMBER TYPE: RED CEDAR. FINISH: CLEAR VARNISH. TBC IF ORIGINAL  
5. CURRENT PAINT FINISH: BEIGE. TBC IF ORIGINAL PAINT TYPE: UNKNOW. PROPOSED PAINT FINISH: LIGHT TONE  
6. ORIGINAL BALTIC PINE TIMBER FLOORING TO REMAIN. NEW TIMBER FLOOR FINISH OVER  
7. NON-ORIGINAL VENT GRILLE CUT-OUTS IN ORIGINAL FLOORING. COVER OVER WITH NEW TIMBER FLOORING.
