Heritage Impact Statement

Revitalisation Project at St. Michael's Uniting Church VHR H0004 122-136 Collins Street, Melbourne

Author Trethowan Architecture

Date 19 December 2024

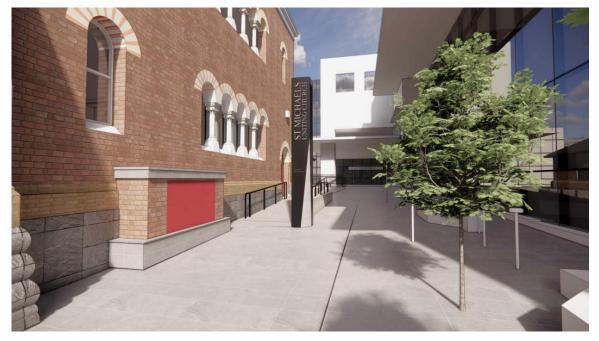
Figure 41 Proposed St. Michael's Walk approach. Source: Trethowan Architecture, 2024.

It is proposed to remove the existing non-compliant accessible entrance to the St. Michael's Walk entry and replace with a new compliant entrance ramp. As part of the works an area of the existing bluestone ground paving along the east wall will be removed. The new ramp will run parallel to the east wall, separated by a 150mm gap (with linear drain) and falling towards the south with new landing centred to the existing double entrance doors. Steps will provide access to the landing at the north. The ramp/stairs will feature bluestone paving to match the surrounding paving and contemporary freestanding metal handrails. A new low masonry wall will run along the east of the ramp. A monolith 'St Michael's Uniting Church' entrance sign will be installed adjacent to the southeast corner of the ramp to assist in wayfinding. The original timber entrance doors will be retained and restored, with later glazing removed and timber panelling installed to match the original design. Door hardware will be updated as required.

The later metal handrails and part of the existing stairs in front of the amenities block will be removed and replaced with new bluestone paving, a low masonry wall and handrail. The handrails and stair to the north end of St. Michael's Walk will be retained.

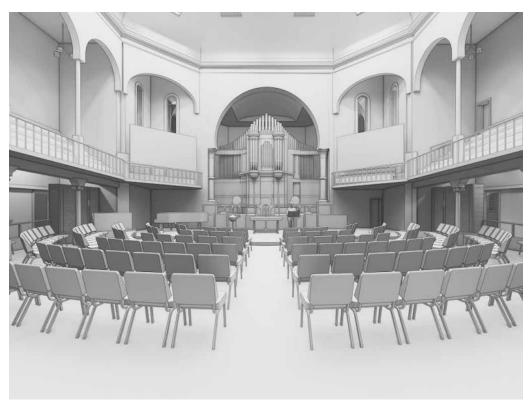
Figure 53 Proposed auditorium as viewed from the aisle. Source: Trethowan Architecture, 2024.
